# Technical Note

| <b>Project:</b> | P18-669 Llanwern – Phase 4B & 5D | | |
| <b>Subject:</b> | Phase 4B & 5D Controlled Waters Detailed Quantitative Risk Assessment Addendum | | |
| <b>Document Ref:</b> | 18669-RLL-24-XX-RP-O-0591 | <b>Revision:</b> | P02 |

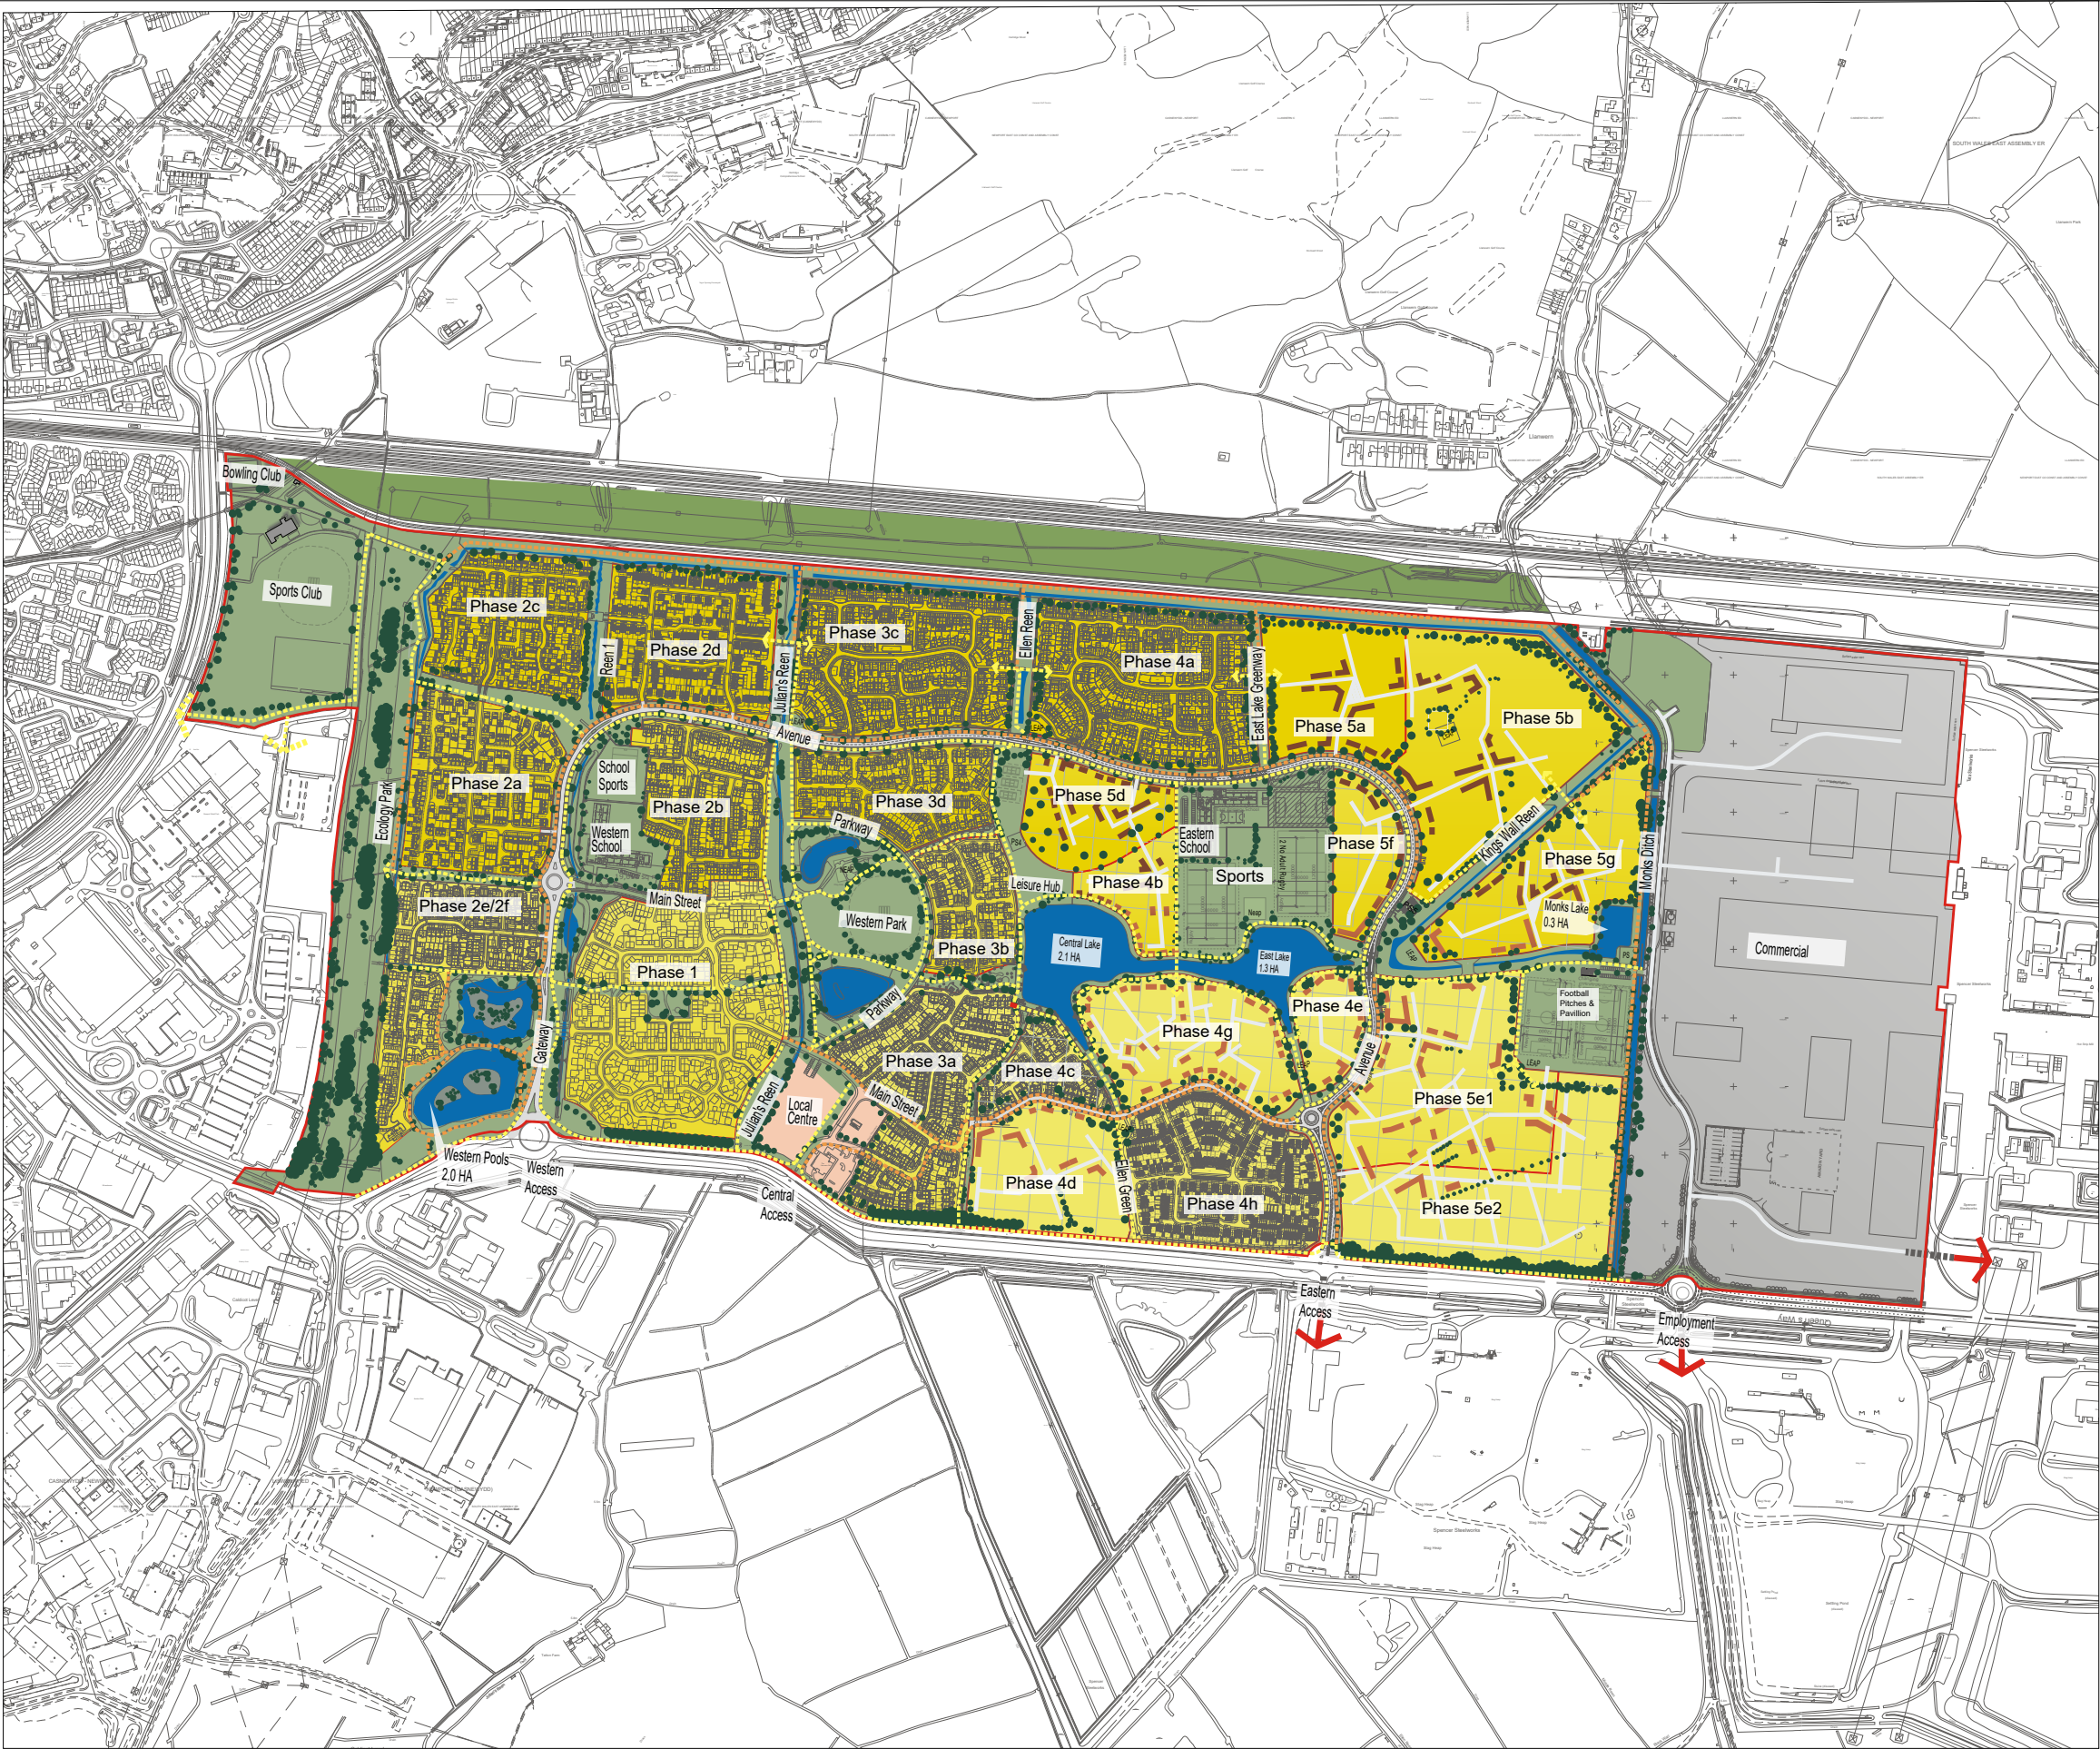
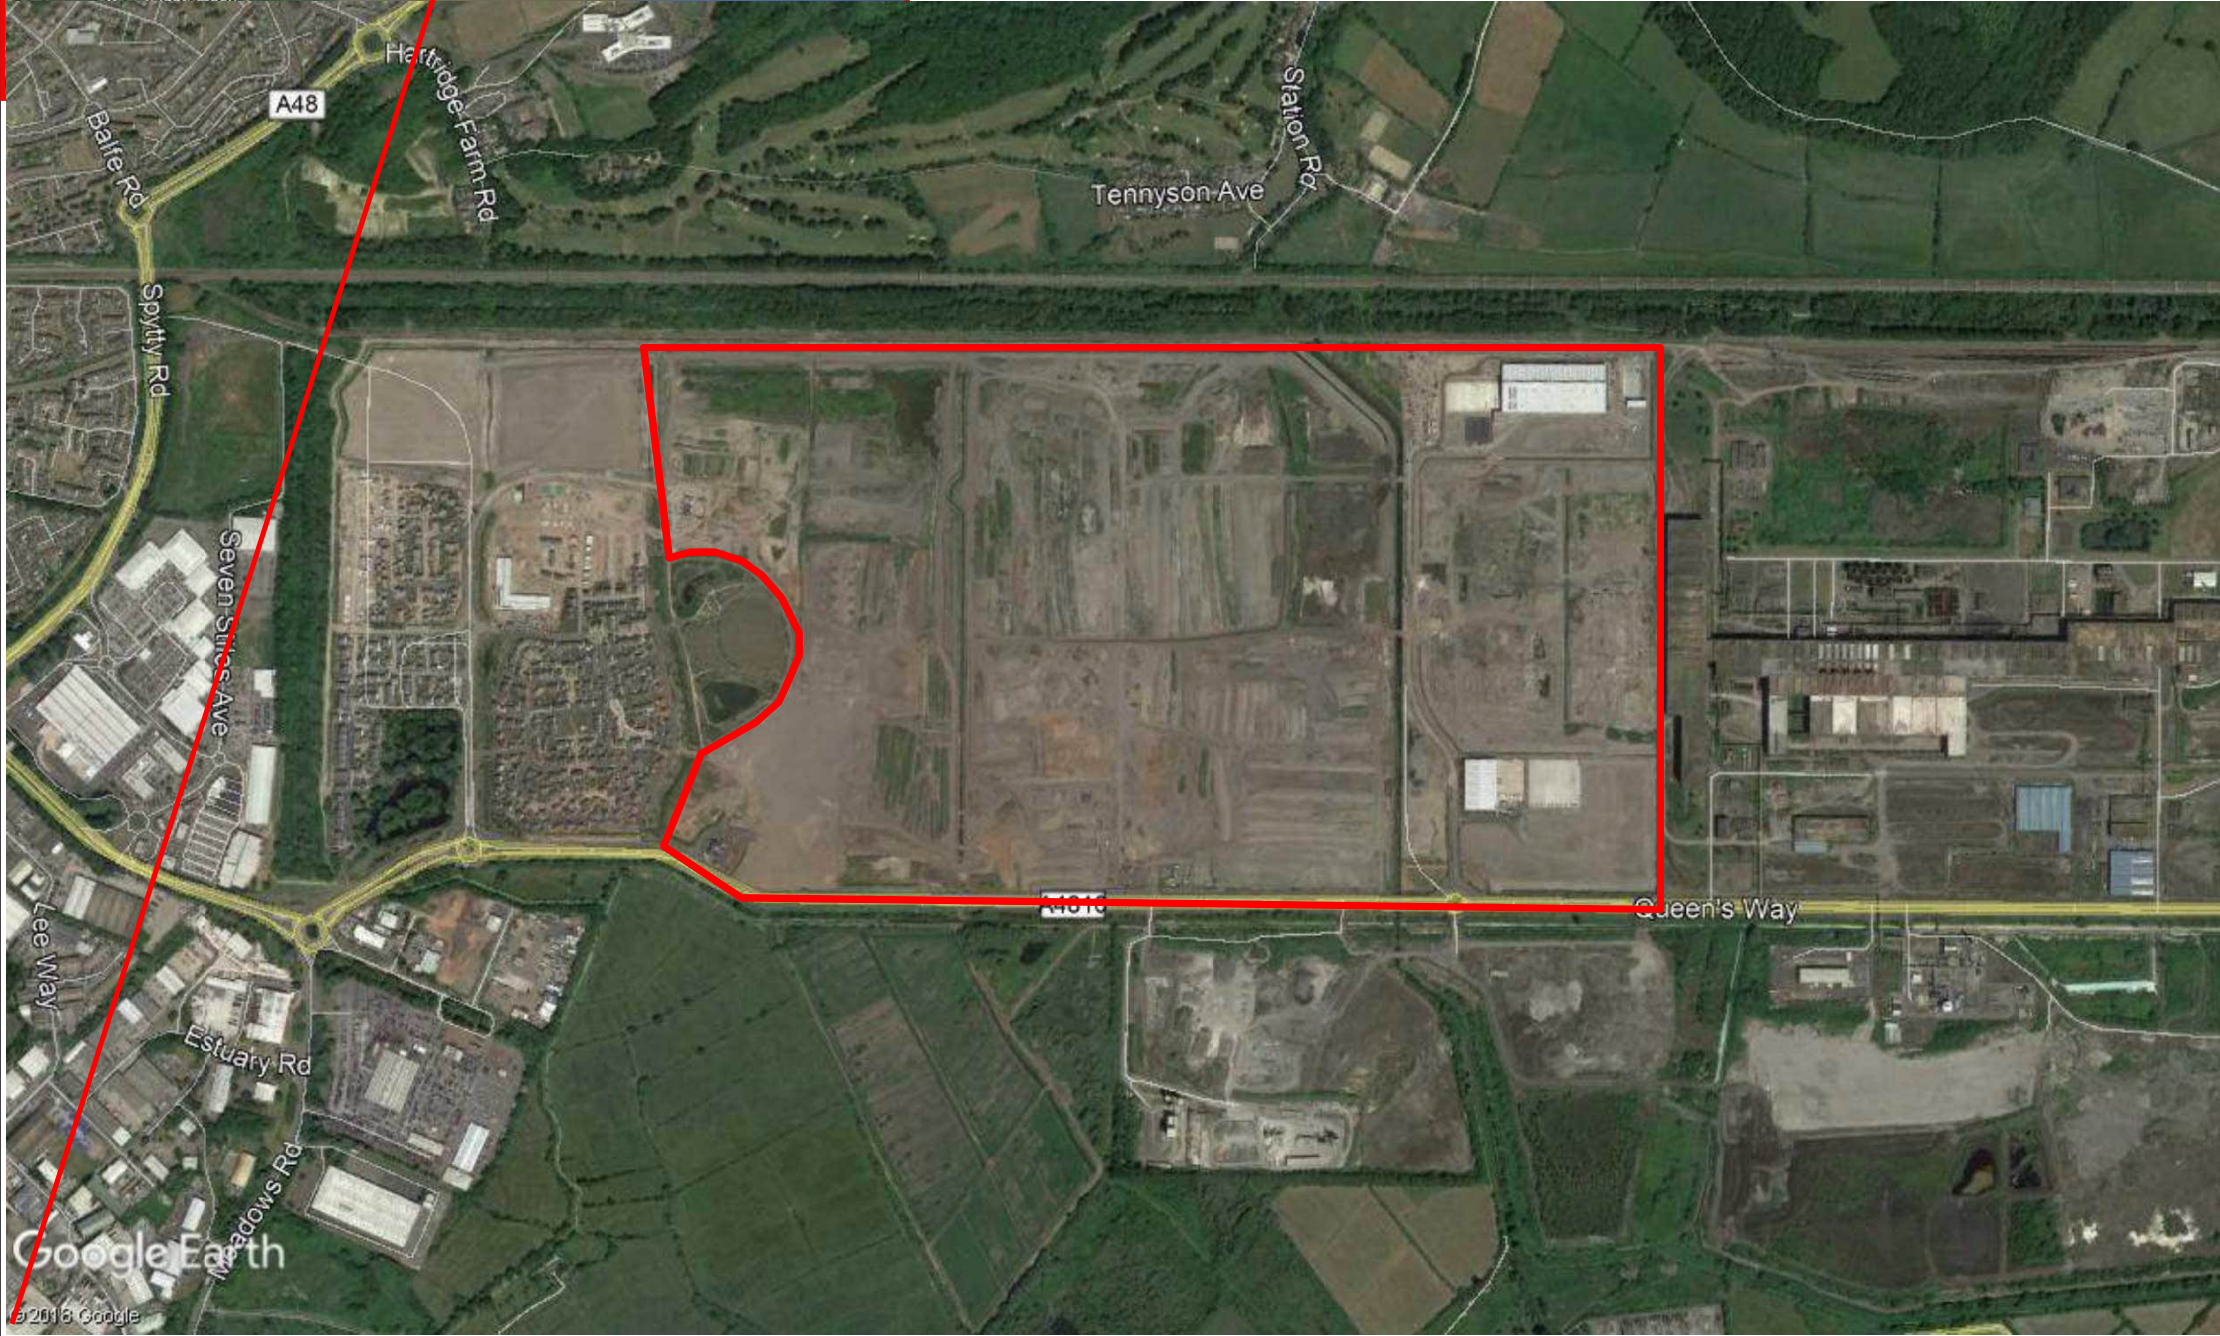
Redline boundary

The Site boundary is shown on drawing 18669-RLL-22-X-DR-O-0323-P02, the site masterplan is presented on Drawing ref. 8111-08-A012, both presented in **Appendix A**.
