# BAT SURVEY REPORT

FORMER PUBLIC  
CONVENIENCE

| <b>Title</b> | Bat Survey Report | |
| <b>Issue Date</b> | 22-Dec-23 | |

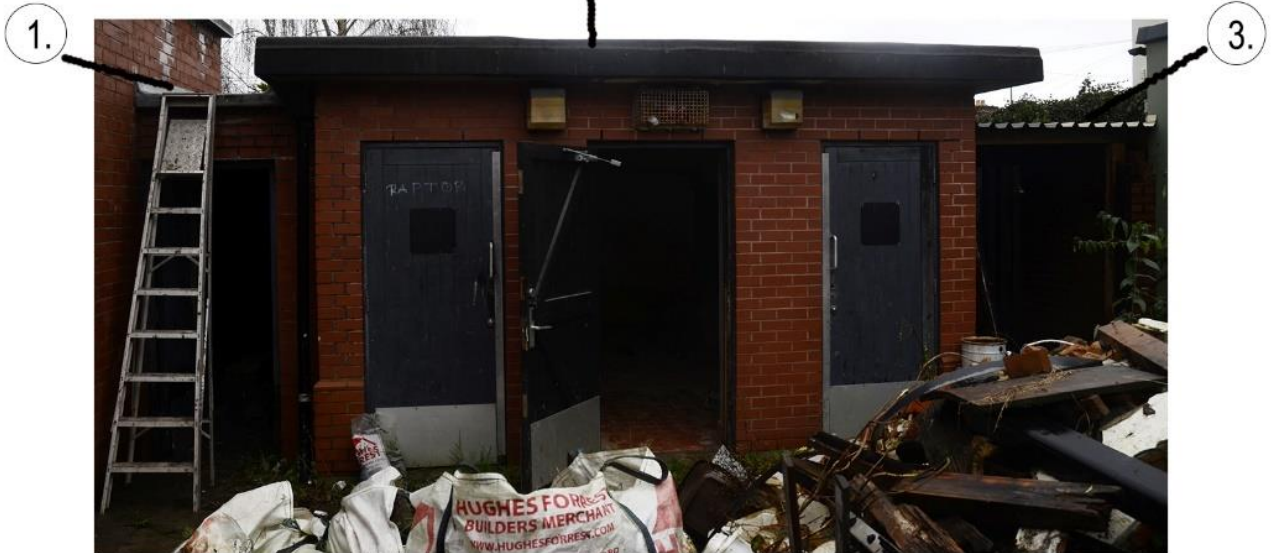
- 3.3 **Photo 1:** Front view. Buildings 1 and 2, are constructed from red brick and are in excellent condition with minimal deterioration for crevice-dwelling bats. The roof of Building 1 is covered in rubber membrane, building 2 has a concrete slab roof, and Building 3, has corrugated sheeting over what was originally an open alleyway. Gaps and crevices were checked using a ladder and torch along the ridge edge of all three entrances. The main body entrance body has three wooden doors with steel side and kick plates. No evidence of bats was found.

Building One - Rubber membrane

Building Two - Concrete roof

Building Three - Corrugated steel roof

Red brick building

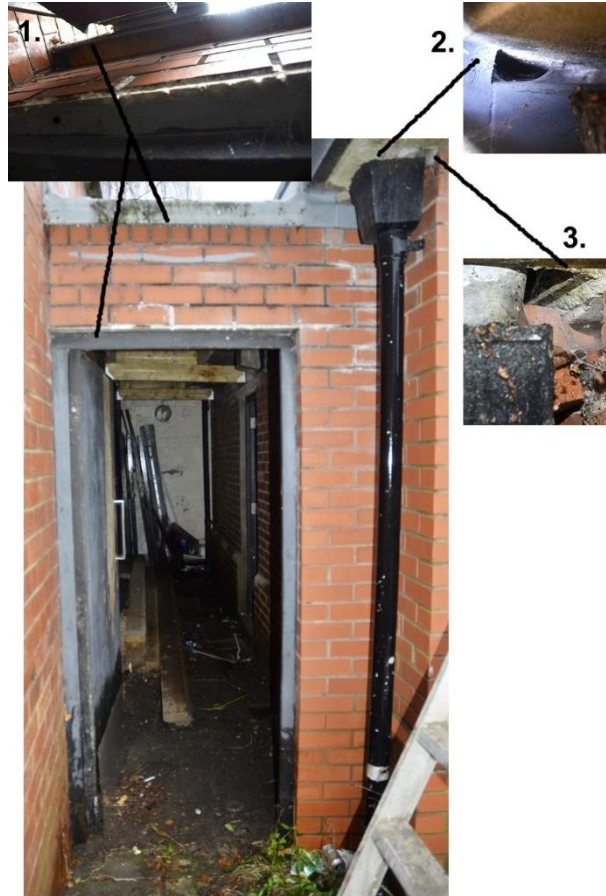
**Photo 2:** Building one: The entrance door and guttering were the only areas with gaps and crevices.

1. The image shows gaps along the length of the door and the roof edge.
2. The image shows a small crevice in the roof covering.
3. The image shows a small crevice in the cement work around the guttering.

All these gaps and crevices were checked with a ladder and torch, and no signs of any bats were found.

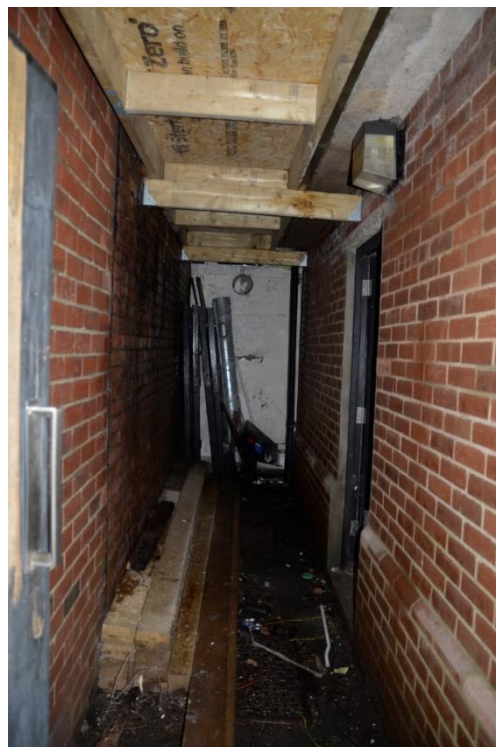
**Photo 3:** Upon entering, a clean red brick wall frames the ceiling which has been fitted with temporary chipboard.

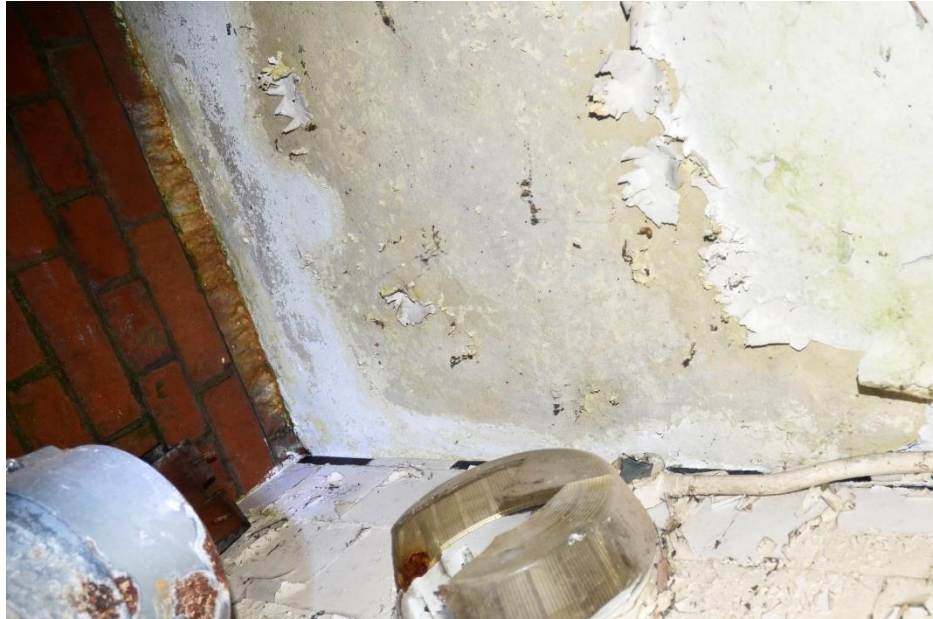
**Photo 4:** Most of the ceiling paint has peeled away along the back ceiling area. The very end of the corridor still has the original ceramic tiles.

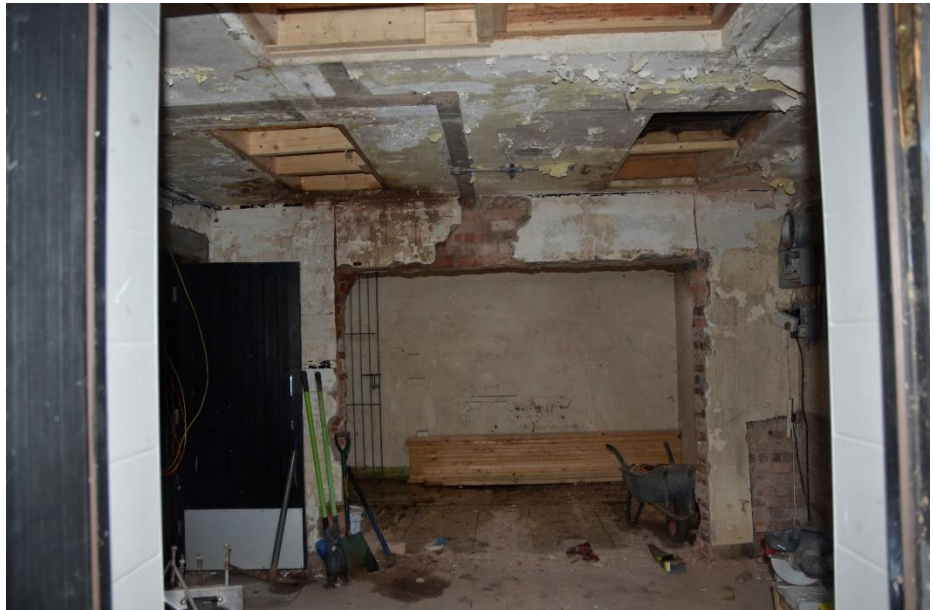
**Photo 5:** The entrance into the main area from the middle door. The paint is peeling off all along the concrete ceiling with three wooden frames firmly fitted. No evidence of bats being found.

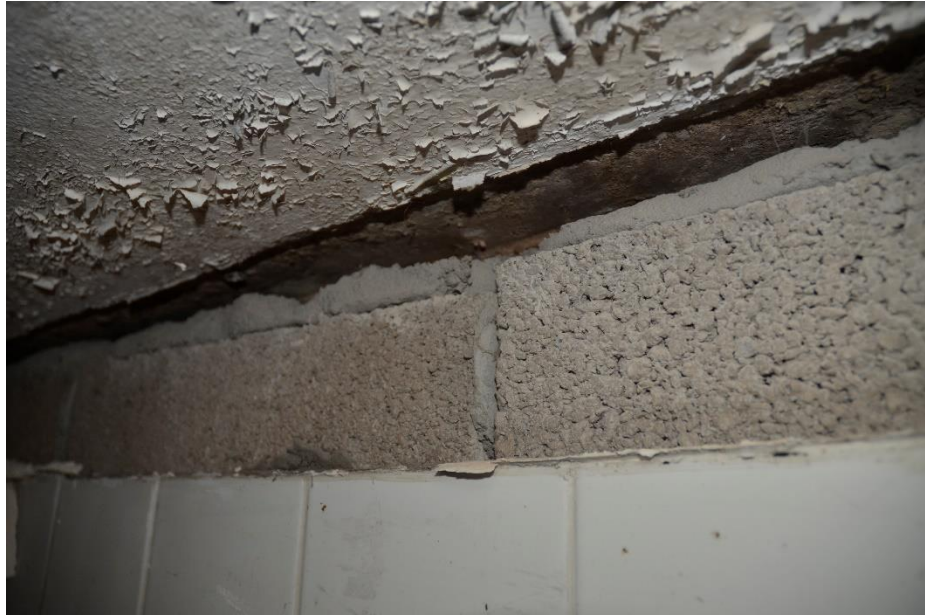
**Photo 6** –There was a small crevice between the concrete blocks and ceiling above the main door into the building. The entrance surrounds and inside wall still had the original ceramic tiles attached. This space was inspected along the full width of the wall and was clear of any evidence of bats.

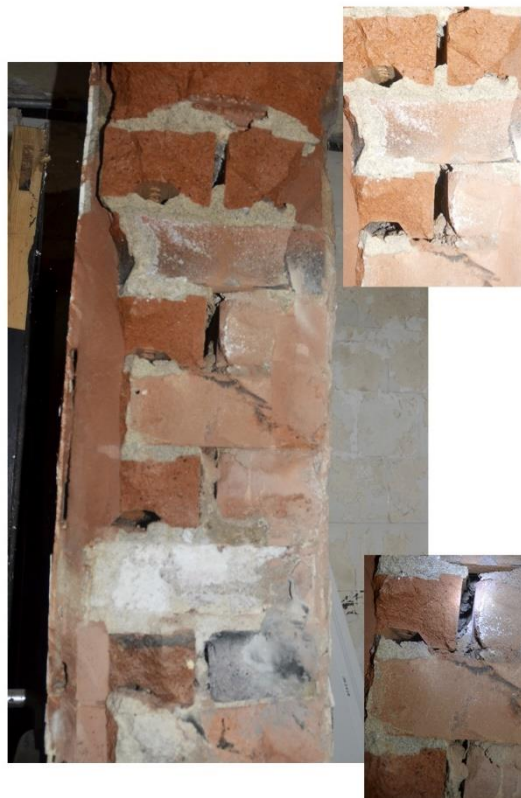
**Photo 7** : The structural edge of the red brick wall separating the front and back room had a small number of crevices within them. Each one was carefully inspected and no evidence of bats were found.

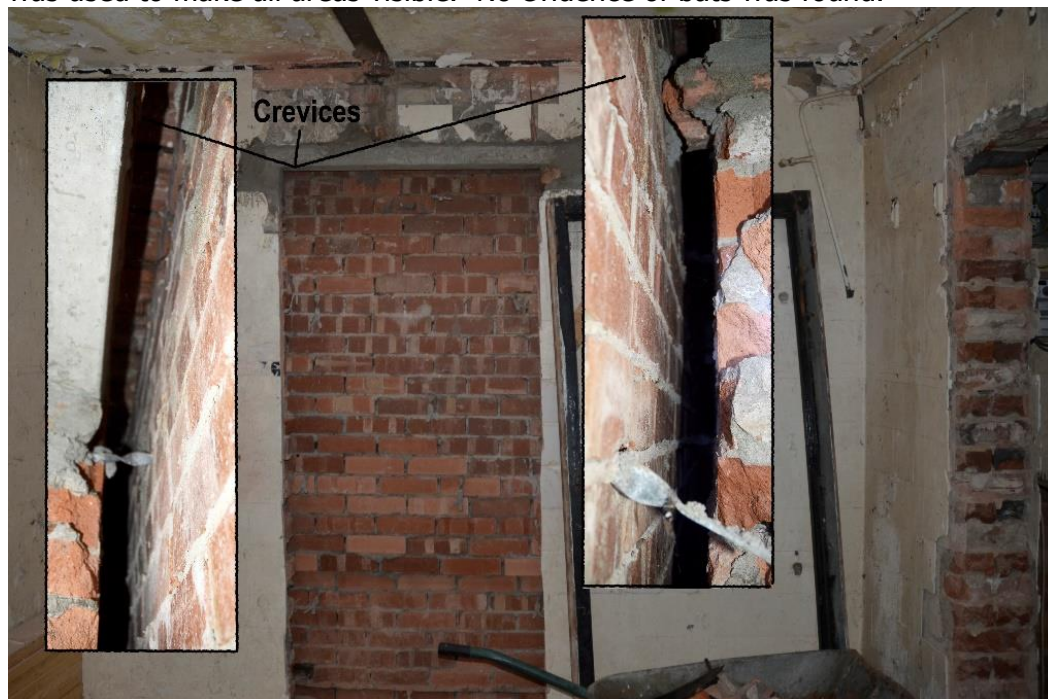
**Photo 8:** The back room: A double layer of red bricks has created a gap between the interior opening and the exterior north facing wall. A torch was used to make all areas visible. No evidence of bats was found.

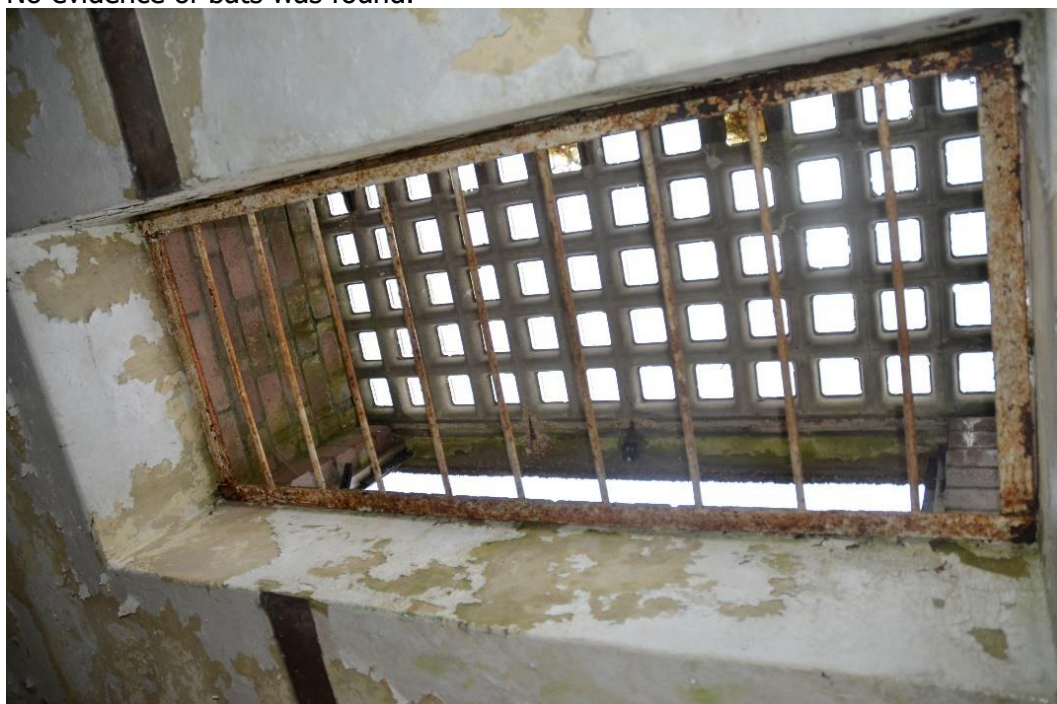
**Photo 9:** Chimney stacks: Built into the concrete roof of the main building were two chimney stacks. The stacks are built with the same red bricks as the exterior of the building and are covered with a hollow concrete inlay and metal grid. This makes the main building open to the elements. No evidence of bats was found.

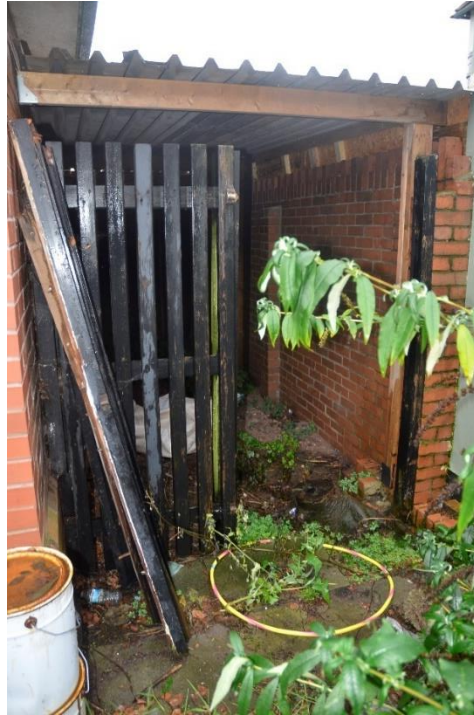
**Photo 10:** Building 3. The North and West walls are not part of the original building. Older images show this as an open access alleyway. A wooden timber frame has been constructed above the north facing wall so that a corrugated roof could be fitted on top.

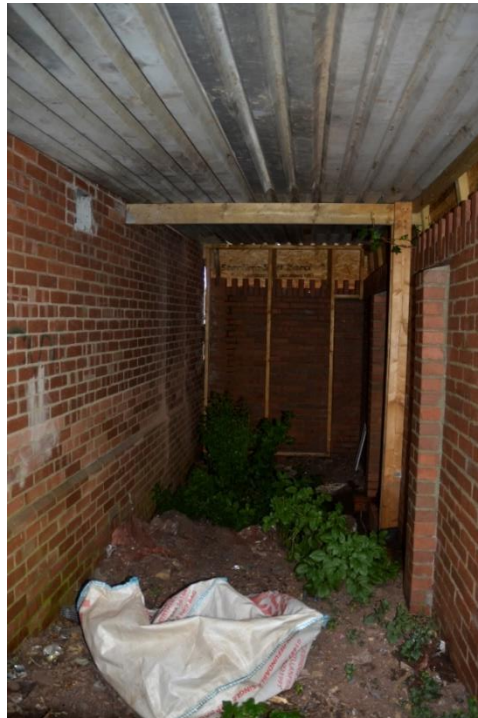
**Photo 11:** The back west-facing wall allows light in through the gap adjacent to the original building. Timber supports are used midway and at the back of the building to support the corrugated roof. The floor is soil and plants.
