## Arboricultural Implications Assessment & Arboricultural Method Statement

In accordance with  
 BS: 5837:2012

At  
**Caerleon Former University Campus**

Dated: January 2021 (Revision 3)

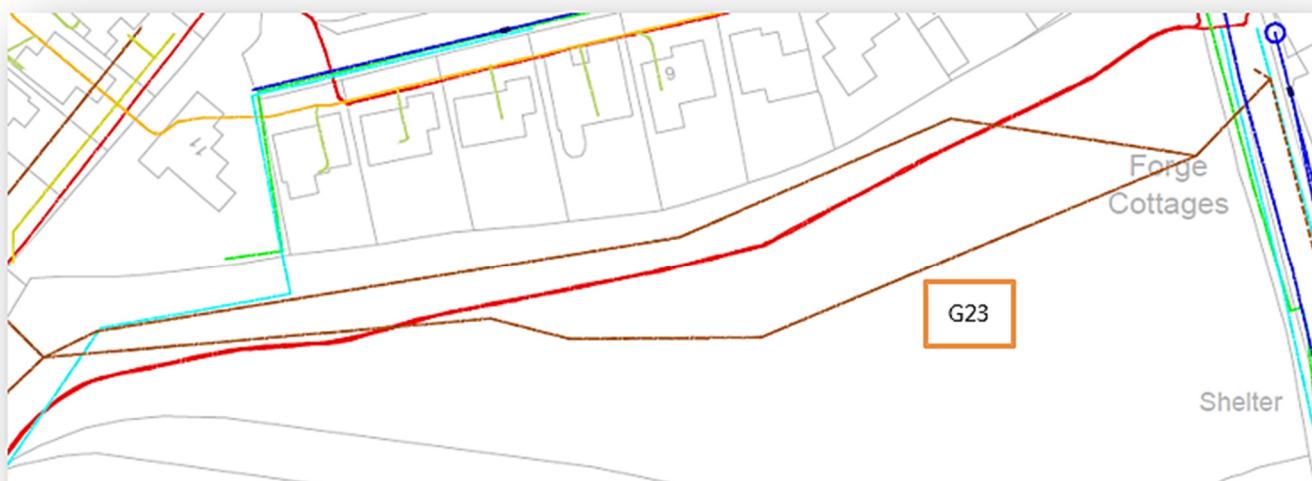
**Plan Extract 1.** Group 23, northern section (TPO) with existing underground water, electricity & sewer runs.

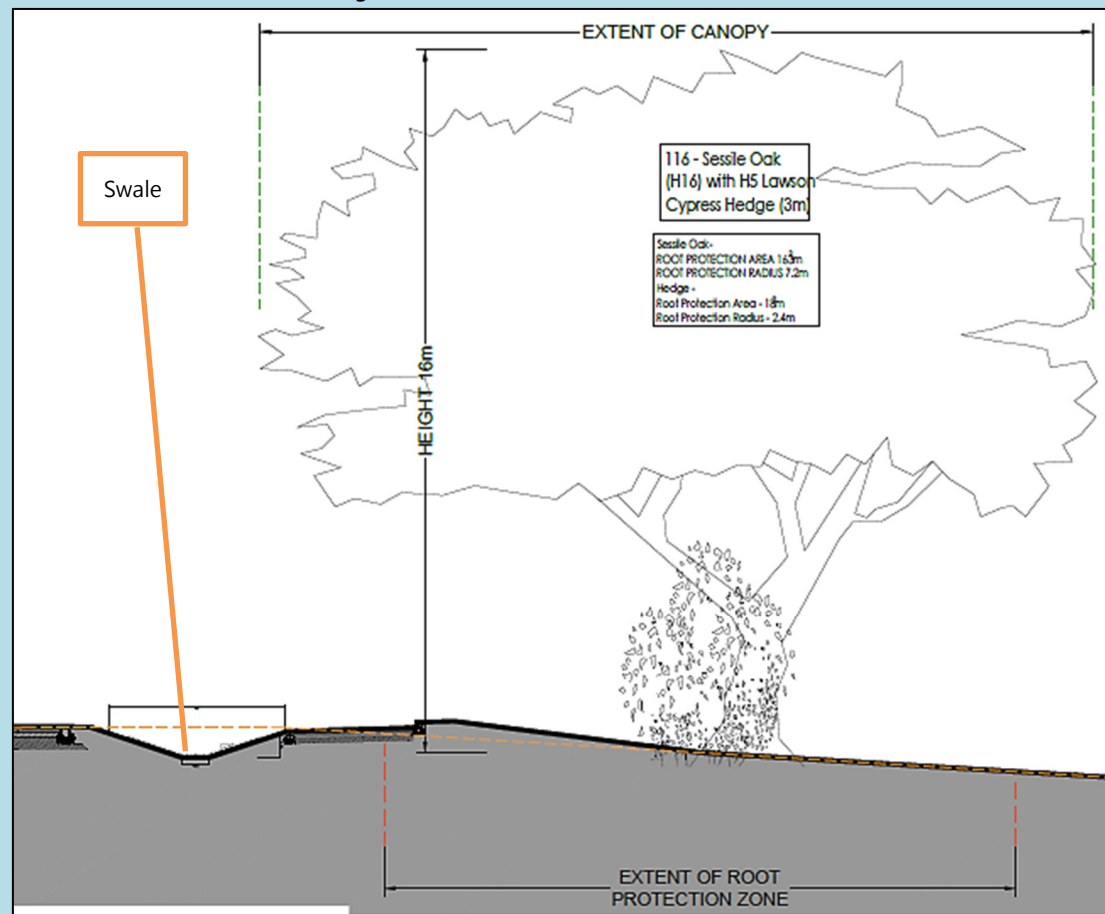
Plan Extract 7h. Section T13 - Swale abutting east of Tree 116.
