## Ground Investigation Report

Proposed LED Floodlit Artificial Grass Pitch

Dragon Park, Newport

Document no.: STX7242-R01-Rev\_A

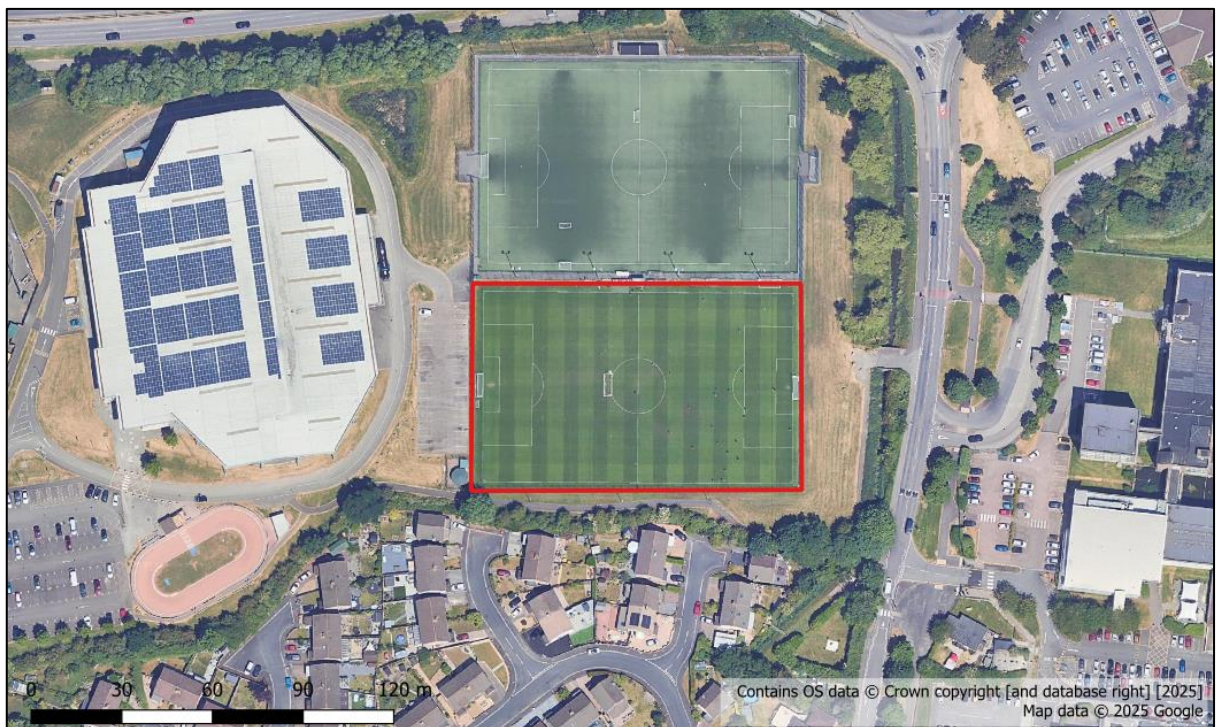
Figure 2-A: Aerial photograph of site boundary and proposed AGP footprint (red)

- 1.1.1 The proposed development is for construction of an 11v11 3G LED Floodlit Artificial Grass Pitch (AGP). The approximate footprint of the proposed AGP is presented in Figure 2-A below.
- 1.1.2 The report is based on the project proposals and information outlined above; should the scheme change then it will be necessary to review the conclusions and recommendations presented in this report.

2.2.2 An aerial image showing the approximate site boundary and approximate development footprint is presented below, followed by a table summarising the key site features. A site plan is provided within Appendix A.

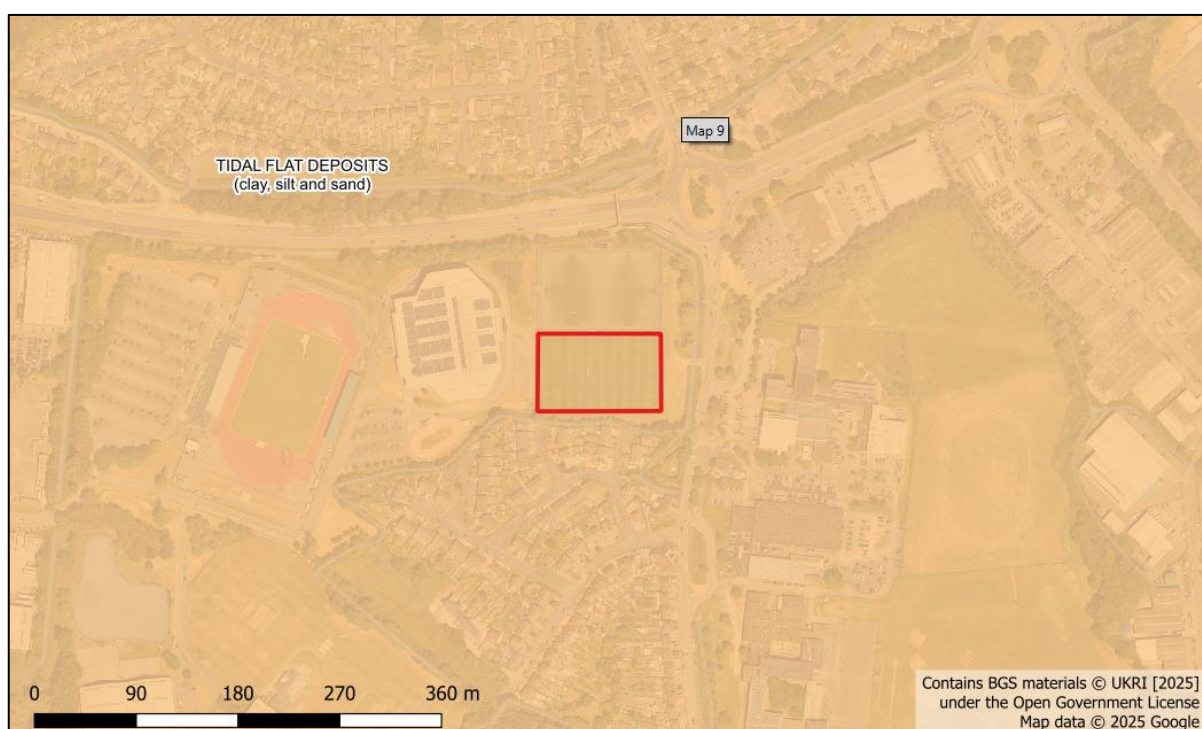
Figure 2-D: Extract from BGS showing superficial geology at the site

- 2.4.1 Based on a review of available records, the site is anticipated to be underlain by superficial deposits Tidal Flat Deposits (refer to Figure 2-D below).
- 2.4.2 Local BGS borehole records suggest the Tidal Flat Deposits comprise of soft to very soft silty organic clays with layers of peat.
- 2.4.3 Made Ground associated with the previous pavilion and carpark is expected in the eastern/southern-eastern part of the site.
- 2.4.4 The underlying bedrock is recorded as Mercia Mudstone Formation across the entirety of the site, comprising mudstone (refer to Figure 2-E below).

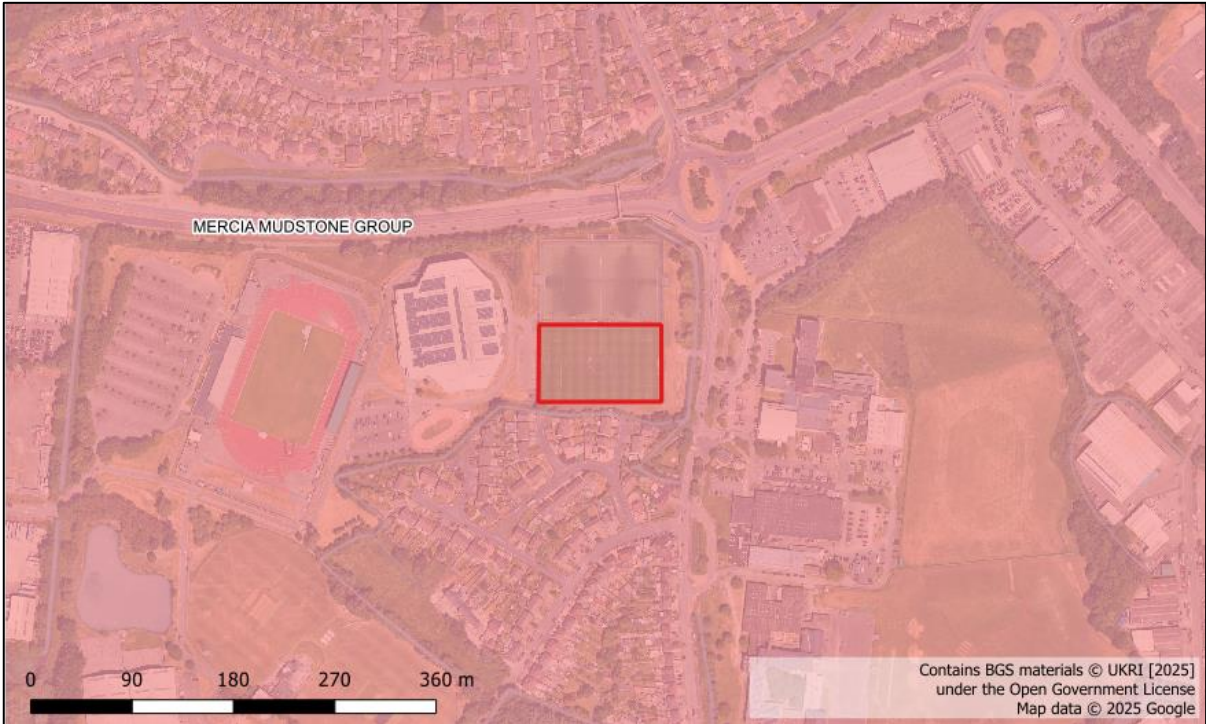
Figure 2-E: Extract from BGS showing bedrock geology at the site

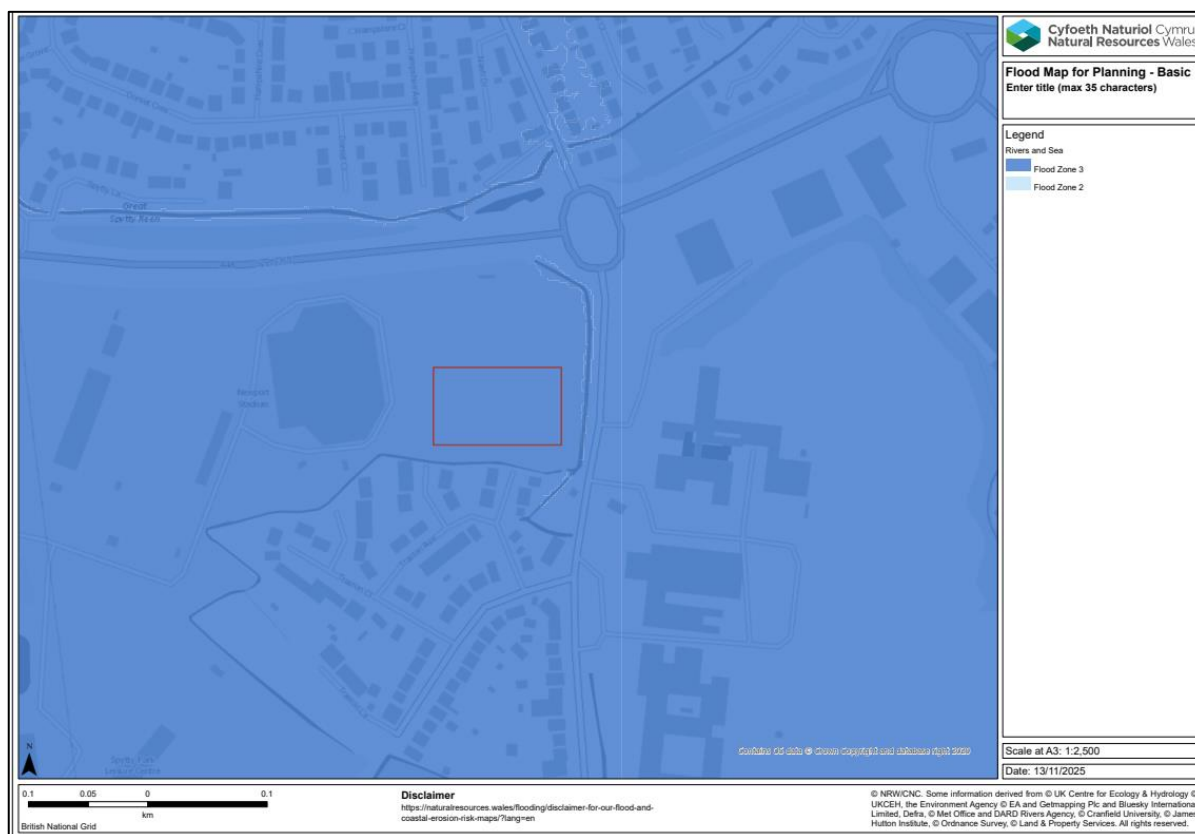
Figure 2-F: Extract of Natural Resources Wales flood risk mapping for the site

2.5.1 The site is recorded within a Flood Zone 3, associated with flooding from rivers or the sea and is in an area designated as benefiting from flood defences (refer to Figure 2-F below).

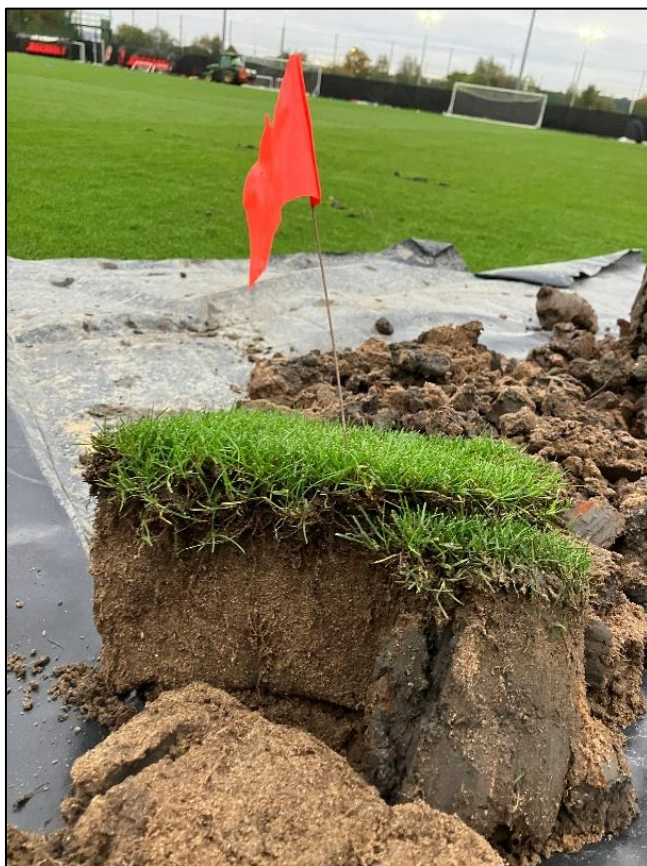
Figure 5-A: Topsoil from WLS04

5.2.1 Topsoil was encountered in all exploratory holes to a thickness of 0.1 m and was typically observed as a brownish grey slightly gravelly sandy clay with frequent rootlets. Gravels comprised of quartzite and sandstone.

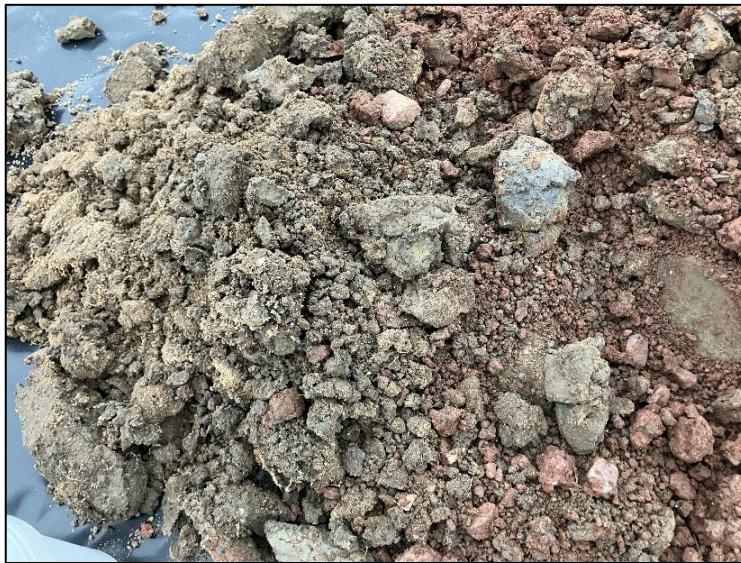
*Figure 5-B: Made Ground from WLS05 between depths of 0.3 to 0.5 m bgl*

- 5.3.2 Made Ground material across site was observed to a depth of 0.3 m to 0.40 m bgl and generally comprised a firm greyish brown sandy slightly gravelly clay/ greyish brown clayey slightly gravelly sand with gravels comprising fine to coarse concrete, sandstone and quartzite. Fragments of animal bone were also observed.

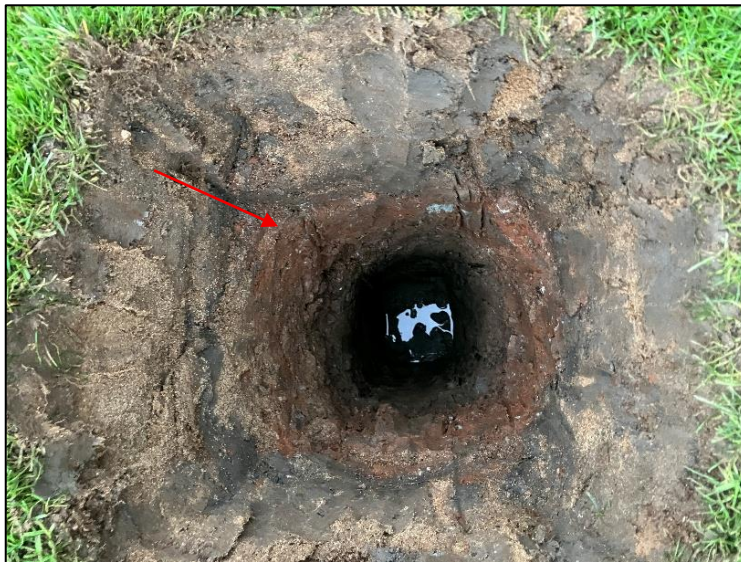
*Figure 5-C: Layer of reddish brown Made Ground observed insitu at WLS04*

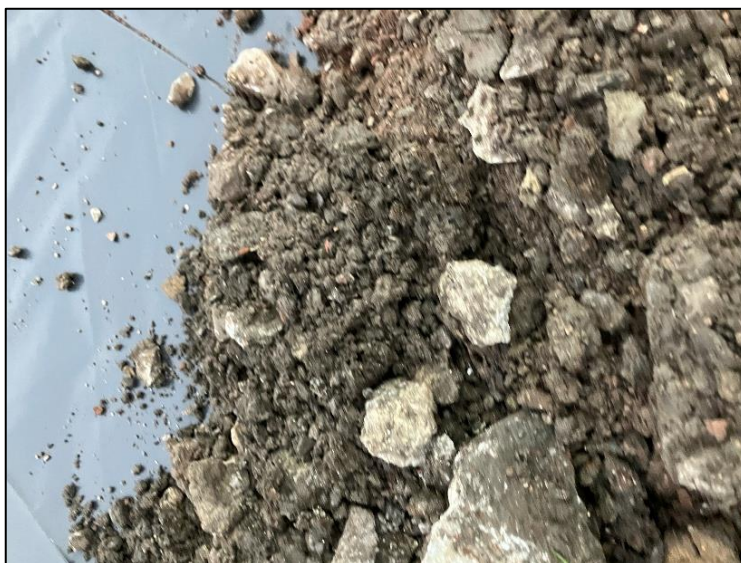
*Figure 5-D: Made Ground at WLS02 between depths of 0.6 to 0.8m bgl*

- 5.3.4 Deeper Made Ground deposits from the locations in the eastern part of the site were observed as dark grey clayey gravelly sand with gravels of fine to coarse brick, glass, concrete and sandstone. The base depth of Made Ground observed the eastern part of the site ranged from 0.8 to 1.1 m bgl. Cobbles of sandstone were also noted in WLS02 at depth.

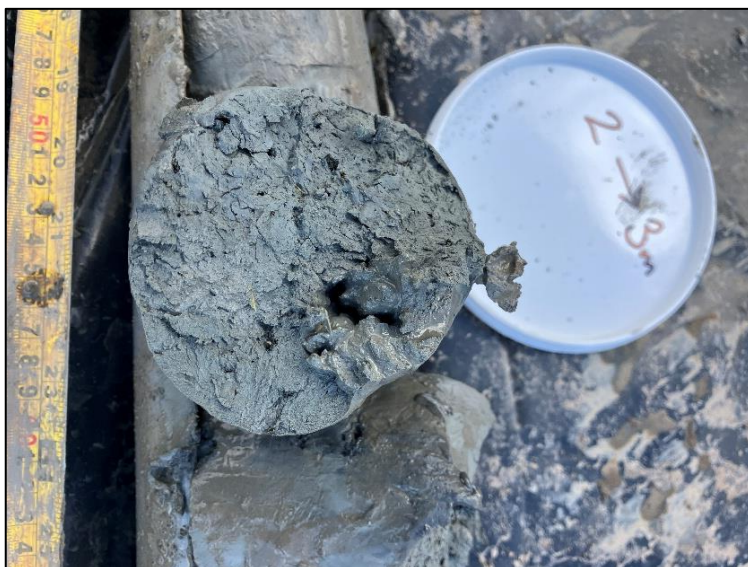
Figure 5-E: Tidal Flat deposits at a depth of ~2.5m from WLS04

5.4.1 Superficial Tidal Flat Deposits were encountered underlying Made Ground across site from top depths ranging from 0.3 m to 1.2 m bgl. The deposit generally comprised a soft to very soft blueish grey slightly sandy silty organic clay/ slightly sandy clayey organic silt with relict plant matter and frequent thick layers of amorphous peat. Peat was also more prominent at depth in the deeper boreholes, particularly WLS01 where it was >1.45 m thick and extending beyond the base of the borehole.

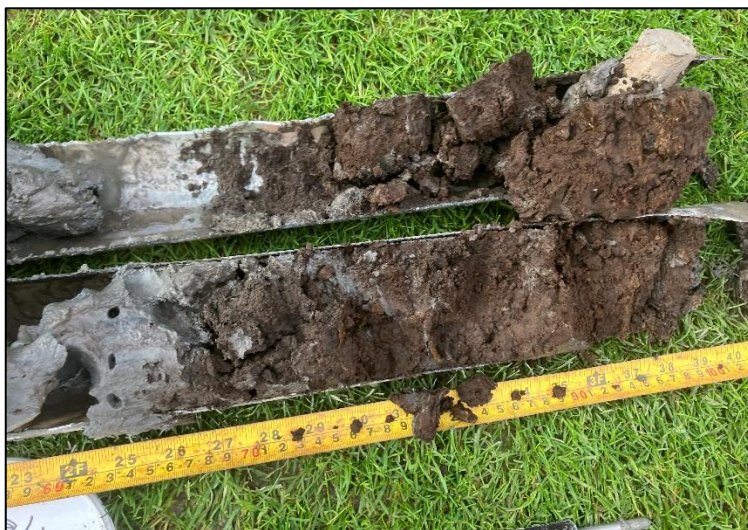
Figure 5-F: Amorphous Peat layer at a depth of 3.7m from WLS01

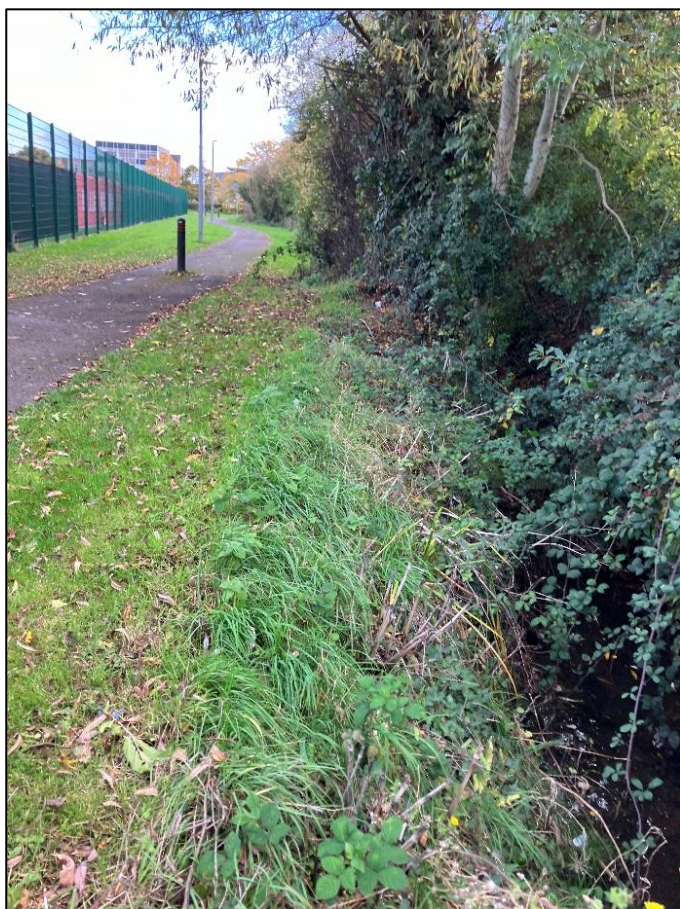
Figure 7-A: Drainage ditch adjacent the southern boundary of the existing grassed pitch

- 7.10.5 Drainage ditches exist along the eastern and southern boundary of the proposed AGP and could be utilised as a surface water disposal point, subject to relevant permissions being sought (refer to Figure 7-A).

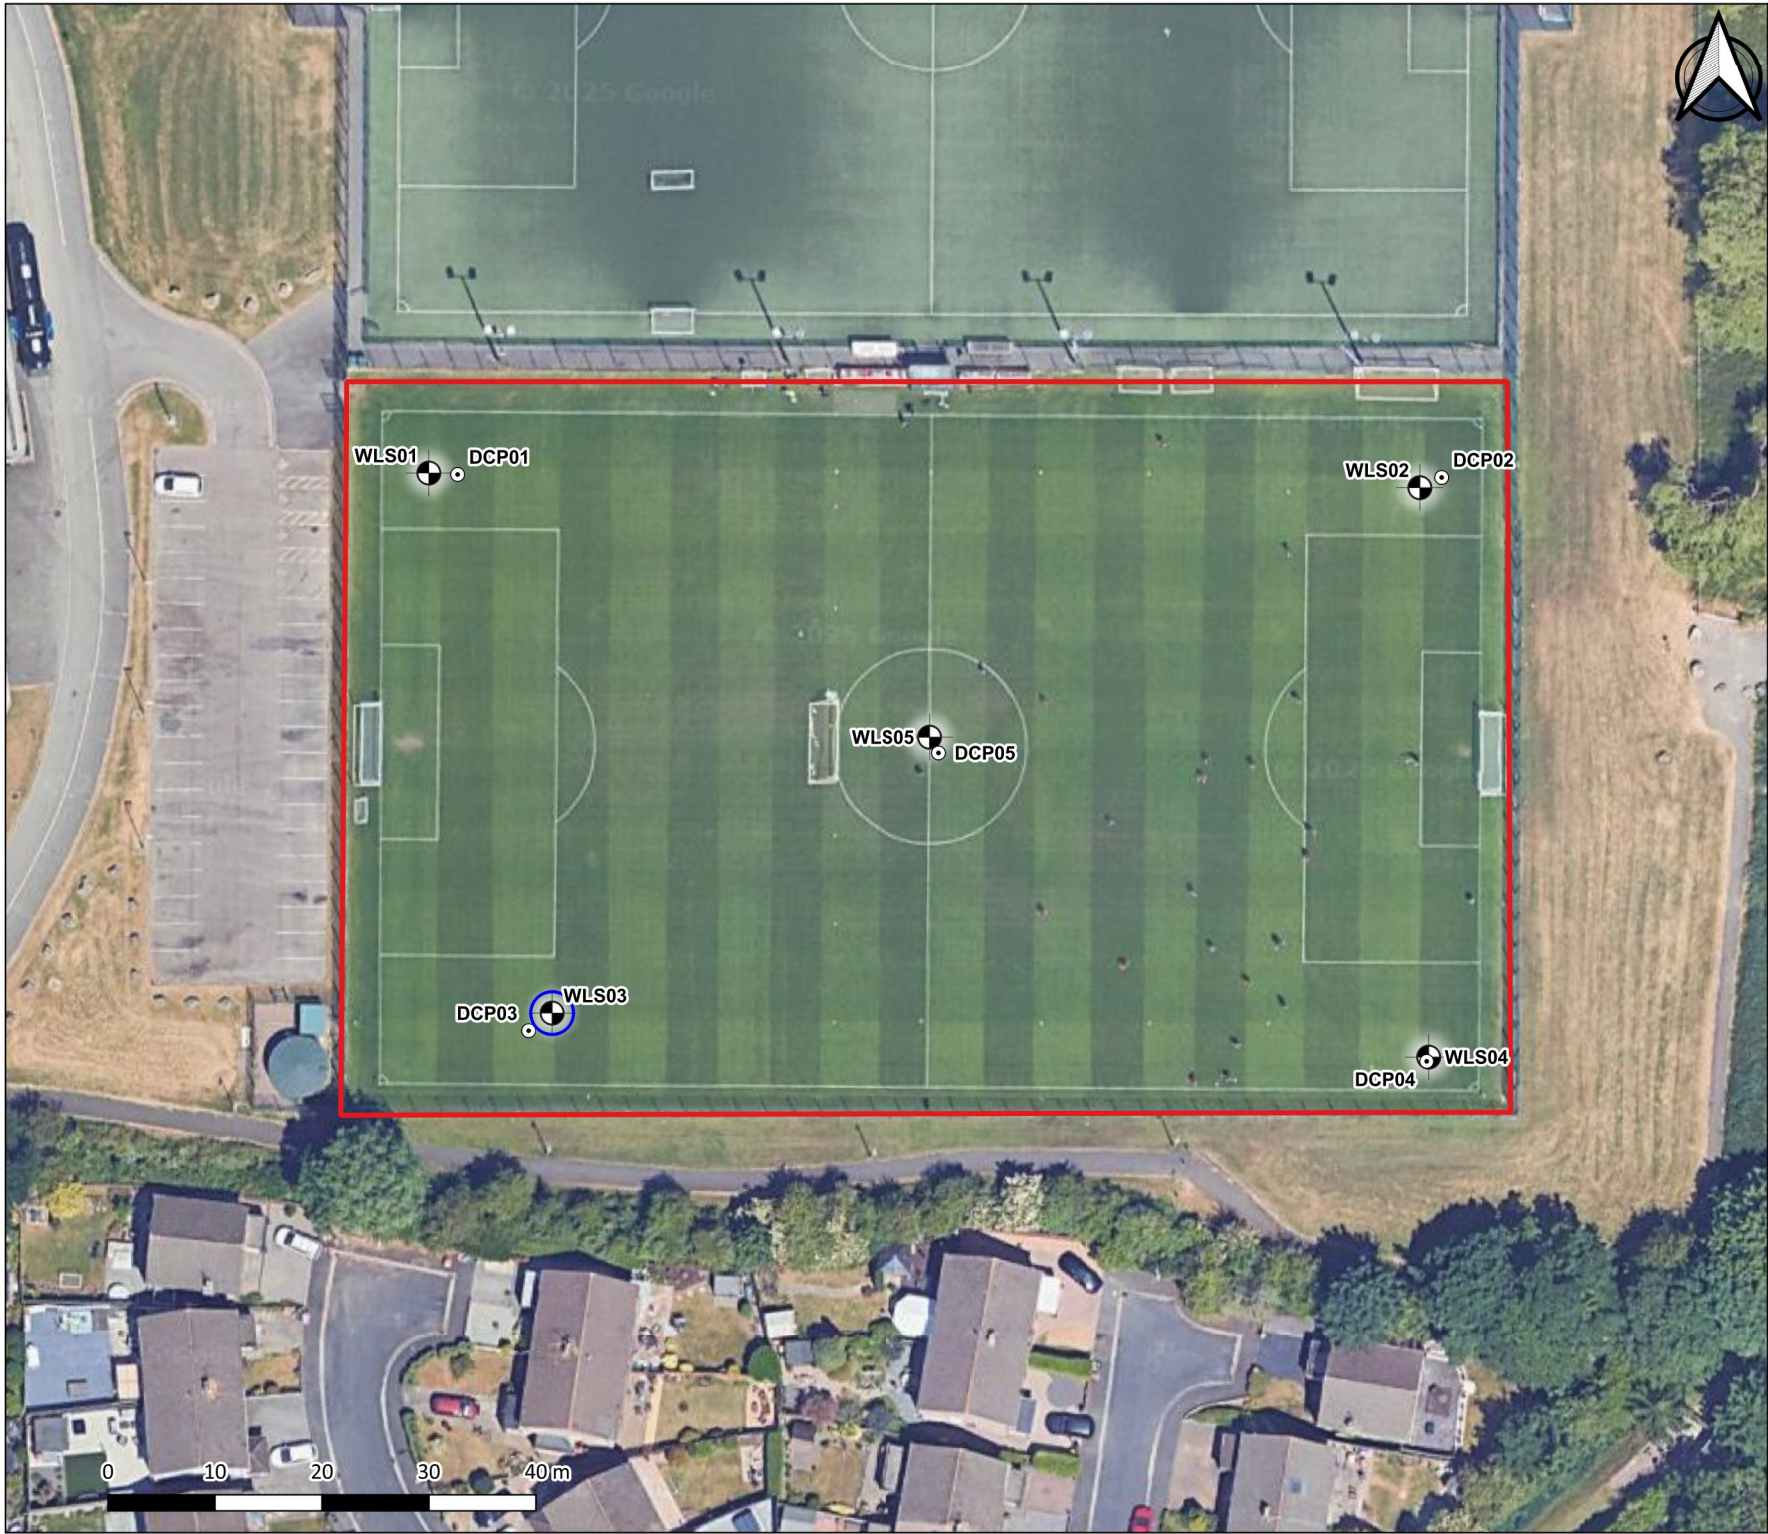
- Key:
- Site Boundary
  - Windowless Sampling Borehole
  - Dynamic Cone Penetrometer Test
  - Infiltration Test

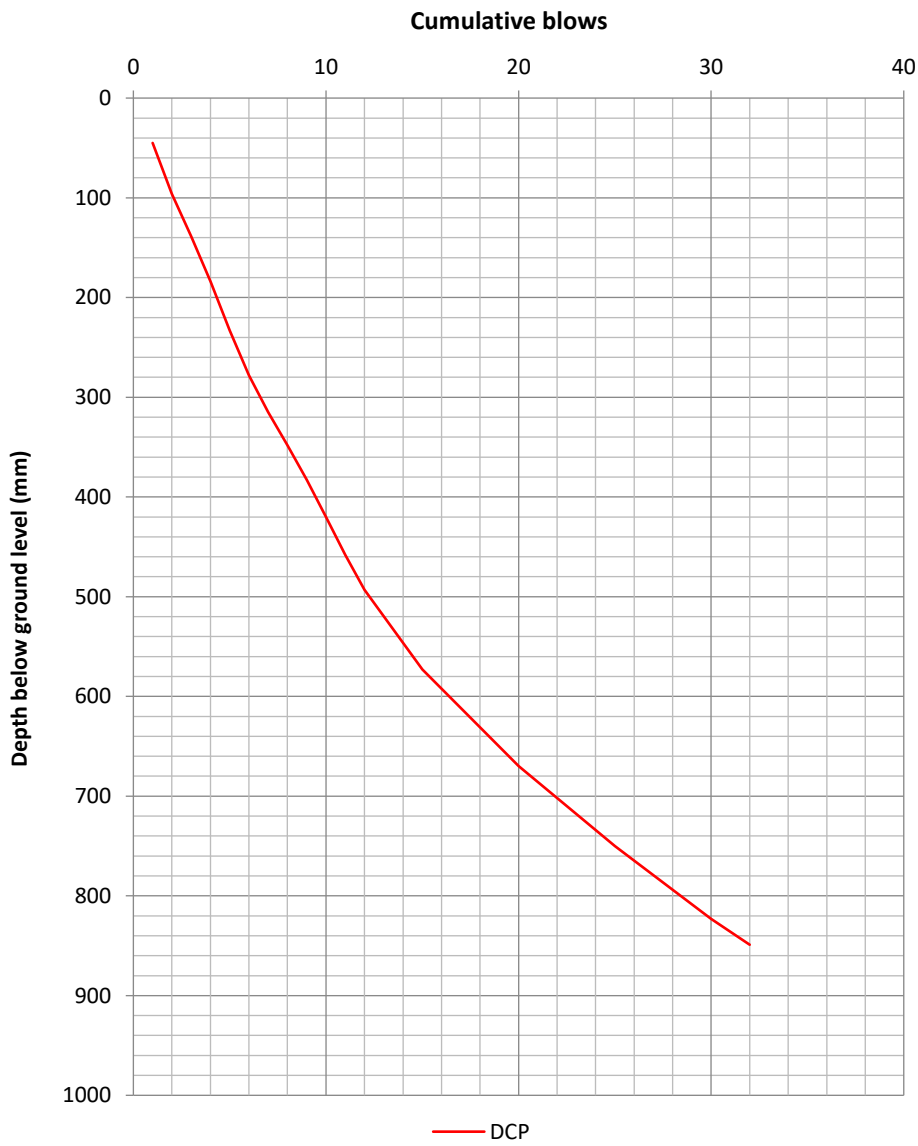
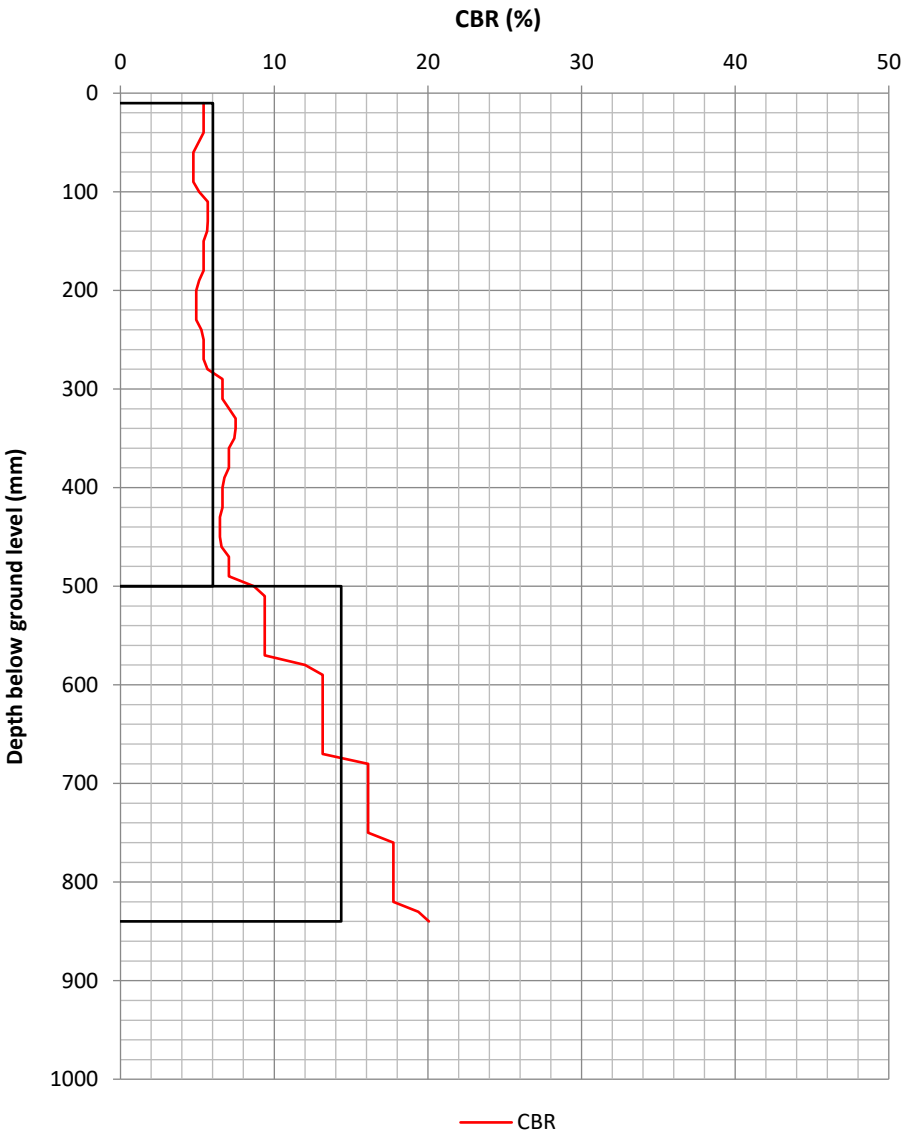
Dynamic Cone Penetrometer (DCP) test

Plot showing number of blows against depth

1. Test procedure following Highways England Document CS229 Data for Pavement Assessment.

Plot showing CBR (%) against depth

$\text{Log10 (Uncorrected (UC) CBR)} = 2.48 - 1.057\text{Log10}(\text{mm/blow})$

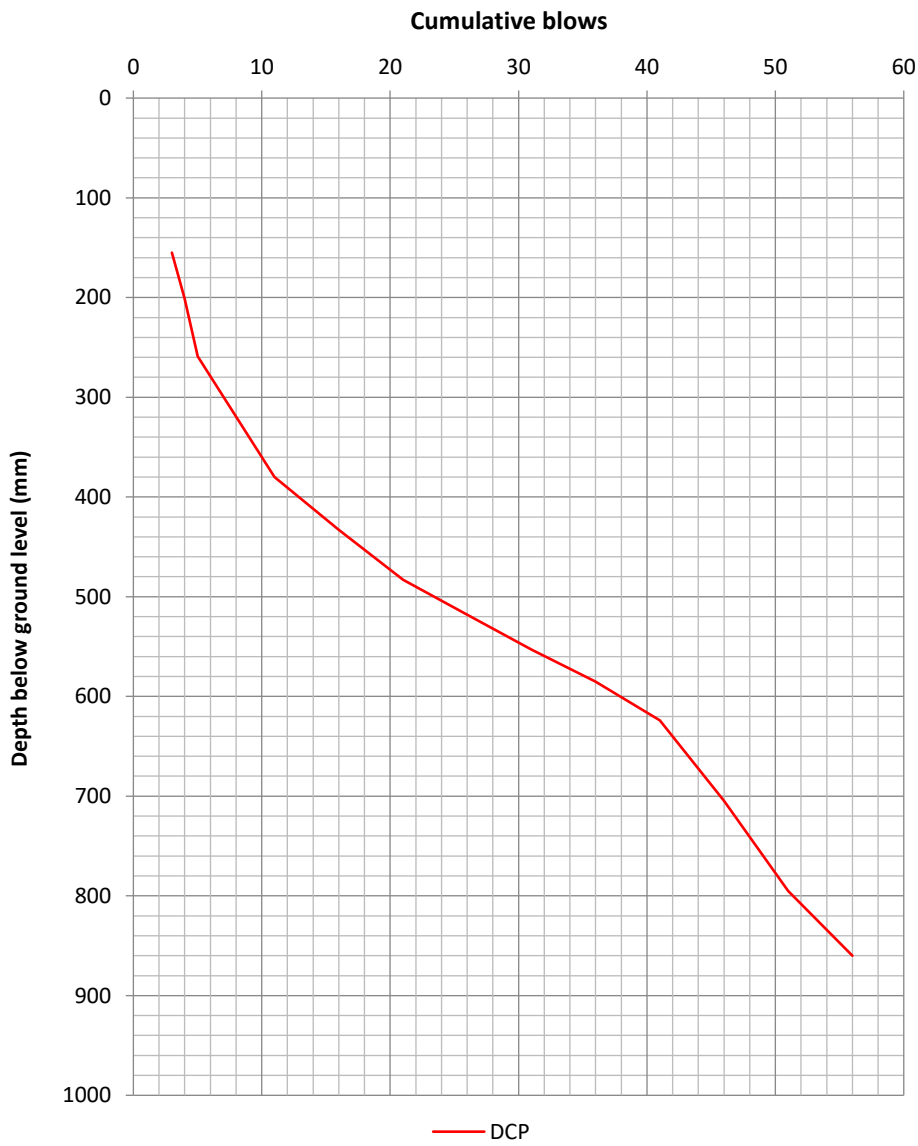
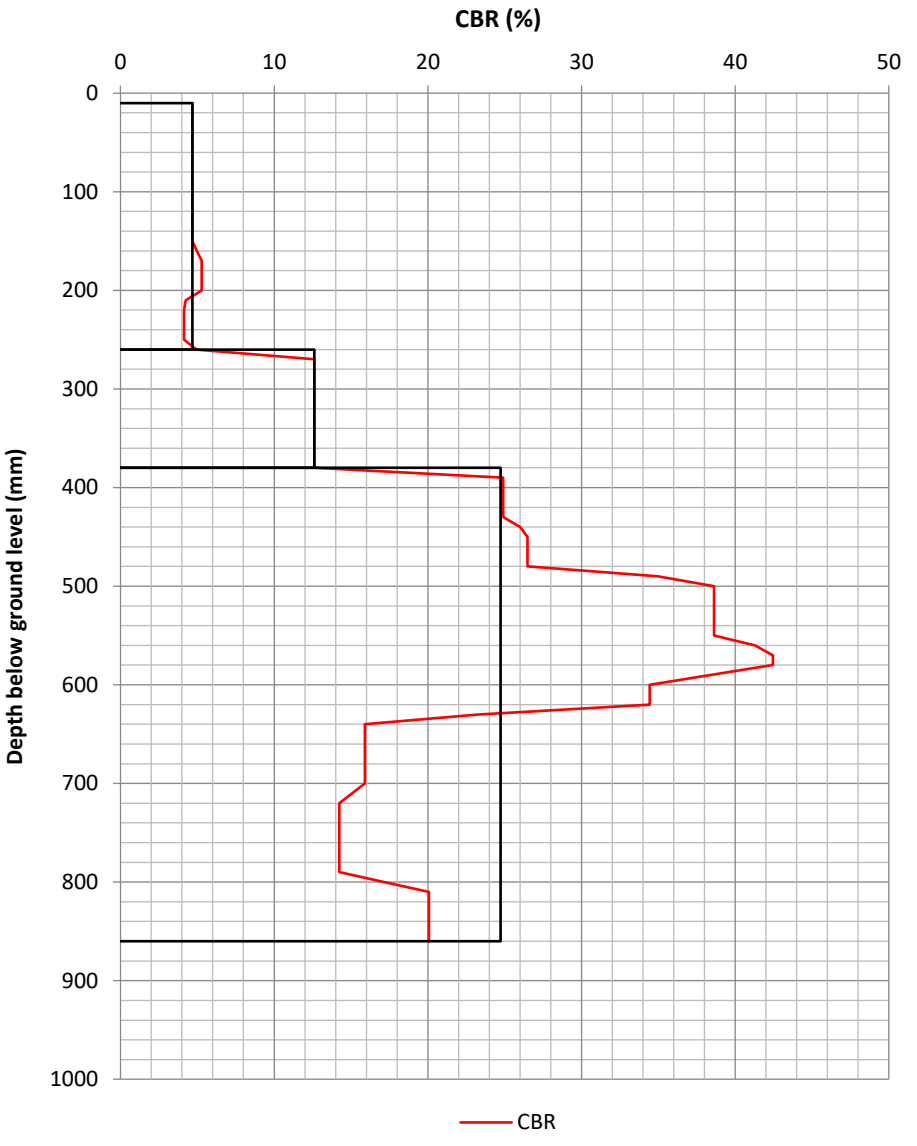
Plot showing number of blows against depth

1. Test procedure following Highways England Document CS229 Data for Pavement Assessment.

Plot showing CBR (%) against depth

$\text{Log10 (Uncorrected (UC) CBR)} = 2.48 - 1.057\text{Log10}(\text{mm/blow})$

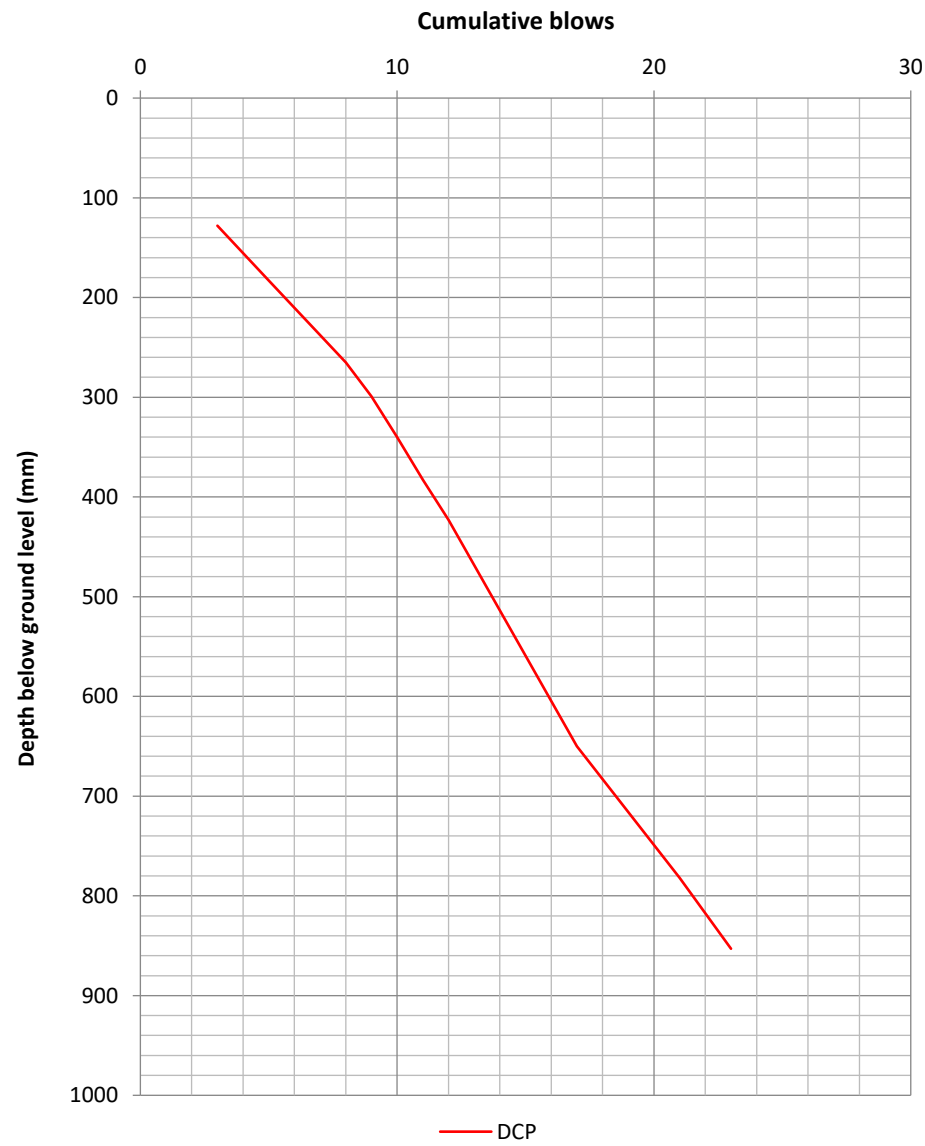
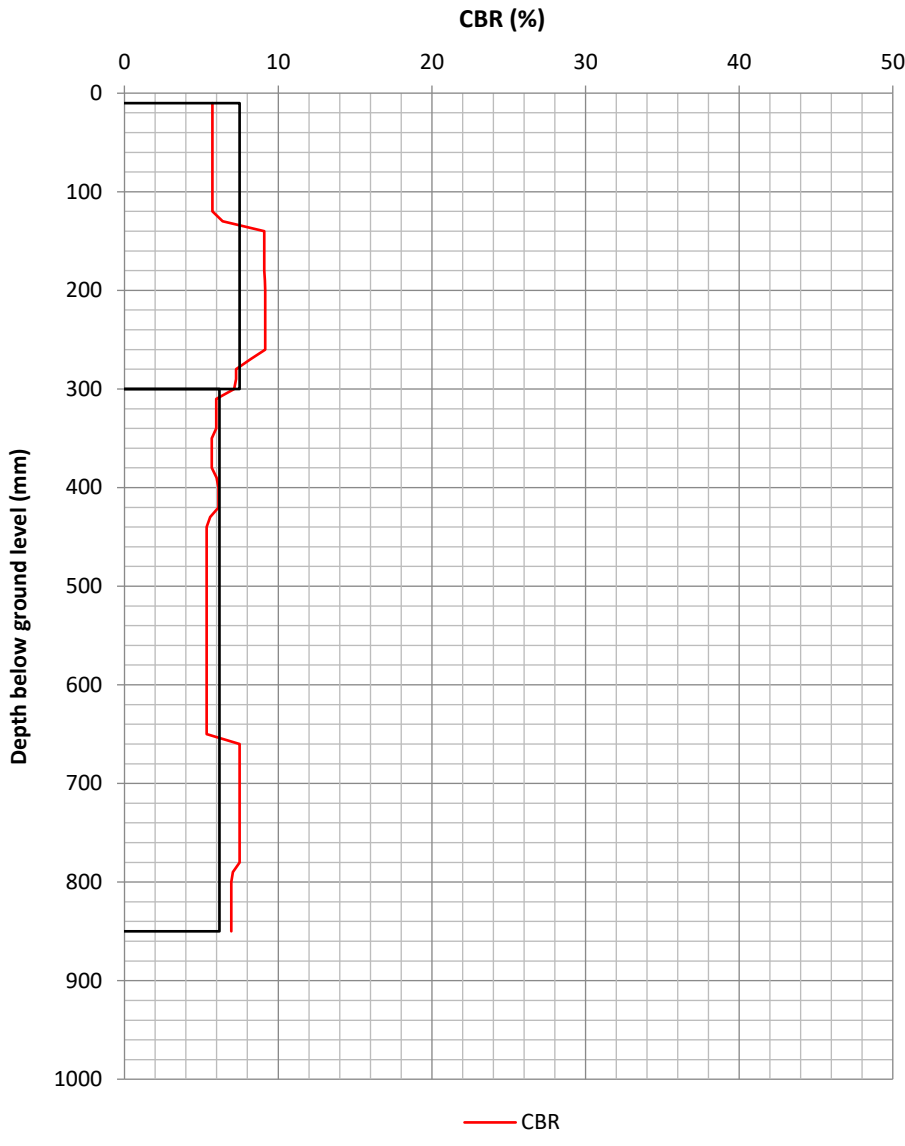
Plot showing number of blows against depth

1. Test procedure following Highways England Document CS229 Data for Pavement Assessment.

Plot showing CBR (%) against depth

$\text{Log10 (Uncorrected (UC) CBR)} = 2.48 - 1.057\text{Log10}(\text{mm/blow})$

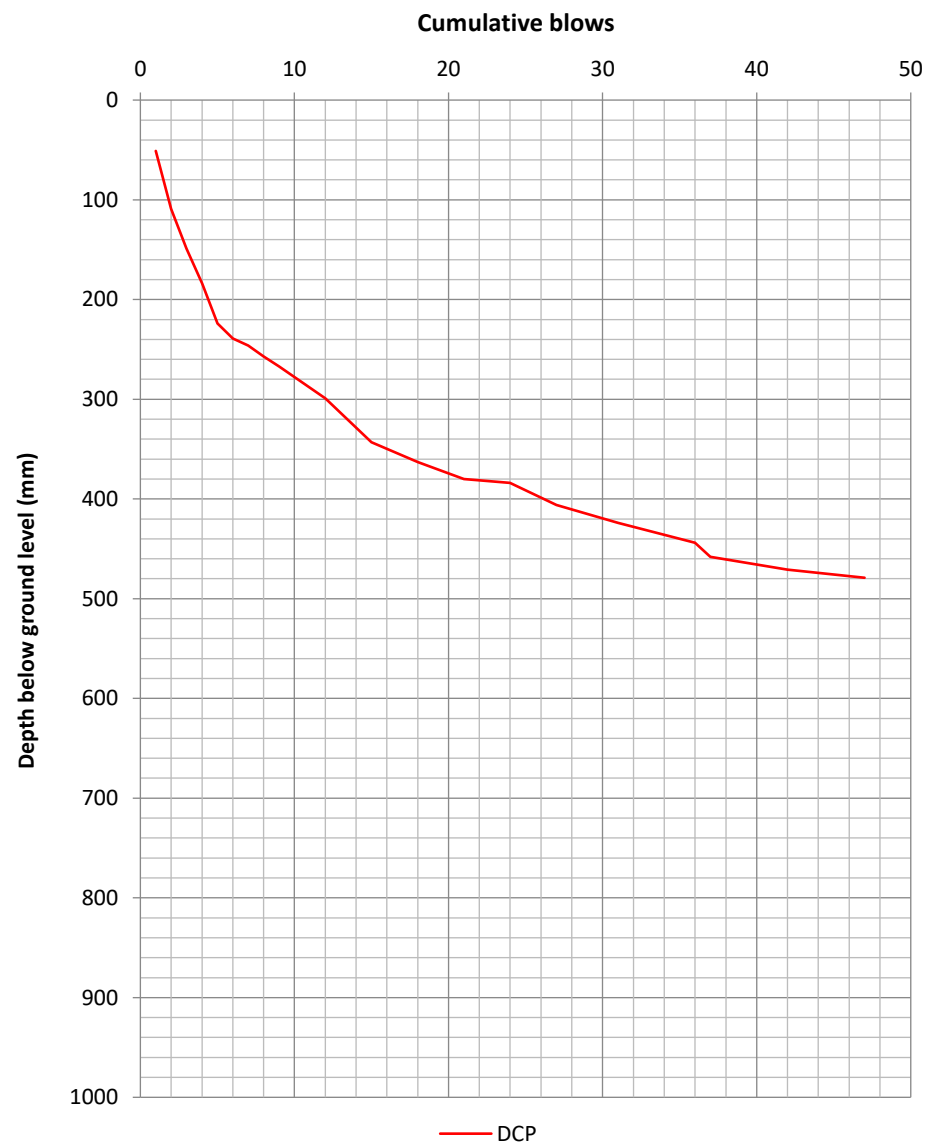
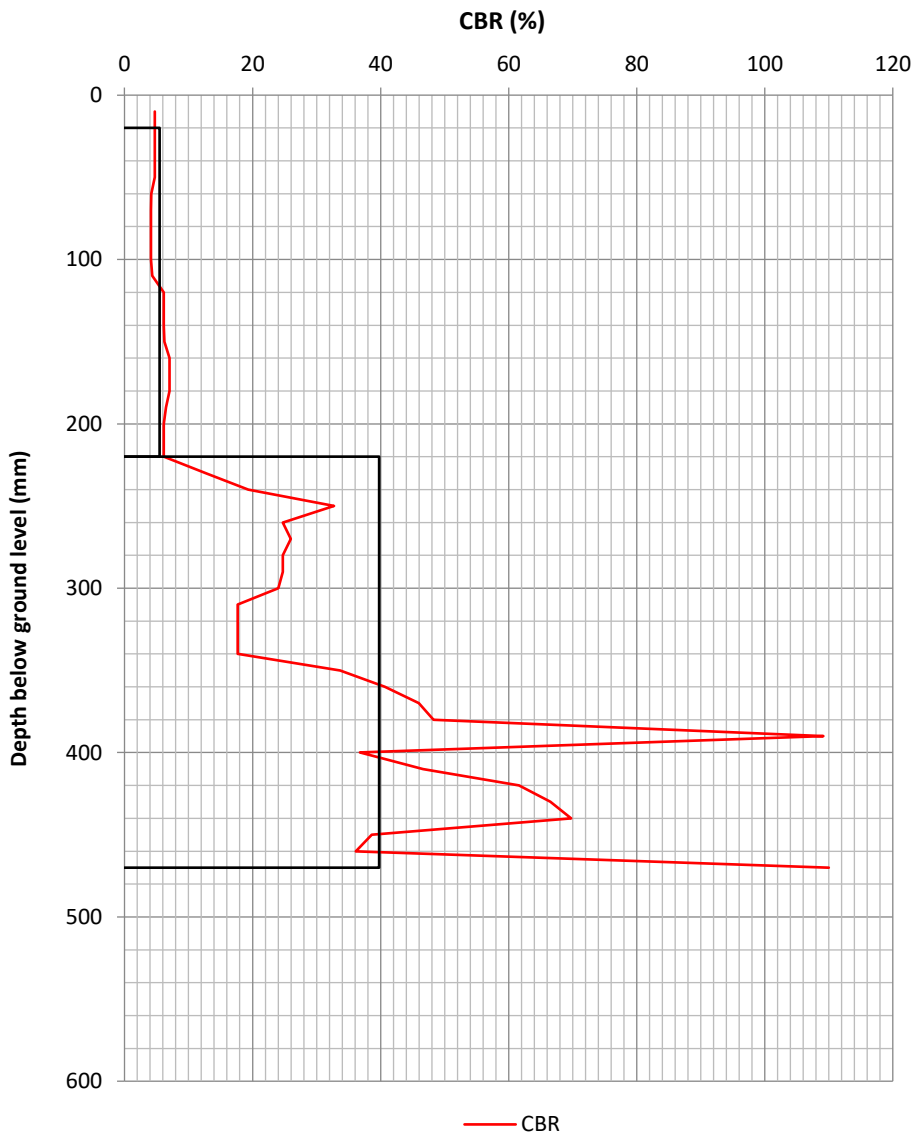
Plot showing number of blows against depth

1. Test procedure following Highways England Document CS229 Data for Pavement Assessment.

Plot showing CBR (%) against depth

$\text{Log10 (Uncorrected (UC) CBR)} = 2.48 - 1.057\text{Log10}(\text{mm/blow})$

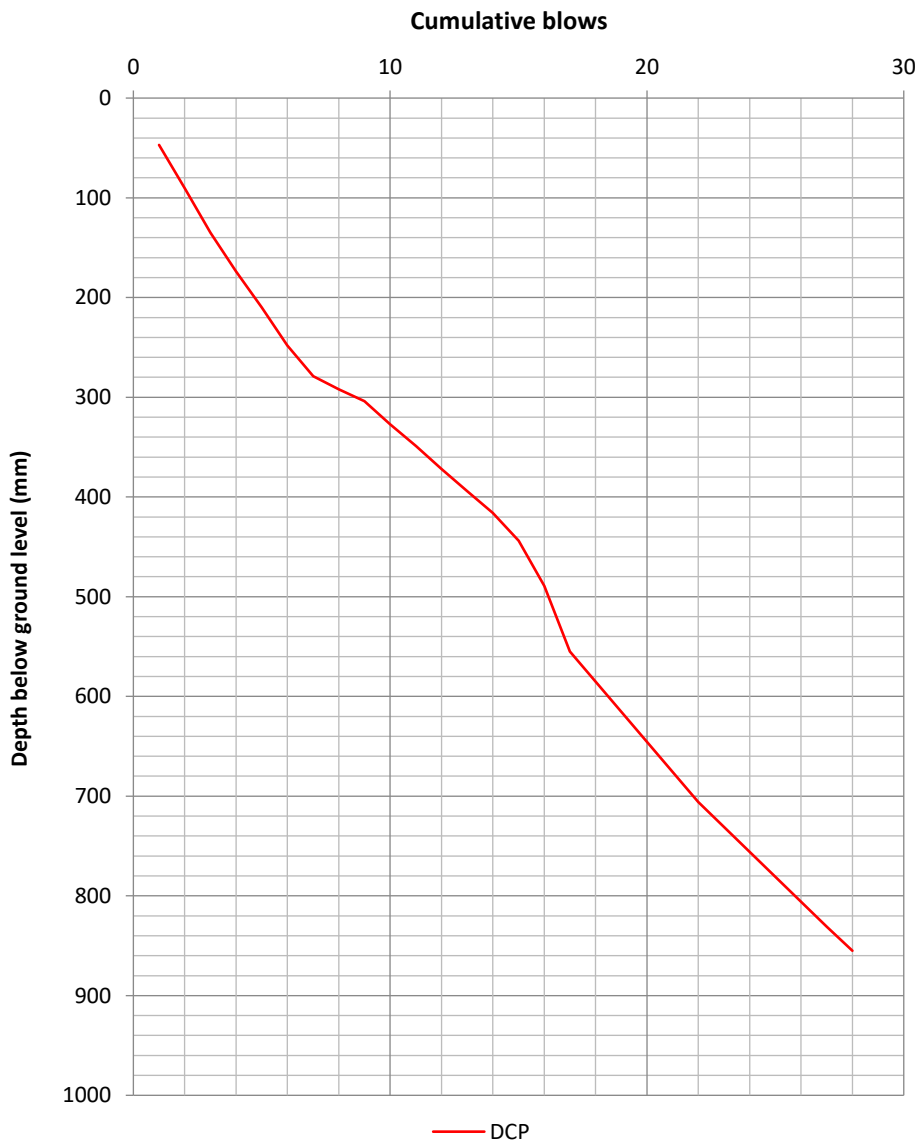
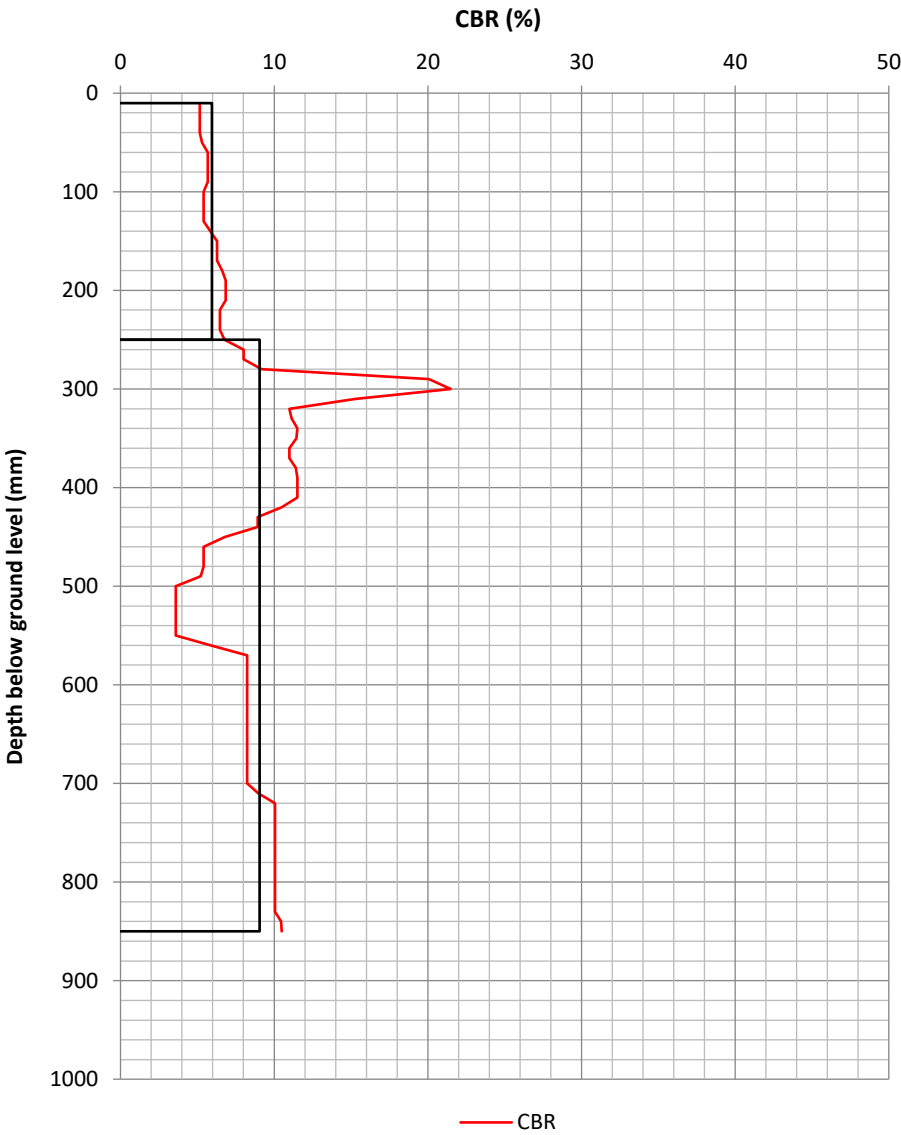
Plot showing number of blows against depth

1. Test procedure following Highways England Document CS229 Data for Pavement Assessment.

Plot showing CBR (%) against depth

$\text{Log10 (Uncorrected (UC) CBR)} = 2.48 - 1.057\text{Log10}(\text{mm/blow})$

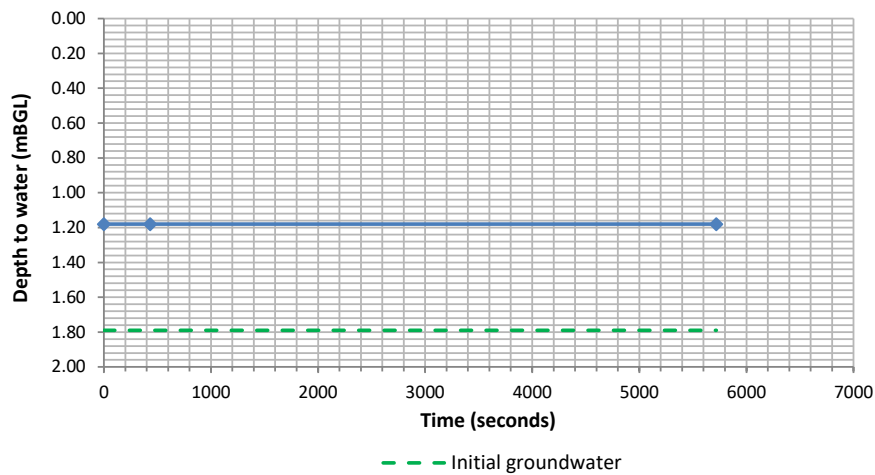
Insufficient infiltration over 95 minutes of monitoring, therefore unable to determine permeability.
