## Ground Investigation Report

Proposed LED Floodlit Artificial Grass Pitch

Dragon Park, Newport

Document no.: STX7242-R01-Rev\_A

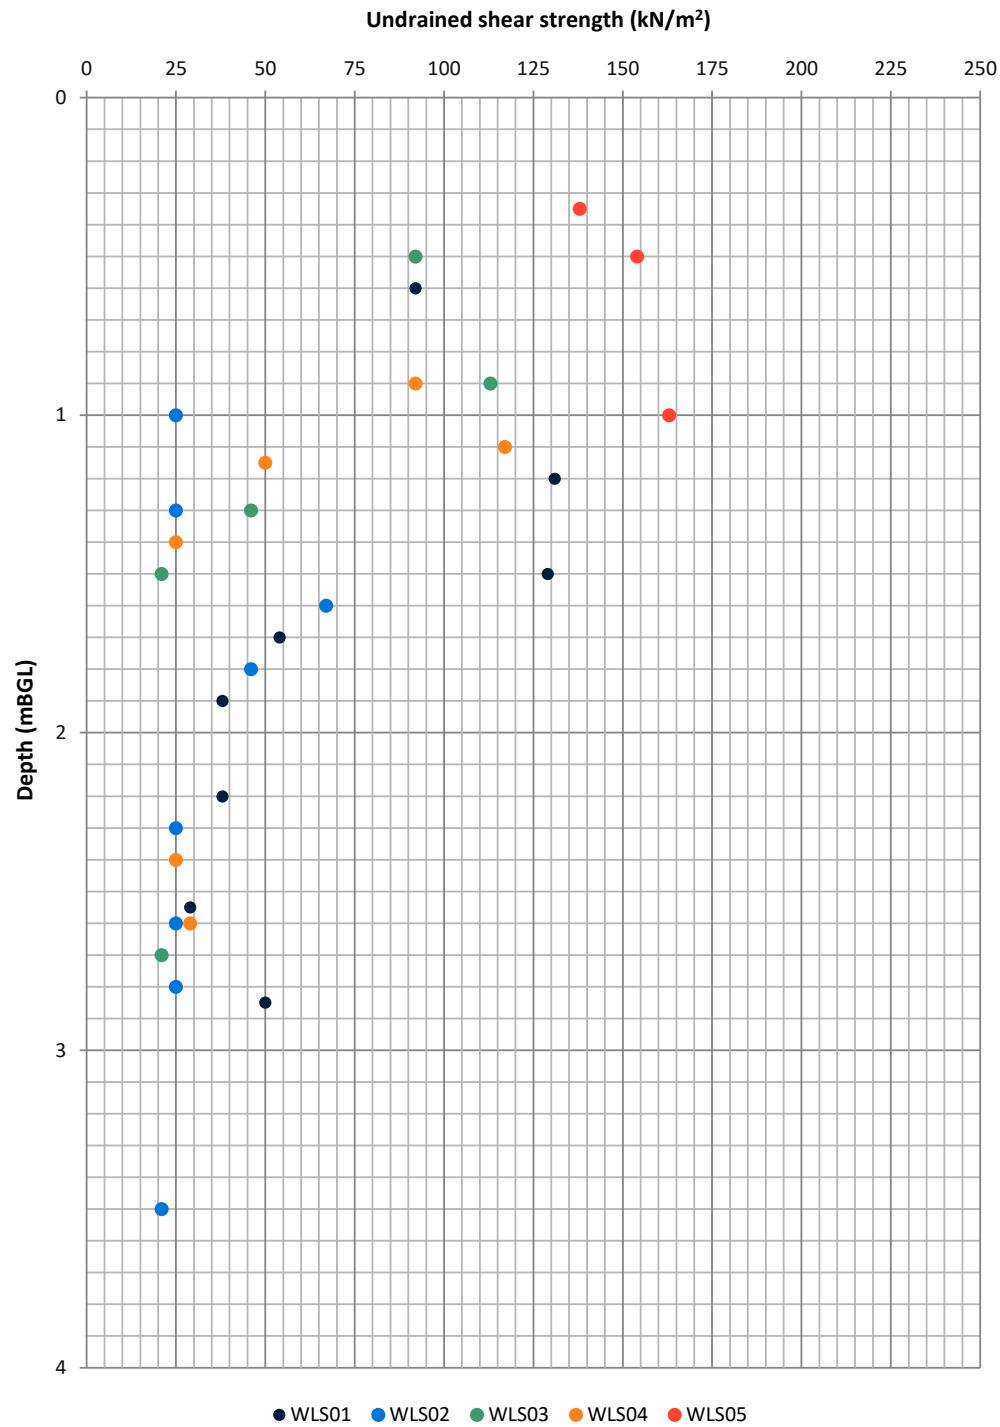
Plot summarising Pocket Penetrometer results versus depth filtered by location

This scatter plot displays the undrained shear strength (kN/m²) on the x-axis (ranging from 0 to 250) against depth in meters below ground level (mBGL) on the y-axis (ranging from 0 to 4). The data is categorized into two types: MADE GROUND (black dots) and TIDAL FLAT DEPOSITS (blue dots). A vertical line is drawn at approximately 165 mBGL.

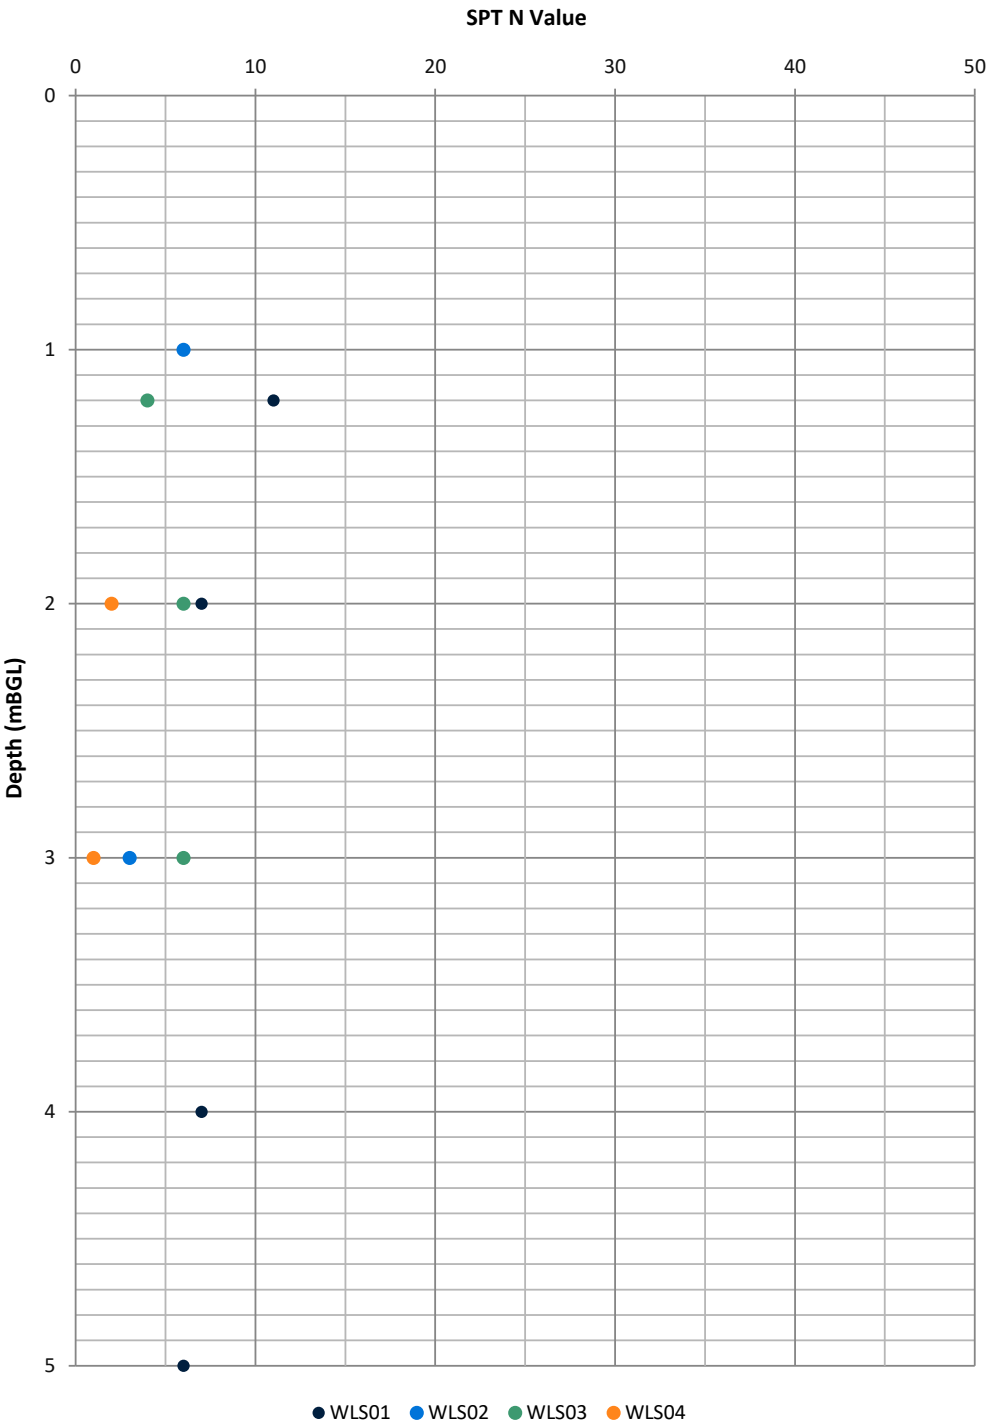
Plot summarising Standard Penetration Test (SPT) results versus depth filtered by location

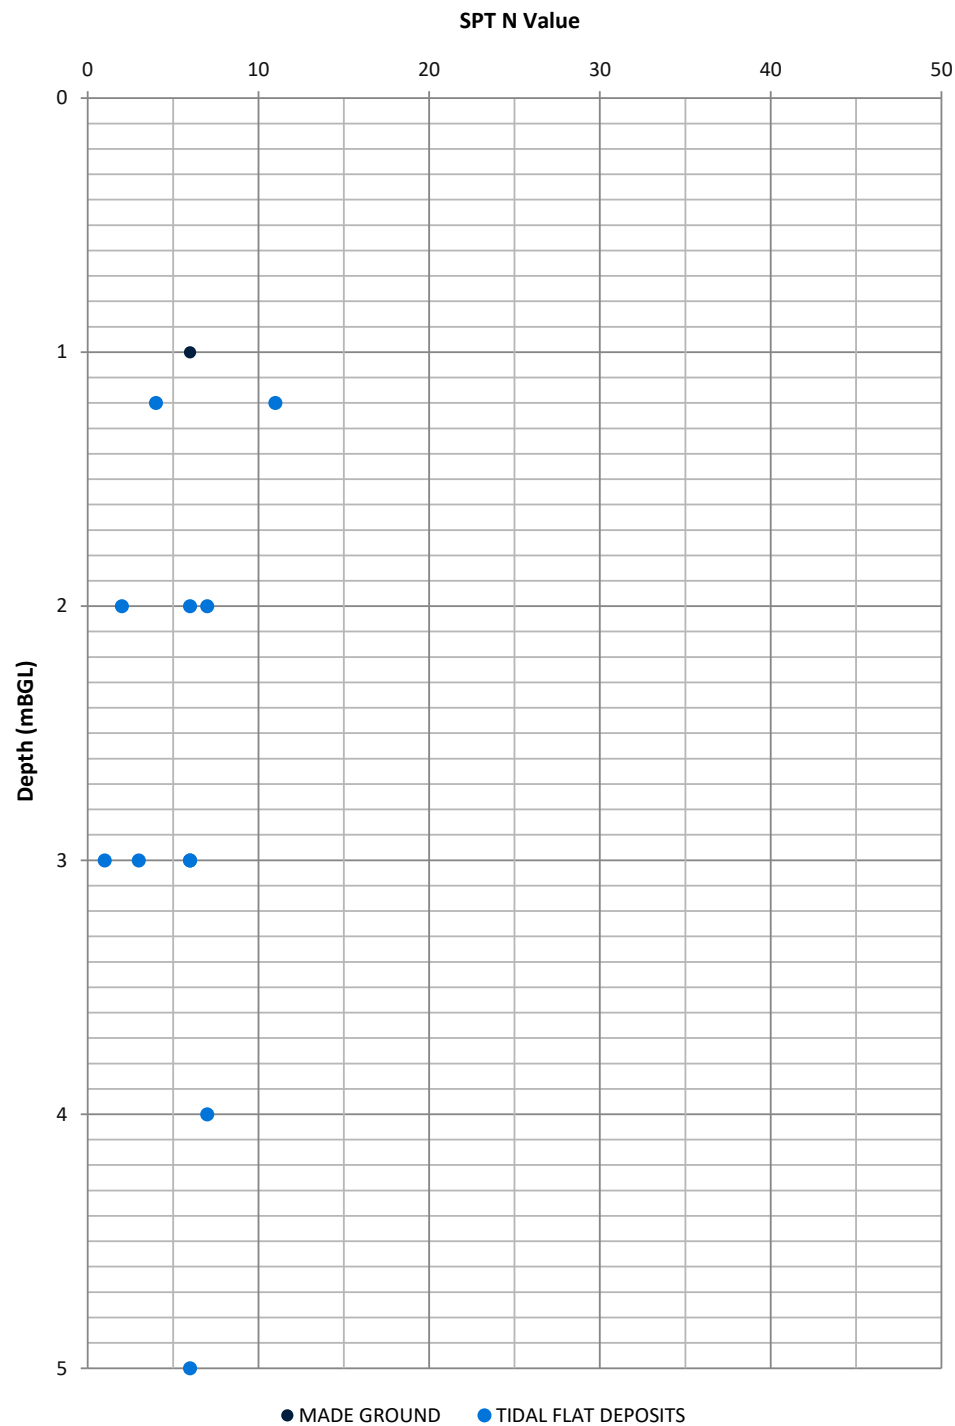
Plot summarising Standard Penetration Test (SPT) results versus depth  
filtered by geology
