**Former Whiteheads Steelworks, Mendalgief Road, Newport, NP20 2HY**  
**NHBC Outstanding Land Quality Conditions, Ref: 216335 LQ conditions LQ5 & LQ6.**  
**Planning Permission Number RM1-18/1039, RM2-18/1142 and RM3-21/0464**  
**Validation of Imported Clean Cover Block E Plots 73 to 81.**

### **Validation of Clean Capping Layer to Block E (Plots 73 to 81)**

**14092: Remedial Capping Works to Gardens and Landscape Areas**

**Former Whiteheads Steelworks, Mendalgief Road, Newport.**

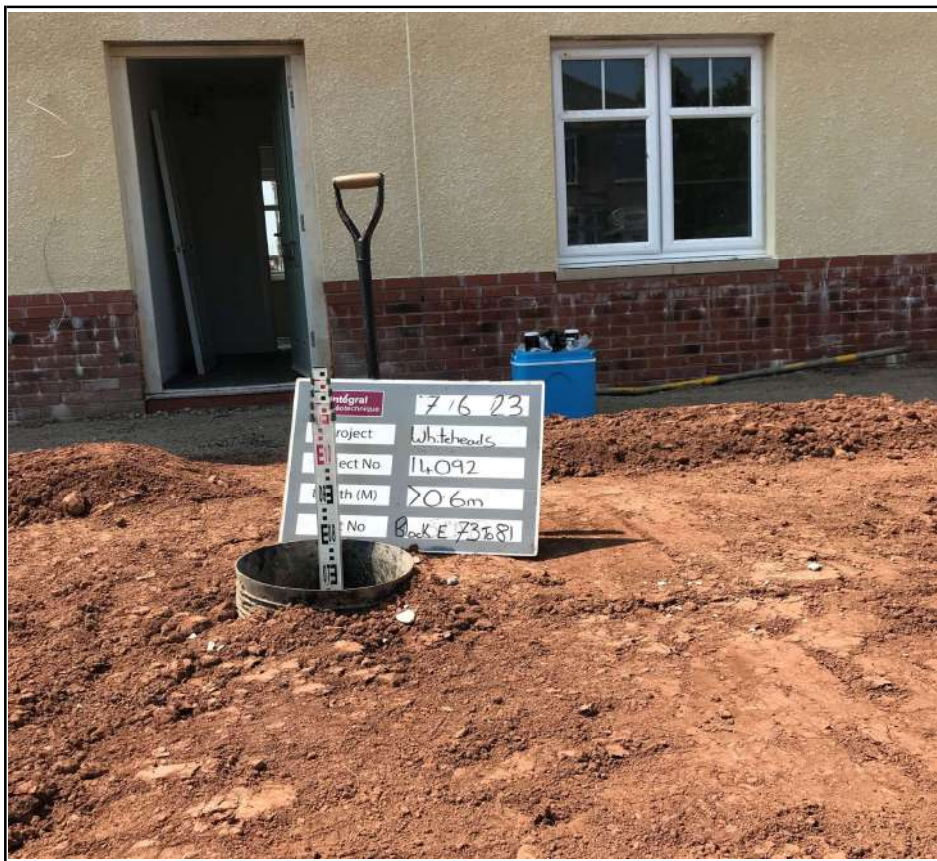
This trial pit was found to exhibit the required total of a minimum 600mm of clean cover soil material placed in the landscaped area along with observation of the Hi-Visibility Geotextile Membrane placed at the base of the capping soils.

Block E Plots 73 to 81 Capping Depth Check

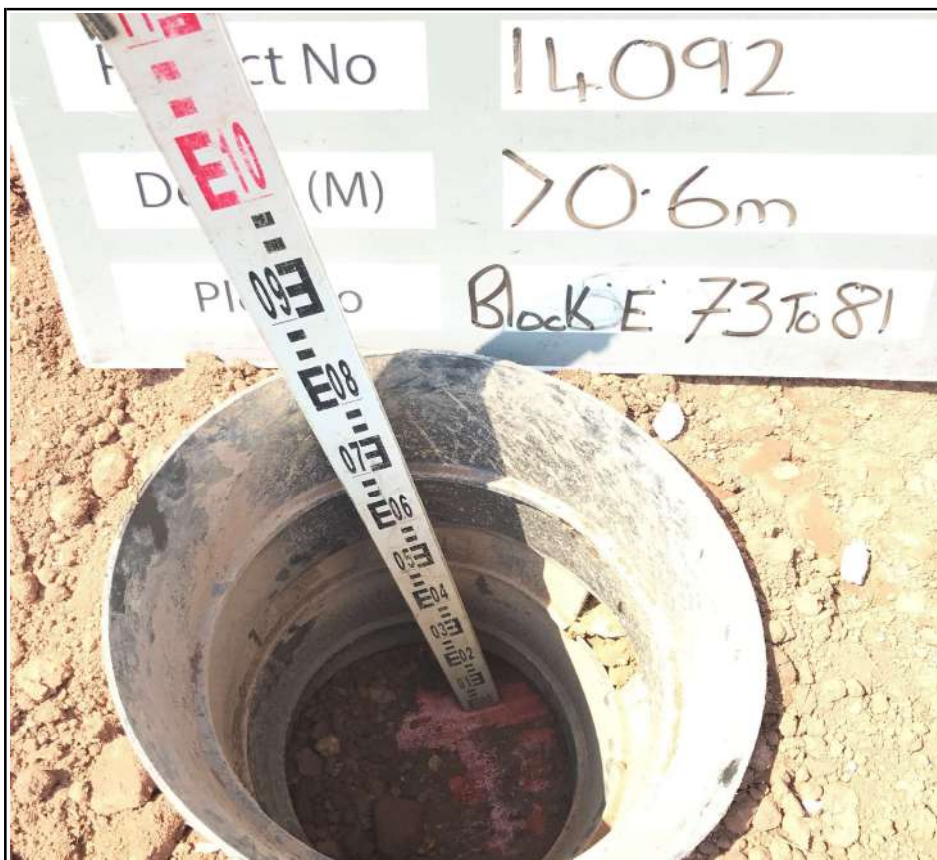
Block E Plots 73 to 81 Membrane Observation

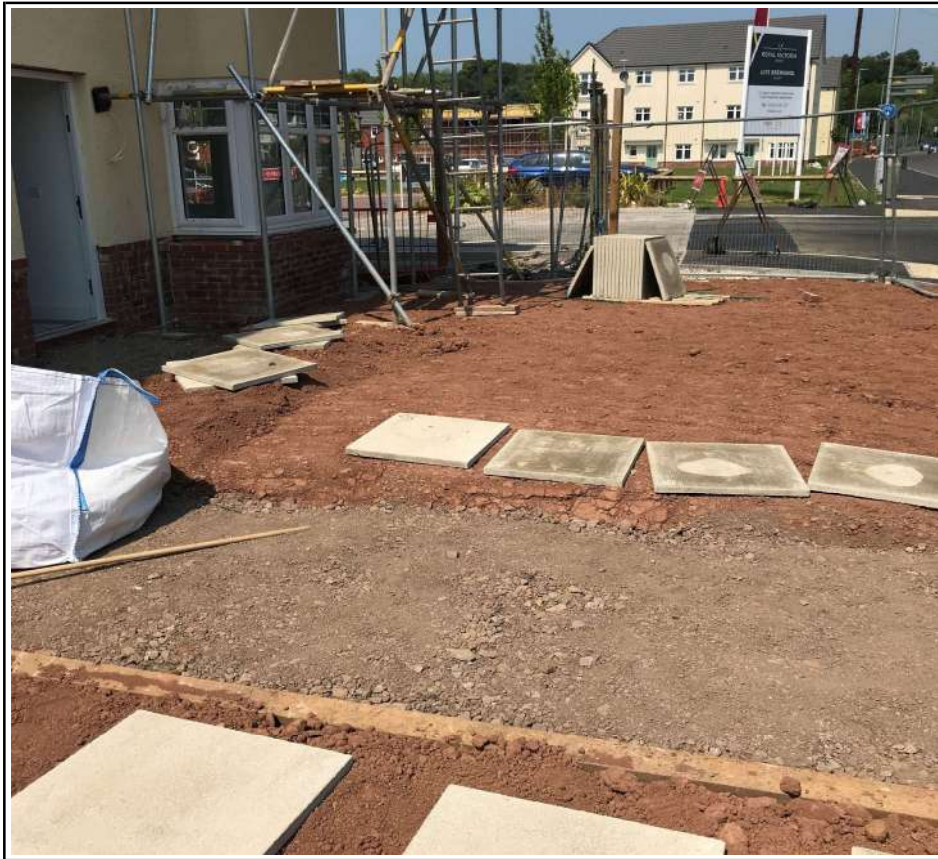
An engineer from Intégral Géotechnique attended site on 7<sup>th</sup> June 2023, Block E plots 73 to 81, is an apartment block of 9 internal apartments, encircling the apartment block are limited landscape areas, entrance pathways and public pavement access. Within the larger landscaped areas to the main entrance of the apartment block a hand/machine dug trial pit for validation purposes was advanced within the east flank of Block E Plots 73 to 81. The topsoil resembled a cohesive silty clay strata and was underlain by a subsoil material found to be a granular material comprising a medium dense becoming dense orangish brown and brown very sandy clayey gravel with medium cobble content.

Block E plots 73 to 81 Area to Main Entrance
