## **PRELIMINARY PROTECTED SPECIES ASSESSMENT**

**Land East of Lyte Buildings, Road C,  
Wern Industrial Estate, Rogerstone, Newport, NP10 9FQ**

**Report Reference – WW/PPSA/060525**

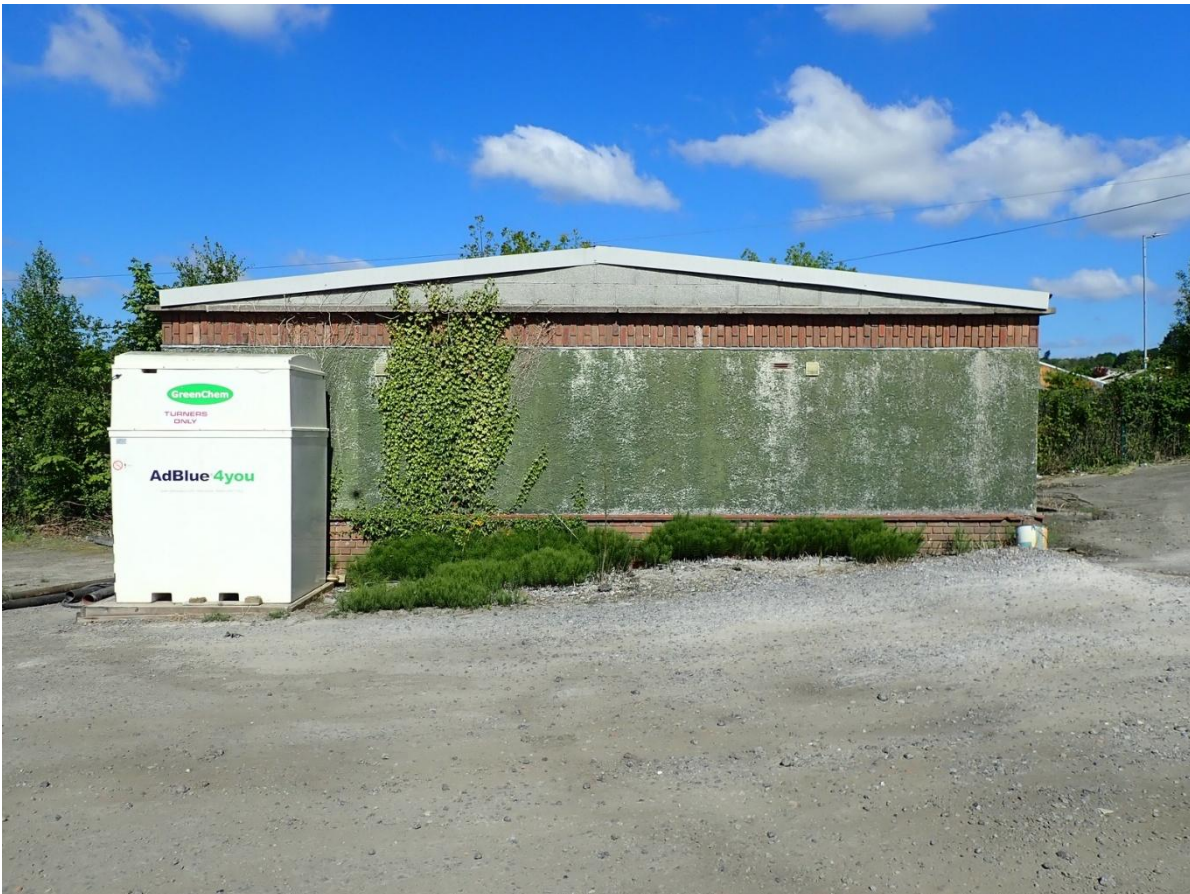
*Building proposed to be demolished.*

The detached building is comprised of well-rendered concrete blockwork walls with well-mortared exposed brick base and top, and metal box-profile sheet mono-pitch roof. No cracks or crevices are present in the walls. Metal verge coverings are present at the roof edge. Gaps between the verges and wall are wide, with the wall tops well-sealed.

Given the lack of suitability the building offers for roosting bats, the lack of potential roost features and complete absence of evidence, the bat roost potential of the structure surveyed is considered 'negligible'. As such, bats do not appear to form a constraint to the development of the site. In the unlikely event that bats are discovered, works should cease immediately and further ecological advice should be sought.

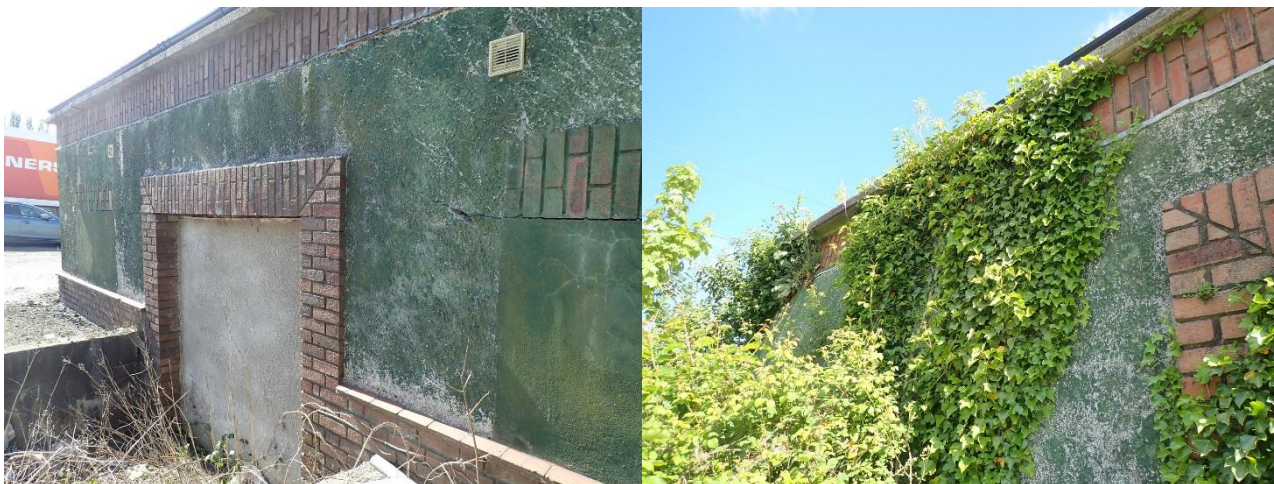
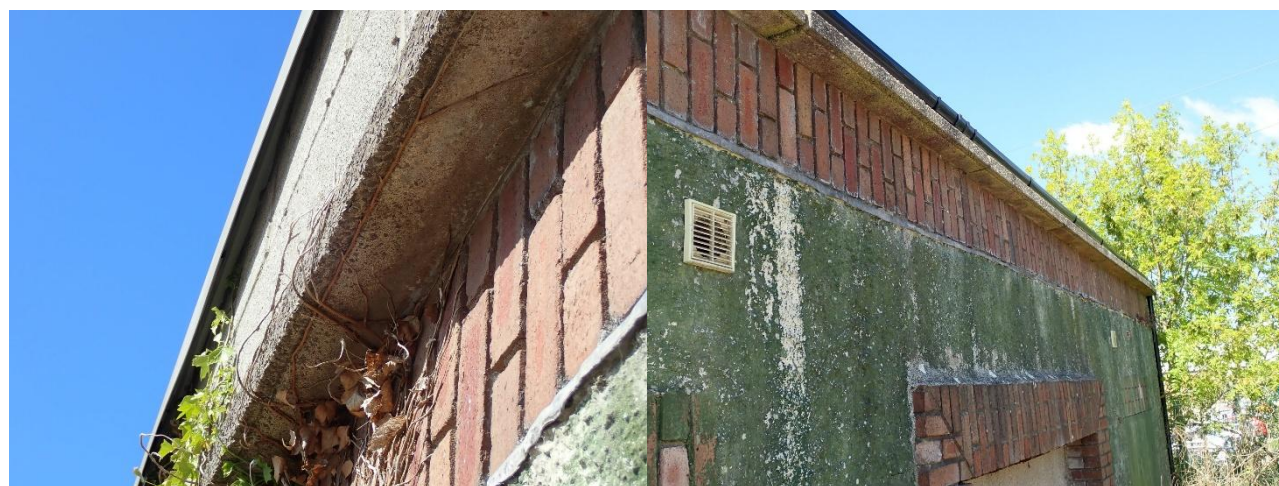
The north-eastern doorway is blocked up. The south-western doorway has a timber door that is tight-fitting. Some narrow gaps are present above the door frame where mortar is missing; these are well-cobwebbed. Light, thin-stemmed ivy cover is present on the north-west, south-west, and south-east elevations.

*External photographs (clockwise from top left): Northern-eastern elevation with blocked doorway; light-thin-stemmed ivy; well-mortared brickwork and ventilation duct; well-sealed wall top.*
