**Bat Survey:** 27 Backhall Street, Caerleon, Newport, NP18 1AR

**Instructed by:** Duncan Anstey

**Reported by:** Ecological Services Ltd  
10 Mount Pleasant, Llanelly Hill, Abergavenny, Monmouthshire, NP7 0NT

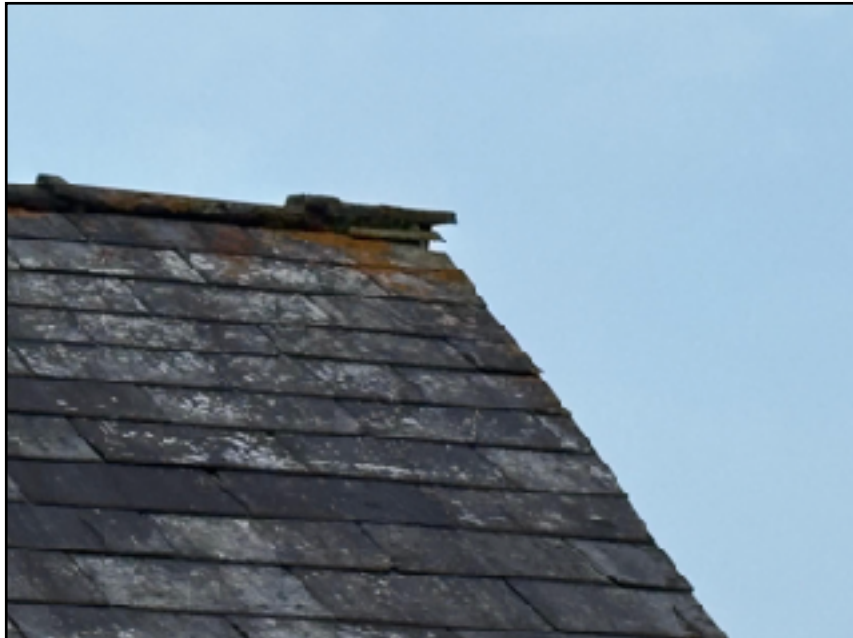
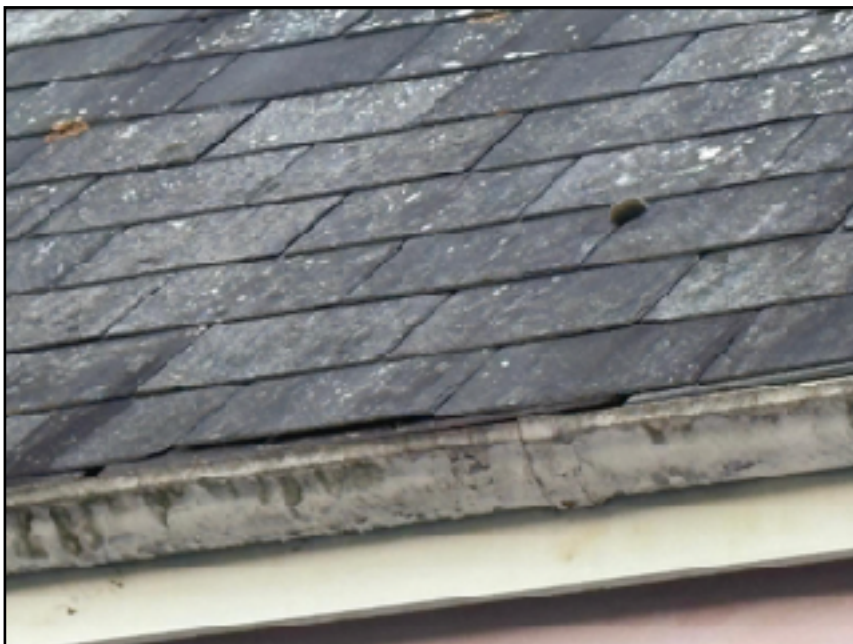
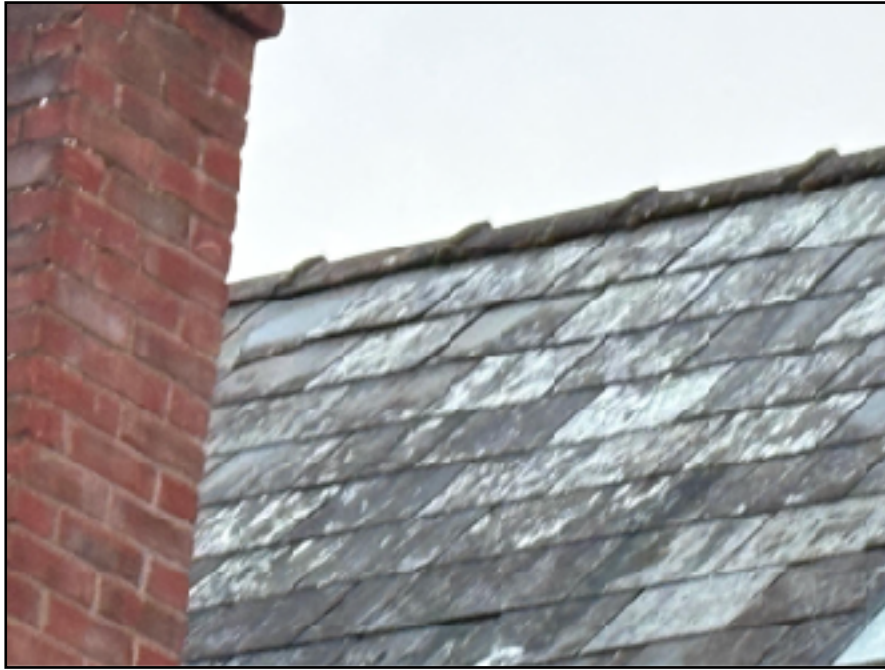
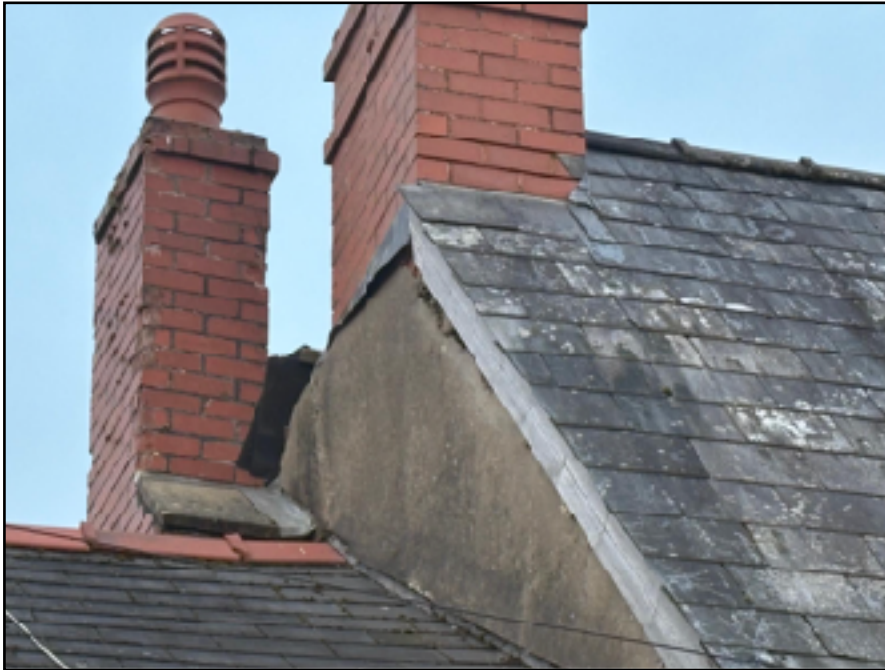
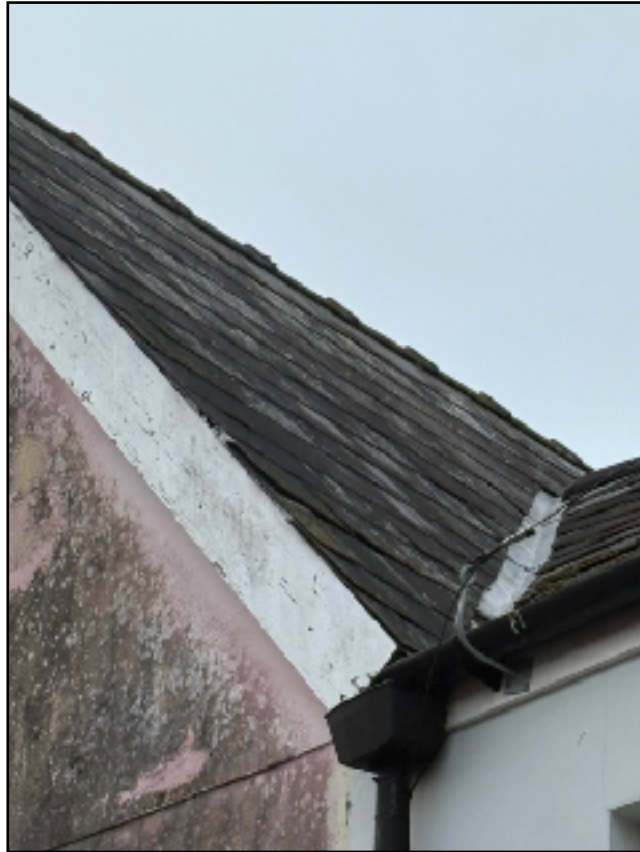
**6.6 Examples of apertures allowing access to cavities in the building:**

**6.3 Due to the age and condition of the building, there were a small number of opportunities present for bats to access and use the building and those that were available were deemed as having moderate potential for roosting bats. There were raised slates and ridge tiles; apertures between the barge boards and the walls and areas of slightly raised lead flashing.**

**6.4 No droppings or evidence of bats were discovered on any external features.**

**10.2** Various patch repair works are proposed to be carried out for slipped and missing slates around the roof. 3 lead bat access slates will be fitted; 2 on the rear of the main roof & 1 on the small area of the roof adjacent to the south western gable. These will be fitted in locations where current missing or slipped slates are present.

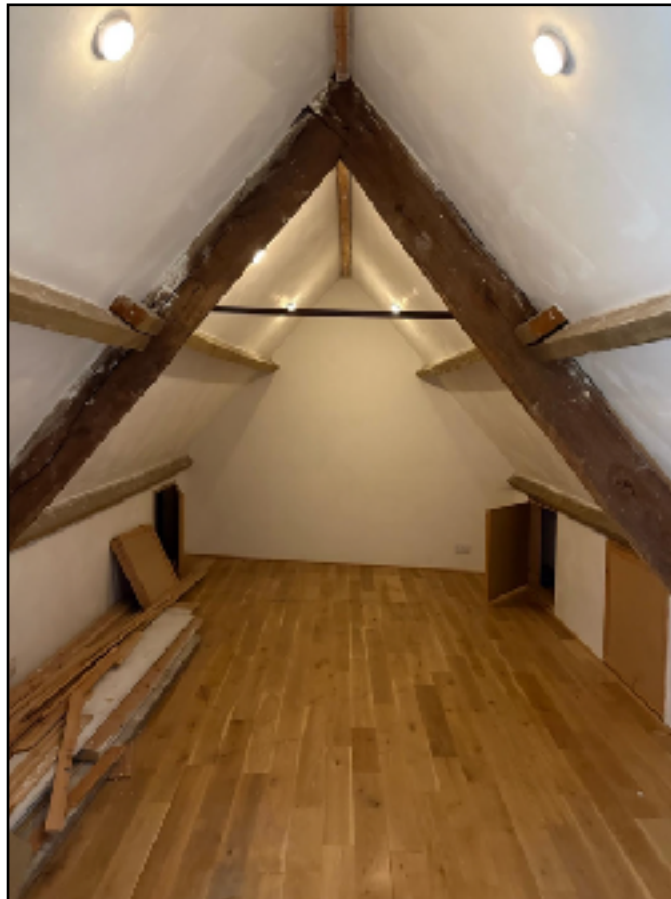
**7.2** There were no internal attic spaces within the property. The property consisted of vaulted ceilings throughout.

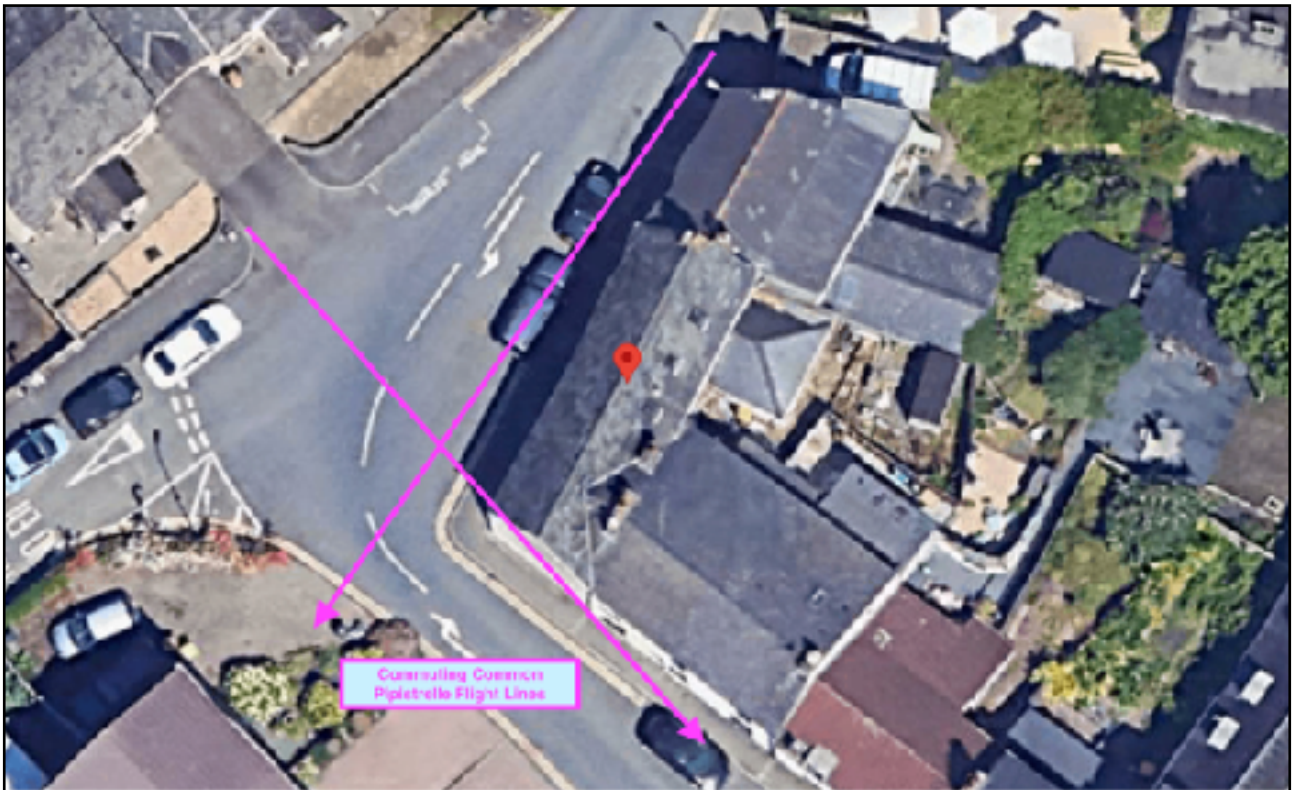
**8.9** During the first emergence survey, a very low number of bat calls were recorded. A small number of Common Pipistrelle passes were observed and a Common Pipistrelle was detected at the rear of the property but was not observed.

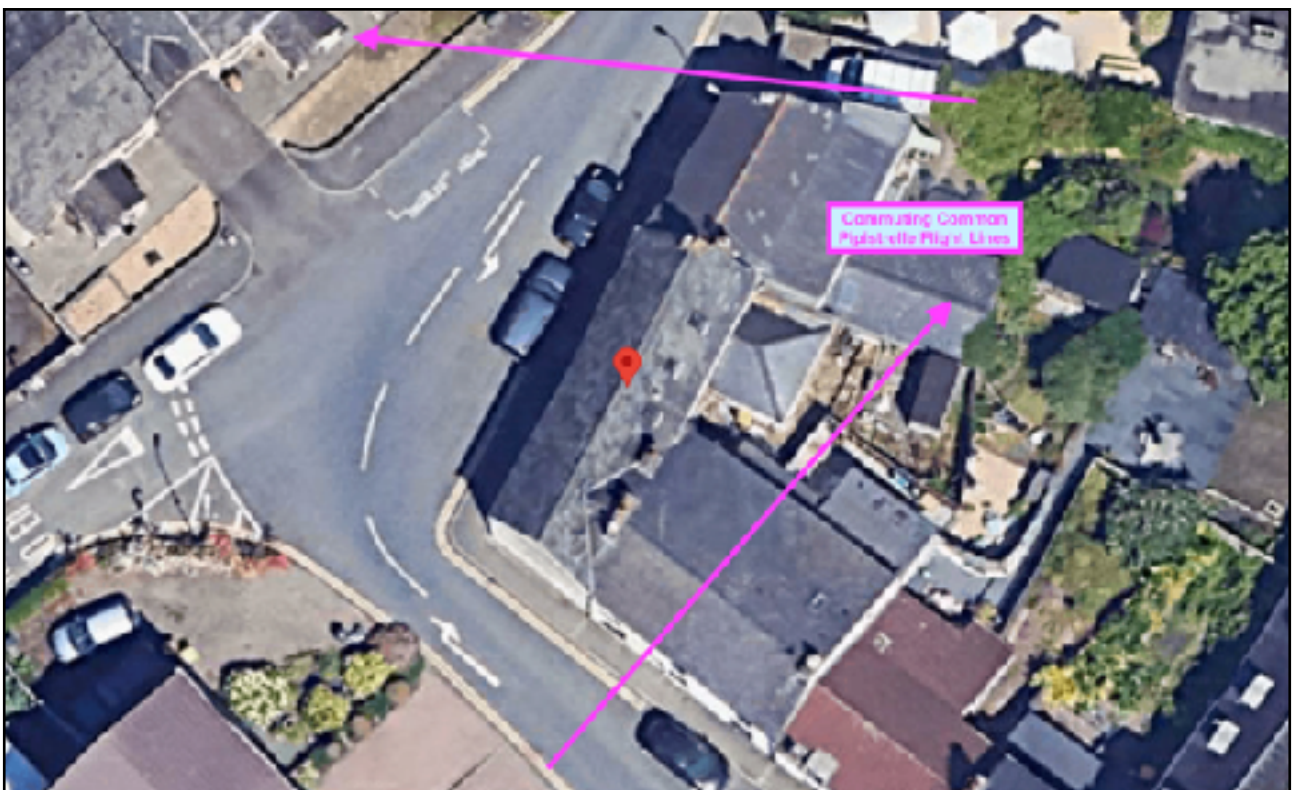
8.10 During the second emergence survey, a very low number of bat calls were recorded. A small number of Common Pipistrelle passes were observed.

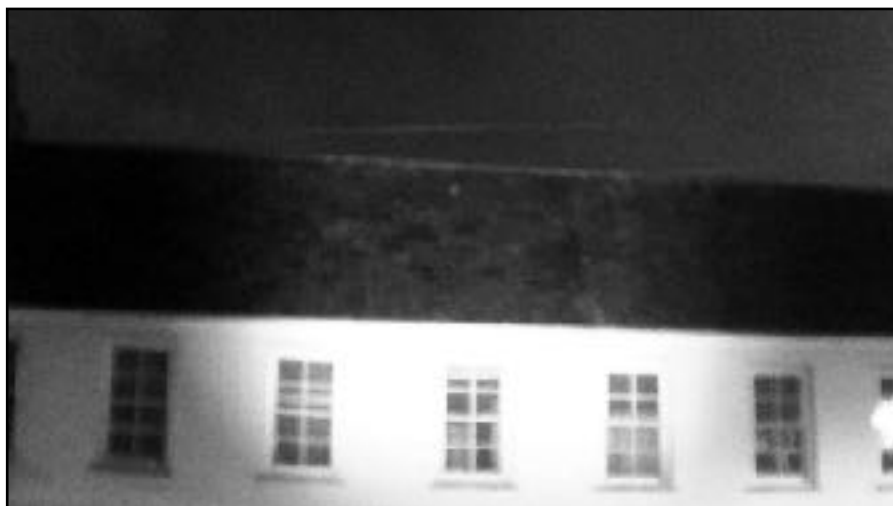
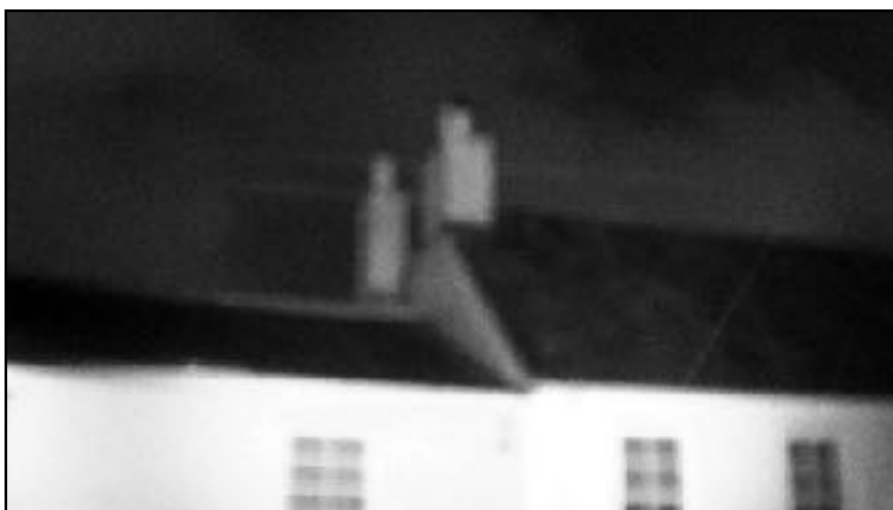
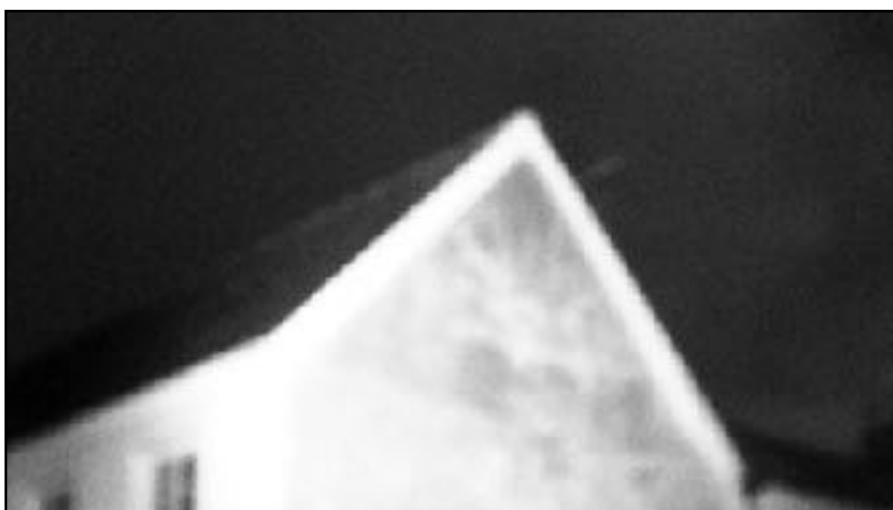
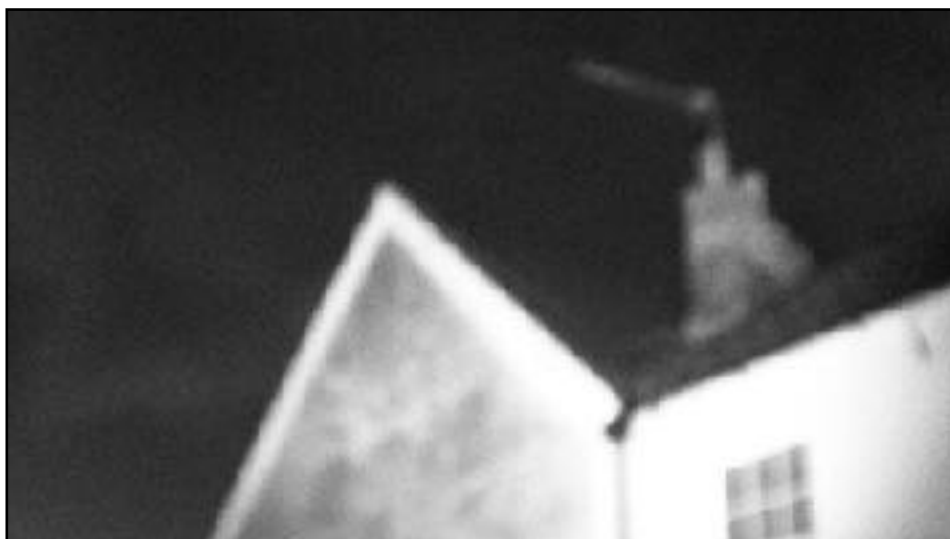
### 8.11 Examples of NVA Still Shots:

**9.1 During the emergence surveys, no bats were observed emerging from the building.**
