# Alexandra Docks, Newport

## Preliminary Roost Assessment

# Preliminary Roost Assessment

Project Number: **61271**

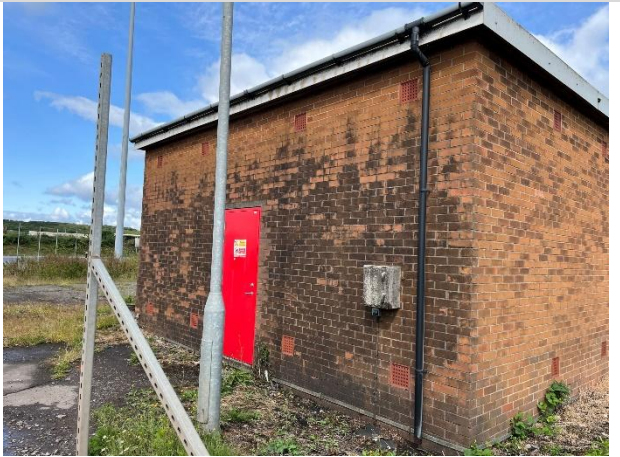
| Building | Description | Photographs |
|---|---|---|
| B1 | Southern frontage of building B1. Flat roof with guttering attached, appeared well sealed with no potential access points for bats. | <p>Image 1</p> |

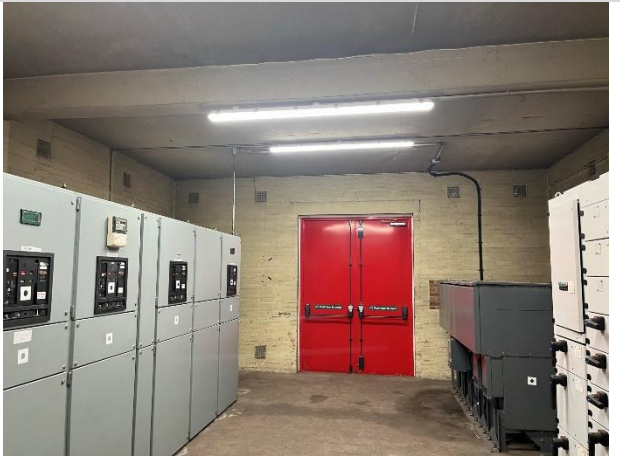
| Building | Description | Photographs |
|---|---|---|
| B1 | Rear of Building B1 (North side) Roof and walls appeared well-sealed with no gaps. Air bricks present at top and bottom of the walls with double access doors present on northern wall. | <p>Image 2</p> |

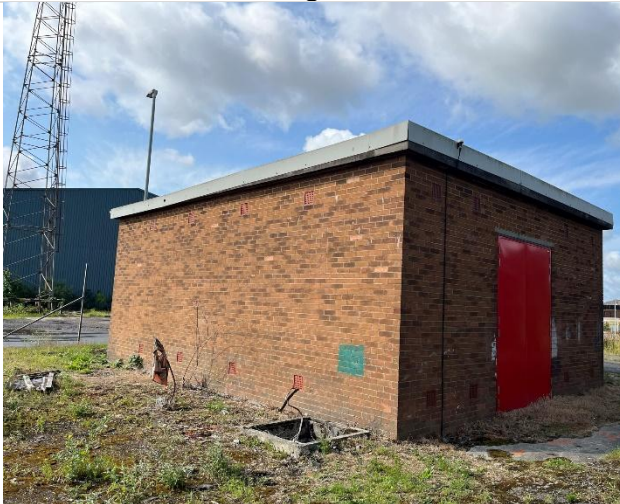
3.2.4 Building B1 is the main substation building. This is a single storey flat roof structure of brick construction, with multiple air bricks positioned along the top and bottom edges of the building on all sides. The southern and northern ends of the building contain locked metal access doors (double to the rear). The interior of the building is of concrete construction. The building was noted to be generally well sealed with a lack of access points (see images 1 to 3 in Table 3 below for photographs). A small gap was noted under a lifting roof cladding panel on the northeast corner of the building, however this was considered to not lead into the roof and not significant (see image 3).

| Building | Description | Photographs |
|---|---|---|
| B1 | Small gap under flat roof cladding on north west corner of building (TN1). No evidence of use by bats at time of assessment | <p>Image 3</p> |

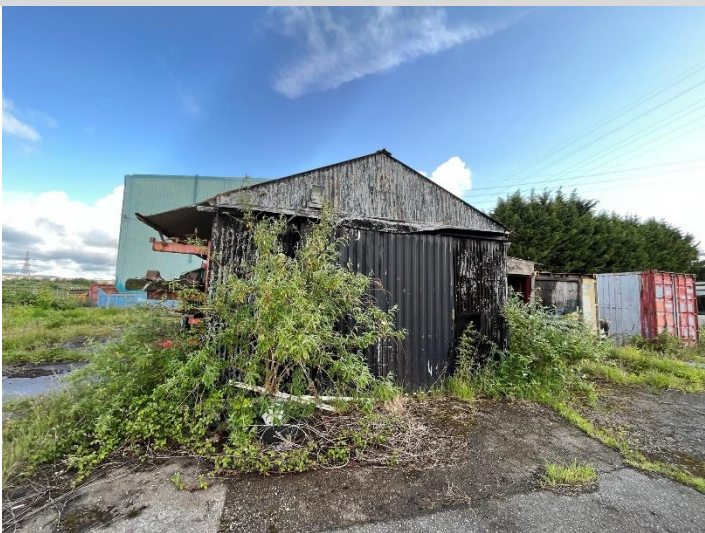
- 3.2.5 Building B2 is a single storey metal corrugated barn with pitched roof, and a wooden/metal lean to attached on the eastern side. (See images 4 & 5 in Table 4 below for photographs). The lean to contained three transparent skylight roof panels, with a wooden door to the south and a corrugated metal door to the north. The southern door was open at the time of the survey, and the door to the north had a narrow gap running round the exterior, with a circular hole in the wall adjacent. The eastern wall had a number of tears present, as well as a vertical gap from floor to ceiling at the southern end of the L shaped wall (see images 6 & 7 in Table 4 below for photographs). These features were considered to be of low potential for roosting bats.

| Building | Description | Photographs |
|---|---|---|
| B2 | Southern frontage of Building B2. Shallow pitched roof. | <p>Image 4</p> |

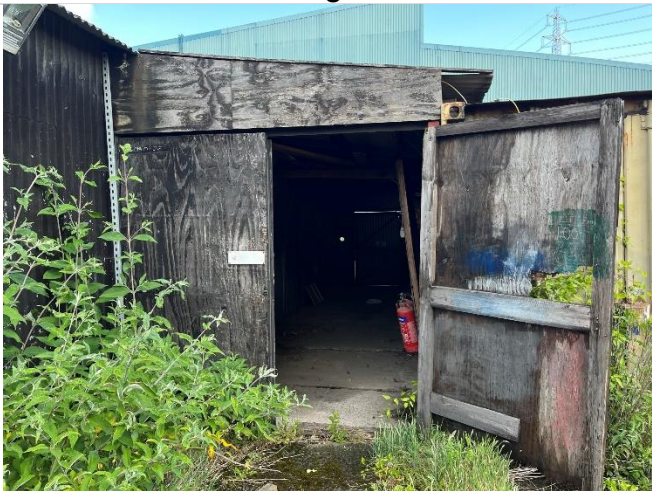
| Building | Description | Photographs |
|---|---|---|
| B2 | Wooden/metal lean to on the eastern side of Building B2. Open door allowing light and access into the building (TN2). | <p>Image 5</p> |

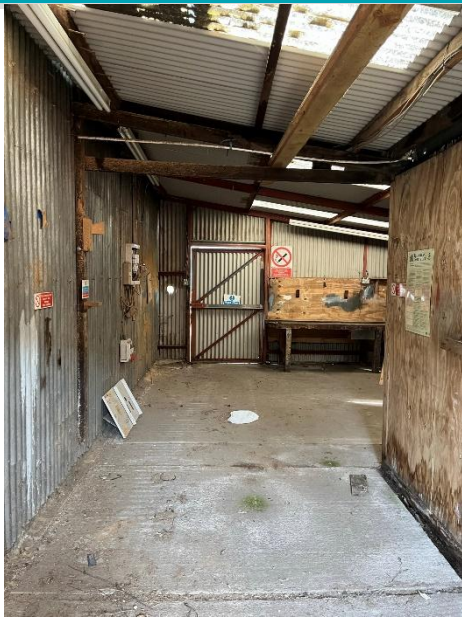
| Building | Description | Photographs |
|---|---|---|
| B2 | Internal of B2, showing skylights, concrete floors and metal wall with gaps around door and hole to left hand side of door. (TN3) | <p>Image 6</p> |

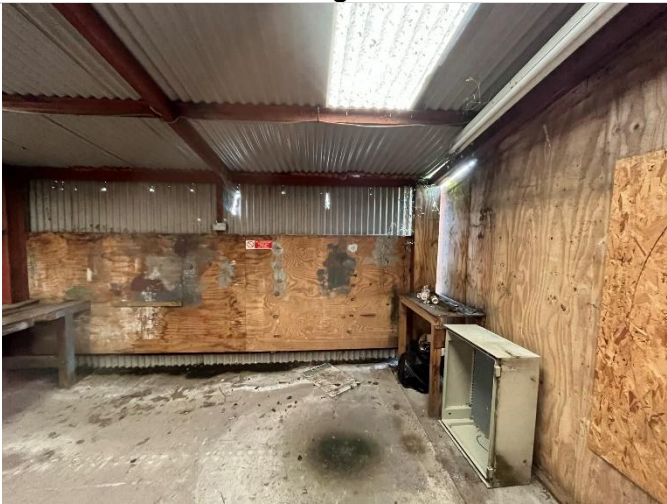
| Building | Description | Photographs |
|---|---|---|
| B2 | L shaped section of lean to, with wood cladding on metal wall. Tears in corrugated metal present, as well as gaps where two walls join. (TN4) | <p>Image 7</p> |

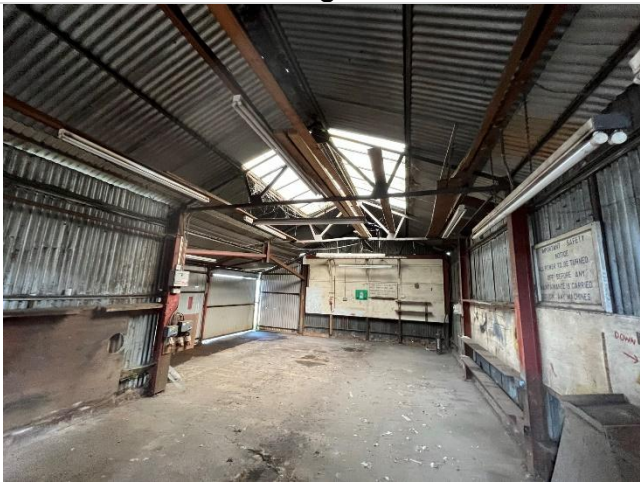
| Building | Description | Photographs |
|---|---|---|
| B2 | Internal of main warehouse of Building B2, with skylights in roof and sliding door to north east corner. | <p>Image 8</p> |

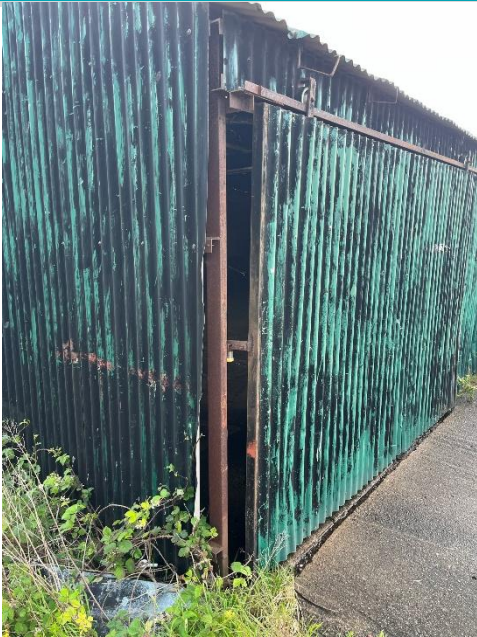
| Building | Description | Photographs |
|---|---|---|
| <b>B2</b> | North east corner of building showing gap between end of sliding door and northern wall. (TN5) | <p><b>Image 9</b></p> |

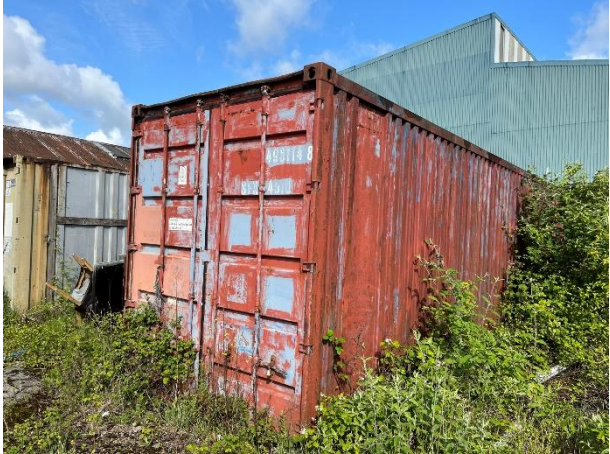
| Building | Description | Photographs |
|---|---|---|
| B3 | Shipping container B3, metal construction with no evidence of bats or gaps noted for access. | <p>Image 10</p> |

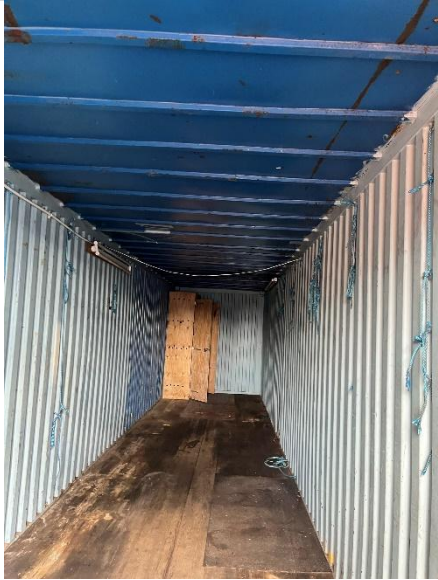
| Building | Description | Photographs |
|---|---|---|
| B3 | Wooden floored interior of shipping container, appeared well sealed with no gaps /potential access points for bats. | <p>Image 11</p> |

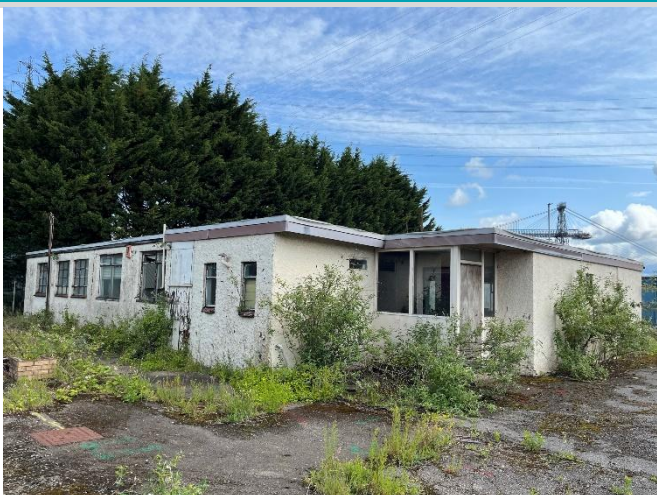
| Building | Description | Photographs |
|---|---|---|
| B4 | External view of flat roofed office building from southwestern corner. | <p>Image 12</p> |

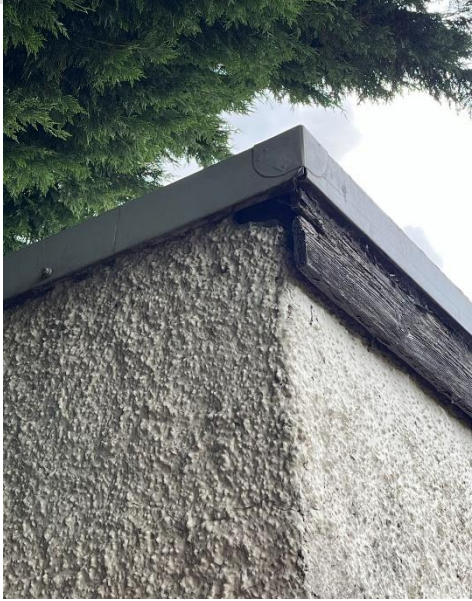
| Building | Description | Photographs |
|---|---|---|
| B4 | Potential gap present behind wooden soffit and flat roof cladding on north western corner. (TN6) | <p>Image 13</p> |

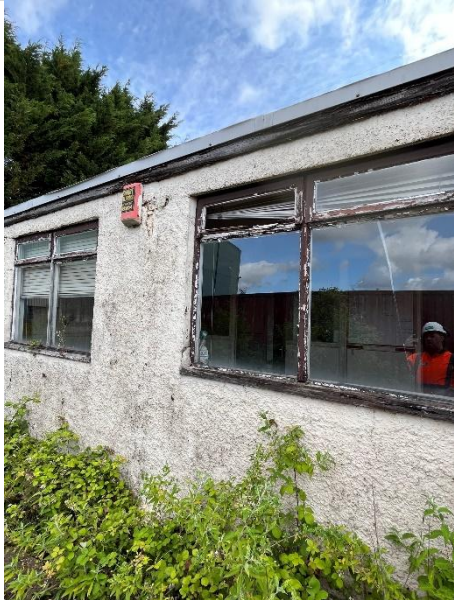
- 3.2.9 A broken window was present on the western side of the building allowing access in for birds, as one was seen inside during the survey. A gap potentially into the roof space was present 3-4m south of the northwestern corner (see images 14 & 15). However, all of these features were assessed as low potential.

| Building | Description | Photographs |
|---|---|---|
| B4 | Broken window on western side of building B4. (TN7) | <p>Image 14</p> |

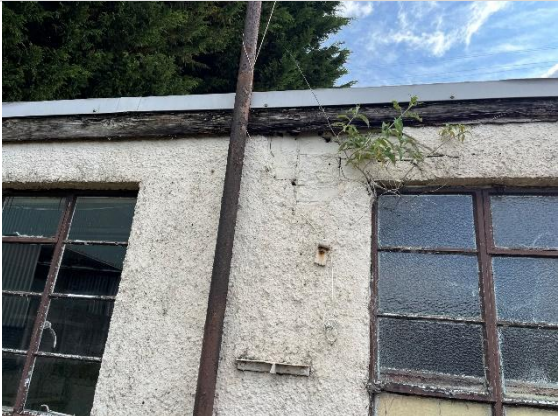
| Building | Description | Photographs |
|---|---|---|
| B4 | Potential gap behind soffit on western side of building, 3-4m south of the northwestern corner. (TN8) | <p>Image 15</p> |

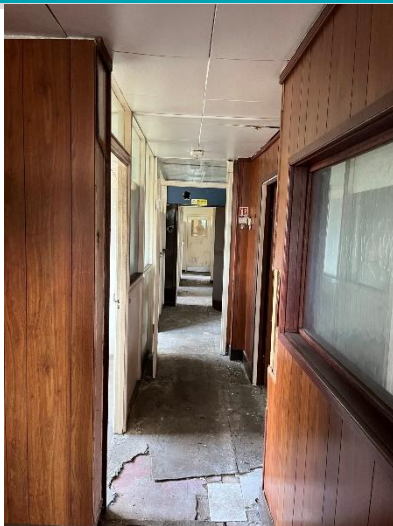
| Building | Description | Photographs |
|---|---|---|
| B4 | Interior of building B4, multiple rooms off a central corridor. | <p>Image 16</p> |

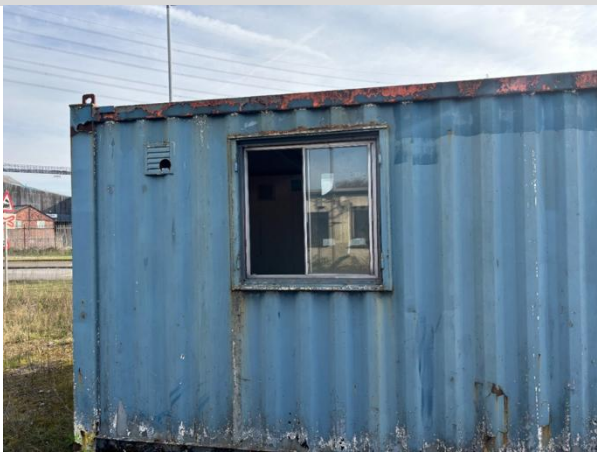
| Building | Description | Photographs |
|---|---|---|
| B5 | Shipping container B5, metal construction with no evidence of bats or gaps noted for access. An open window was noted at time of survey on the northeast corner of the building. | <p>Image 17</p> |

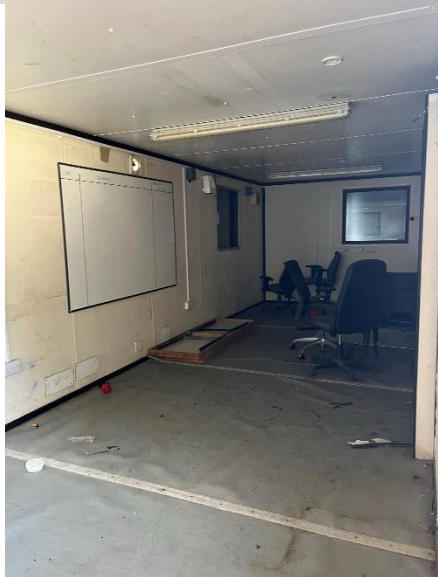
| Building | Description | Photographs |
|---|---|---|
| B5 | Interior of shipping container containing abandoned office. Roof and walls appeared to be well sealed with no evidence of bats. | <p>Image 18</p> |

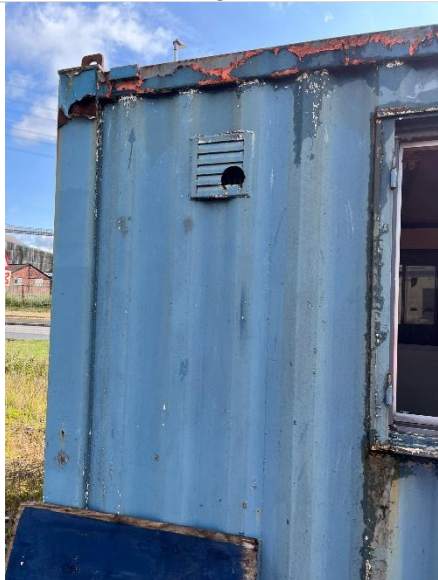
| Building | Description | Photographs |
|---|---|---|
| B5 | A broken vent was noted on the eastern side of the container (TN9), on closer inspection, this did not lead further and provided negligible roosting potential | <p>Image 19</p> |
