## FORMER HOT MILL, LLANWERN

### Bat Activity Survey Report

Tata Steel UK Ltd

2486598-D05 (02)

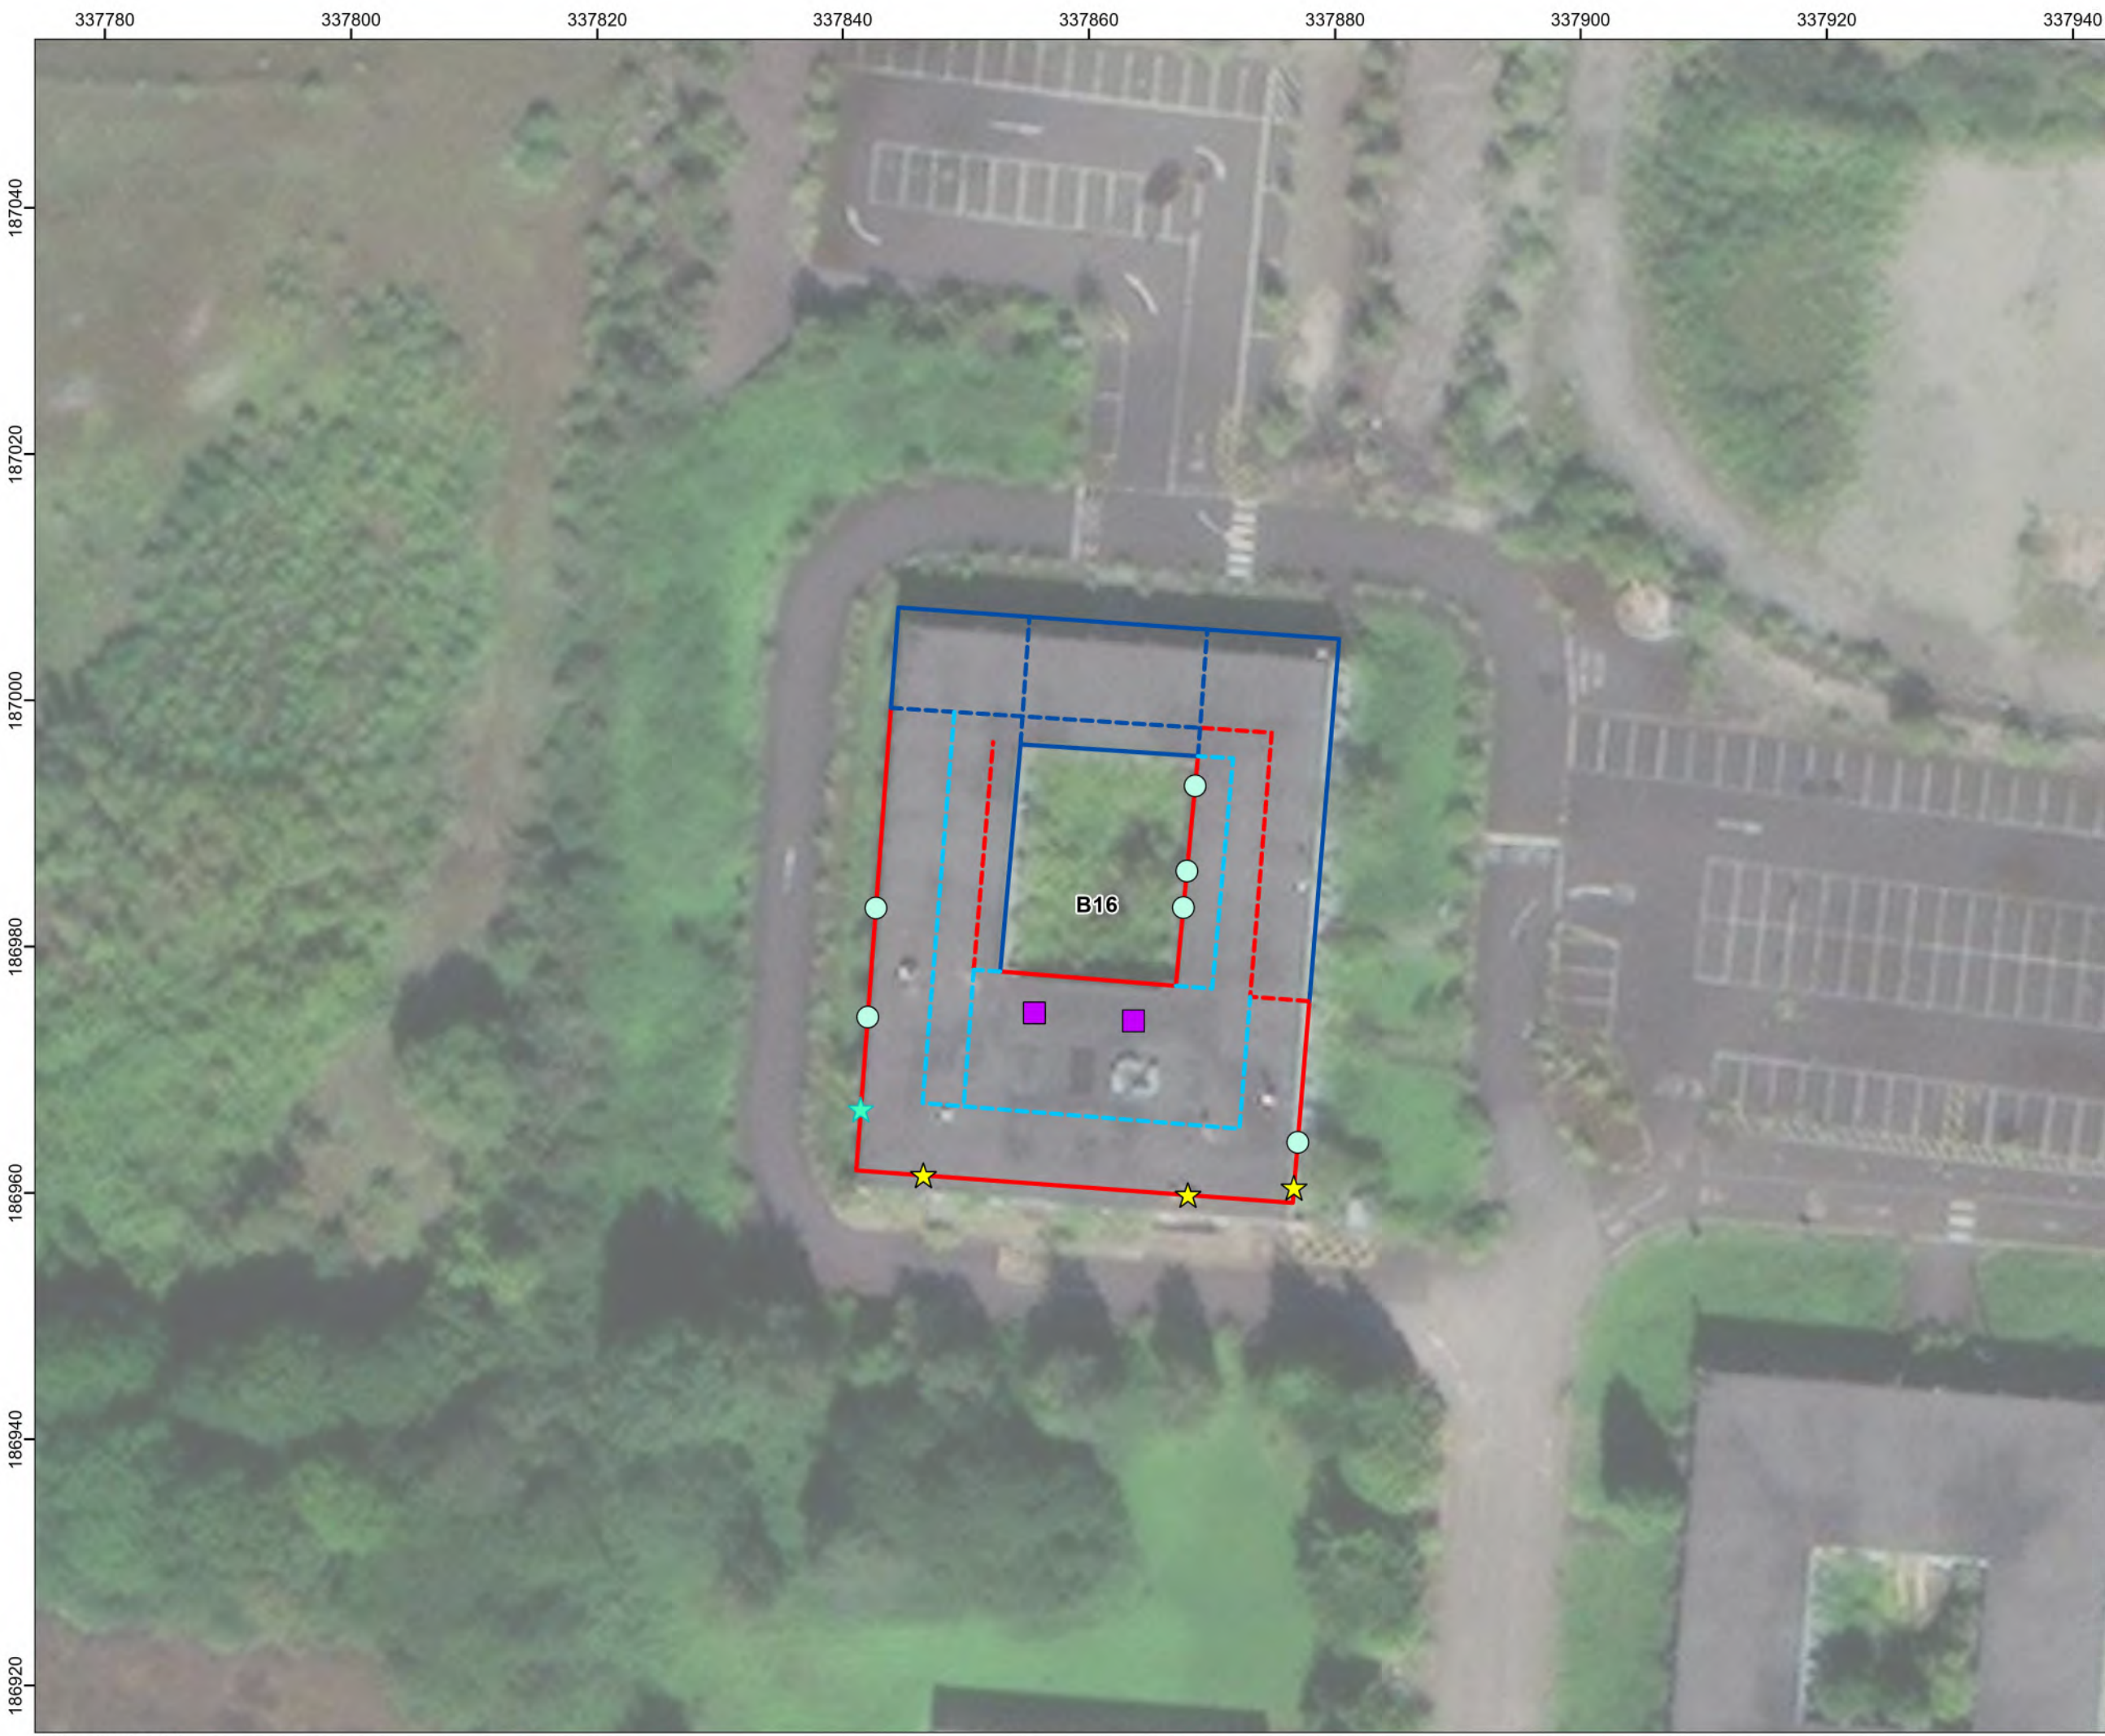
**Current open / broken windows**

- keep open, remove glass where broken for safety
