# Llanwern Hot Mill

Preliminary Roost Assessment and Bat Hibernation  
Survey of the Motor Room

2486598

JUNE 2025

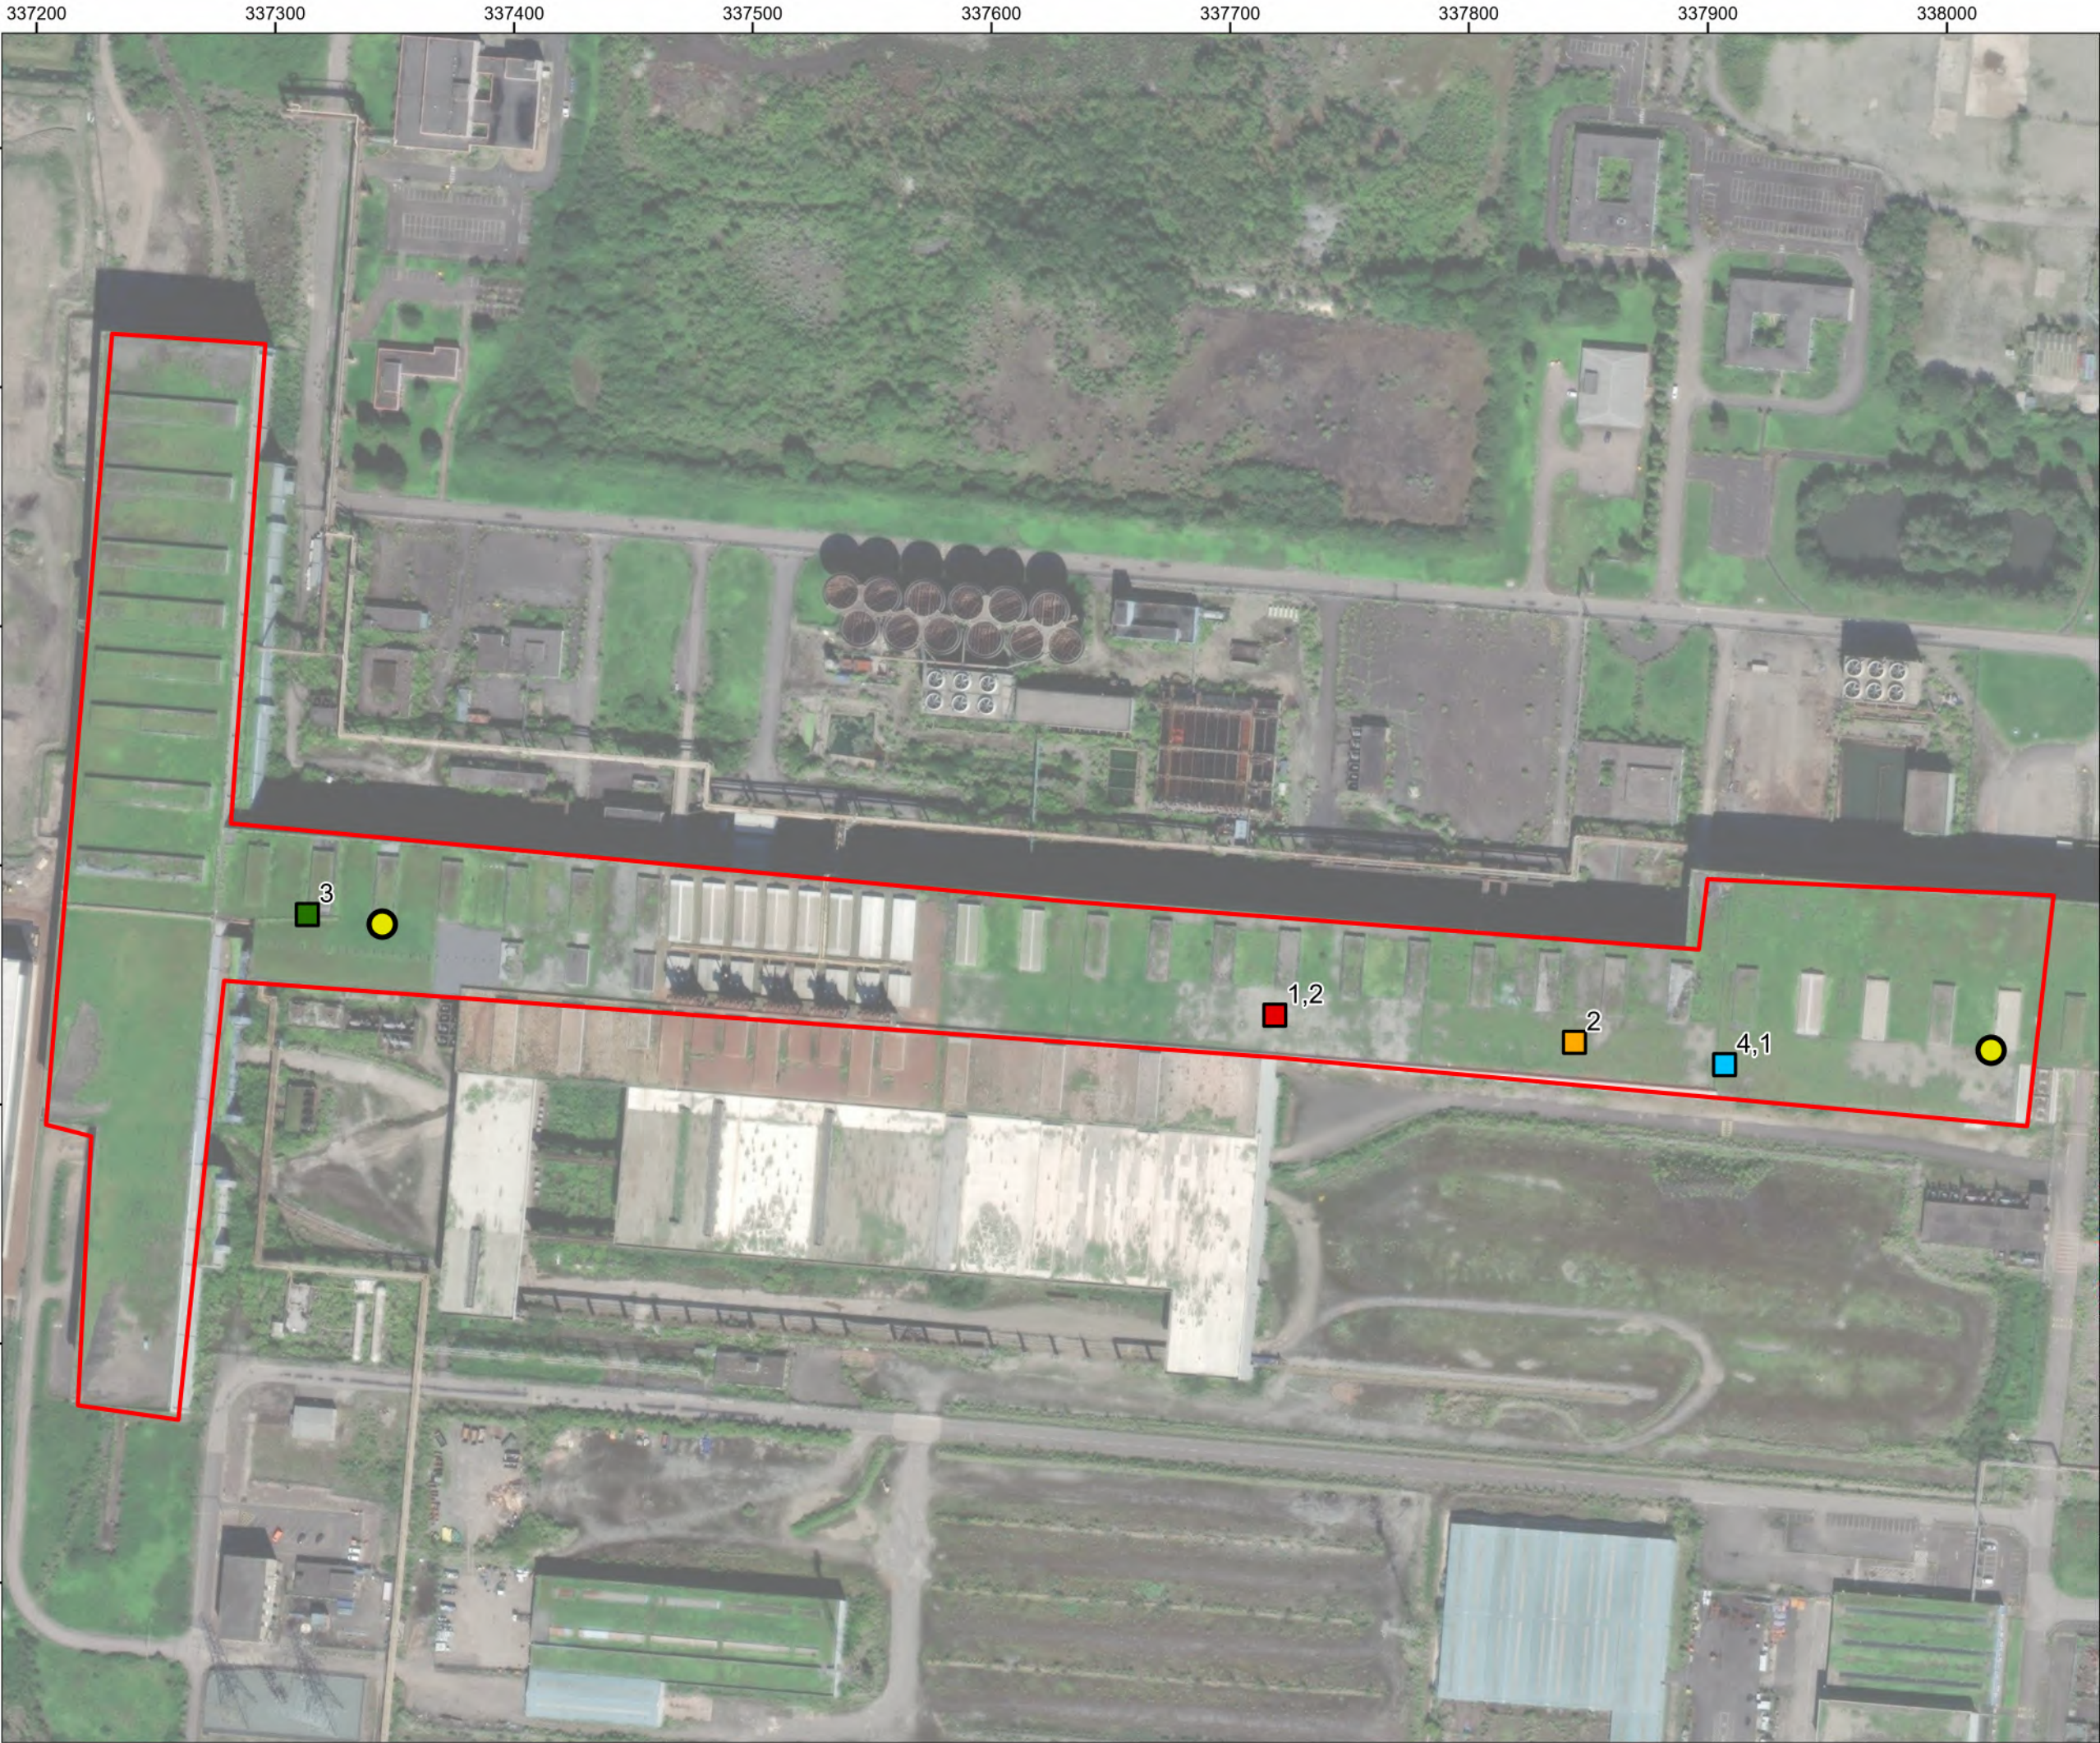
## FIGURE 3 – LOCATION OF STATICS AND DATALOGGERS

- Static 1 and Datalogger 2 were positioned on the stairs near centre of the main part of the building. Set at height to capture bats flying internally above machinery. The room is generally quite light with lights on 24/7 so this location seemed best to cover largest area.
- Static 2 was positioned inside the two-storey internal building, in a dark area of the building.
- Static 3 was positioned in the basement on the western end, in a dark area next to where one dead bat (*Pipistrelle* sp.) was found on the floor.
- Static 4 and Datalogger 1 were positioned in the eastern half of the basement, in a dark area.

- Survey Area
- Static Detector and Datalogger Locations
  - Static detector 1 and datalogger 2
  - Static detector 2
  - Static detector 3
  - Static detector 4 and datalogger 1
  - Dead bats found

- 3.1.25 Datalogger 1 was positioned in the basement, while Datalogger 2 was positioned at first floor level.
- 3.1.26 See Figure 3 for location of statics and dataloggers
- 3.1.27 Data loggers comparing the first floor to the basement showed that the basement is generally a bit warmer (lowest temp 5.5°C with an average of 7.9°C) than the location measured at the first floor (lowest temp 2°C with an average of 6.8°C), while the humidity is broadly similar in both locations (lowest approx. 62% at both levels with an average of 80.5% for the basement and 84.6% for the first floor).

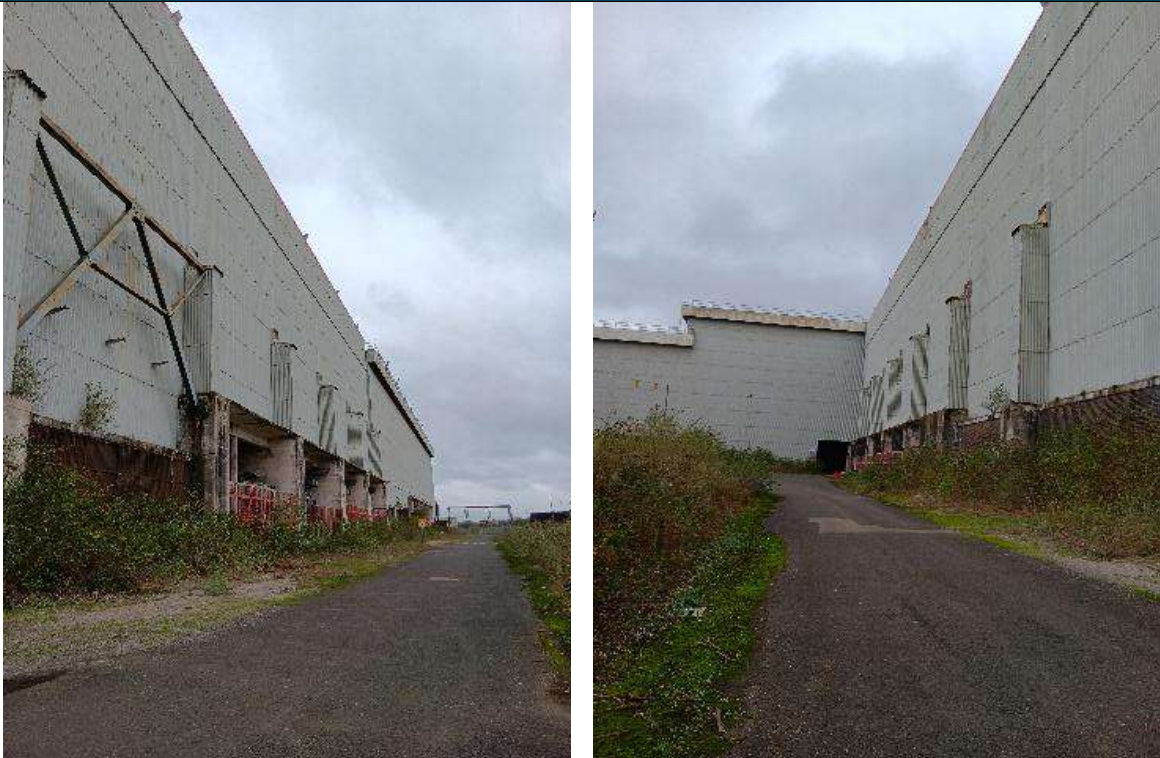
| Photographs 12 December 2025 | Description |
|---|---|
| | <p>Very large metal warehouse.</p> <p>Building has a flat metal roof and louvred sides which form large gaps providing access to the interior along the northern and eastern elevations.</p> <p>Lots of potential access points; i.e. open doorways, gaps around pipework, louvred sides and missing panels of metal sheeting.</p> |

- 3.1.2 Externally, the Motor Room is approximately four storeys high, with corrugated metal and asbestos sheeting. Recesses were present on the southern and eastern elevations, with machinery present. Unsealed square ventilation holes were present in some of these recesses, which lead into the interior.

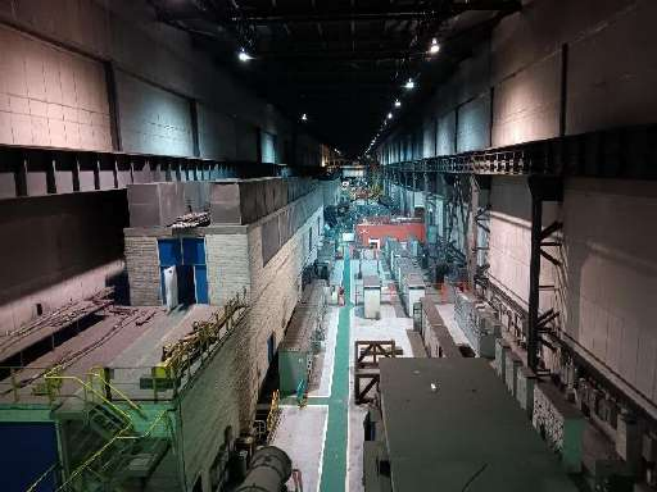
| Photographs 12 December 2025 | Description |
|---|---|
| | <p>Ground level interior is open to the apex with metal rafters. Artificial lighting is always kept on.</p> <p>Multiple office buildings are contained within the warehouse interior space - These are of standard brick construction with flat bitumen roof and are in good condition and protected from the elements by the main warehouse.</p> |

- 3.1.6 Lighting is on constantly in most areas of the building, with the main first floor room fairly well-lit, and the basement having some sections that are well-lit and some that are unlit. The two storey ventilation buildings were not lit internally. Site works were suspended in 2016, and until early 2023 the lights were only on when in use. However, lights have been left on since 2023 to secure the site and motion light detectors have been installed for additional security.

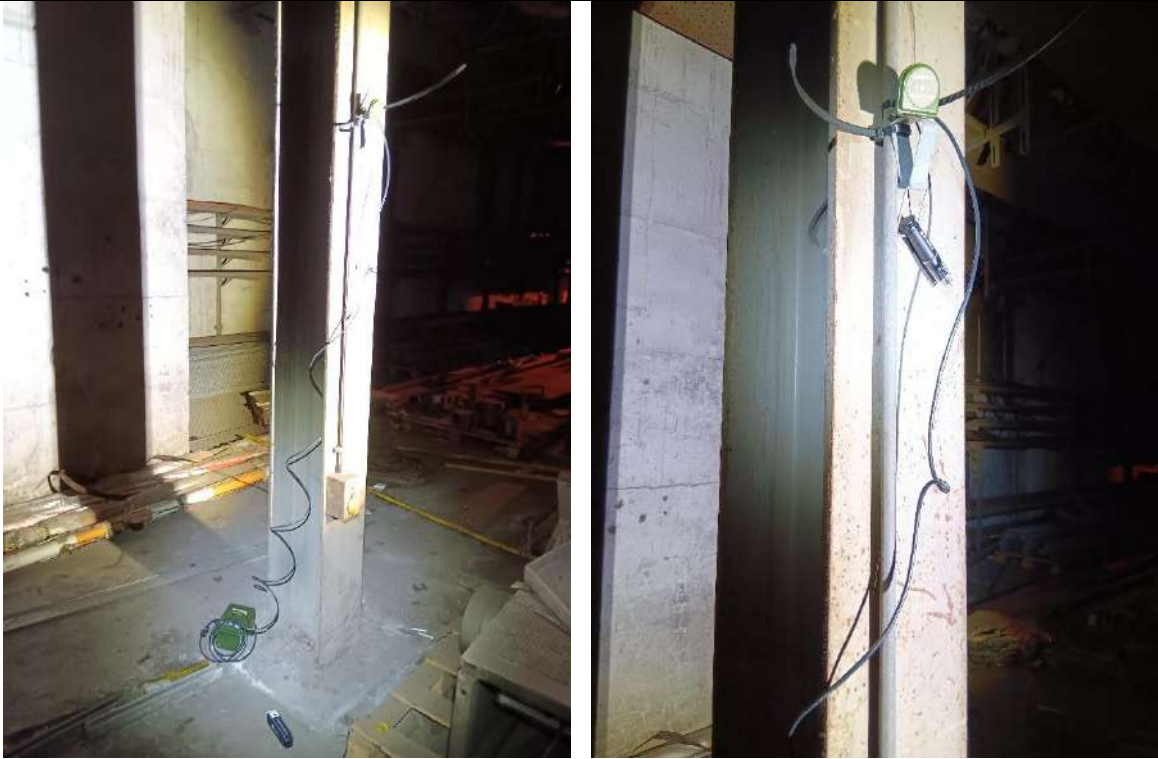
| Photographs 12 December 2025 | Description |
|---|---|
| | <p>View of deployment of Static and Datalogger inside building on first floor.</p> |

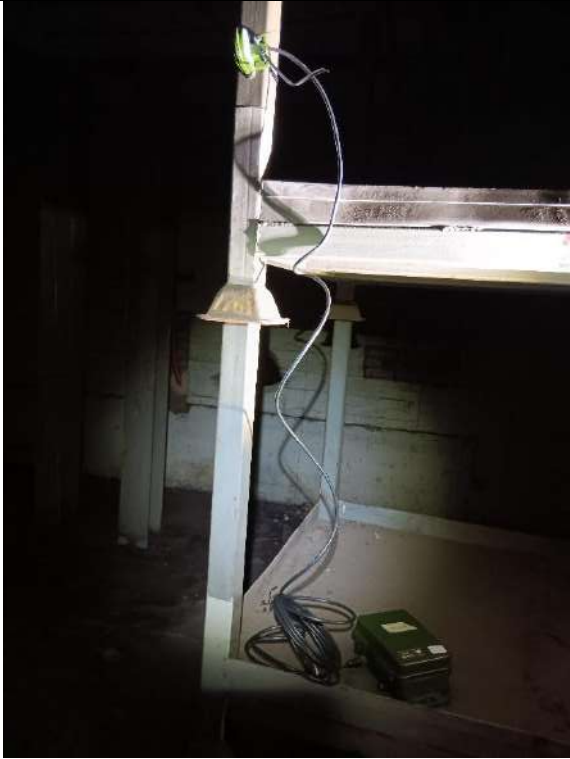
| Photographs 12 December 2025 | Description |
|---|---|
| | <p>View of deployment of Static in basement.</p> |

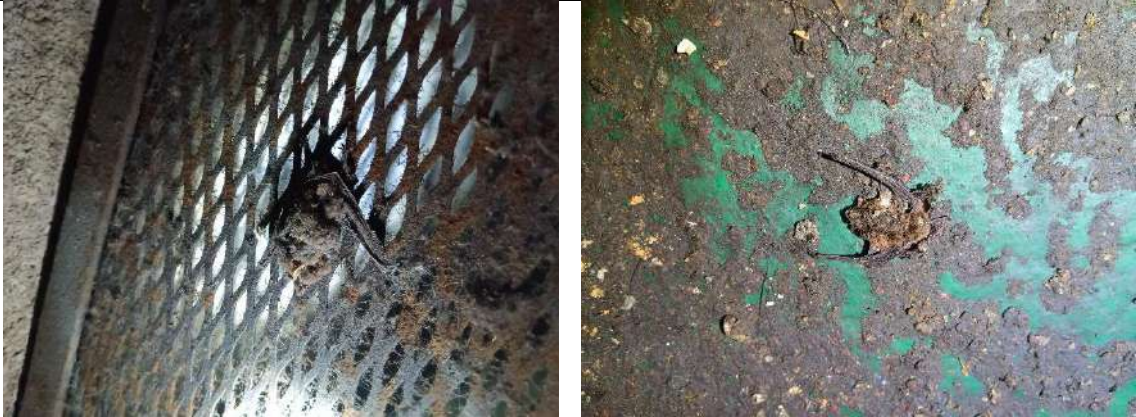
- 3.1.8 Two dead bats were found in two different locations of the building, see Figure 4 for approximate location.
- 3.1.9 One of the dead bats, identified as a long-eared species, most likely brown long-eared (*Plecotus auritus*), was found on a wire mesh cage beside a single storey internal

building at the south-east corner of the Motor Room. No other evidence e.g. bat droppings, were found nearby.

- 3.1.10 A second dead bat (a pipistrelle species) was found on the floor in the basement, near the western end of the building. No other evidence e.g. bat droppings, were found nearby.
- 3.1.11 No other conclusive evidence of bats was found (noting limitations due to size and complexity of building). Occasional moth wings were identified on floor, but there were no concentrations to suggest evidence of bat feeding perches.
- 3.1.12 Remains of at least ten dead birds and one dead cat were also found inside the building.

| Photographs 12 December 2025 | Description |
|---|---|
| | <p>A dead Long-eared species identified on a wire mesh cage beside single storey internal building of first floor (at SE corner of engine room).</p> <p>A dead Pipistrelle species bat found in basement, near western end of building.</p> |

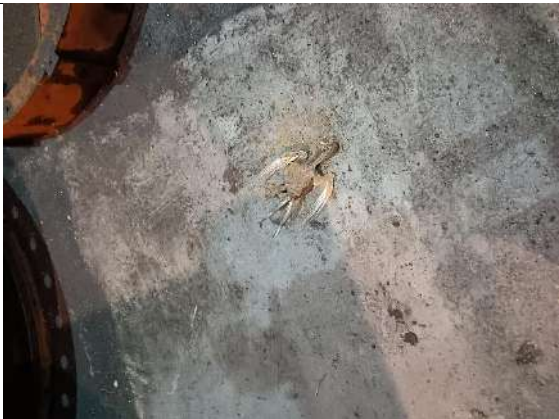
| Photographs 12 December 2025 | Description |
|---|---|
| | <p>Example of dead bird. More than ten dead birds, and one cat were also found.</p> |
