**7 Tregarn Road  
Newport**

## **Bat and Nesting Bird Survey Report**

**July 2026**

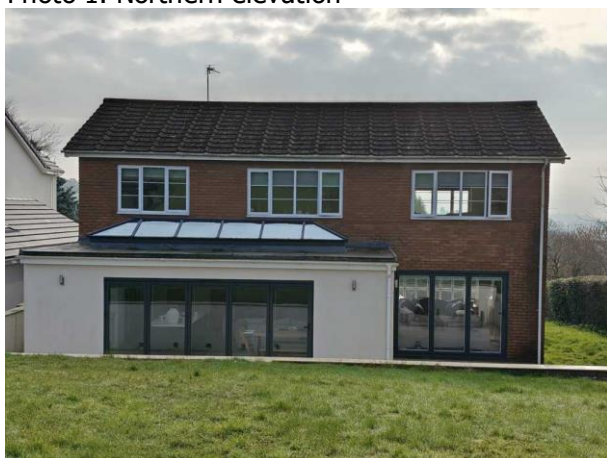
Photo 1: Northern elevation

| Feature | Description and Condition | Ecological Interpretation | Bat Roost Suitability |
|---|---|---|---|
| Windows and Doors | Numerous uPVC windows and doors are present around the perimeter of the house (Photos 1 and 3). | All appear in good condition and flush to the exterior wall with negligible potential for bats to gain access. | Negligible |

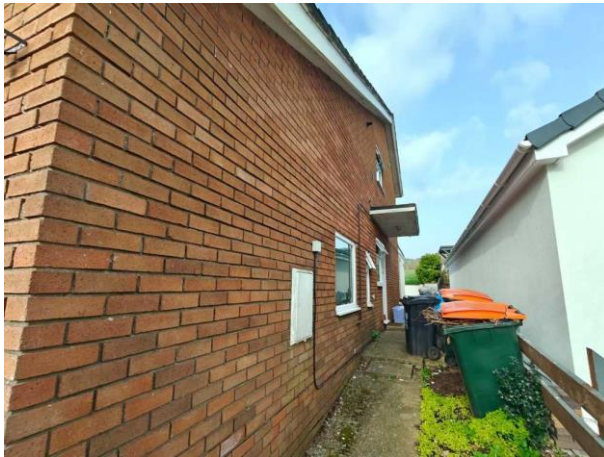
Photo 5: Eastern elevation

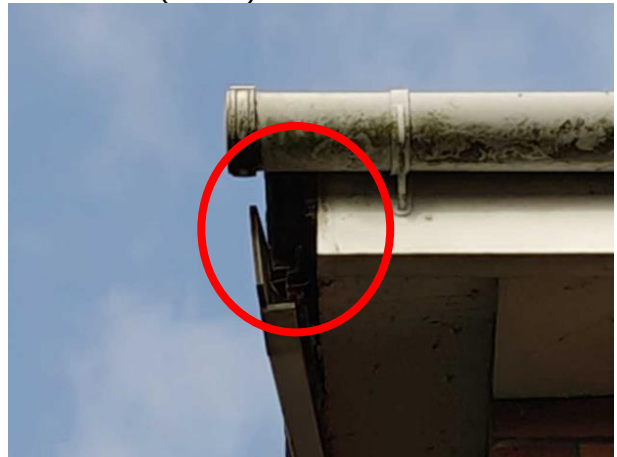
| Feature | Description and Condition | Ecological Interpretation | Bat Roost Suitability |
|---|---|---|---|
| Soffits, Fascias and Bargeboards | The main house has uPVC fascias / bargeboards / soffits around the perimeter, with associated uPVC guttering (Photos 2, 3 and 8). | The majority appear in good condition and flush to the wall apart from a large gap between the fascia and soffit on the south-west corner (Photo 6), providing roosting opportunities for crevice dwelling bats. | Moderate |

Photo 6: Gap between fascia and soffit at south-west corner (circled)

The building has low suitability for hibernating bats due to the presence of features such as gaps in roof tiles, gaps between fascia and soffit box , and gaps under fascia on garage providing sheltered roosting opportunities. However, the lack of direct evidence of bats found using the house during the preliminary roost assessment and dusk emergence survey makes it unlikely that the house would be used as a hibernation site.

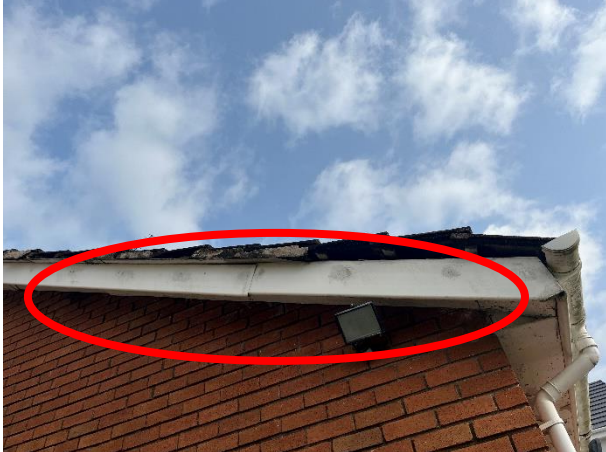
Photo 7: Gap between fascia and western elevation of garage (circled)

There are confirmed access points into loft void 2 (garage) through the raised fascia on the western elevation and the raised tiles / fascia on the southern elevation. The majority of features on the main house provide external roosting opportunities only.

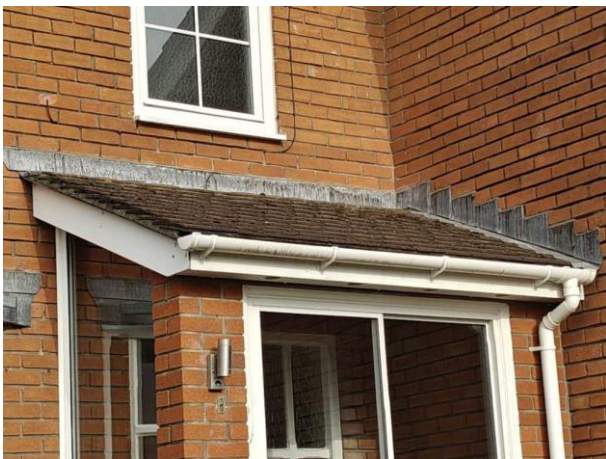
Photo 9: Roof tiles, flashing and soffit box appear well sealed on porch at southern elevation

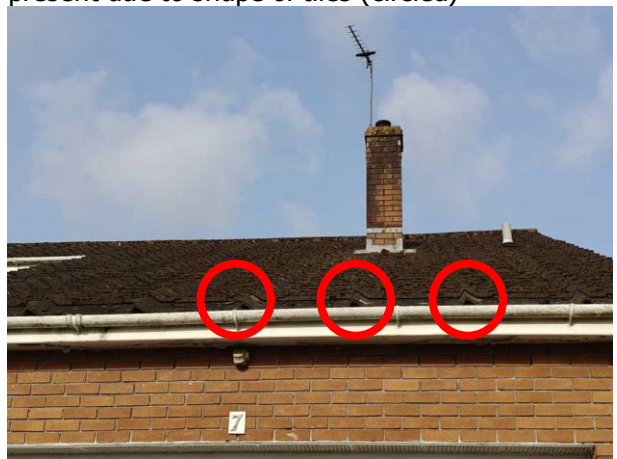
| Feature | Description and Condition | Ecological Interpretation | Bat Roost Suitability |
|---|---|---|---|
| Chimney | There is a chimney present towards the east of the southern roof pitch (Photo 10). | The chimney and flashing around the base appear in good condition, providing limited potential roosting features for bats. | Low |

Photo 10: Tiles on main roof and flashing around chimney appear flush, with small access gaps present due to shape of tiles (circled)

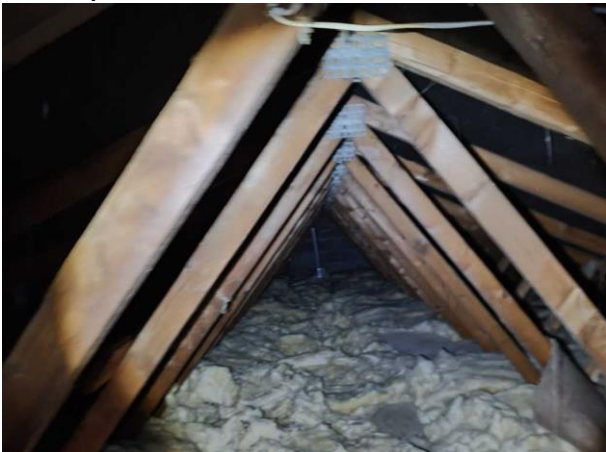
| Feature | Description and Condition | Ecological Interpretation | Bat Roost Suitability |
|---|---|---|---|
| Roof Void | There is an unused loft void within the main house - Loft void 1. The floor of the void is covered with insulation (Photo 11) and bitumen felt lines the sides (Photo 12). | The bitumen felt appears in good condition with limited gaps. No light ingress was seen, suggesting limited possibilities for void dwelling species to gain access. | Low |

Photo 11: Insulation within roof void 1 (main house)

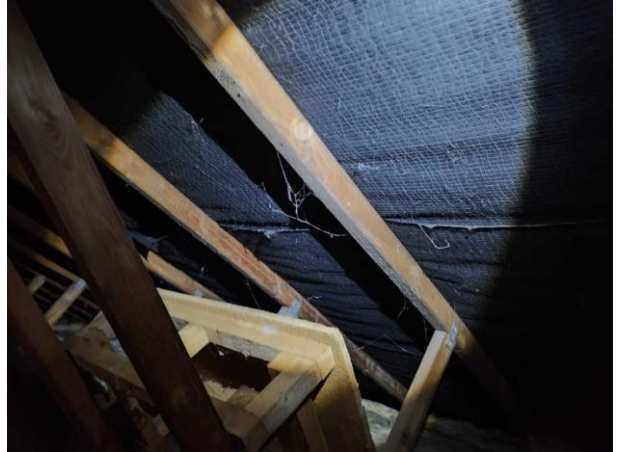
Photo 12: Lining within roof void 1 (main house) appears well sealed, with no light ingress

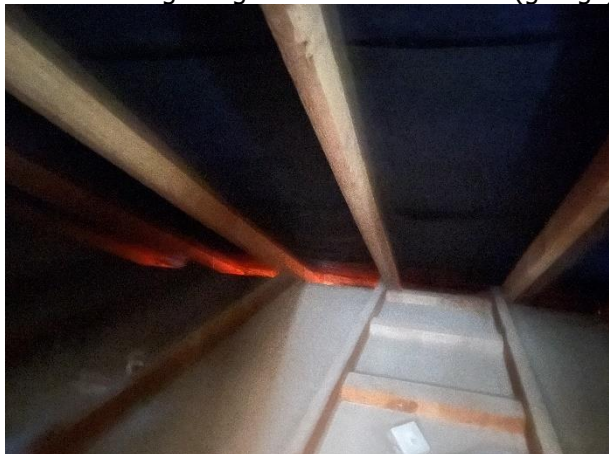
Photo 13: Light ingress within loft void 2 (garage)

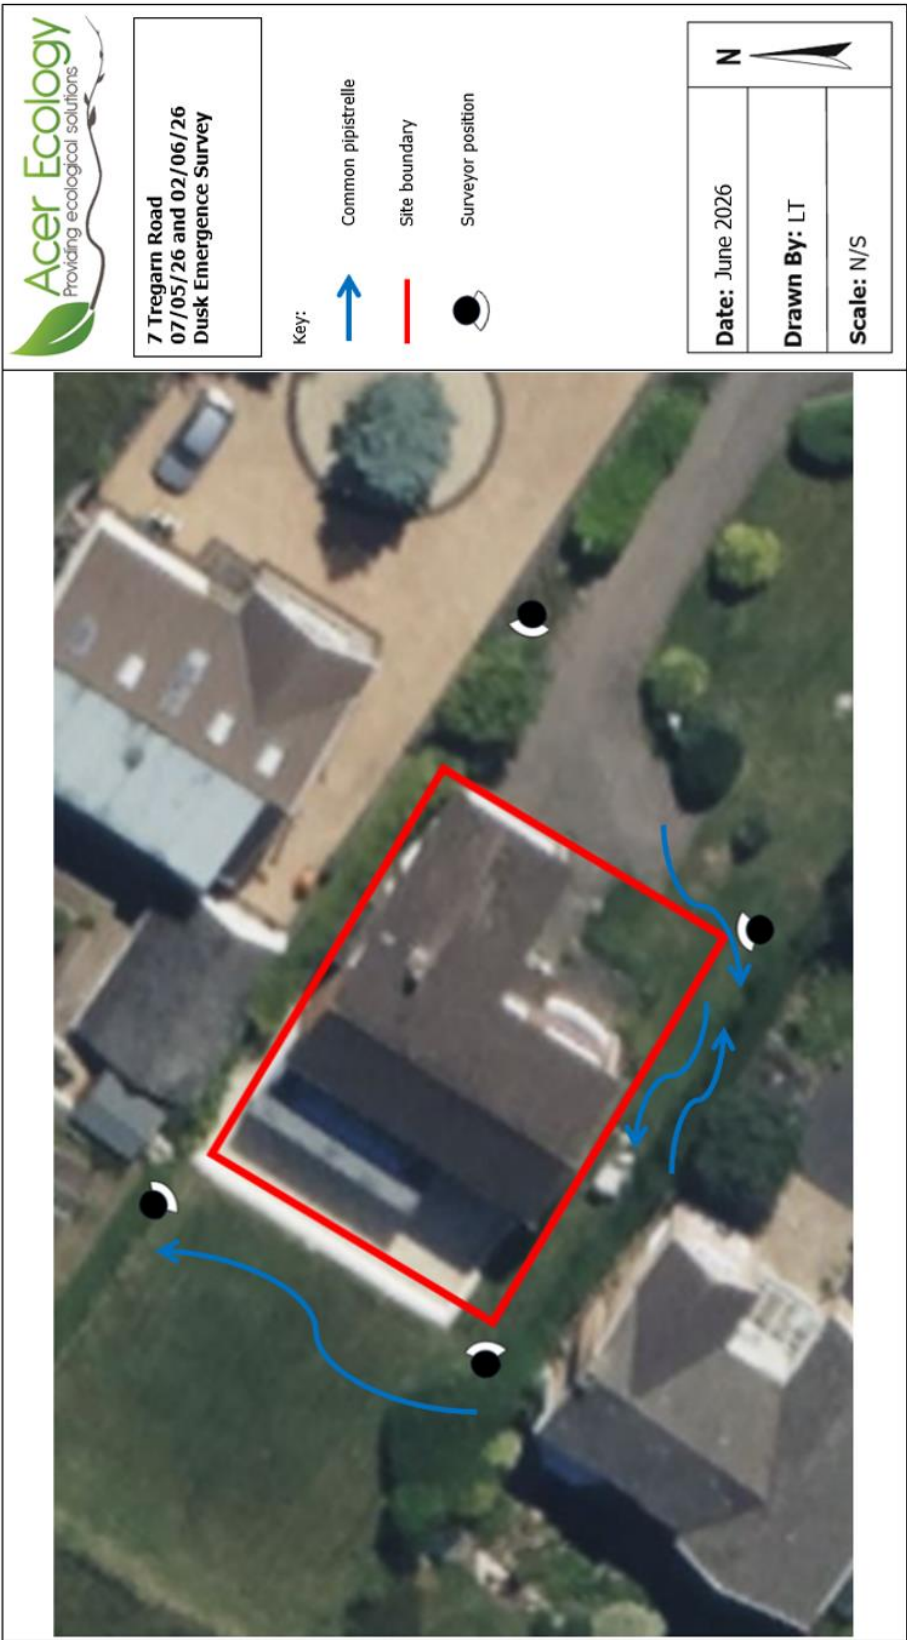
Plan 3: Results of Dusk Emergence Surveys

| | Survey 1 | Survey 2 |
|---|---|---|
| <b>Important Commuting and Foraging Routes</b> | Common pipistrelles ( <i>Pipistrellus pipistrellus</i> ), were observed foraging in the garden to the west of the property and within the vegetation to the south. | Common pipistrelles were observed foraging in the garden to the west of the property and within the vegetation to the south. |

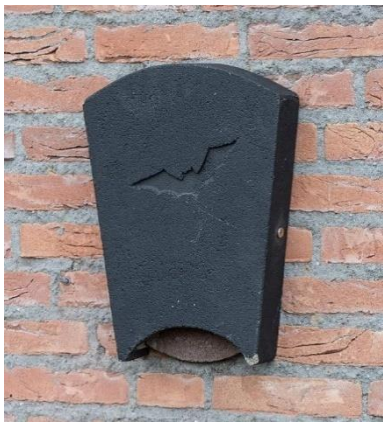
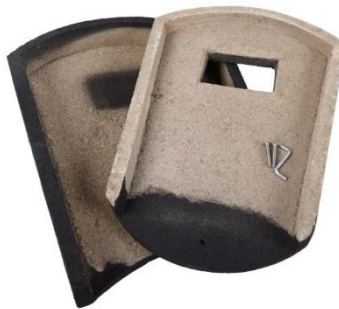
This bat box is made entirely from woodstone, a robust material comprising concrete and wood fibres. This means that, not only does the box have excellent insulating properties maintaining a more consistent temperature throughout the year, it also provides excellent protection from predators. The Beaumaris box has a single narrow cavity which makes it suitable for crevice roosting bats such as the common pipistrelle, soprano pipistrelle, Nathusius' pipistrelle, Brandt's bat and whiskered bat. The interior of the box has a rough surface for bats to cling to and the front of the box features a subtle but attractive imprint of a bat in flight.

Suitable for attaching to external walls and should be sited as high up on the façade as possible, at a height of at least 3m from the ground. Avoid siting under artificial lights. Bats prefer to change roosts to benefit from varying ambient temperatures, so bat boxes should ideally be clustered in small groups.

- Height: 39cm
- Width: 29cm
- Depth: 6cm
- Weight: 4.4kg

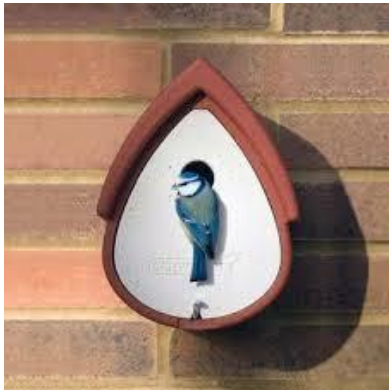
### Schwegler Bird Home

This nest box is for installation on external walls of buildings (including sheds and garages) and is suitable for a range of bird species. With a 32mm hole it allows entry to species such as coal tit, blue tit, great tit, redstart, nuthatch, house sparrow, tree sparrow and other species.

The recommended height is between 1.5m and 5m above ground with a south-east to south-west orientation.

Cleaning after the breeding season (wait until October) is advised to provide a clean nest for the following year, or utilisation by non-migratory birds for winter roosting.

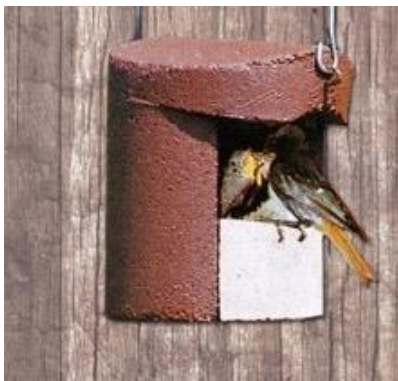
### Schwegler Bird Home

These should never be hung on trees or bushes as this could allow small predators to access the interior and predate nesting birds.

This nest box should always be installed on the external walls of houses, barns, garden sheds etc. It is designed to be hung so that the entrance is to one side (90° angle to wall).
