# Remediation Verification Report

Home Bargains, Newport

**CLIENT:** TJ Morris Ltd.  
**PROJECT TITLE:** Home Bargains Newport  
**REPORT TITLE:** Remediation Verification Report  
**PROJECT REFERENCE:** 151157  
**DOCUMENT NUMBER:** R5.0

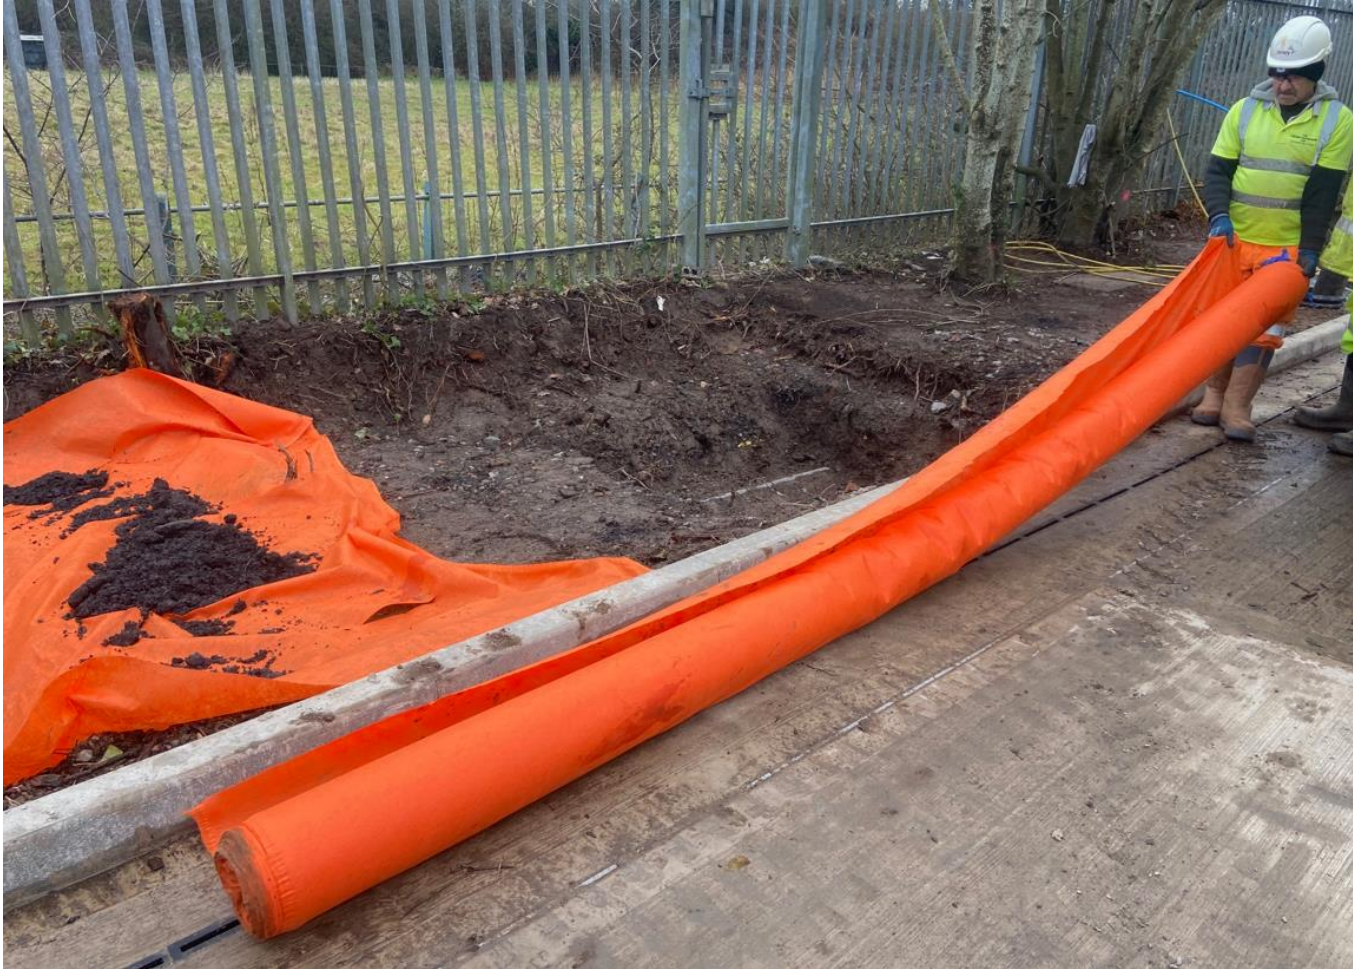
**Photo 1 – High visibility marker at the perimeter of the site.**

The Principal Contractor has provided photographs of the installed high visibility marker and a statement that the correct thickness of landscaping materials has been installed >450mm.

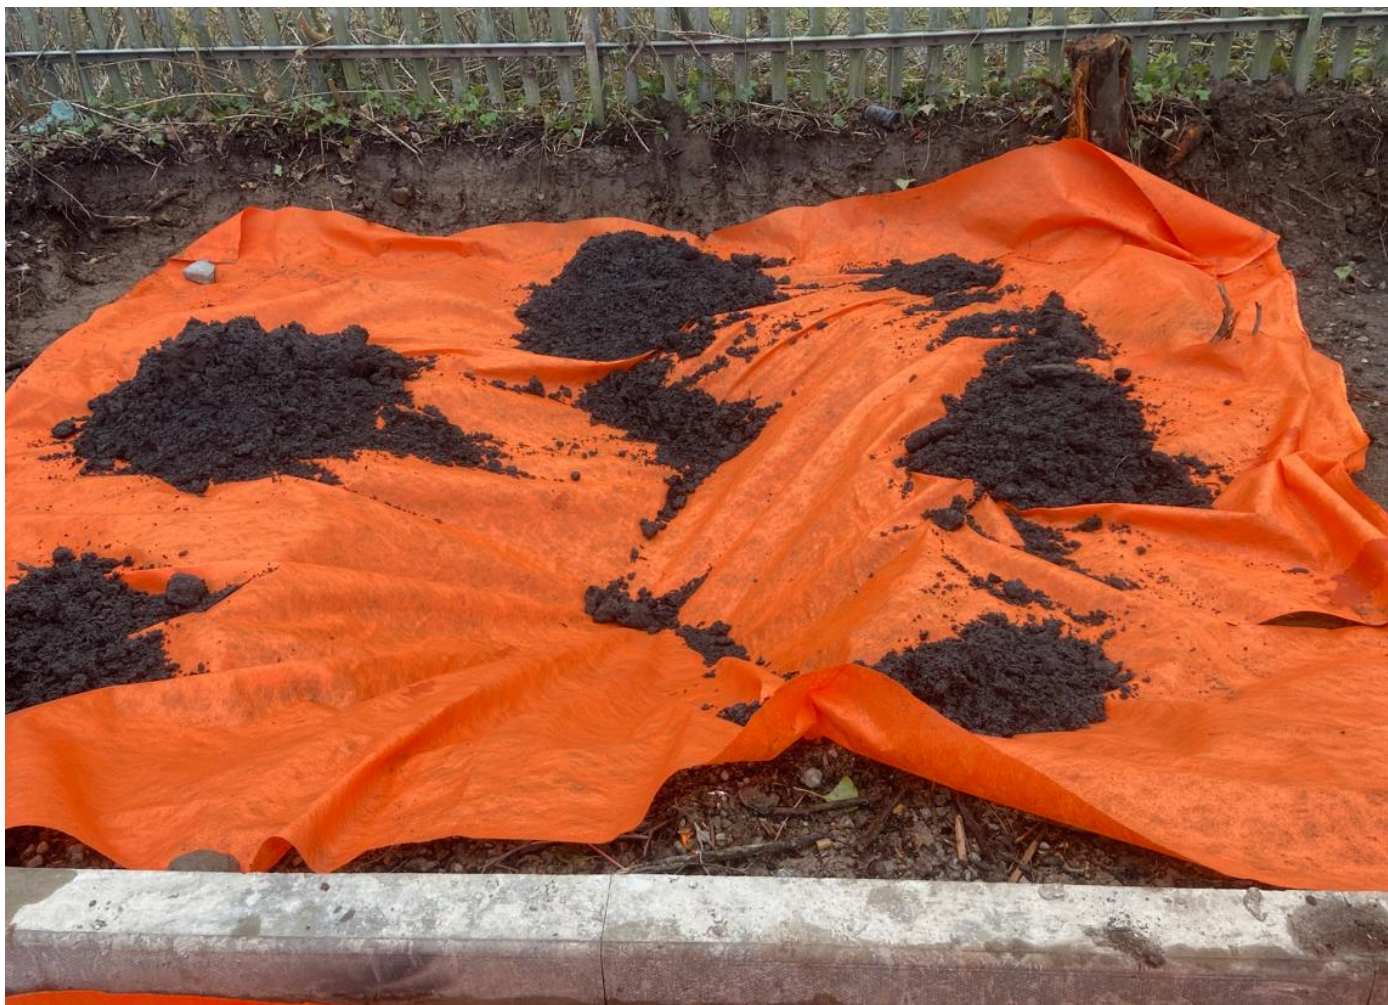
**Photo 2 – High visibility marker at the perimeter of the site.**
