**DAY'S PROPERTY HOLDINGS LIMITED**

**LAND OFF SEVEN STILES AVENUE, NEWPORT RETAIL PARK, NEWPORT, NP19 4TX**

**SITE INVESTIGATION REPORT**

October 2024  
Report No. CCL03796.CU99

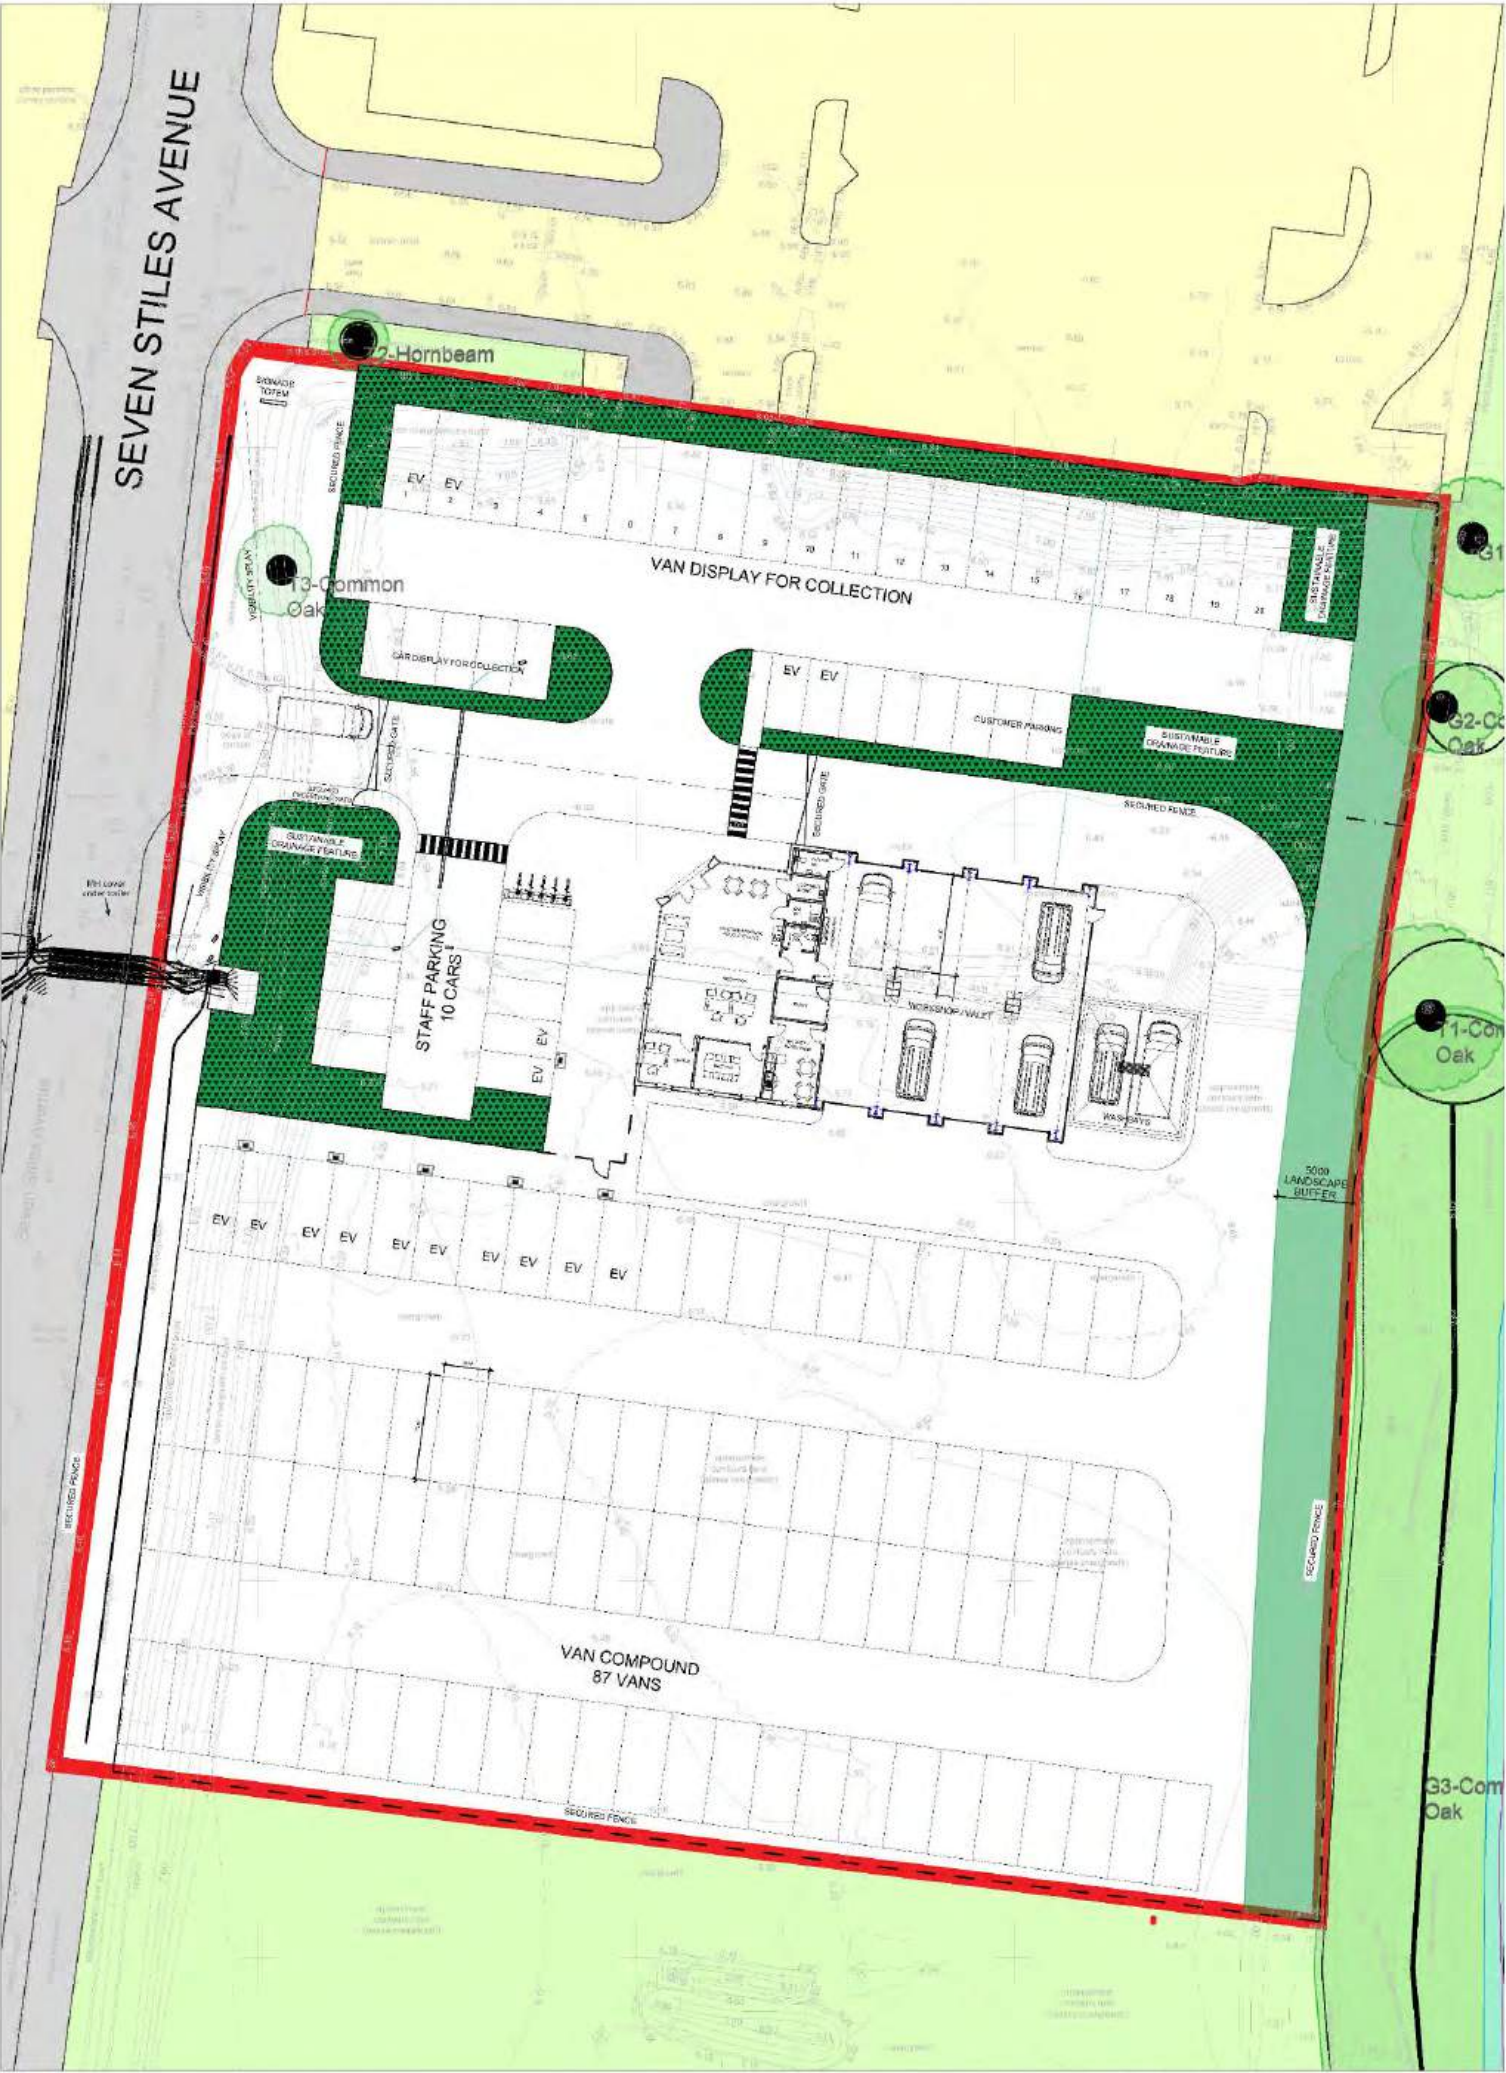
FIGURE 4

PROPOSED DEVELOPMENT PLAN  
Scale 1:500

Reproduced from Site Plan as Proposed, dated April 2024, by Opfer Logan Architects, Dwg No. SK-SP-01

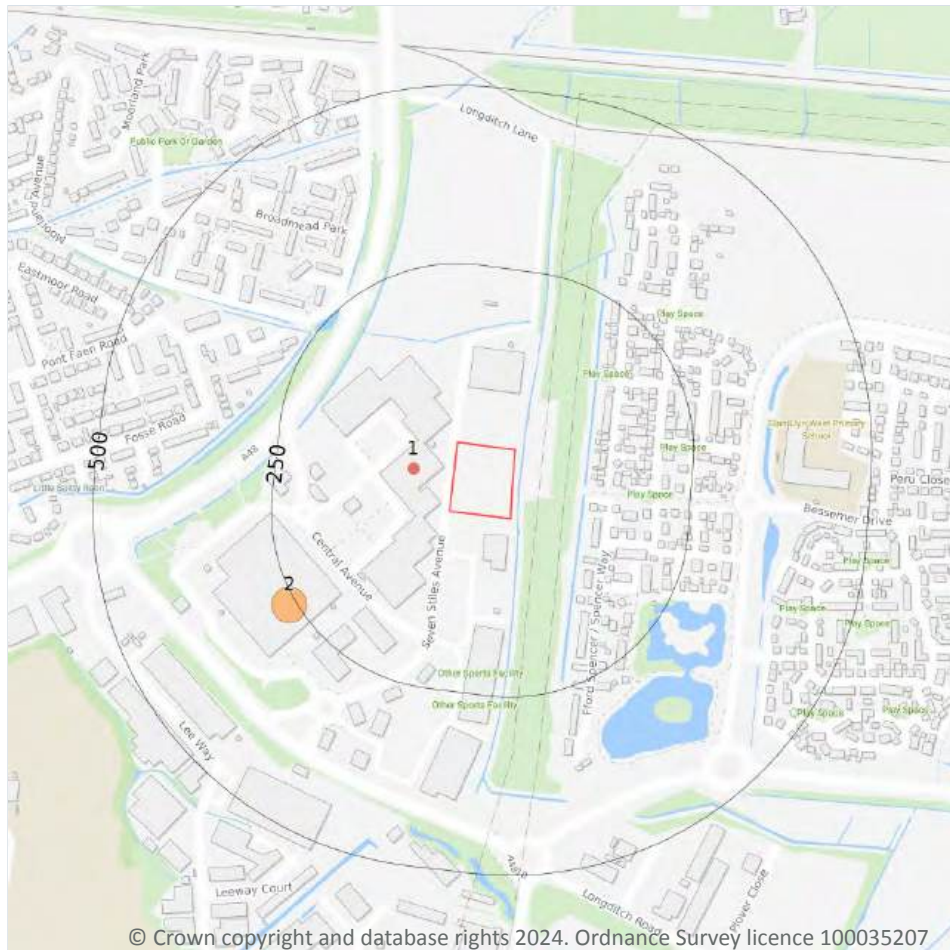
## 3 Waste and landfill

- Site Outline
- Search buffers in metres (m)
- Historical waste sites
- Waste exemptions

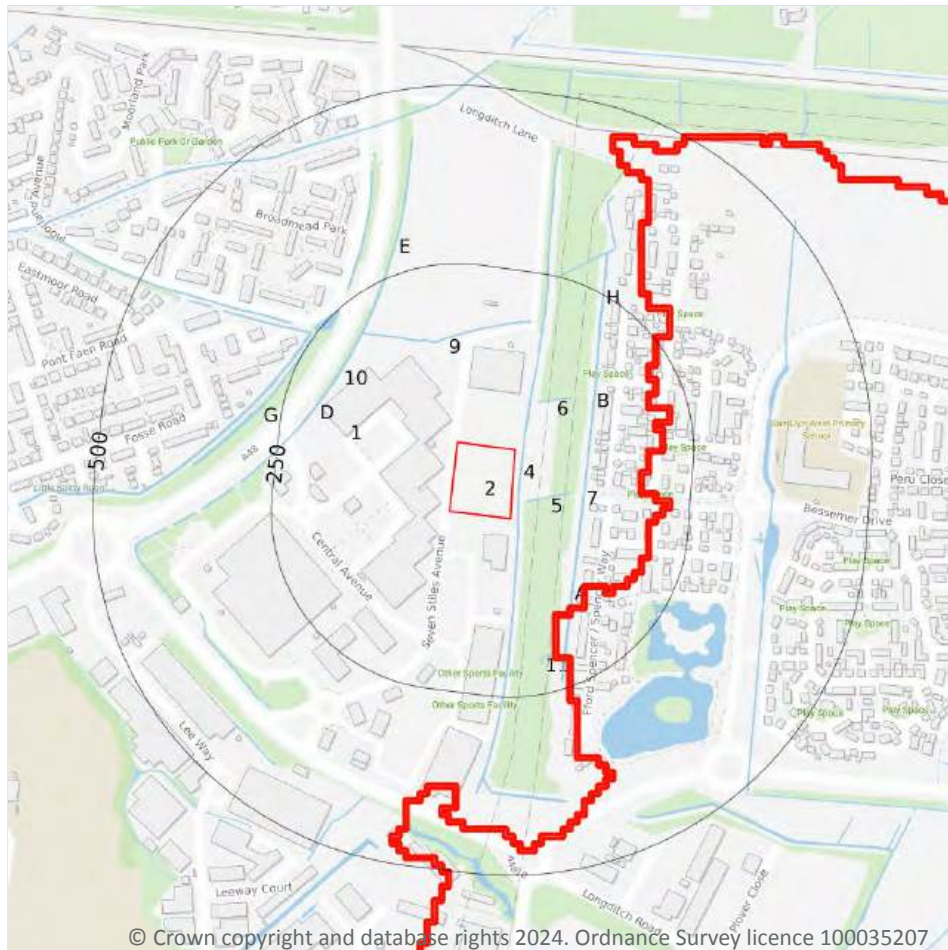
## 6 Hydrology

- Site Outline
- Search buffers in metres (m)
- Water Network (OS MasterMap)
- Surface water features (wider than 5m)
- Surface water features (narrower than 5m)
- ⋯ WFD River, canal and surface water transfer water bodies
- WFD Lake water bodies
- WFD Transitional and coastal water bodies
- WFD Surface water body catchments boundaries
- WFD Groundwater body boundaries

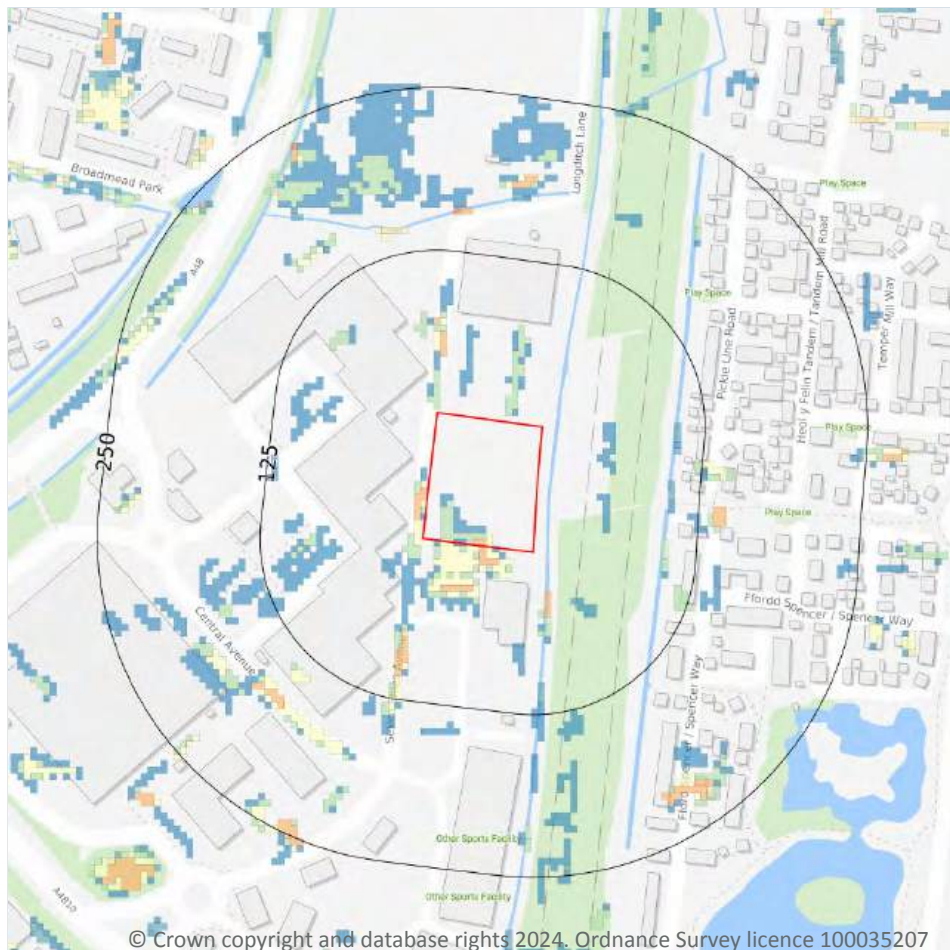
## 8 Surface water flooding

— Site Outline

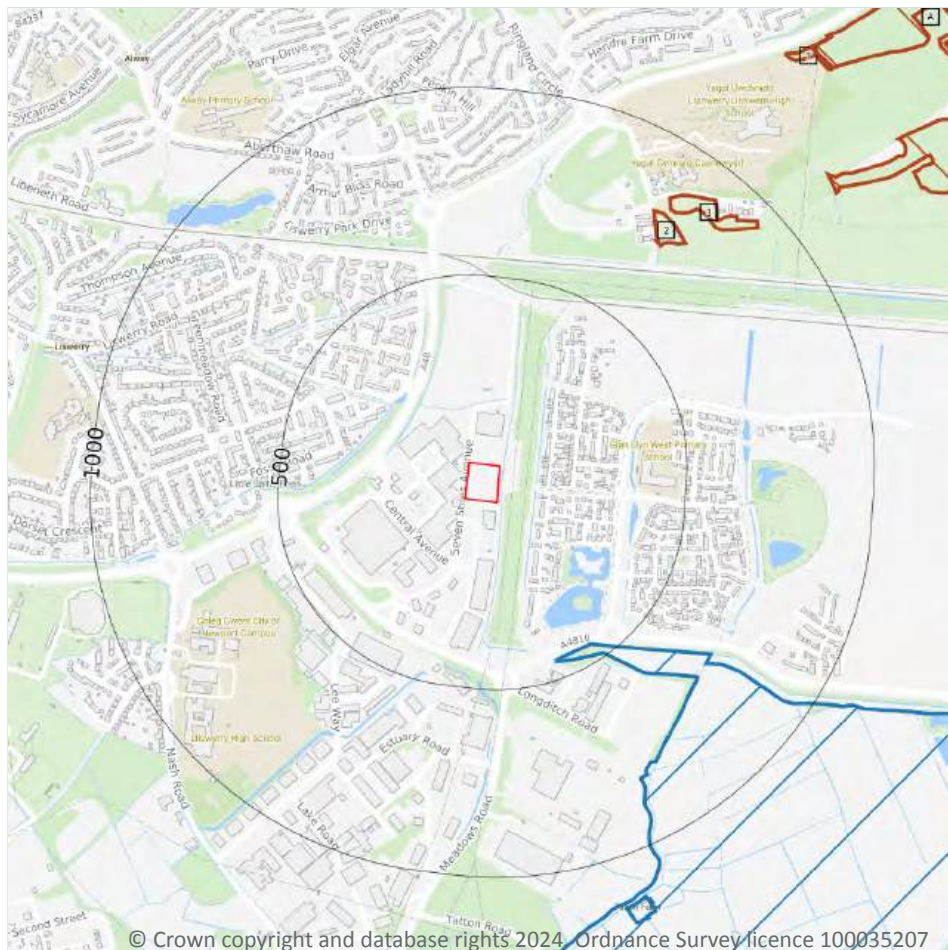
## 10 Environmental designations

- Site Outline
- Search buffers in metres (m)
- Sites of Special Scientific Interest (SSSI)
- + Special Areas of Conservation (SAC)
- Designated Ancient Woodland

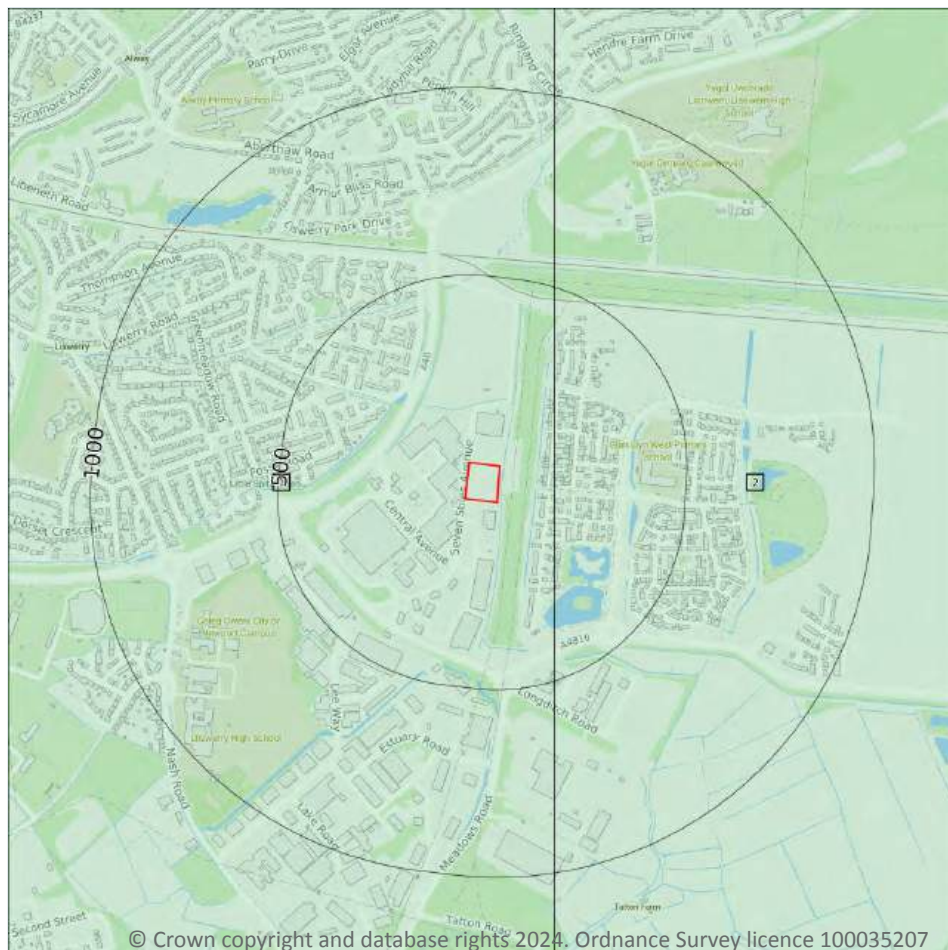
## 14 Geology 1:10,000 scale - Availability

— Site Outline  
Search buffers in metres (m)

- Full coverage
- Partial coverage
- No coverage

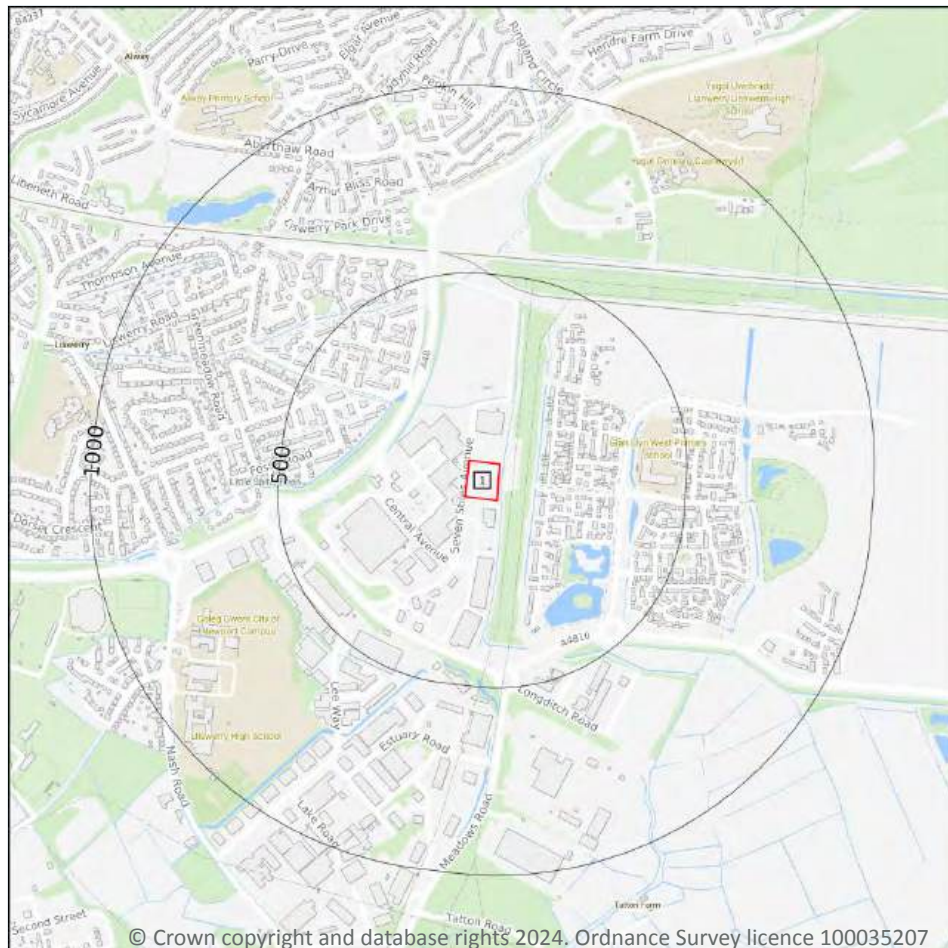
## 15 Geology 1:50,000 scale - Availability

— Site Outline

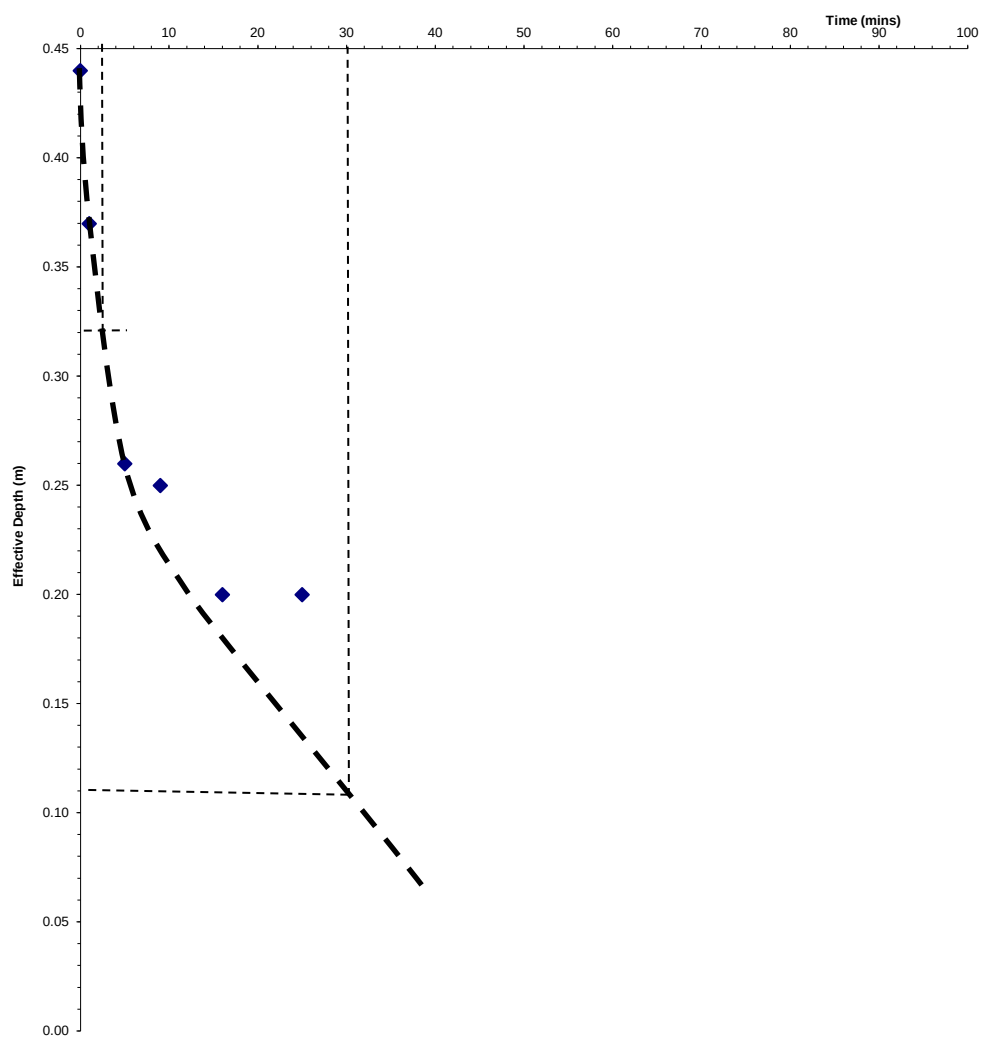
**Test 1**

### Infiltration Rate

## In Situ Percolation Test

Hole Ref. **TP 2**

The in-situ percolation tests undertaken within the shallow Made Ground strata in TP2 indicated soil infiltration rates of  $7.2 \times 10^{-5}$  m/s and  $9.7 \times 10^{-5}$  m/s. It is generally recommended that soakaways should not be constructed to discharge water within Made Ground materials due to potentially adverse settlements within those materials being impossible to predict if large quantities of water are introduced to Made Ground (and the potential for significant inundation settlements if concentrated volumes of water are discharged to Made Ground). It is therefore recommended that an alternative drainage system be adopted, such that potential future deleterious settlements beneath proposed hardstanding are avoided. However, if a soakaway drainage system based on permeable paving is to be progressed then, due to potential future settlements, it should be appreciated that future and/or ongoing maintenance may be required to hard surfacing if adverse settlements occur. Soakaways associated with permeable paving should be located an appropriate distance from existing/new structures (both on and off site) so that water discharging to Made Ground does not have an adverse effect on foundations. Conventional chamber type soakaways discharging to Made Ground should not be used for the proposed development due to the concentrated volume of water that may be discharged to the ground from such a system.

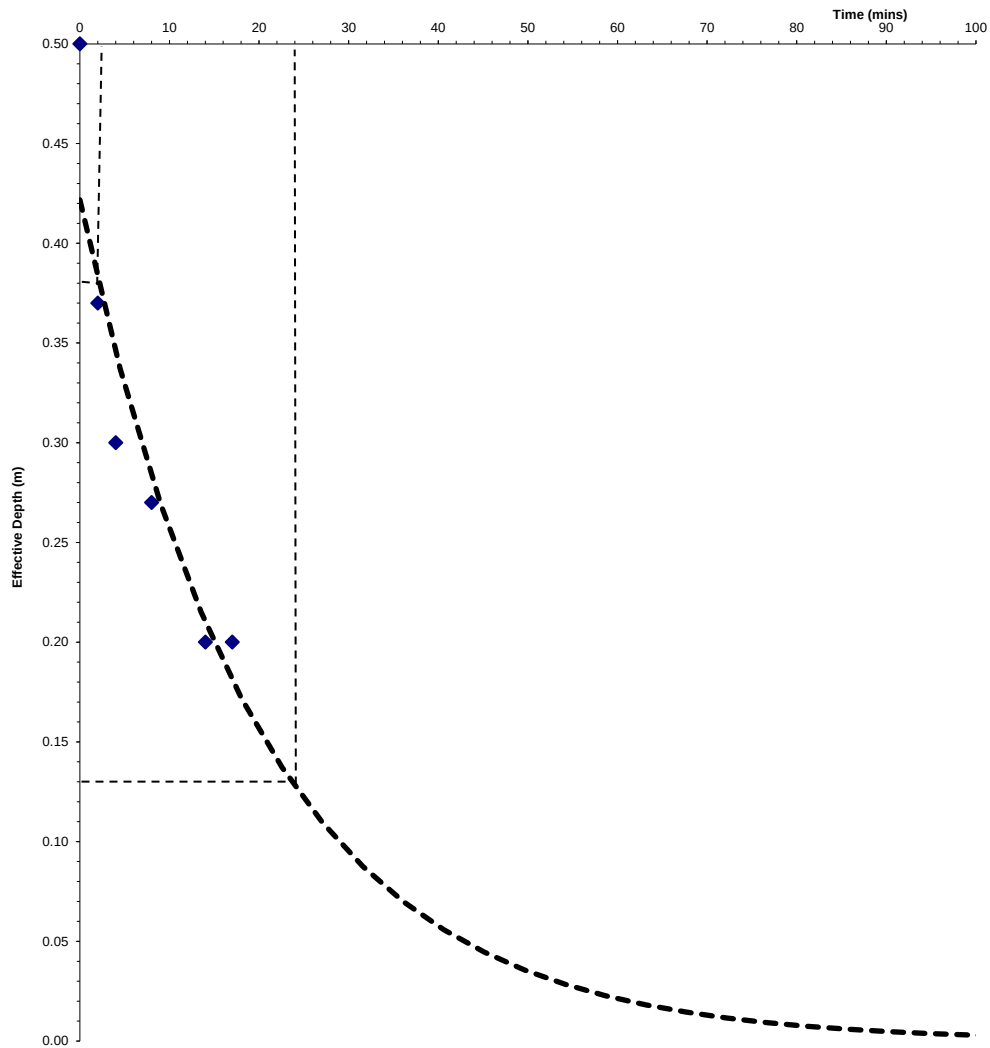
**Test 2**

### Infiltration Rate

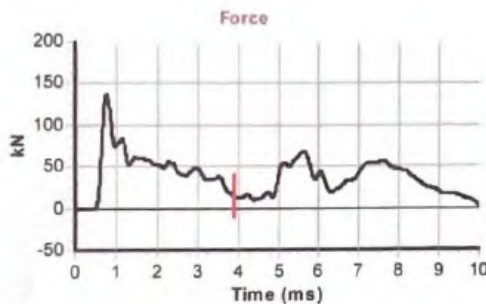
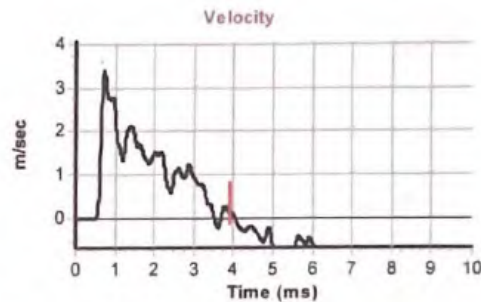
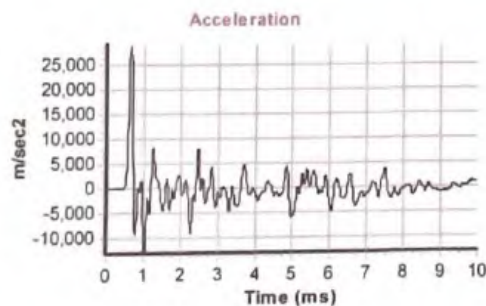
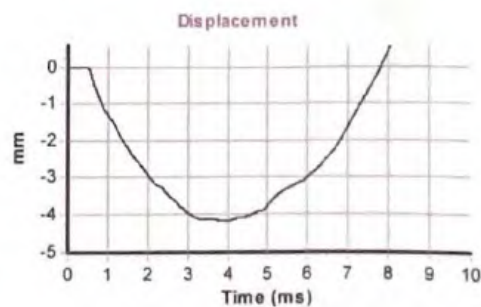
## Calculations

Area of Rod A ( $\text{mm}^2$ ): 983  
Theoretical Energy  $E_{\text{theor}}$  (J): 473  
Measured Energy  $E_{\text{meas}}$  (J): 283

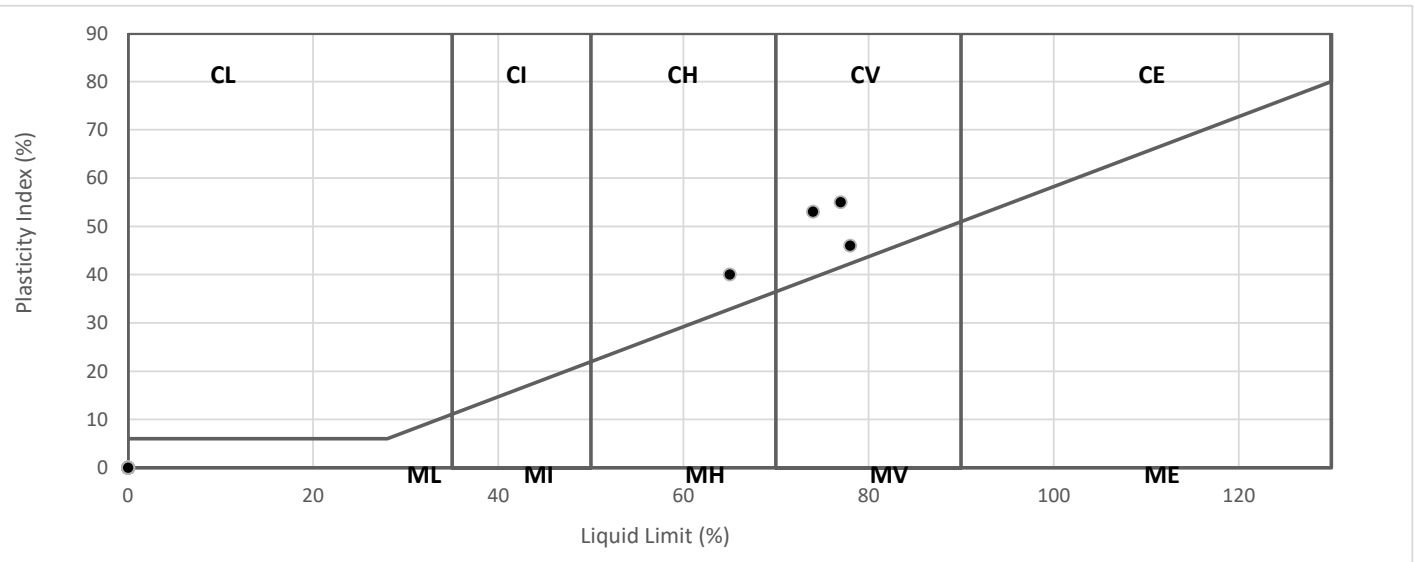
### PLASTICITY CHART FOR CASAGRANDE CLASSIFICATION

Geotechnical laboratory testing has been undertaken on samples of the Tidal Flat Deposits. Moisture content values of between 31% and 41% have been recorded with plasticity index values of between 40% and 53%, indicating high volume change potential soils.

Laboratory testing results indicate that clay soils beneath the site are classified as 'high' volume change potential soils, as defined in NHBC Standards (2024) and referenced by the Building Regulations Approved Document C. Within the influence zones of existing or proposed trees, suitable foundation precautions should be adopted, as outlined in NHBC Standards (2024). However, the depth to groundwater should be noted when determining requirements for precautions as soils below groundwater should be moisture stable.

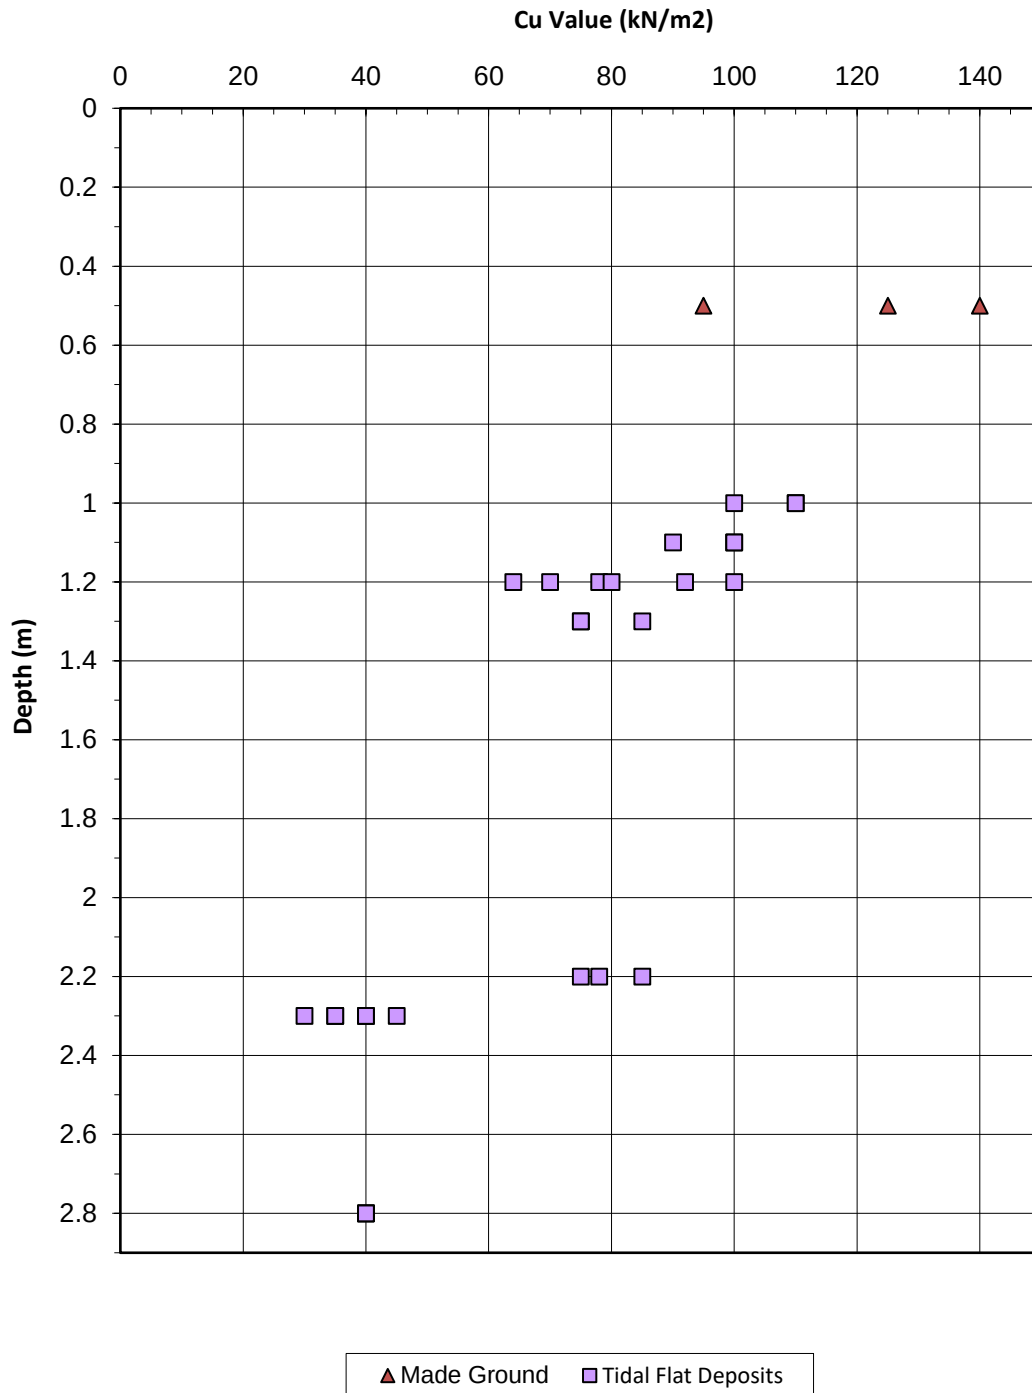
FIGURE III-1

Values based on field hand vane test results

**UNDRAINED SHEAR STRENGTH ( $c_u$ ) PROFILE**

A higher strength 'crust' is identified below the Made Ground and at the top of the Tidal Flat Deposits. However, that 'crust' is then underlain by low strength materials and horizons of peat of significant thickness. Therefore, structural loads transferred to the ground from pad or trench fill foundations taken into the Tidal Flat Deposits 'crust' or a reinforced shallow foundation (reinforced grillage connecting columns or raft) constructed in Made Ground, may induce adverse total and differential settlements in the low strength and/or peat materials.

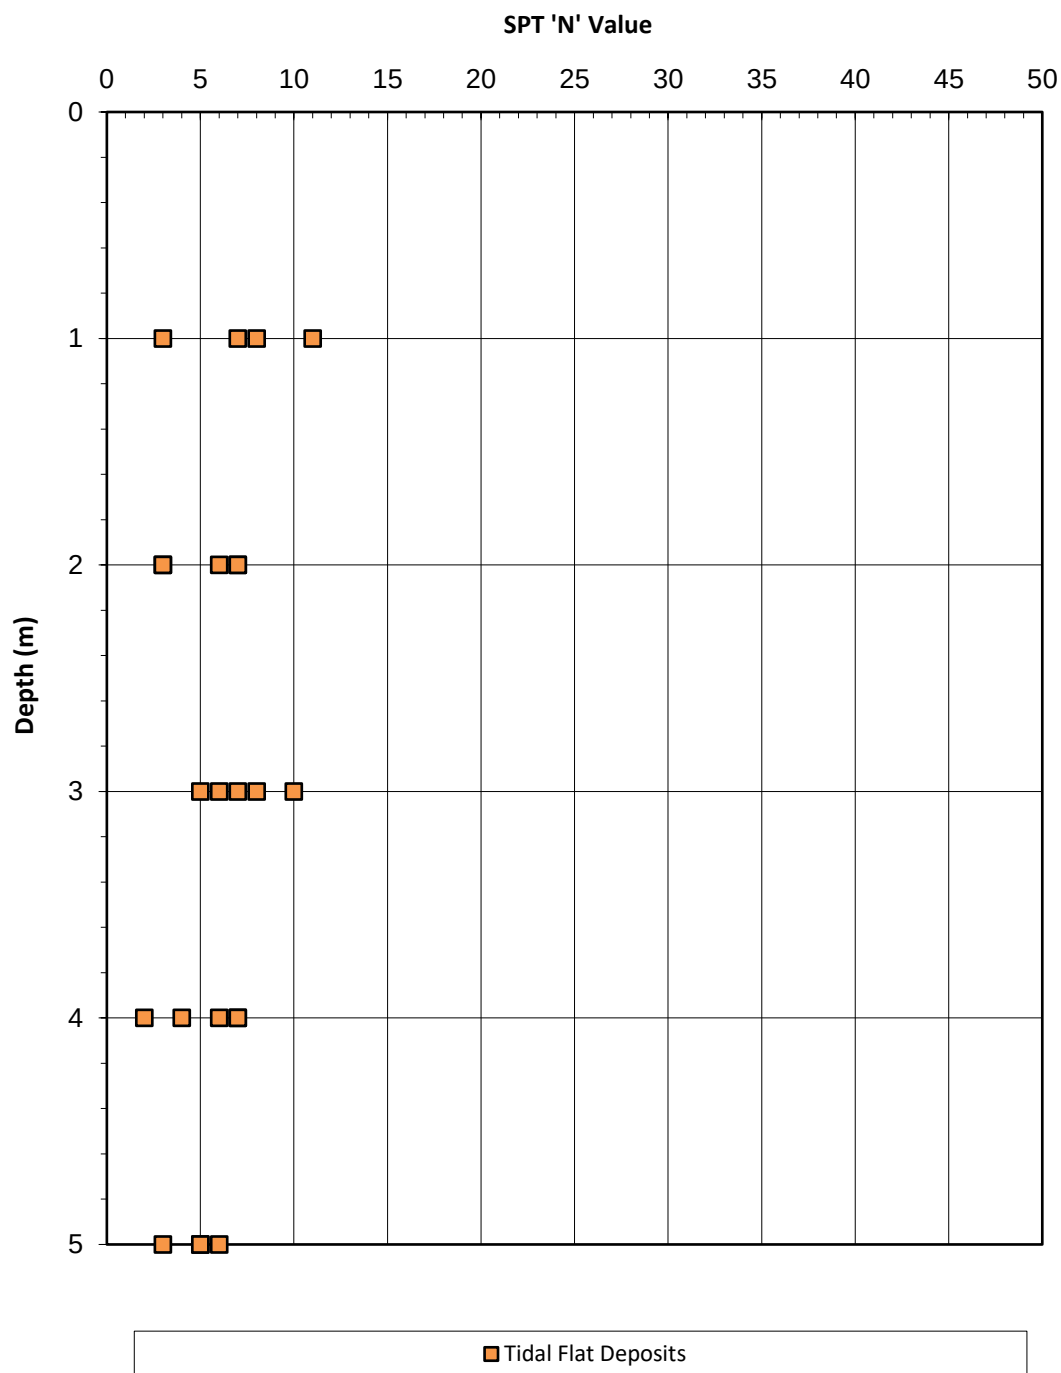
FIGURE III-2

'N' values are uncorrected

SPT 'N' VALUE PROFILE
