VINCI Construction UK Limited

Glan Usk School, Newport

Remediation Validation Report

November 2009

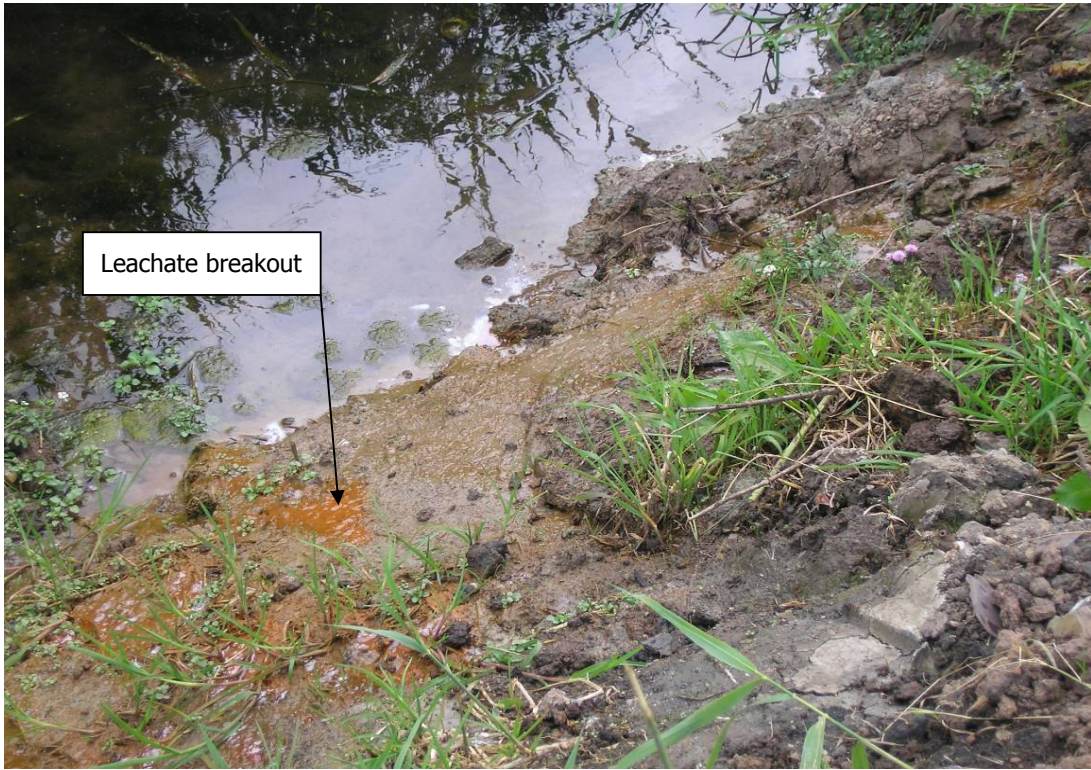
Lotery's Reen showing where sheen on water was first identified

During the remediation works, the reen was cleared of vegetation by workers from NCC as part of regular maintenance of the reen channel. Historically the Council have reacted to flooding issues at the Bowl Club building to the north of the site by undertaking maintenance of the reen. The Council carry out regular clearance work along the channel to ensure water flow to the Usk. Following their clearance work, a small area of suspected oily leachate breakout was observed along the reen, south of the PCB remediation area (Plates 1-3) and indicated on Figure 4.

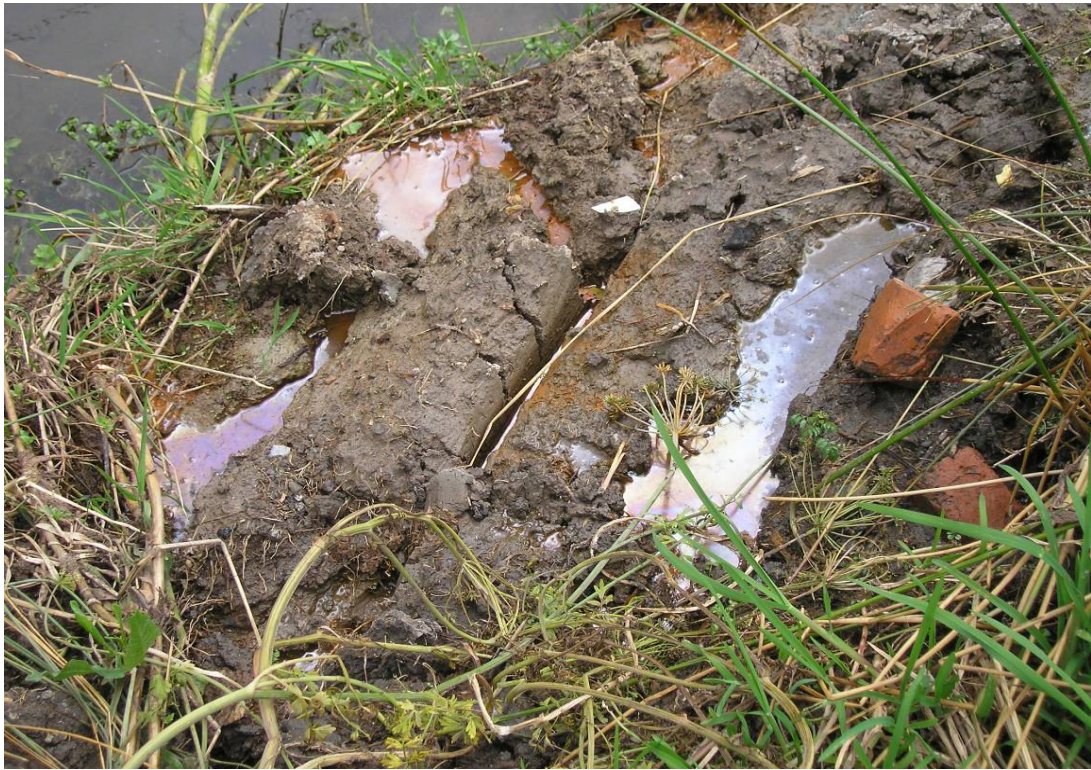
Sheen on water on the bank of Lotery's Reen

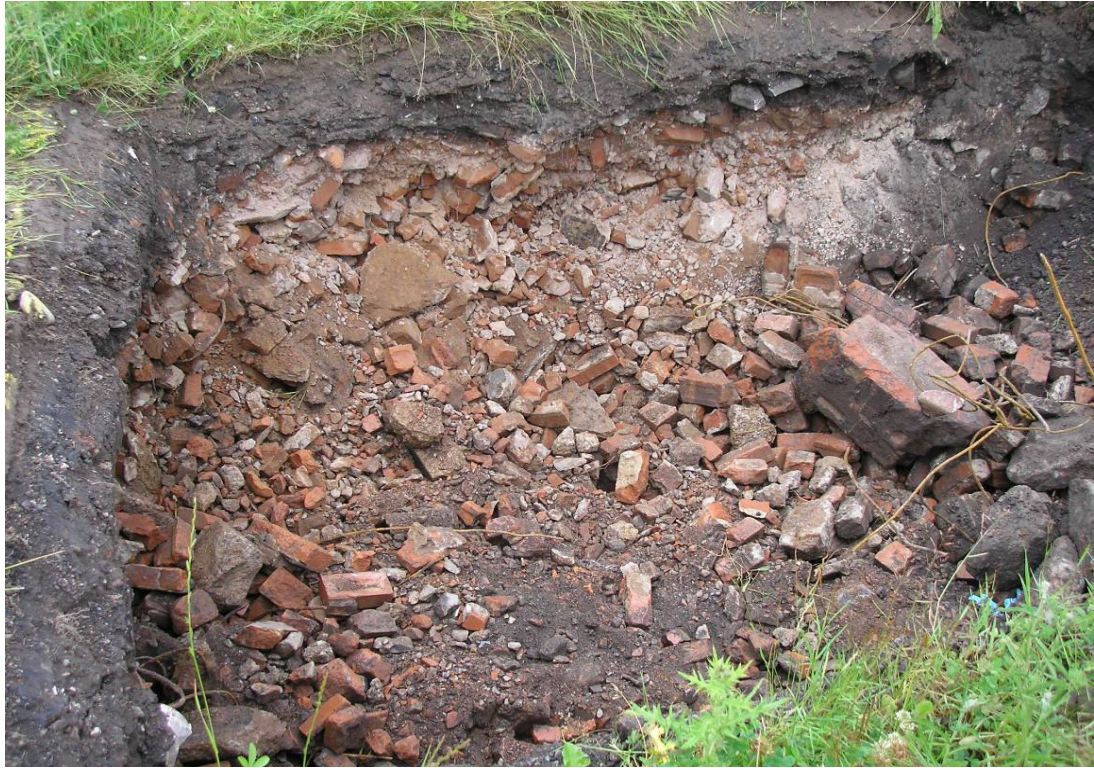
Excavation of TP911

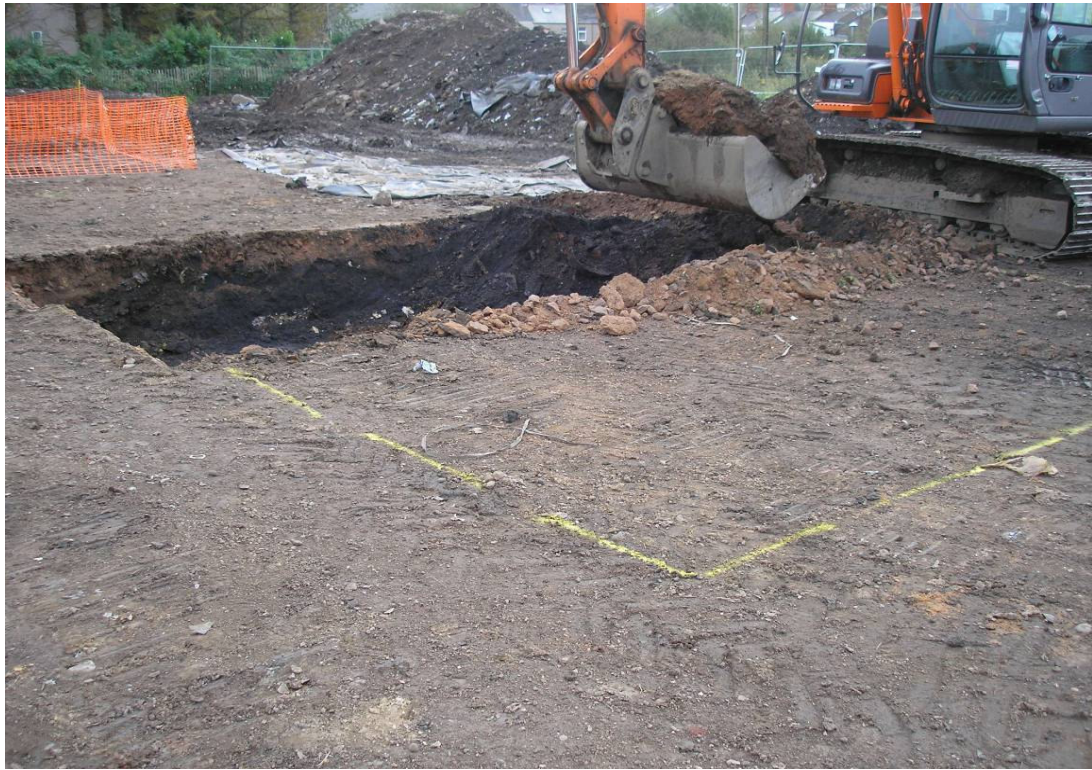
Excavation of TP636

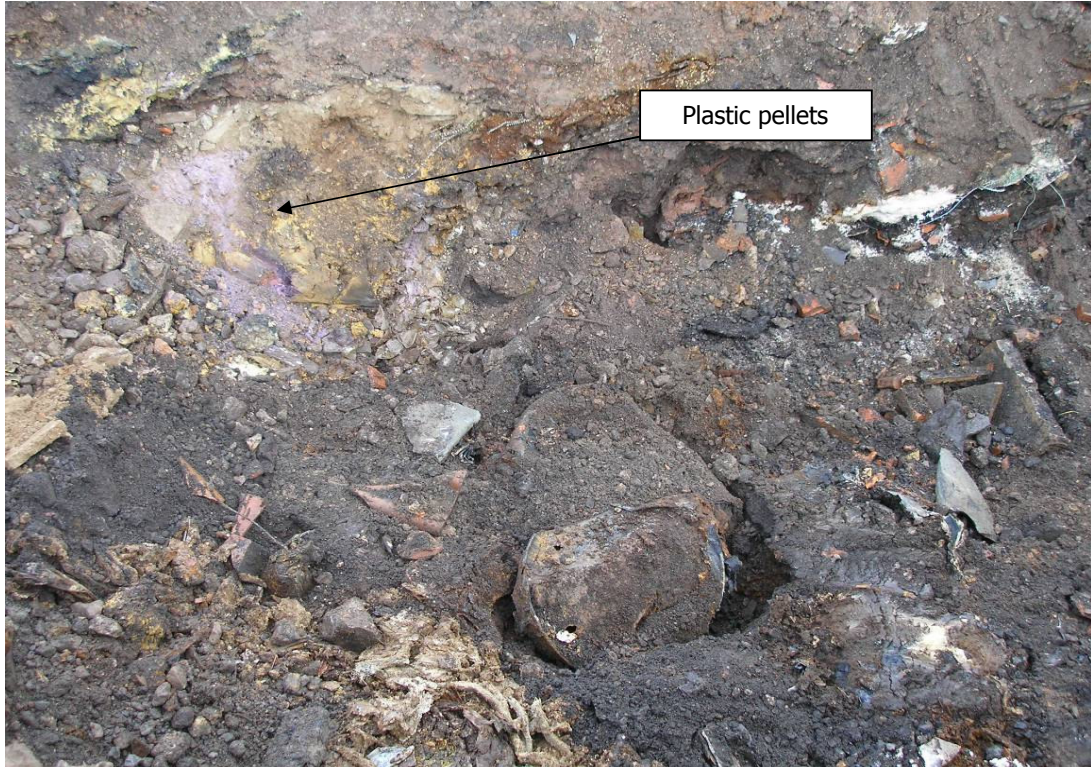
Insitu drums with surrounding waste in TP914.

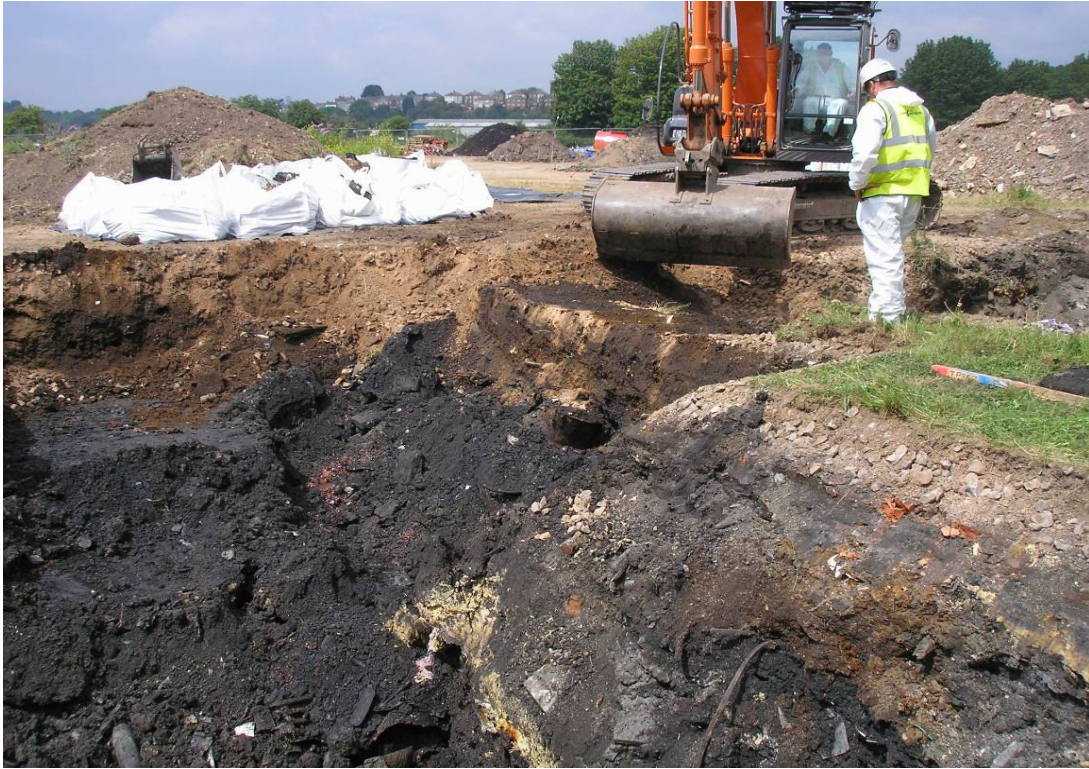
Excavation of TP908

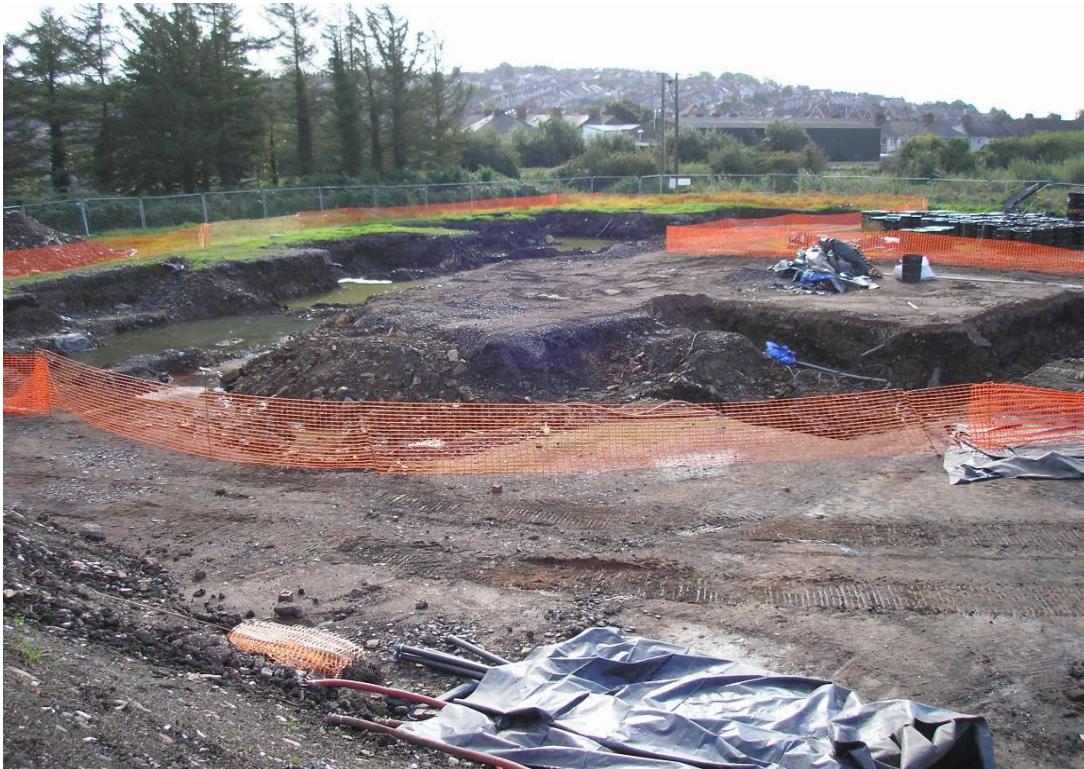
Large excavation during remediation

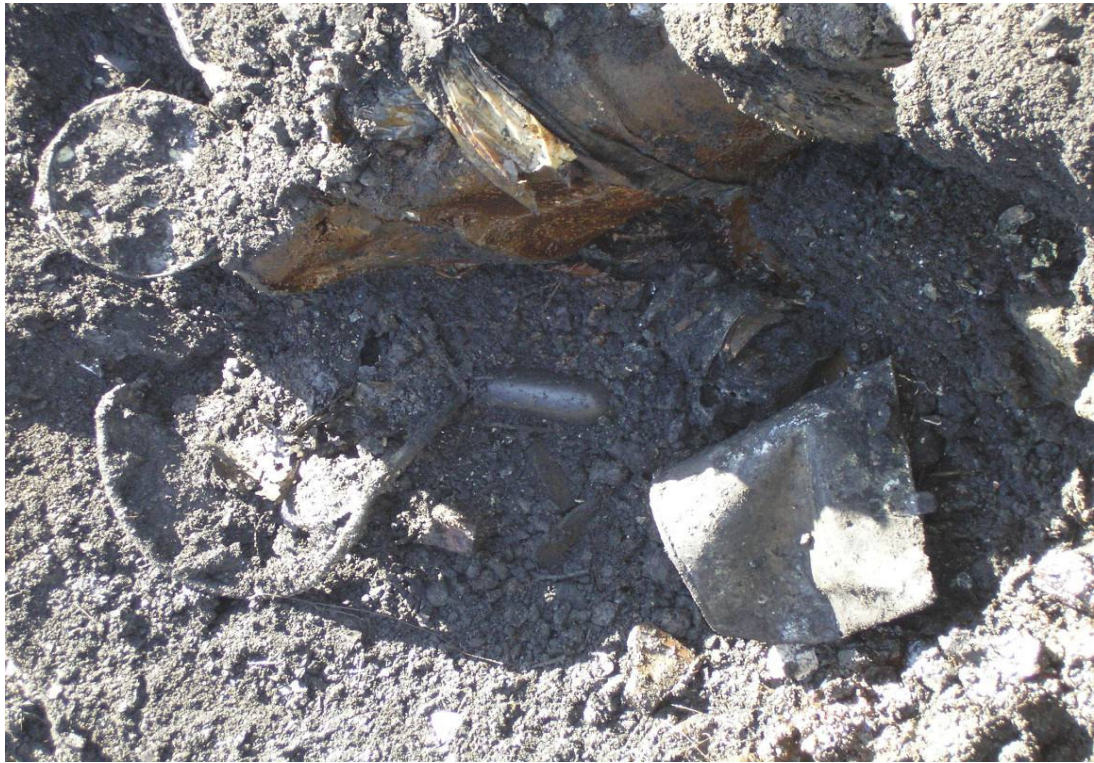
Drums waiting for excavation in TP910

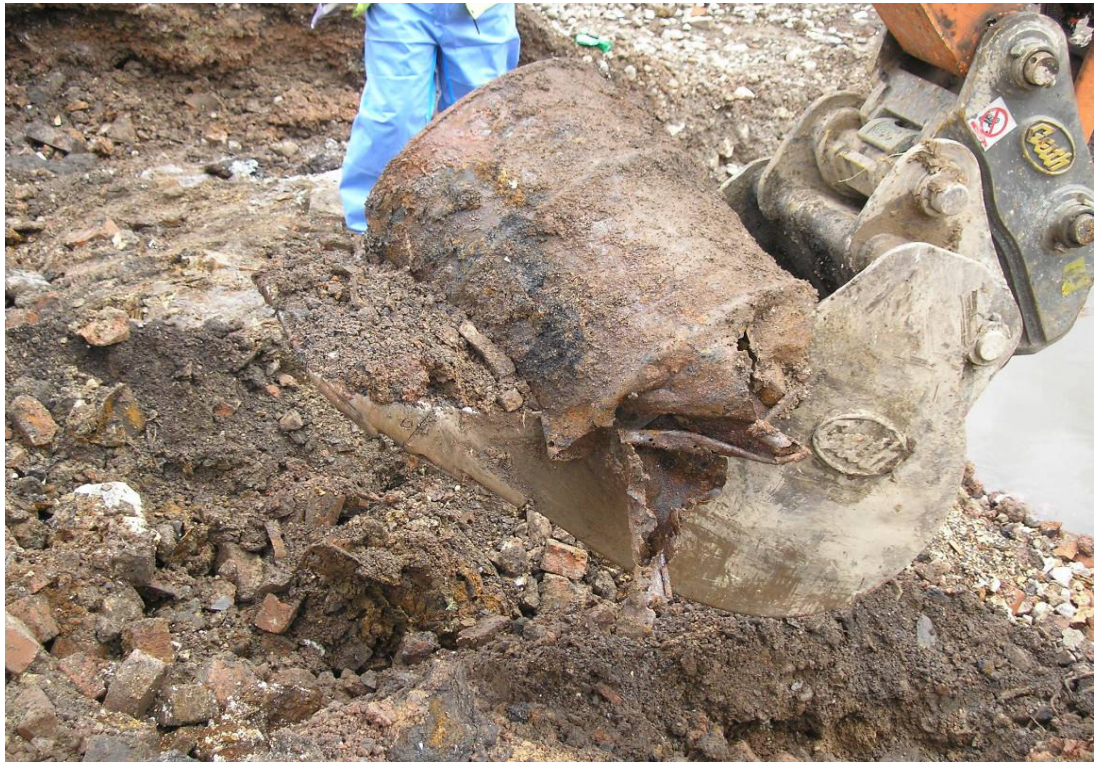
Excavation of drums in TP908

- A brittle dark red brown/black glass/ceramic material – fractured unevenly on impact and on exposure over time to strong sunlight would become viscous and was observed to flow under gravity. This product is shown in Plates 24-26.
- A thick red-brown grease-like substance with a varying viscosity from highly viscous to a thick but free flowing fluid. The grease like material was generally encountered within or surrounding damaged/corroded drums. The fluid type product was less dense than water, light non-aqueous phase liquid (LNAPL), and as such would float on the surface of the perched water in the excavations. Plates 18, 21 and 22 show examples of this product.

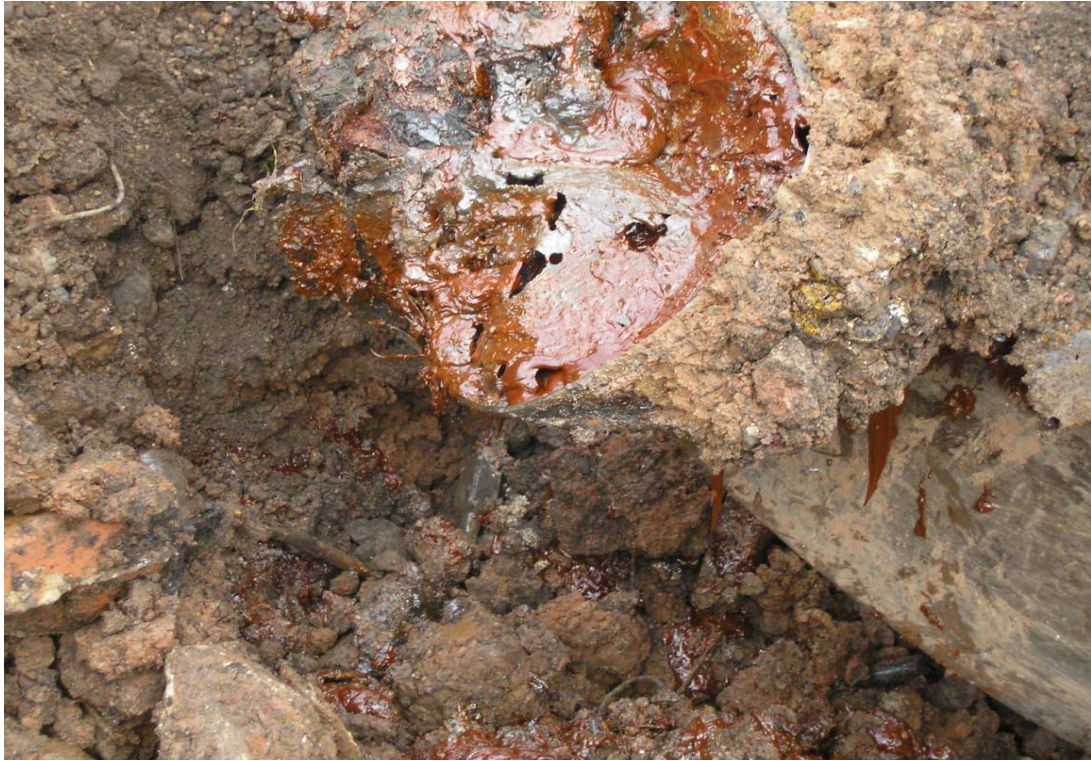
Red brown grease shown to contain high levels of PCBs in TP902

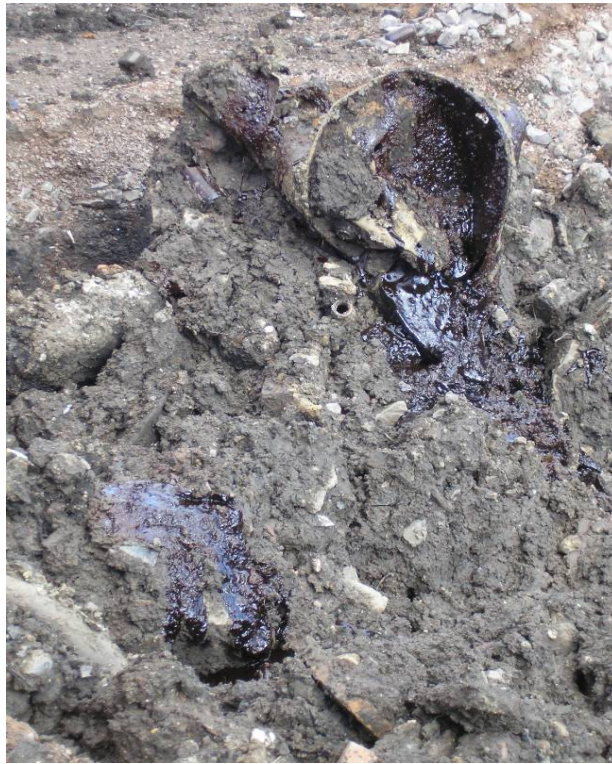
PCB containing material leaking from exposed drum in TP910.

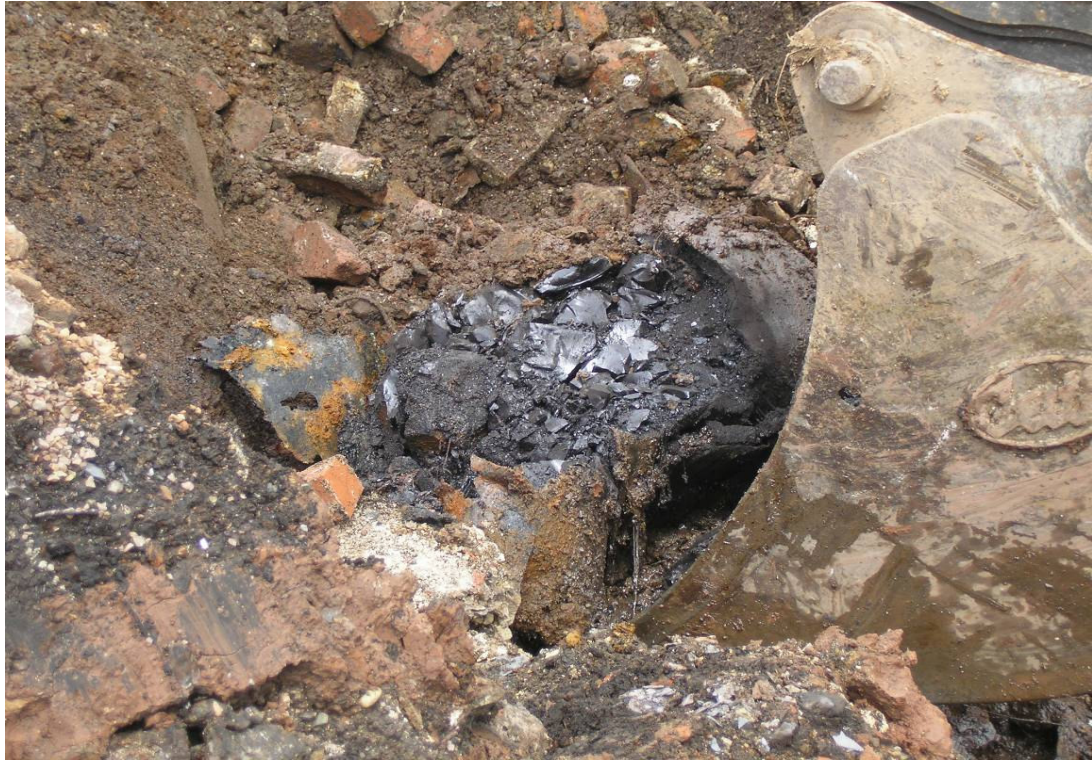
Brittle Glassy material in drum during excavation from TP655A

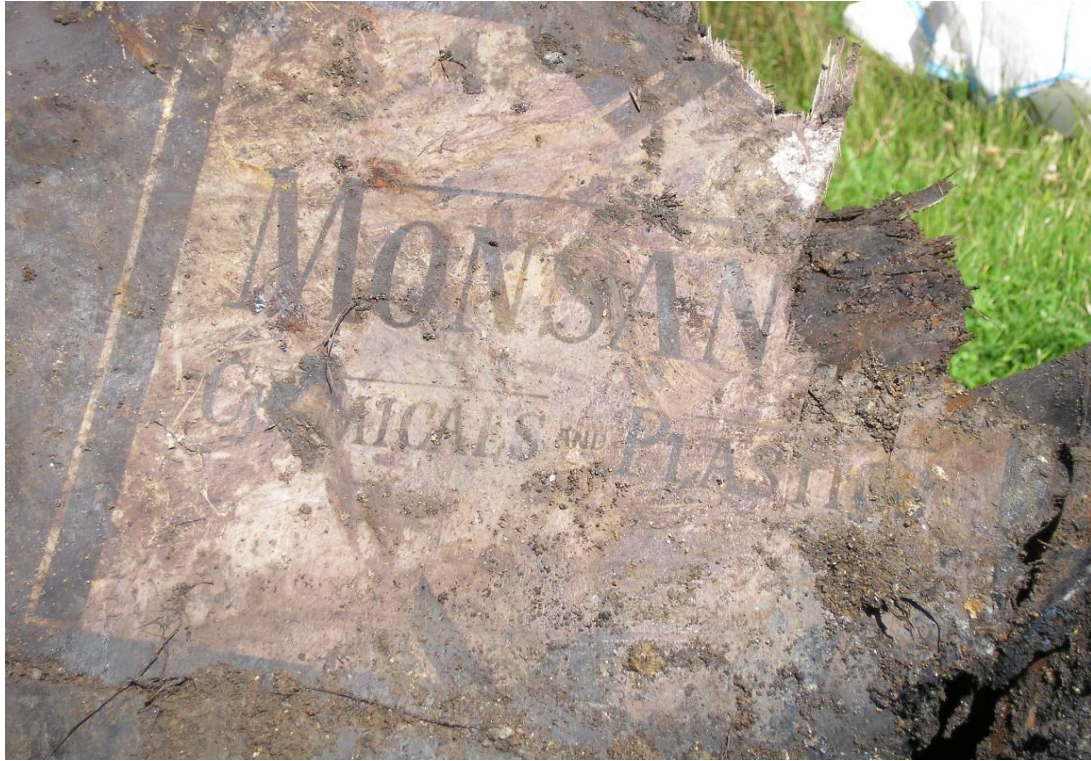
Plate Title
Packing case with Monsanto label excavated from TP655a in the vicinity of drummed material

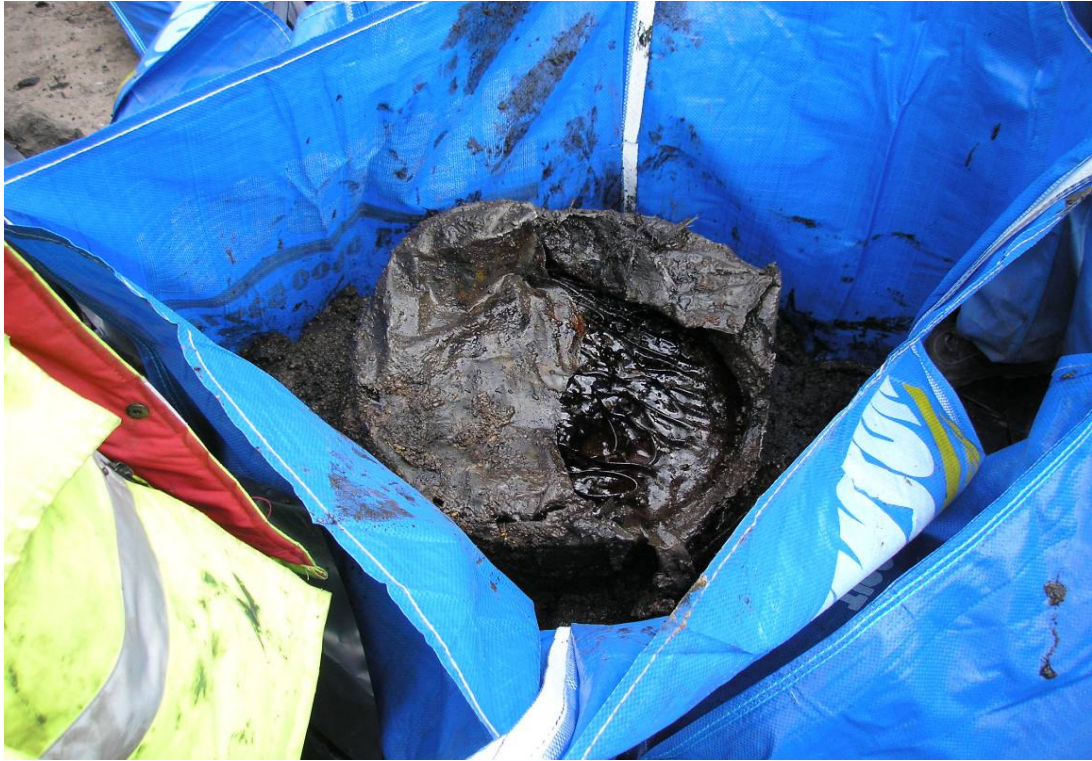
Excavated PCB containing material being placed in tonne bags

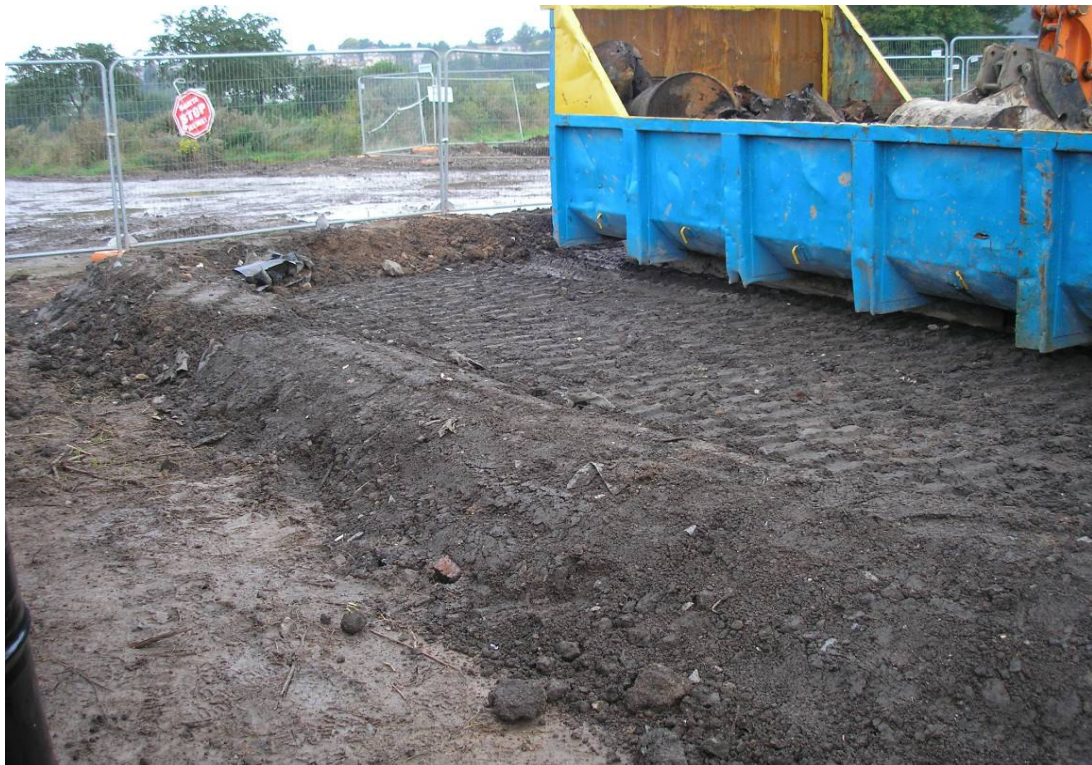
Plastic lined bunded area below skip

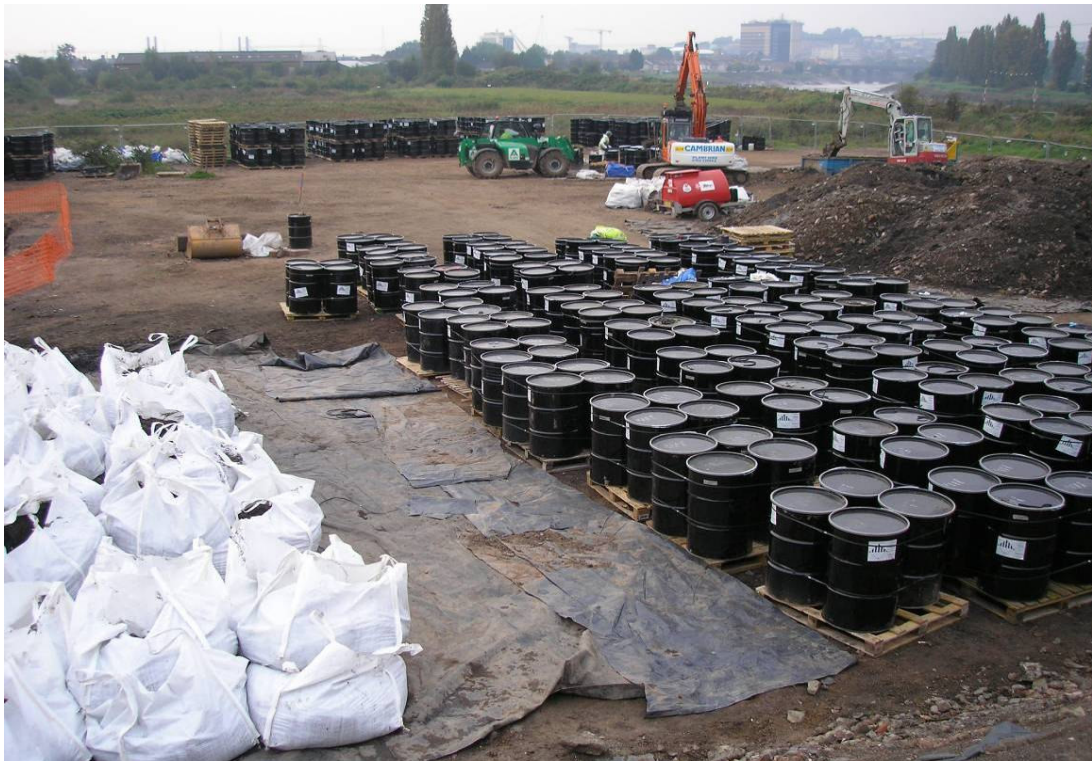
General site activities showing loading of drums and material stockpiled on site

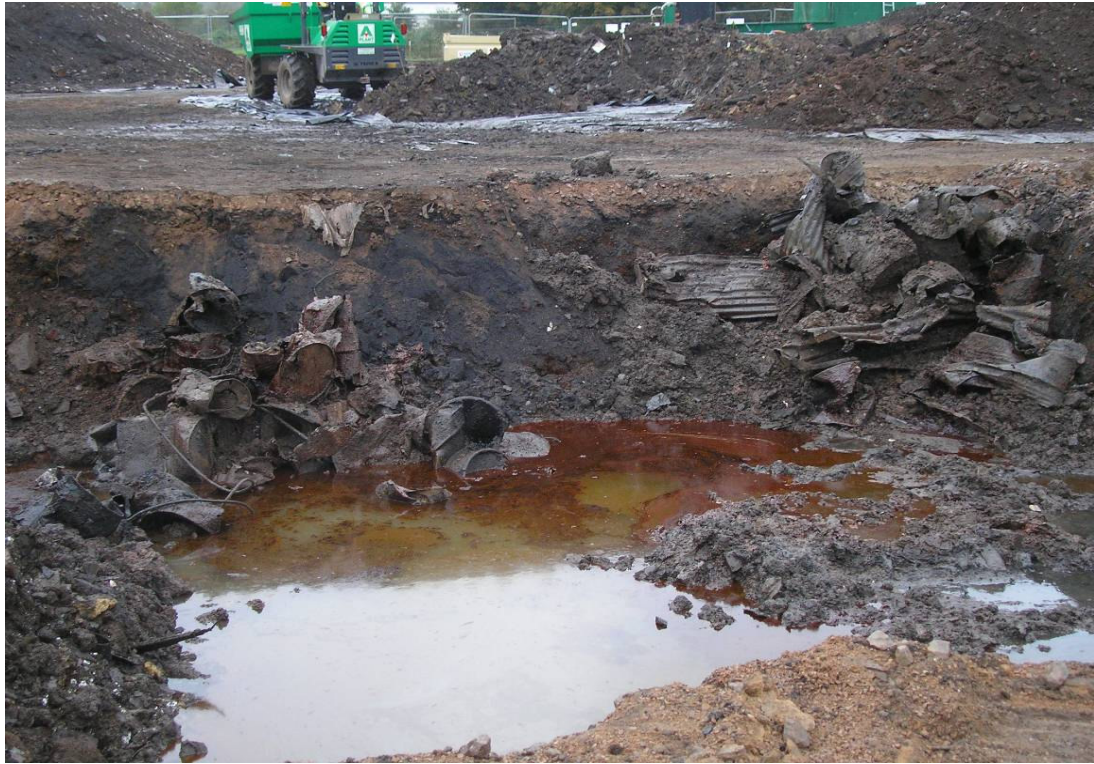
Product with elevated levels of LNAPL on surface or perched water in TP910

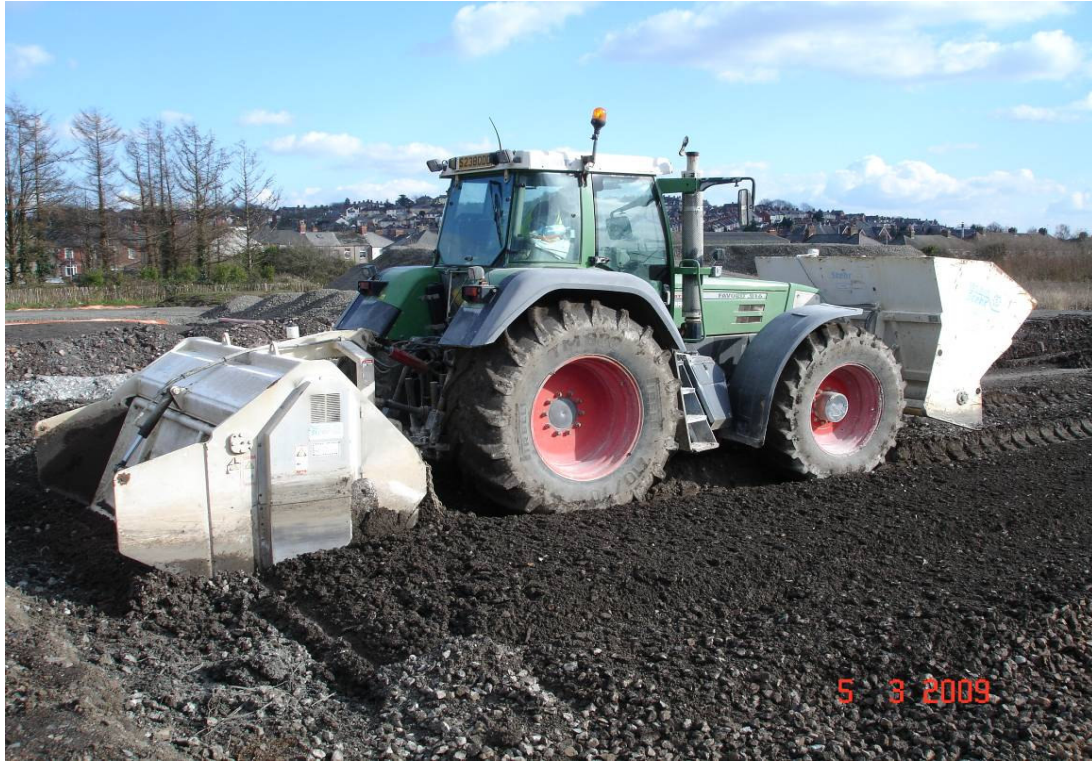
Lime stabilisation of bund material

process was observed by WYG and is included in the Plates 42-44. Treatment was carried out in a plastic lined bunded treatment area constructed within the dirty area of the PCB remediation area.

The lime stabilisation process was undertaken on the 5th of March 2009 and all the material had been exported to landfill for disposal by the 9th of April 2009. The surface soils above the plastic lining within bunded area were tested (ES02, ES03, ES04 and ES05) and compared against the WYG RTVs. Of these, two areas of the bund indicated the soils were suitable for reuse onsite; however, the other two samples (ES03 and ES04) exceeded the RTVs and this material was exported to a non-hazardous landfill.

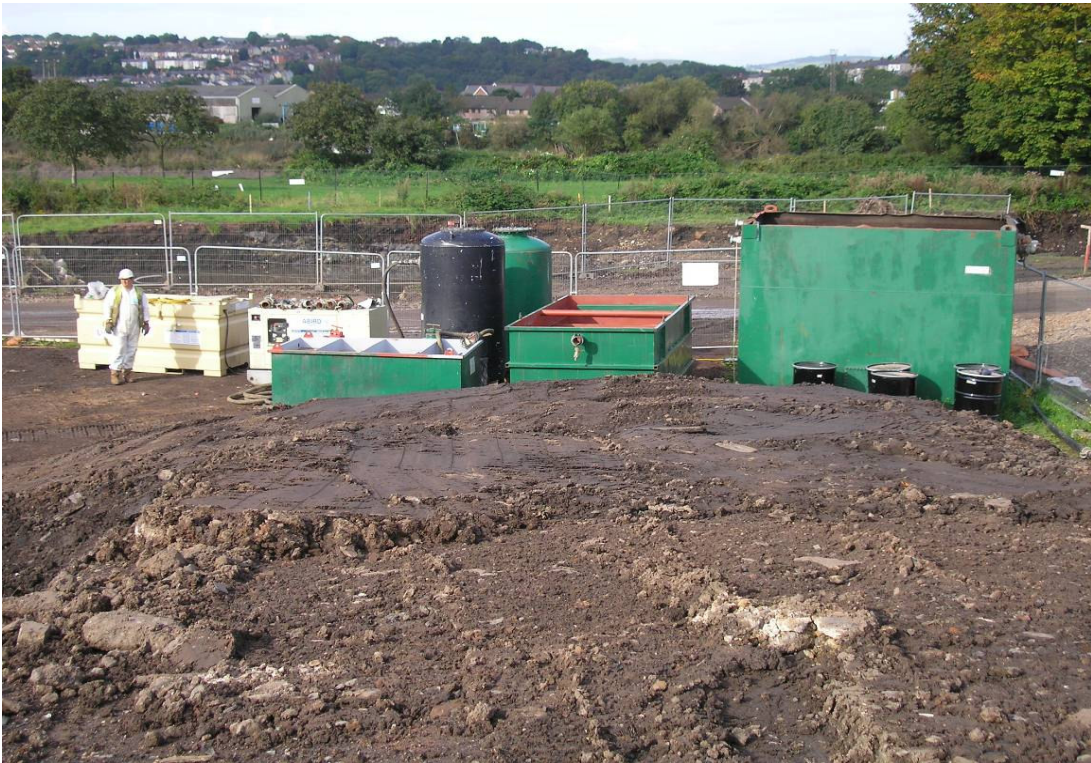
Water treatment system, installed on site

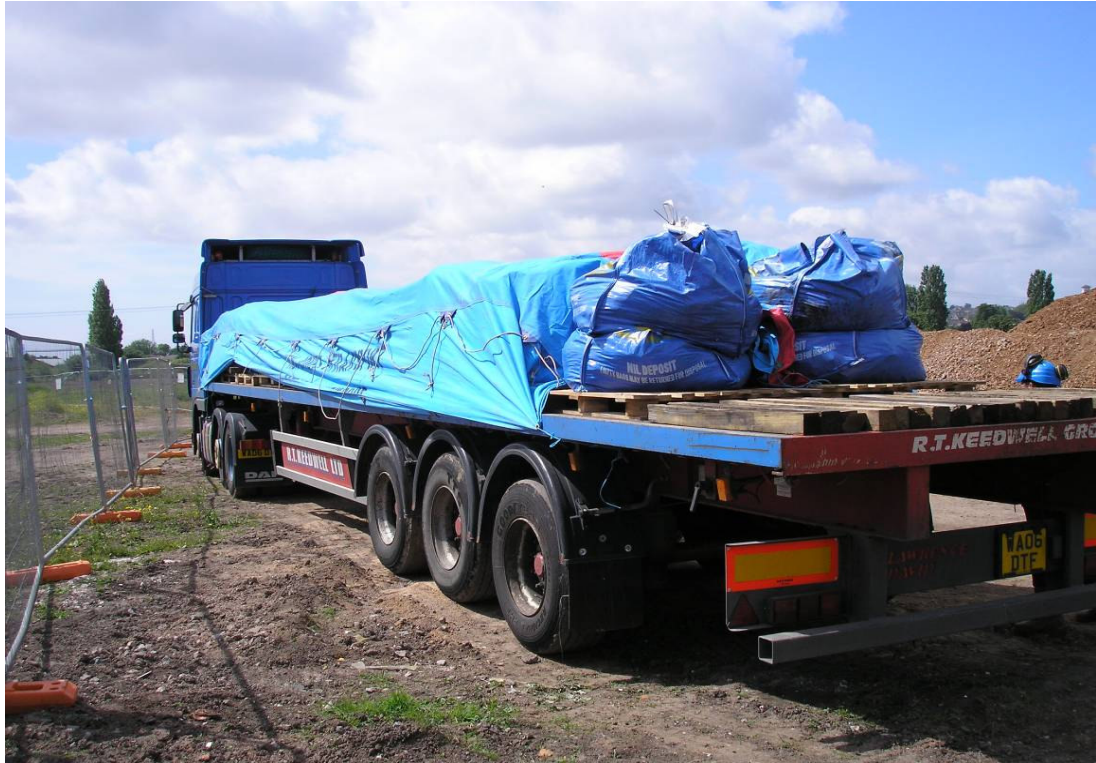
Plate Title
Load being secured prior to removal from site to Grundon's Facility

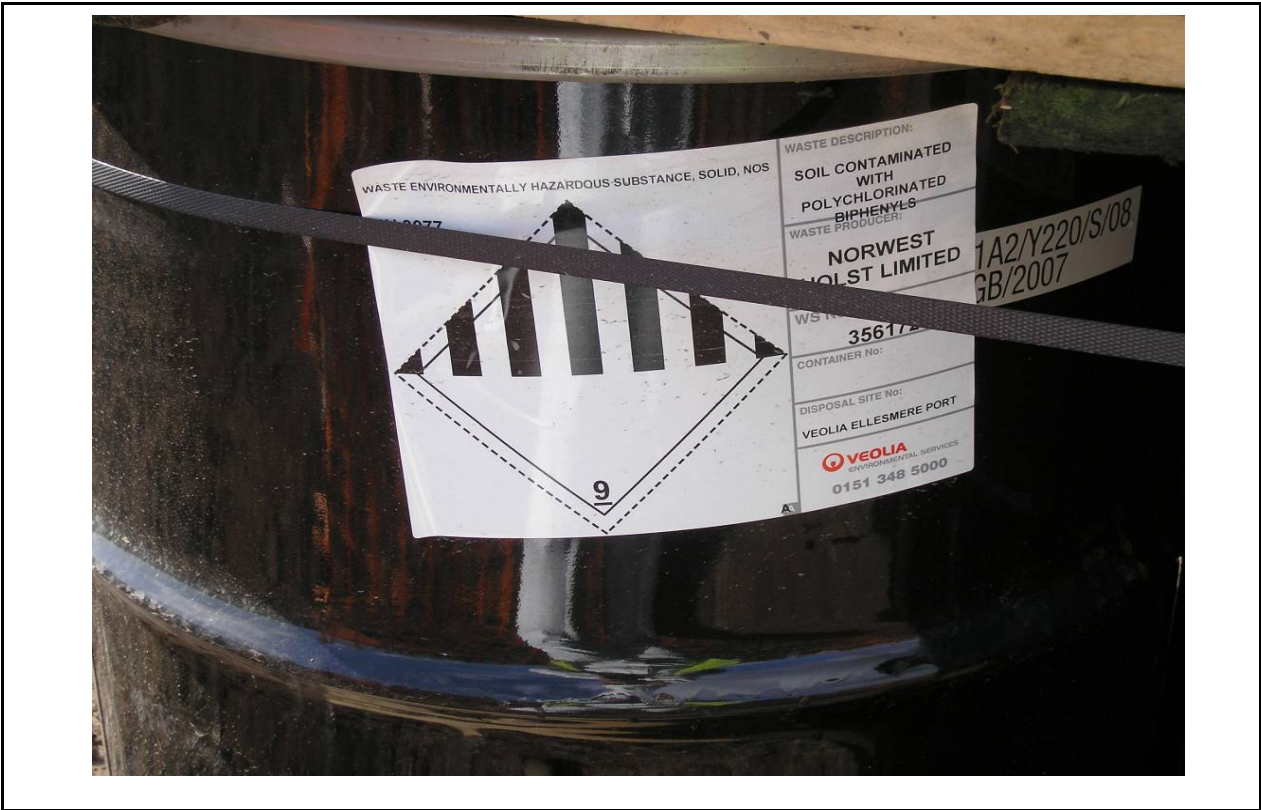
Plate Title Waste identification label for material for off site disposal	Plate No 49
--	----------------

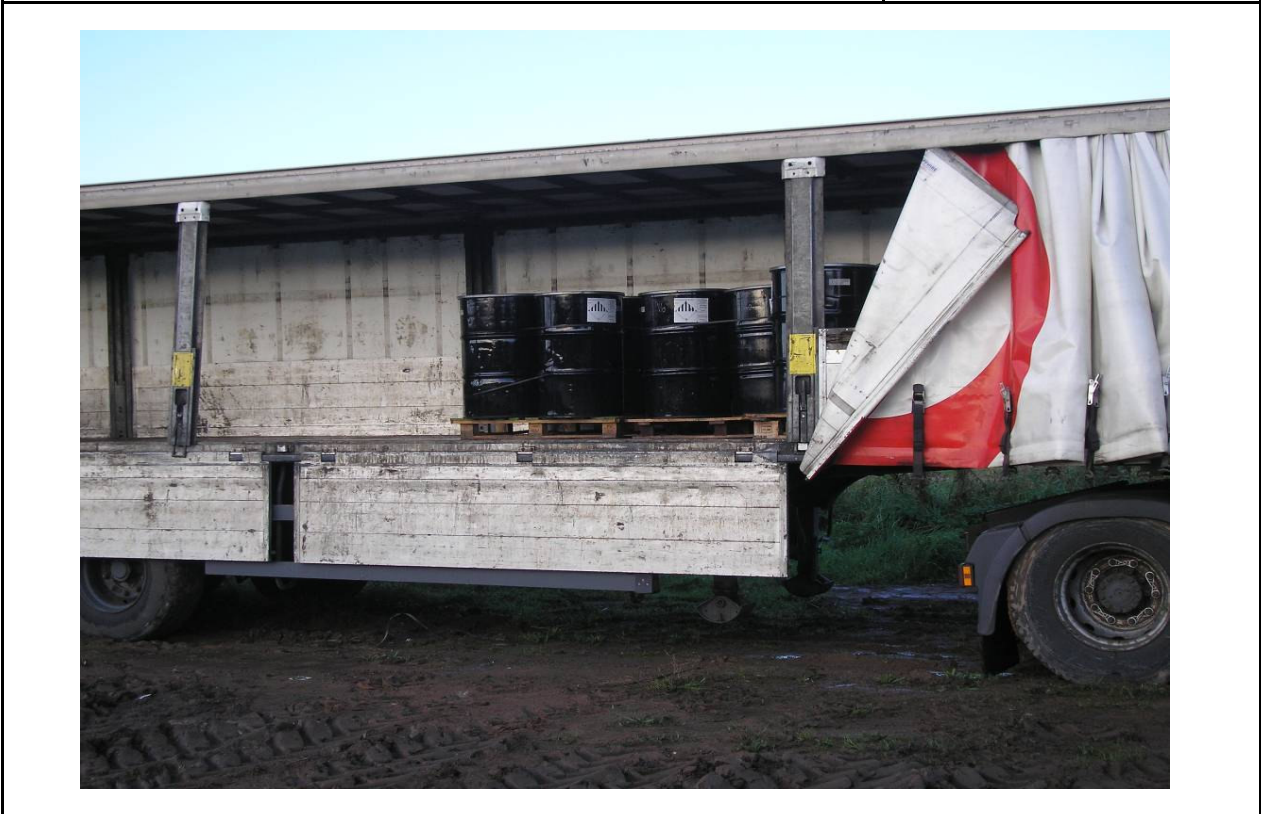
Plate Title Loading lorry prior to removal off site Checked by CBP Plate No. 50
---	--	--

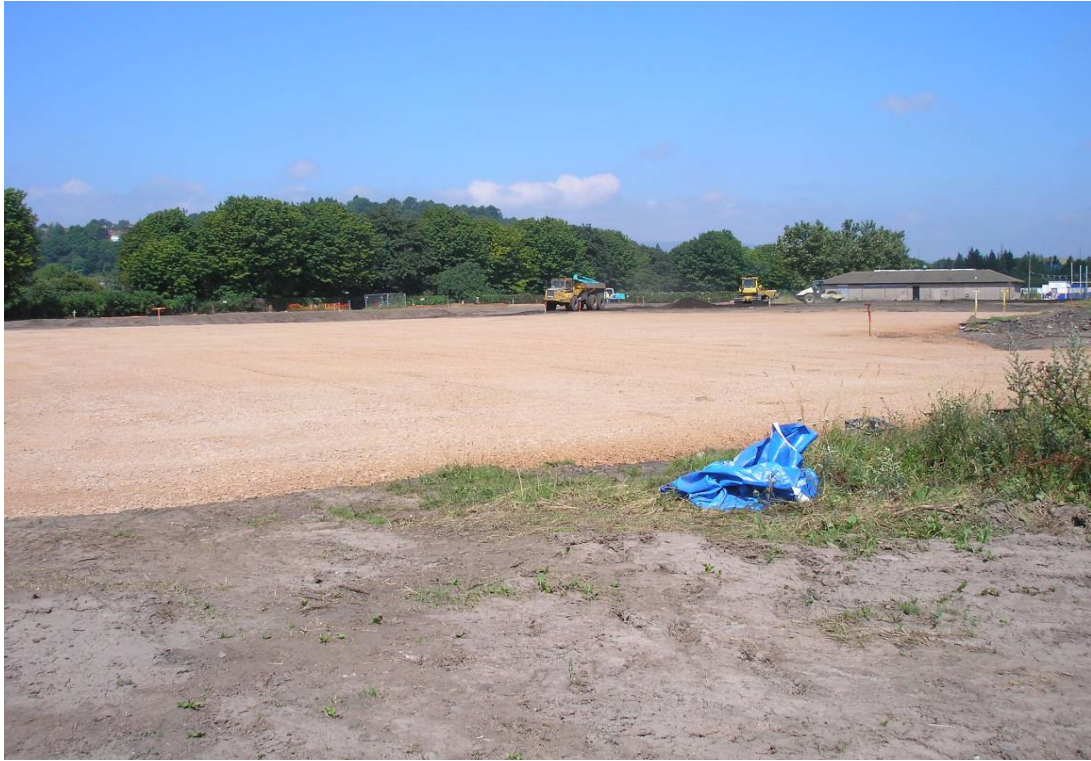
Ground levels being raised under footprint of school building

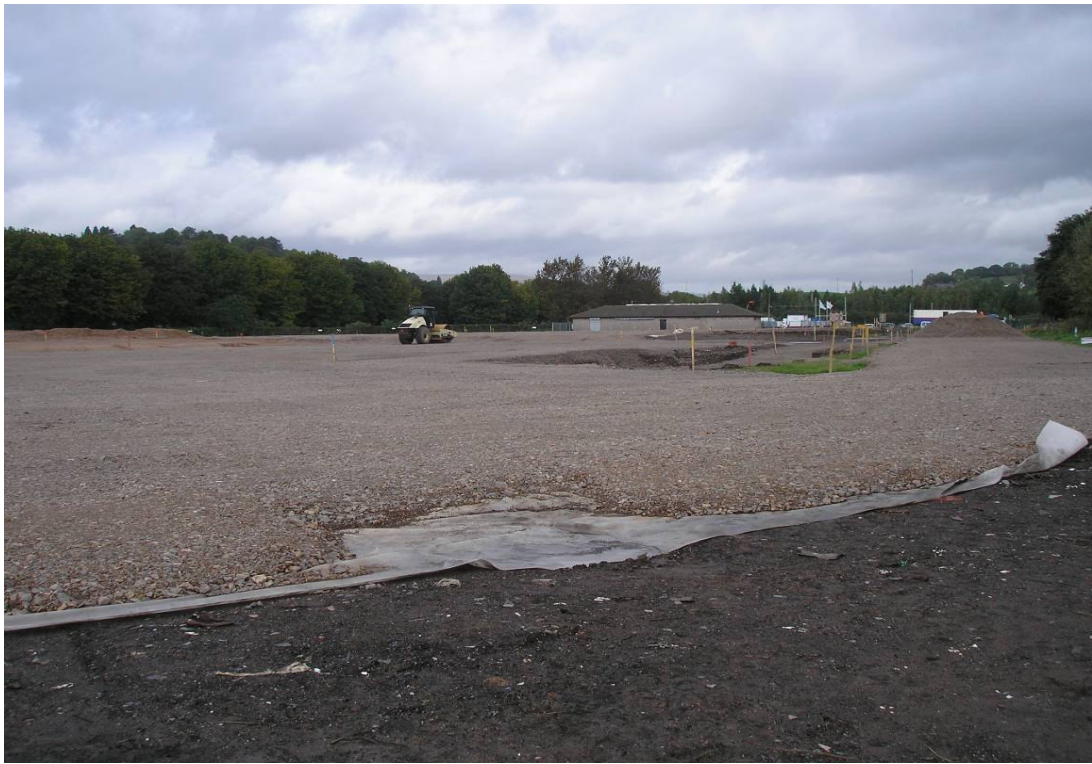
Cover material with barrier membrane on top of made ground deposits

A visual barrier of an orange woven geotextile was placed on the surface of the Made Ground (Plate 52 & 68) in areas of soft landscaping, gardens, and grassed playing fields. The geotextile was laid in overlapping strips to ensure complete coverage of the required areas. The installation of the visual barrier was observed during site visits and through the excavation of exploratory holes in the capping layer.

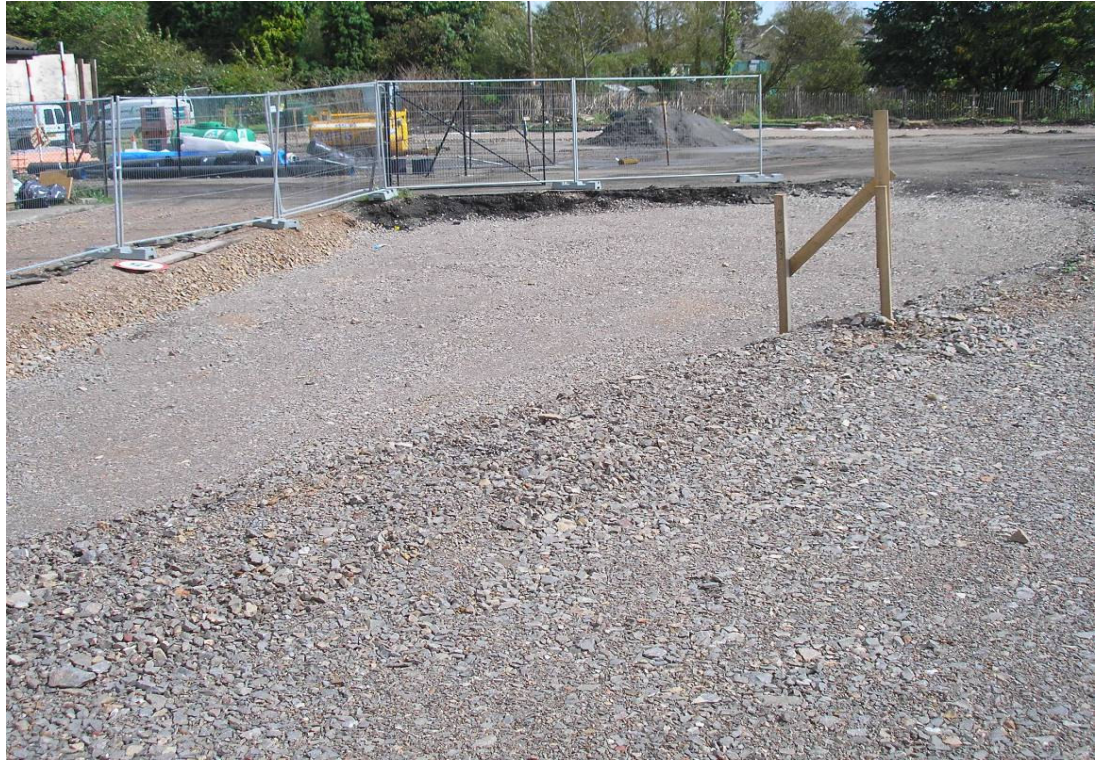
Area of soft landscaping in northern section of site

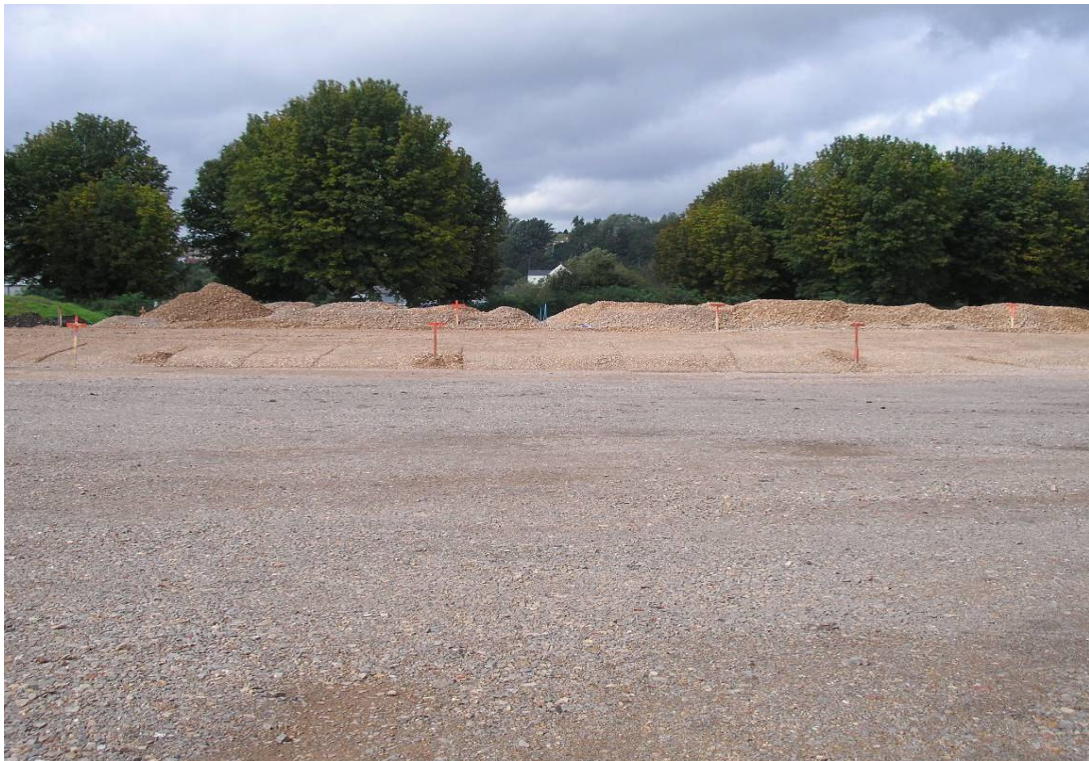
Capping material being laid on areas of soft landscaping
