VINCI Construction UK Limited

Glan Usk School, Newport

Remediation Validation Report

November 2009

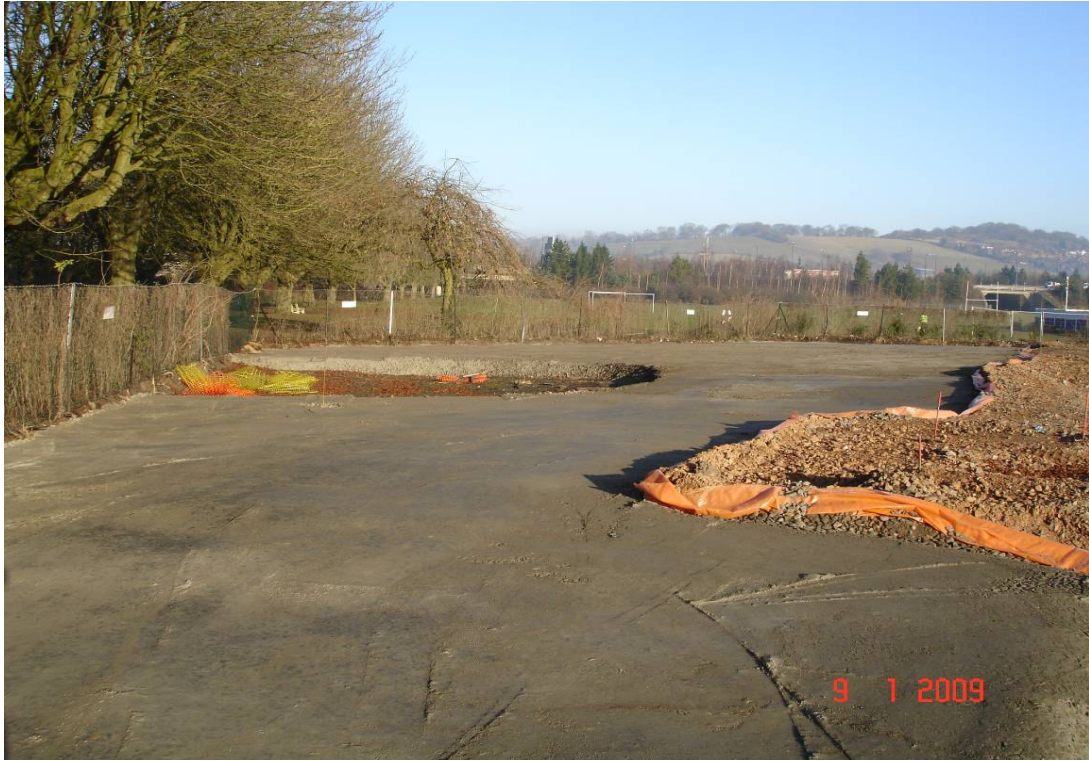
Installation of capping system (visible barrier & aggregate)

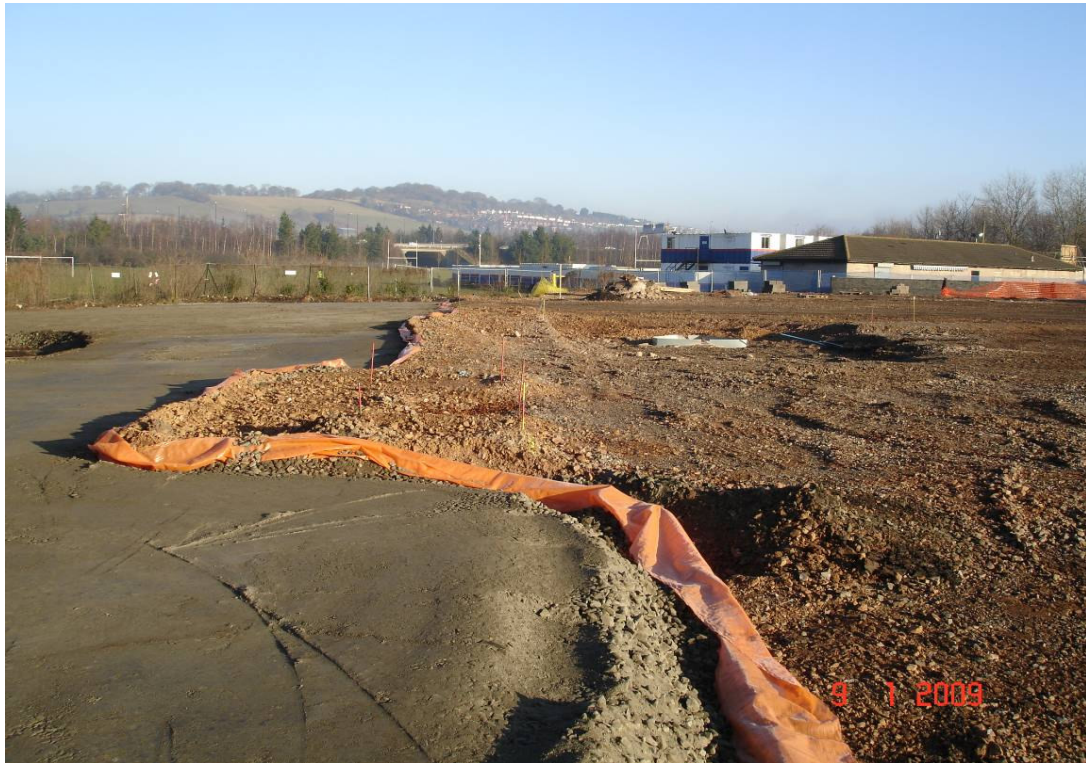
Installation of capping system (visible barrier & aggregate)

A visual barrier of an orange woven geotextile was placed on the surface of the Made Ground (Plate 52 & 68) in areas of soft landscaping, gardens, and grassed playing fields. The geotextile was laid in overlapping strips to ensure complete coverage of the required areas. The installation of the visual barrier was observed during site visits and through the excavation of exploratory holes in the capping layer.

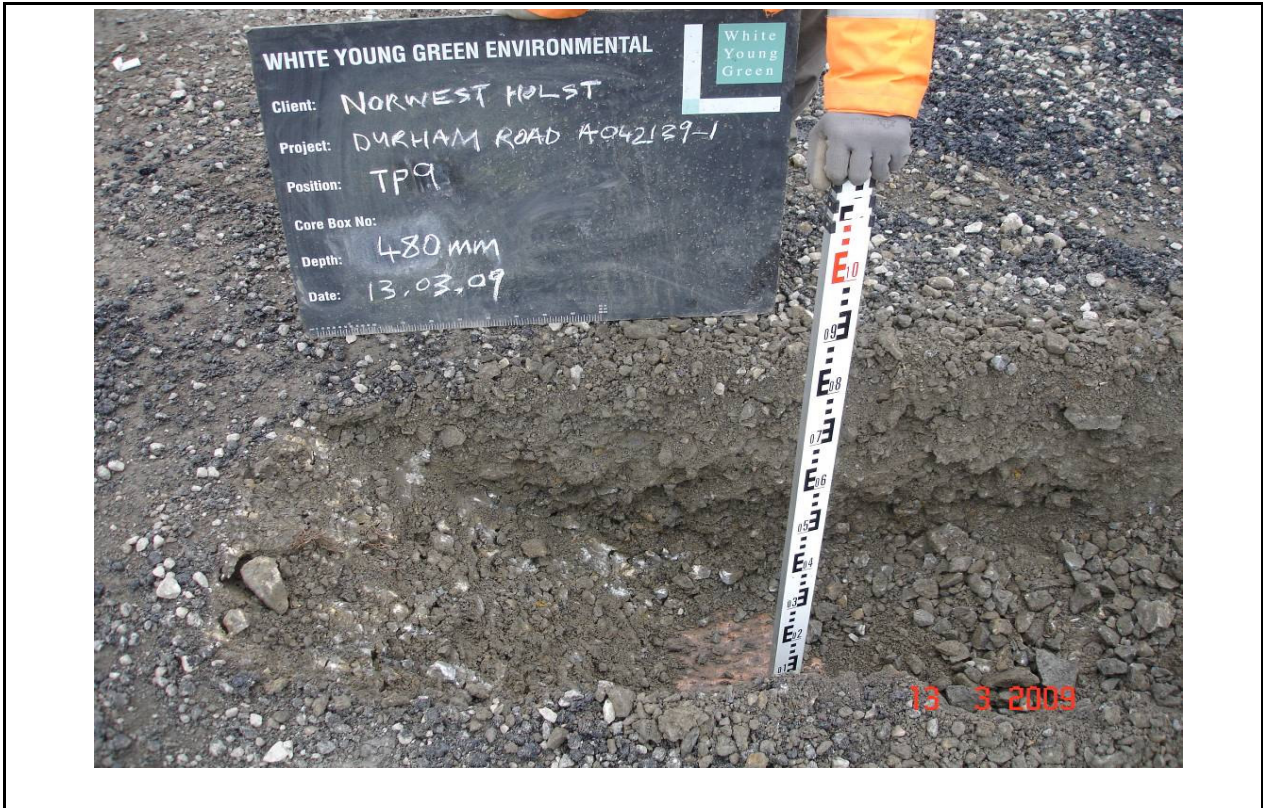
Plate Title
Excavation of TP9 through Cap aggregate layer.

Independent validation of cap thickness and identification of the visual barrier at depth was provided by WYG on five occasions between 30th January 2009 and 5th November 2009. Machine dug inspection pits were excavated in the presence of a WYG engineer to allow the measurement of the depth of capping material and the presence of the visible barrier, on subsequent visits the inspection pits were excavated in preparation of the site visit and left open for inspection. The visible barrier, formed by the orange geotextile was observed in all inspection pits at the base of the aggregate layer. The location of the inspection pits are shown in Figure 6. The findings of the inspection pits are presented in Table 10 and Plates 59-100.

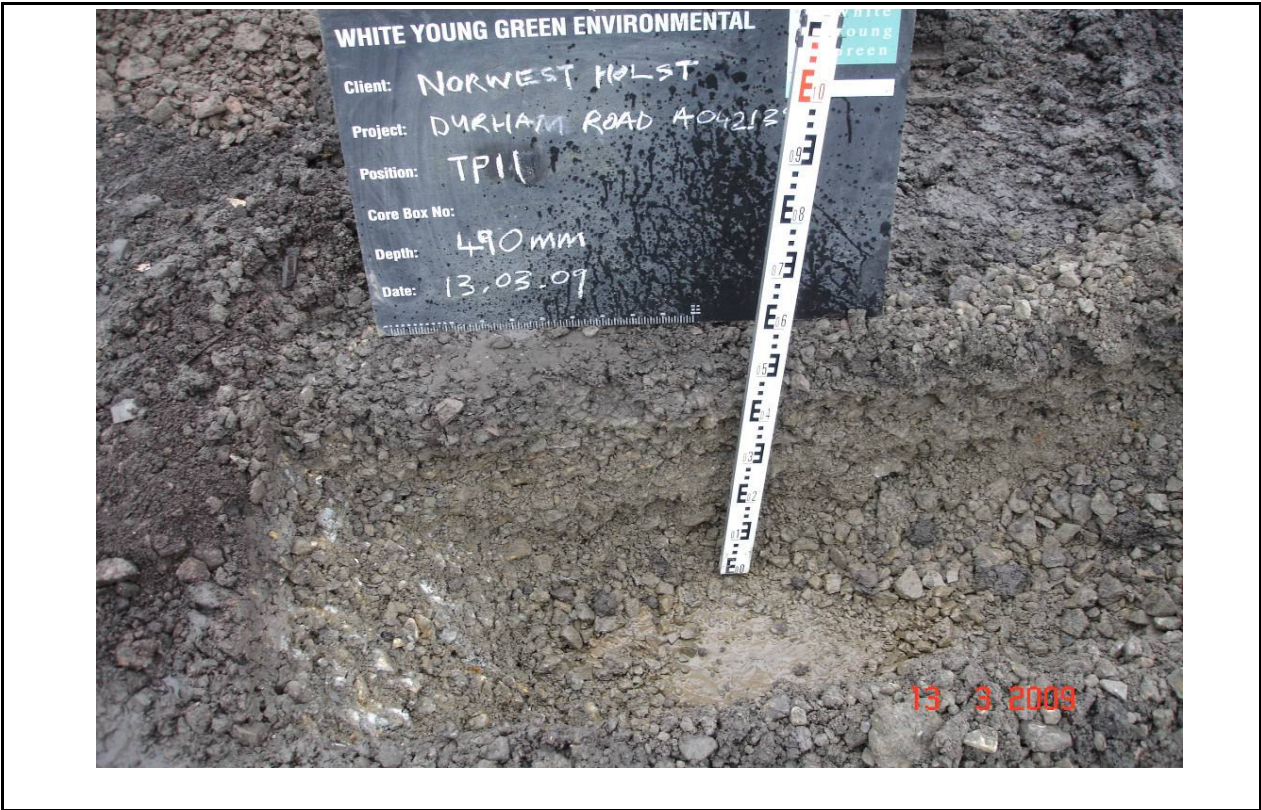
Plate Title
Excavation of TP11 through Cap aggregate layer.

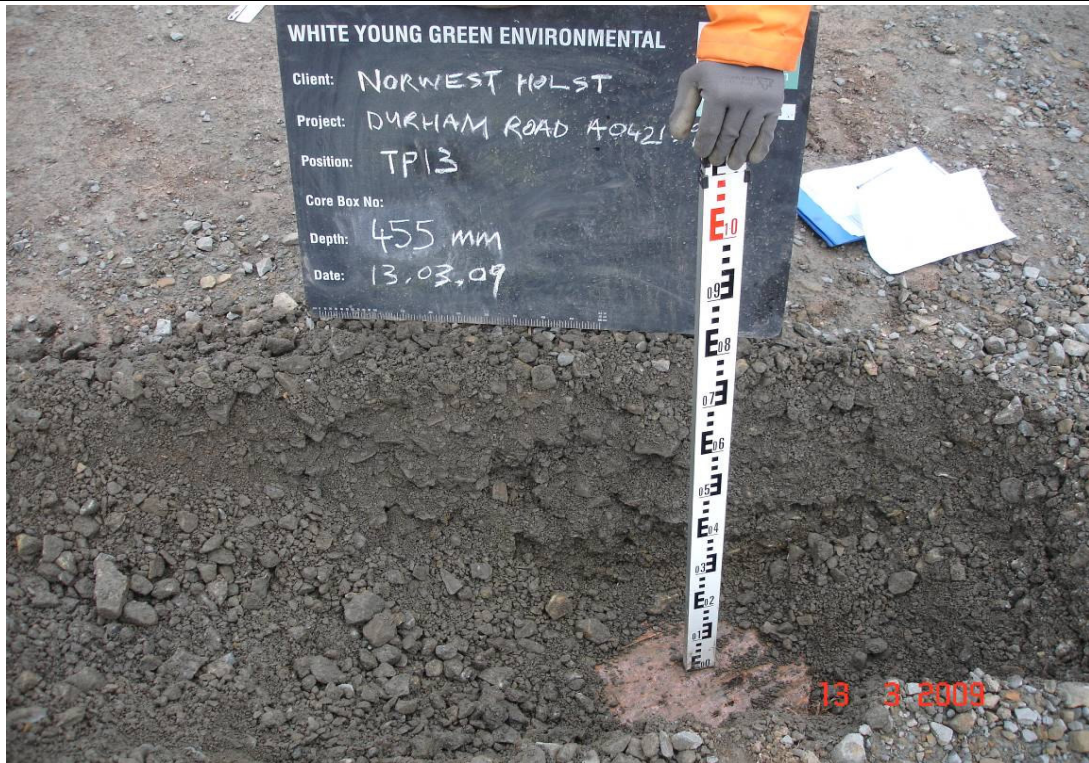
Excavation of TP13 through Cap aggregate layer.

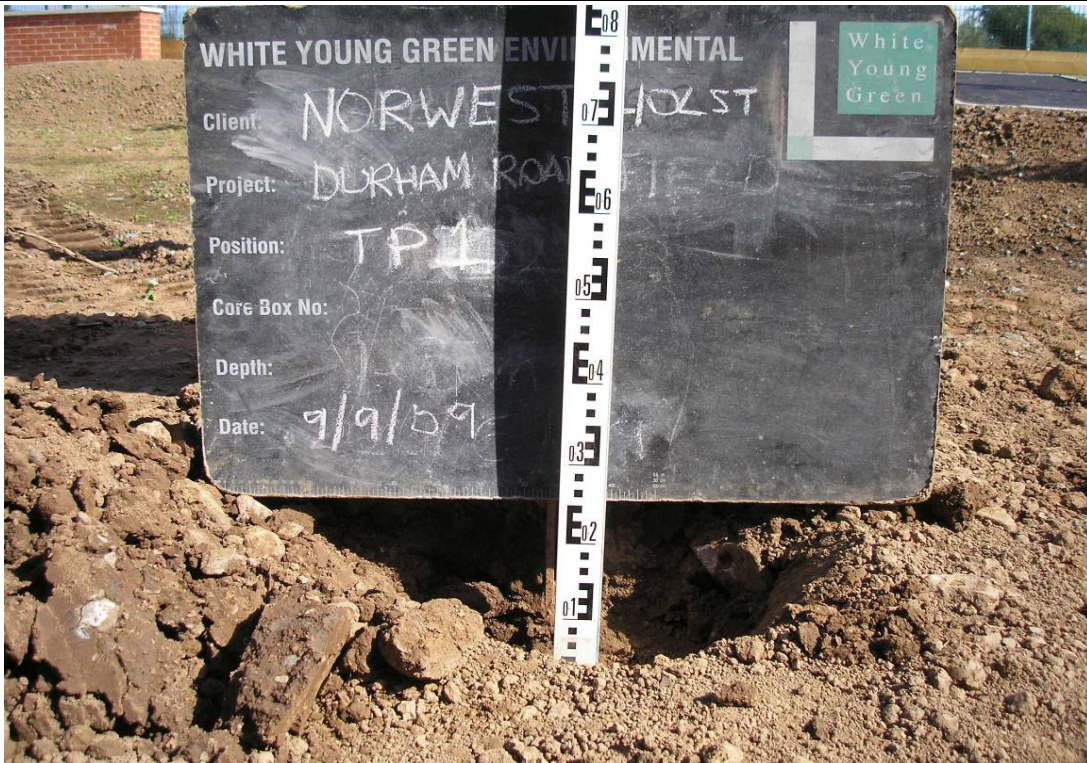
Excavation of TP1 through cap topsoil layer.

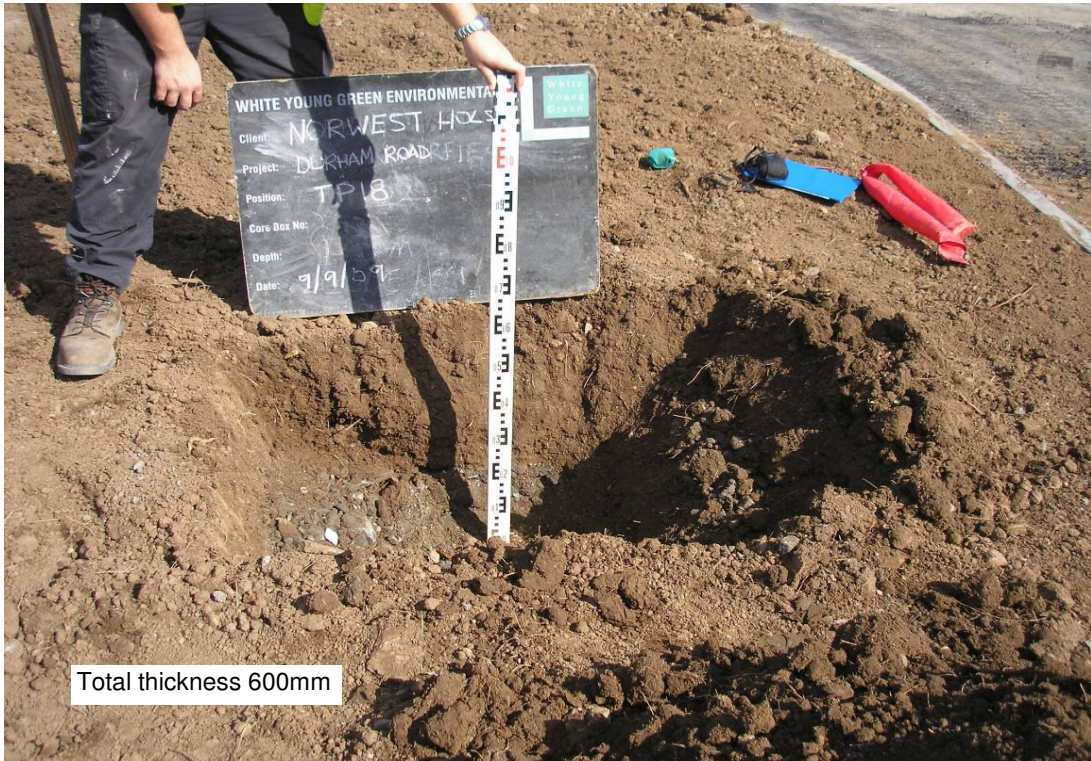
Total thickness 600mm

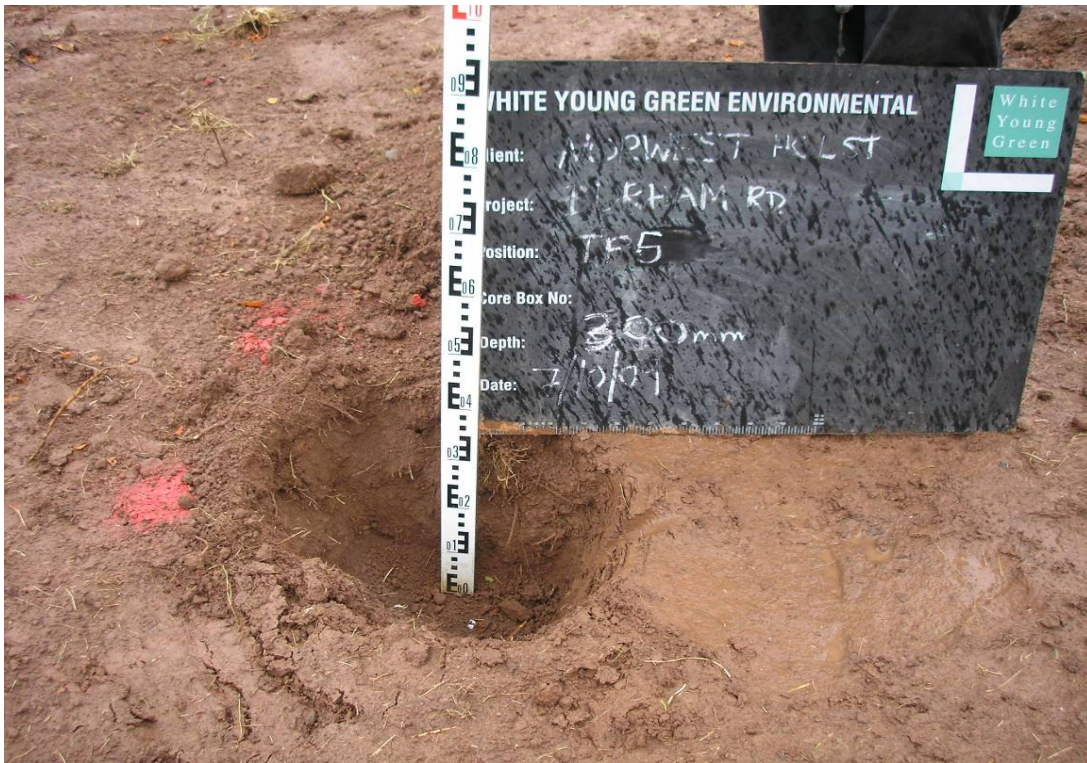
Excavation of TP5 through Cap topsoil layer.

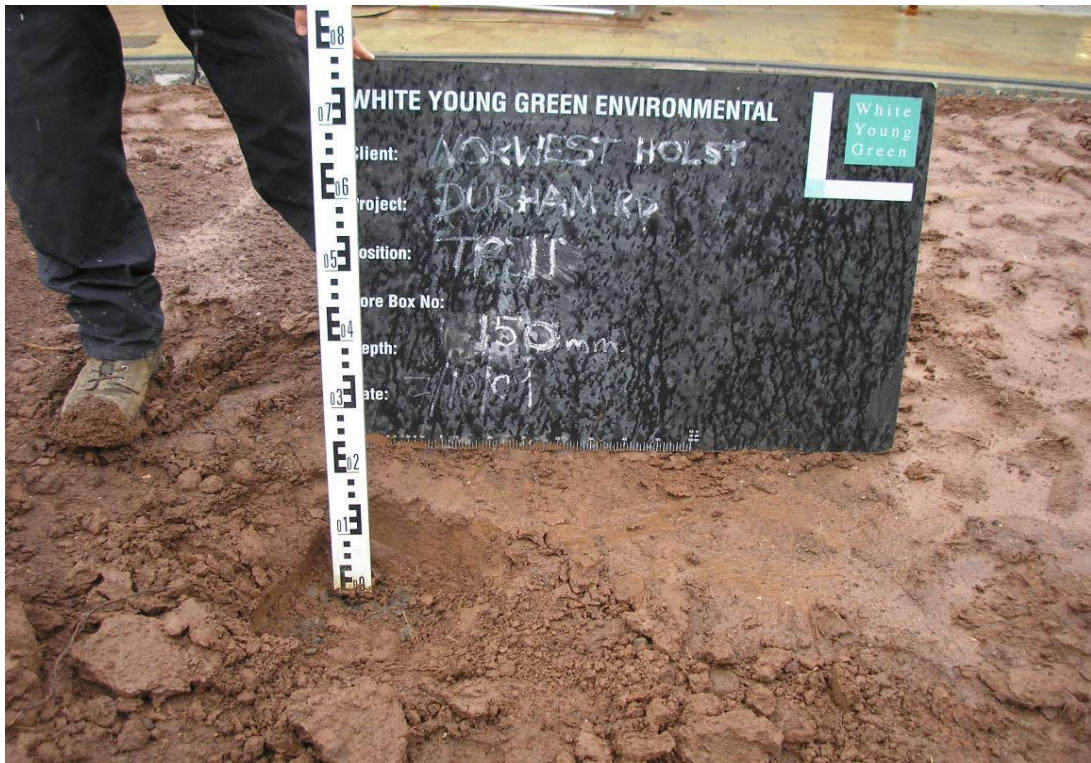
Excavation of TP11 through Cap topsoil layer.

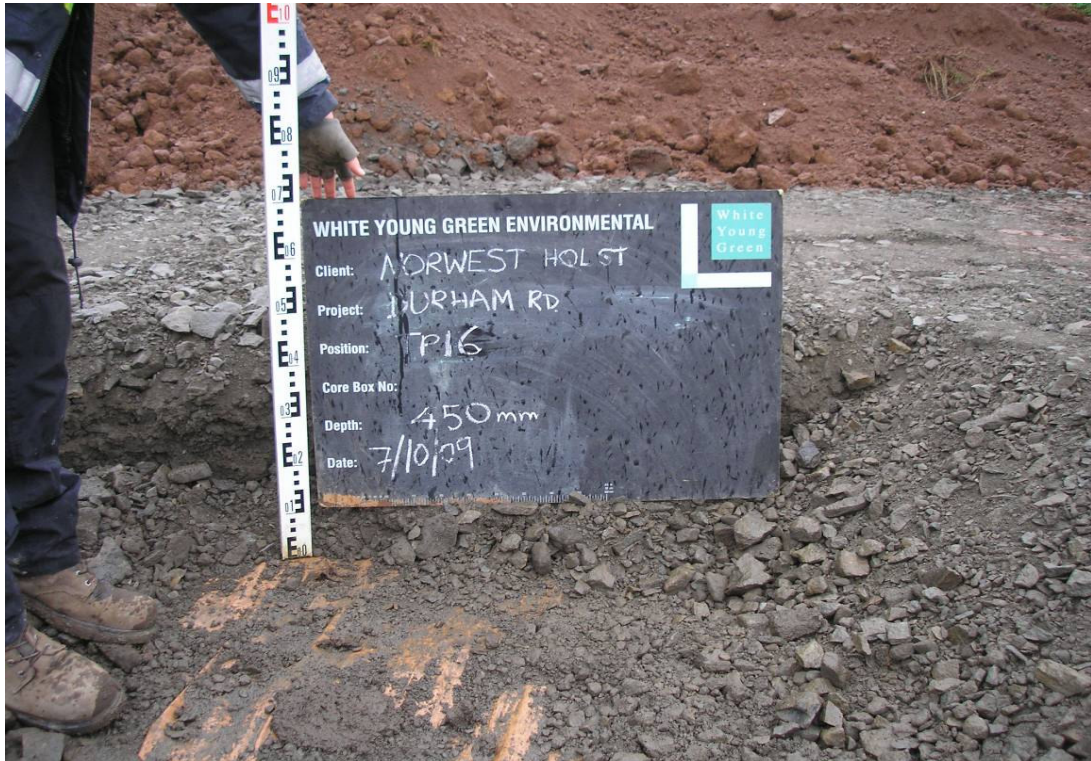
Excavation of TP16 through Cap aggregate layer.

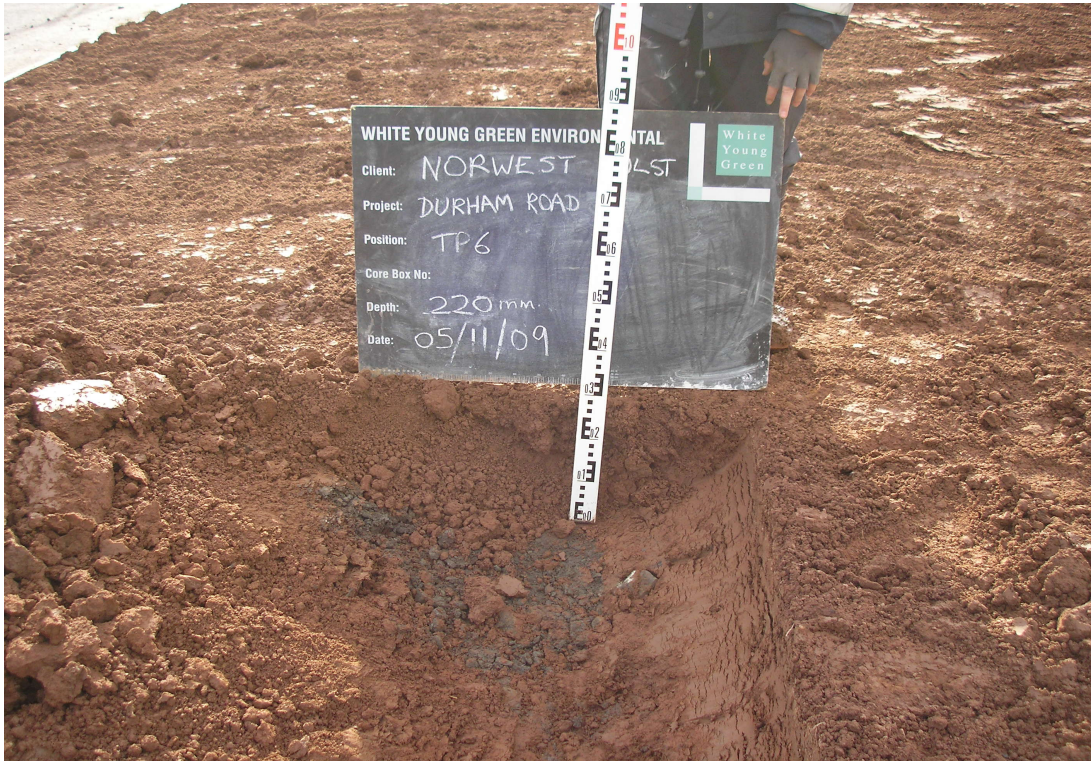
Excavation of TP6 through topsoil layer

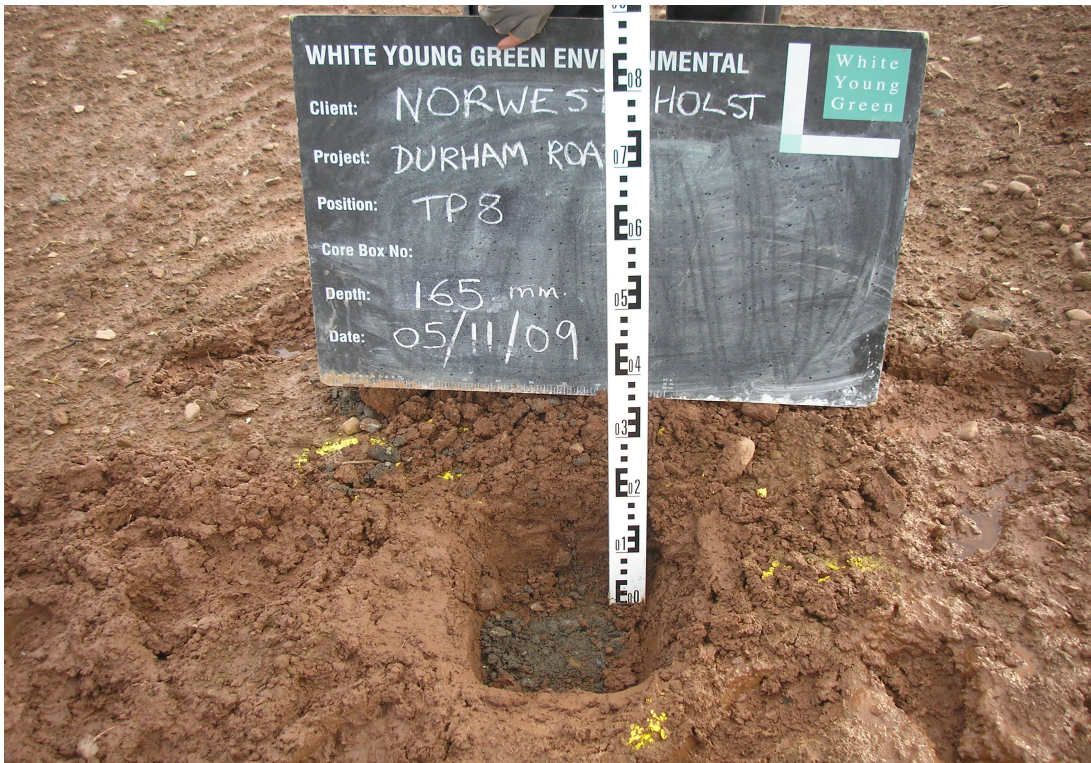
Excavation of TP8 through topsoil layer

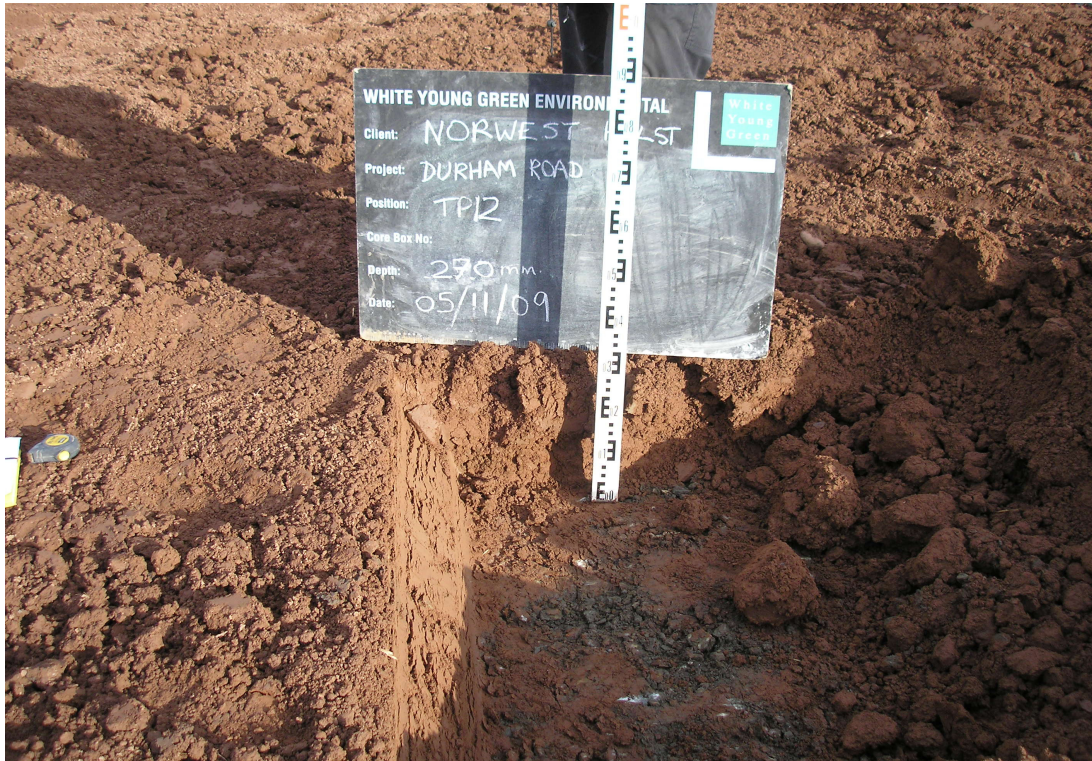
Excavation of TP12 through topsoil layer
