# **Bassaleg Bridge**

Water Framework Directive (WFD) Impact  
Assessment

September 2025

**Document reference:** 100119581-MMD-XX-XX-RP-GM-0002

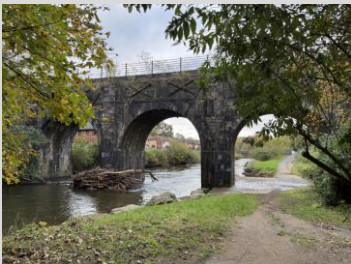
| Feature ID | Feature type | NGR | Description and ecological significance | Photograph |
|---|---|---|---|---|
| 1 | Modification | ST 27800 87223 | Downstream view of River Ebbw. Large arched bridge present with supports in-channel, reinforced banks, and concrete on the bed below the bridge. Modification may locally reduce habitat availability for aquatic communities. | |

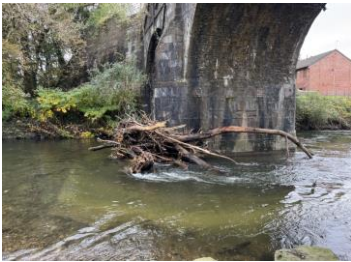
| Feature ID | Feature type | NGR | Description and ecological significance | Photograph |
|---|---|---|---|---|
| 2 | Habitat feature | ST 27806 87207 | Woody debris noted within the channel. Where woody debris is present in-channel this may create flow diversity that supports fish community diversity. | |

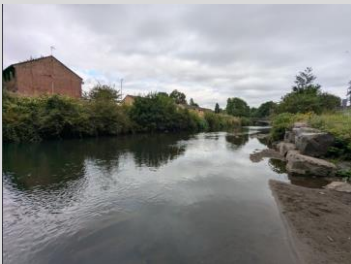
| Feature ID | Feature type | NGR | Description and ecological significance | Photograph |
|---|---|---|---|---|
| 3 | General character | ST 27807 87194 | The substrate was observed to be a mixture of sand and silt with some pebble and cobble. The flow type was mostly glide.<br><br>Riparian vegetation includes grassland and scrub on both banks.<br><br>The invasive species Japanese knotweed ( <i>Fallopia japonica</i> ) and Himalayan balsam ( <i>Impatiens glandulifera</i> ) were noted. | |

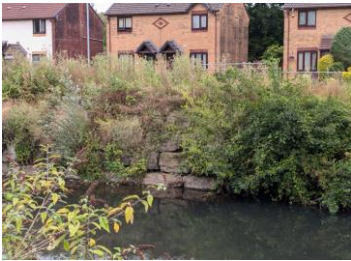
| Feature ID | Feature type | NGR | Description and ecological significance | Photograph |
|---|---|---|---|---|
| 4 | Modification | ST 27813 87117 | Modified stone banks noted on both eastern and western extent of the channel. Overhanging vegetation was present, which may provide cover for fish. | |

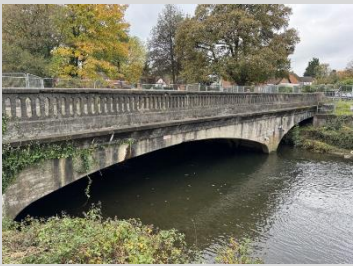
| Feature ID | Feature type | NGR | Description and ecological significance | Photograph |
|---|---|---|---|---|
| 5 | Modification | ST 27857 87057 | Large arched bridge was present over the channel, with reinforced banks that constrict flow. This likely creates a flow increase that affects habitat diversity in this area. | |

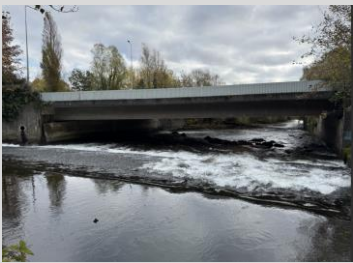
| Feature ID | Feature type | NGR | Description and ecological significance | Photograph |
|---|---|---|---|---|
| 7 | Modification | ST 27854 86993 | Large concrete weir with fast flows. Both banks reinforced with concrete. The weir may restrict fish passage upstream.<br><br>Outfall pipe noted on the eastern bank which may be a potential source of pollution/runoff into the channel. | |

Bank/bed protection is visible along the river reaches assessed, including rip-rap, walls, and concrete beds. There is also a historic weir immediately downstream of the bridge, that looks to be in poor condition.

The historic weir acts as a grade control reducing bed gradient upstream. This causes some upstream impoundment but also reduces stream energy and helps to moderate scour and erosion through the bridge, mitigating some of the impacts of the confinement and straightening. However, the extensive bed/bank protection and reduced longitudinal connectivity may be limiting sediment supply and risks of sediment starvation and channel incision are particularly heightened near the bridge proposed under the Scheme.

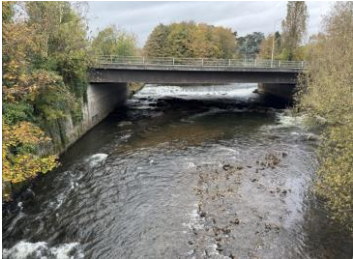
| Feature ID | Feature type | NGR | Description and ecological significance | Photograph |
|---|---|---|---|---|
| 8 | Modification | ST 27933 86965 | Large bridge was present with reinforced banks constricting flow. Banks approximately 6m high. The substrate was observed to be cobble with occasional larger boulders. | |

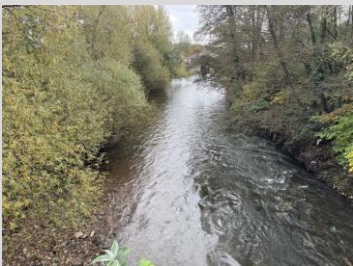
| Feature ID | Feature type | NGR | Description and ecological significance | Photograph |
|---|---|---|---|---|
| 9 | General character | ST 27946 86961 | Channel was wider and substrate was predominantly cobble and pebble with some boulders. Overhanging vegetation was present along the banksides. Substrate diversity may support spawning fish. | |

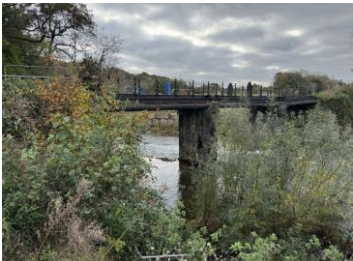
| Feature ID | Feature type | NGR | Description and ecological significance | Photograph |
|---|---|---|---|---|
| 10 | Modification | ST 28390 86670 | Bridge with pipe running adjacent. In-river bridge supports present which may affect flow types and habitats present. | |

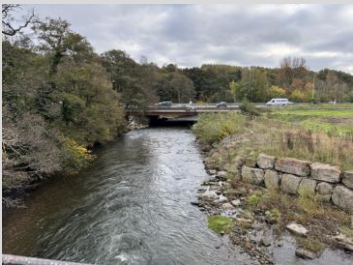
| Feature ID | Feature type | NGR | Description and ecological significance | Photograph |
|---|---|---|---|---|
| 11 | General character | ST 28435 86634 | Modified stone banks on the western bank. Cobble and pebble substrate was observed, with some boulders present. Habitats include riffle, runs, glides and pools. Flow diversity likely provides suitable fish habitat. Motorway bridge present downstream. | |

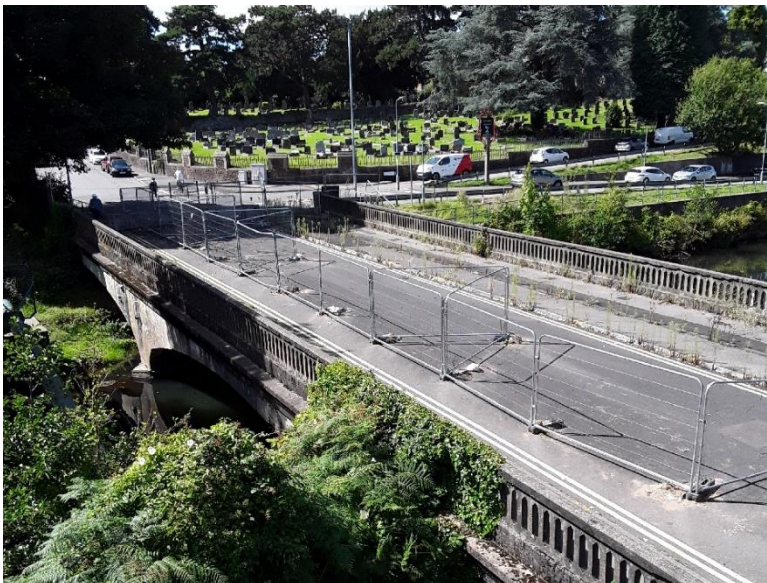
**Figure 1.1: Image of the old Bassaleg Bridge.**

The old Bassaleg Bridge, as seen in Figure 1.1, is located on the River Ebbw at OS Grid Reference ST278870, off Caerphilly Road (Figure 1.2). The proposed bridge is located immediately upstream at ST278870.

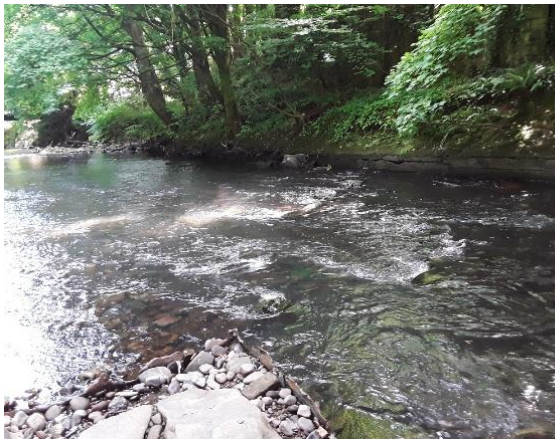
**Figure A.1: Downstream facing view of Reach 1**

Reach 1 can be characterised as a medium gradient of  $\sim 0.0035$  based on LiDAR data<sup>3</sup> and confined by steep banks (Figure A.1). The river typology is currently passively meandering. Flow diversity was high with various glide, riffle, and pool sections, showing an overall pool-riffle type morphology (Figure A.2). Flow generally appears to have relatively high energy, compared to downstream reaches. The channel cross-section varies, average bankfull width is  $\sim 20\text{m}$ , wetted width  $\sim 15\text{m}$ , bankfull depth  $\sim 3\text{m}$ , and wetted depth is  $\sim 0.2\text{m}$ .

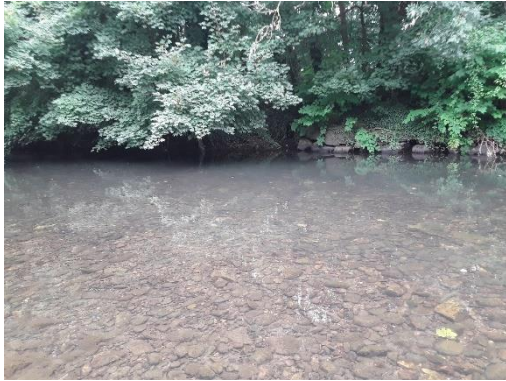
**Figure A.3: View of Reach 1 substrate at downstream extent.**

Bankfull depth was 1.5-2m, and the river appeared somewhat incised and disconnected from the floodplain. The bed substrate was mostly cobble-sized (Figure A.3). Bank material was variable, comprising a mixture of cobble, gravel, sand and silt (Figure A.4). Fluvial bank erosion was visible on the outside bends of meanders, with bare earth and exposed tree roots. Banks were undercut, indicating erosion through hydraulic action. Full bank erosion and lateral migration have been largely prevented by the presence of rock revetments. Banks were predominantly vegetated, with dense coverage of deciduous woodland and scrub on both sides.

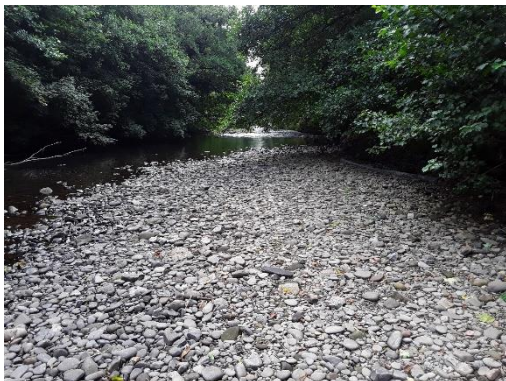
**Figure A.5: Downstream view of large bar on right bank.**

Depositional features included a series of unvegetated lateral bars as seen in Figure A.5 and Figure A.6. These mostly occurred on the inside bends of meanders and comprised gravel-pebble to cobble-sized clasts.

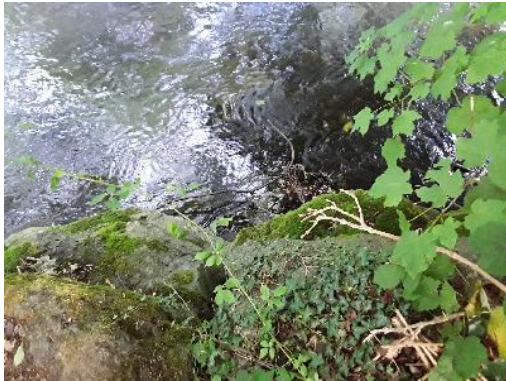
**Figure A.7: View of right bank vegetation.**

Riparian vegetation was dominated by scrubs and deciduous woodland, with many overhanging trees (Figure A.7 and Figure A.8). No 'in-channel' aquatic vegetation was observed.

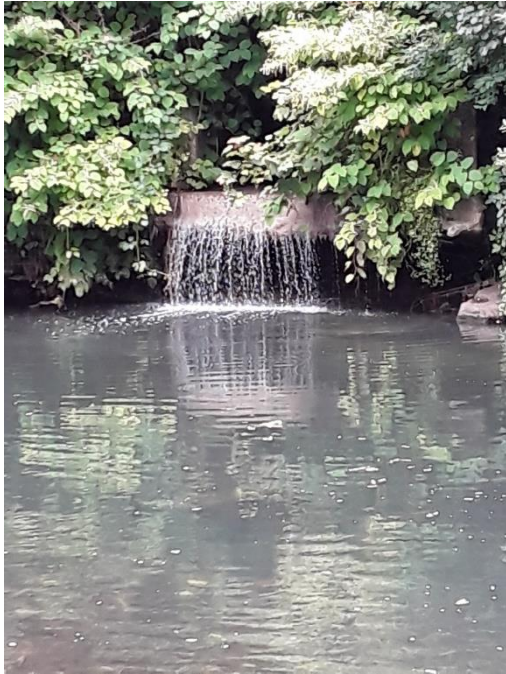
**Figure A.9: View of perched outfall indicating channel degradation.**

Physical modification along Reach 1 included two crossings, various outfalls, and bed/bank protection. A pedestrian footbridge (Figure A.10) is located at the upstream extent and a historic railway viaduct is observed at the downstream extent of the reach. The remains of an old, deconstructed bridge were also visible. Outfalls along the reach were likely road drainage, although this could not be confirmed. A perched outfall is shown in Figure A.9, which may indicate historic incision of the channel. Bank protection and artificial stabilisation was extensive along the reach, comprising mostly of rock revetment and gabion baskets, some of which had failed (e.g. Figure A.11). Bed protection was observed at the railway viaduct comprising concrete (Figure A.12).

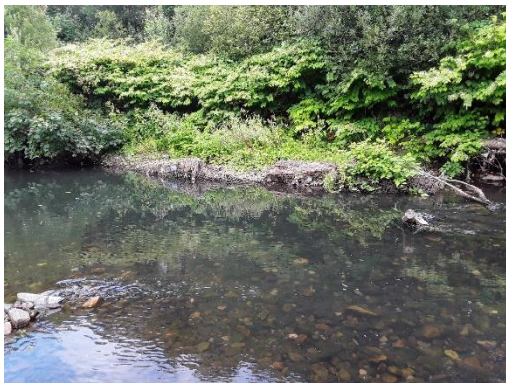
**Figure A.11: View of failed gabion baskets on left bank.**

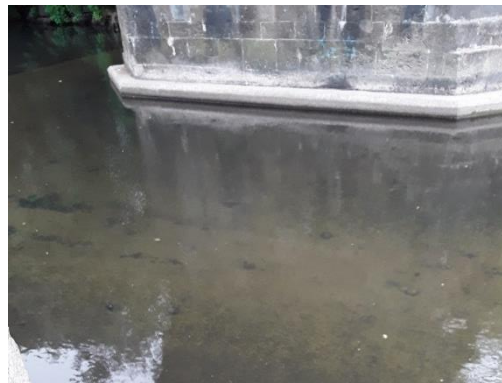
**Figure A.12: View of concreted river bed below railway bridge.**

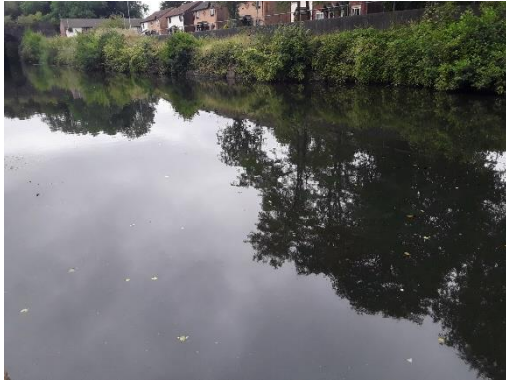
**Figure A.13: Upstream facing view of Reach 2.**

Reach 2 had a relatively low-gradient, with water levels controlled by a weir at the downstream extent (Figure A.13). The channel was over-deep (Figure A.14) and lacked natural flow diversity. The planform appeared artificially straight. Flow was mostly relatively slow and dominated by glides. The channel has a bankfull width of ~20m, a wetted width of ~17m, a bankfull depth of 4m and a wetted depth of 1.5m.

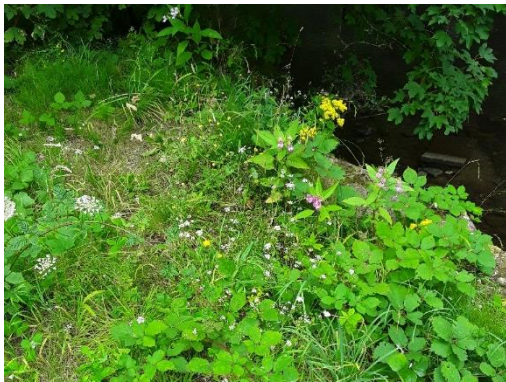
**Figure A.17: View of right bank vegetation, including Himalayan Balsam.**

Riparian vegetation comprised improved grassland and scrub on both banks with sparse tree cover. No in-channel vegetation was visible. Invasive species were prevalent along both banks (Figure A.17 and Figure A.18).

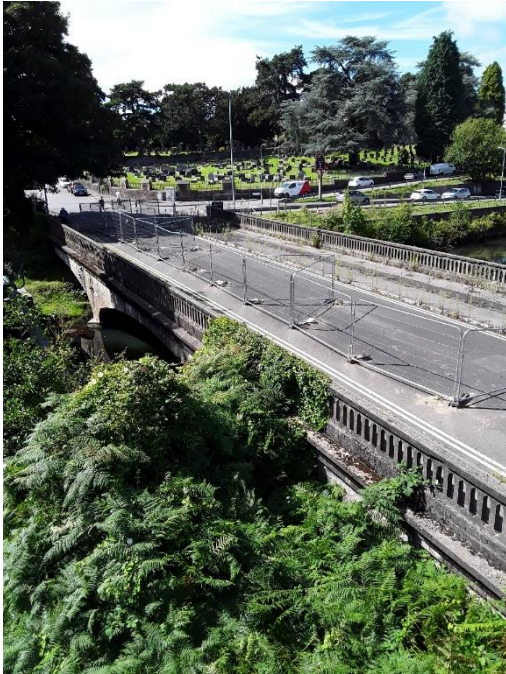
**Figure A.19: View of the existing Bassaleg Bridge.**

This reach is constrained by many physical modifications, including bank protection, outfalls, bridges, and the impoundment caused by a downstream weir (Figure A.20). Natural flow diversity has been significantly reduced by the occurrence of the weir which has artificially raised the river level, causing upstream impoundment. One outfall was observed, presumably related to road drainage. The old Bassaleg Bridge shades the channel, with the right bank pier appearing to have undergone scour (Figure A.19; Figure A.21). Bank protection and stabilisation is extensive, and the river is confined by riprap and concrete walls which line both banks (Figure A.22).

The aperture of the new bridge is larger than the existing bridge, and no abutment extend into the river itself. This represents an improvement over the existing bridge layout which does have abutments intruding into the banks, and is the most open span design possible under the site constraints. Compared to the baseline conditions, the river will be less constricted, particularly during flood events.

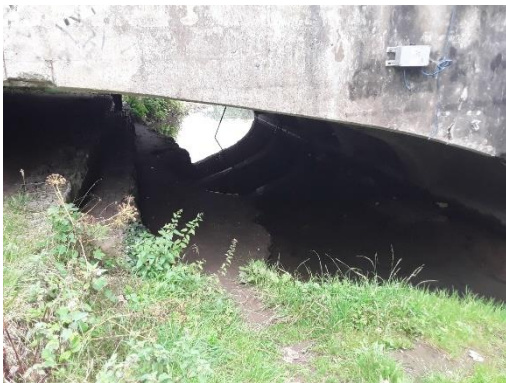
**Figure A.21: View of gabion baskets beneath Bassaleg Bridge.**

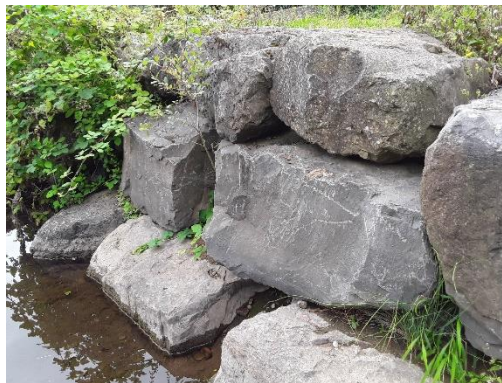
**Figure A.22: View of blockstone reinforcing both banks**

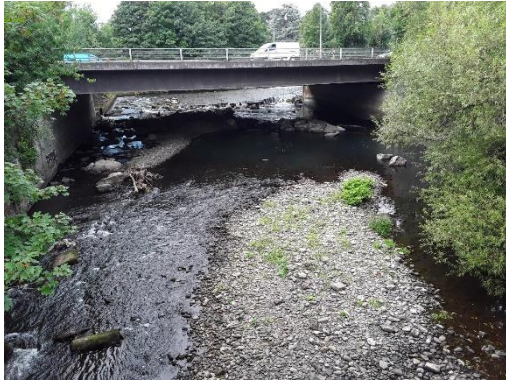
**Figure A.23: Upstream facing view of Reach 3.**

Reach 3 begins at the weir where there is an artificial cascade which drops the bed level by about 1.5m. This passes into a moderate gradient section with high flow diversity (Figure A.23). The planform is straight and confined by walls, but a range of flow types were recorded including riffles, runs, and pools (Figure A.24). Due to the high walls forming the bank, bankfull depth was ~6m compared to the 0.5m wetted depth.

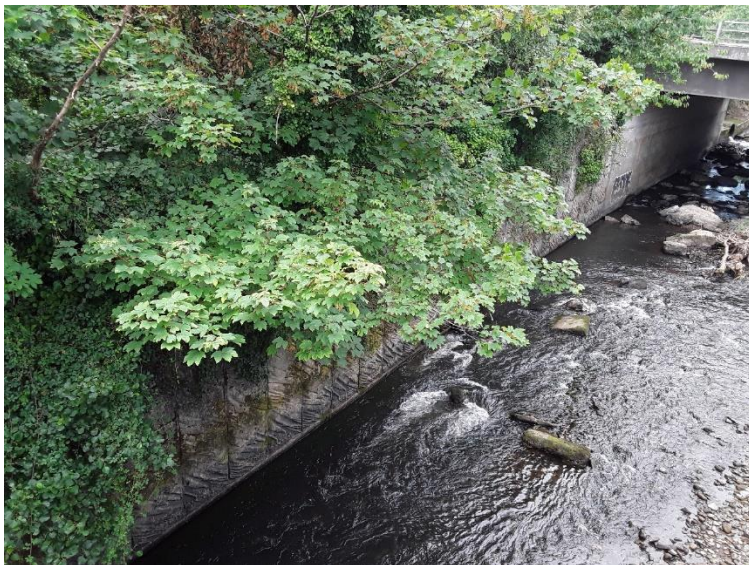
**Figure A.25: View of Reach 3 concrete banks and substrate.**

Reach 3 was entirely disconnected from the floodplain by the ~6m high artificial concrete banks that line both banks (Figure A.25). Given the artificial nature of these banks, there were no signs of bank erosion, and the river was entirely constrained. The substrate was mostly composed of cobbles, with some larger boulders.

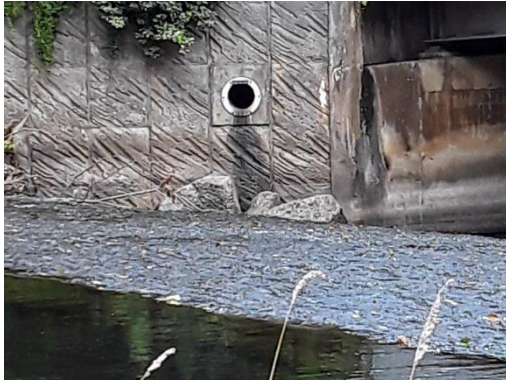
**Figure A.28: View of drainage outfall near the weir.**

Anthropogenic features included the weir, which has the effect of impounding flow upstream, and adding a flow diversity downstream (Figure A.28; Figure A.30). The weir appeared to be in a poor state of repair, partly undermined at the toe (Figure A.29). Other modification included the concrete embankments, which confine flow to the channel, and a large motorway bridge which shades the channel (Figure A.31). A road drainage outfall (Figure A.28) was also observed.

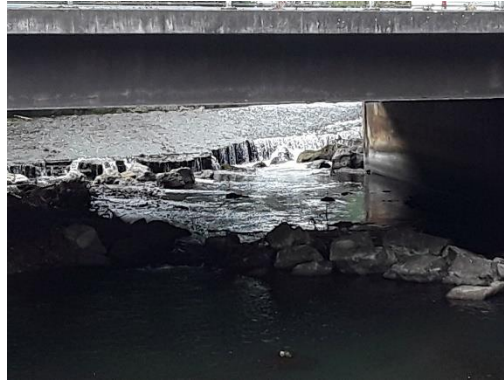
**Figure A.29: Upstream view of weir, including apparent erosion damage.**

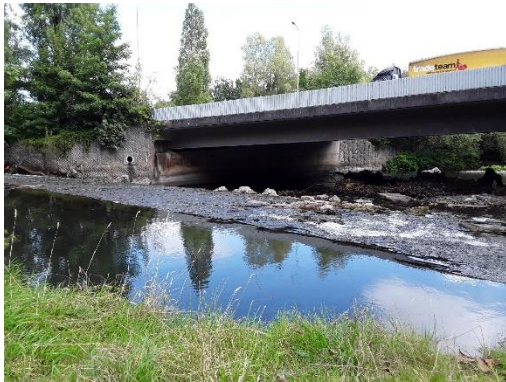
**Figure A.30: Downstream view of weir.**

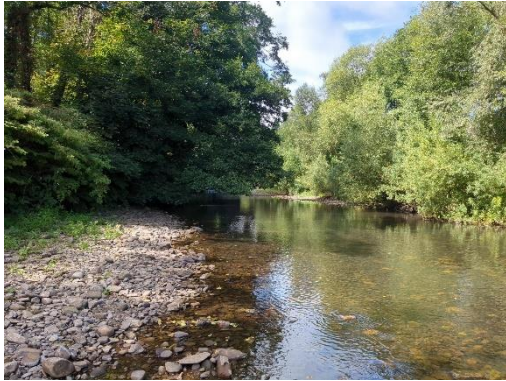
**Figure A.32: Upstream facing view from upstream end of Reach 4.**

Reach 4 is characterised by a wider channel with relatively high flow diversity, moderate gradient, and a return to a more sinuous planform (Figure A.32). Geomorphological features were more natural and pool riffle sequences were observed. These provide flow diversity, including runs, glides and riffles and pools (Figure A.33). Flow appeared to be relatively energy in places but at the time of survey, turbidity appeared to be low. Bankfull width is notably wider at c.34m. The wetted channel width is c.15m, bankfull depth c.1m, and wetted depth c.0.3m.

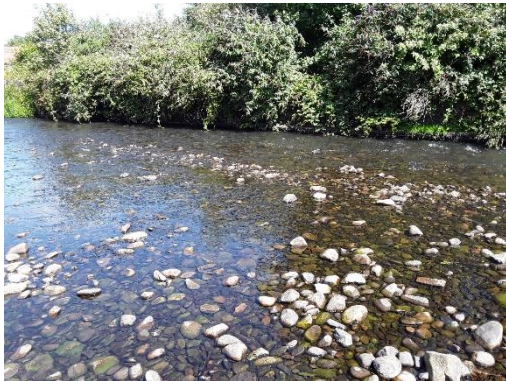
**Figure A.34: View of Reach 4 substrate midway through reach.**

Reach 4 appeared connected to its floodplain on the right bank, which is not substantially raised above the water level. The left bank is comparatively disconnected due to the presence of rip-rap and gabion baskets protecting a housing estate (Figure A.34). Active fluvial bank erosion was observed on the right bank on the outside bend of a meander (Figure A.35). Substrate was mostly composed of cobble-sized clasts.

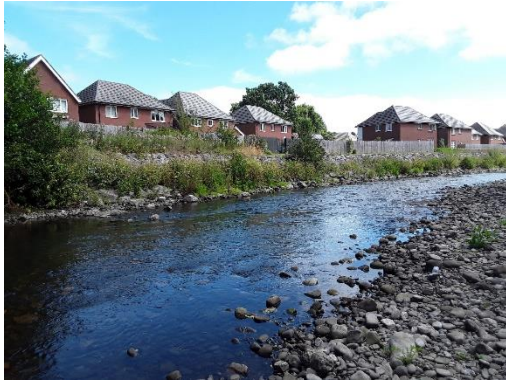
**Figure A.36: Downstream view of large bar on right bank.**

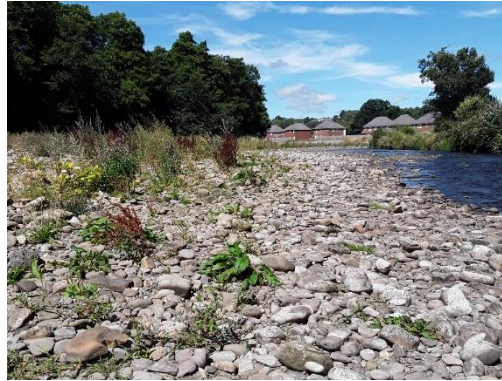
**Figure A.37: Closer view of bar strata and vegetation.**

Depositional features included a large lateral bar occurring on the right bank (Figure A.36). This joins up with a confluence bar downstream, marking the confluence of a small tributary. Bars were partially vegetated with small plants (Figure A.37).

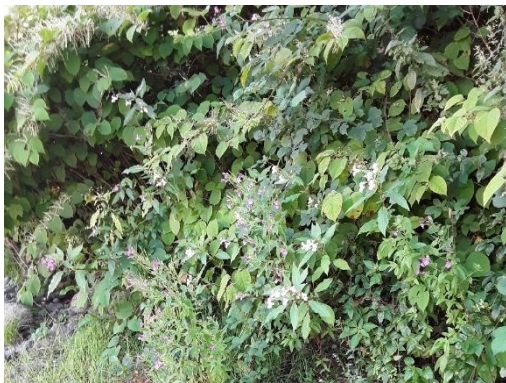
**Figure A.38: View of right bank vegetation, including Himalayan balsam and Japanese knotweed.**

Riparian vegetation mostly comprised scrub, with deciduous woodland lining the right bank, which extends into a large woodland area. Notably, this area had a very large amount of Himalayan balsam near the banks, as well as on the floodplain (Figure A.39). Japanese knotweed was also visible on the right bank (Figure A.38). No in-channel vegetation was visible.
