# **Bassaleg Bridge Optioneering and Design**

Geomorphology Report

August 2025

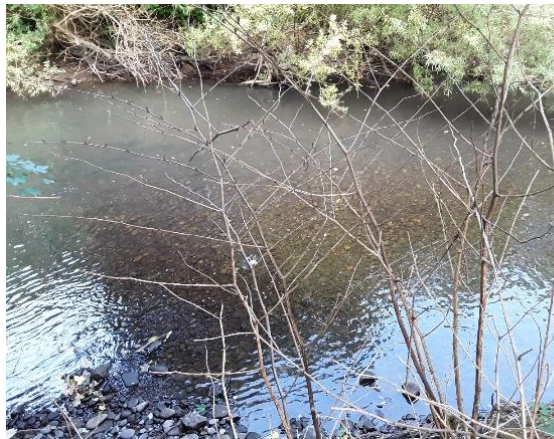
Reach 1 can be characterised as a medium gradient of  $\sim 0.0035$  based on LiDAR data<sup>3</sup> and confined by steep banks (Figure A.1). The river typology is currently passively meandering. Flow diversity was high with various glide, riffle, and pool sections, showing an overall pool-riffle type morphology (Figure A.2). Flow generally appears to have relatively high energy, compared to downstream reaches. The channel cross-section varies, average bankfull width is  $\sim 20\text{m}$ , wetted width  $\sim 15\text{m}$ , bankfull depth  $\sim 3\text{m}$ , and wetted depth is  $\sim 0.2\text{m}$ .

**Figure A.1: Downstream facing view of Reach 1**

**Figure A.2: Side view of upstream end of Reach 1**

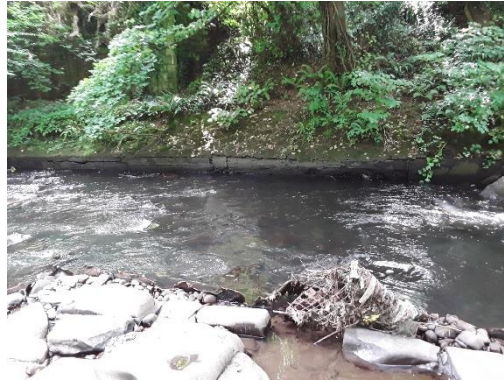
Bankfull depth was 1.5-2m, and the river appeared somewhat incised and disconnected from the floodplain. The bed substrate was mostly cobble-sized (Figure A.3). Bank material was variable, comprising a mixture of cobble, gravel, sand and silt (Figure A.4). Fluvial bank erosion was visible on the outside bends of meanders, with bare earth and exposed tree roots. Banks were undercut, indicating erosion through hydraulic action. Full bank erosion and lateral migration have been largely prevented by the presence of rock revetments. Banks were predominantly vegetated, with dense coverage of deciduous woodland and scrub on both sides.

**Figure A.3: View of Reach 1 substrate at downstream extent.**

**Figure A.4: View of bank and substrate towards upstream end of Reach 1.**

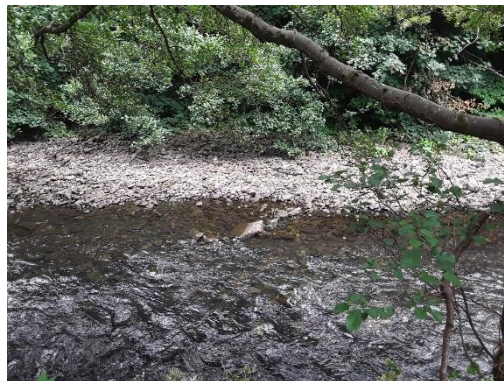
Depositional features included a series of unvegetated lateral bars as seen in Figure A.5 and Figure A.6. These mostly occurred on the inside bends of meanders and comprised gravel-pebble to cobble-sized clasts.

**Figure A.5: Downstream view of large bar on right bank.**

**Figure A.6: Example of a smaller bar on left bank.**

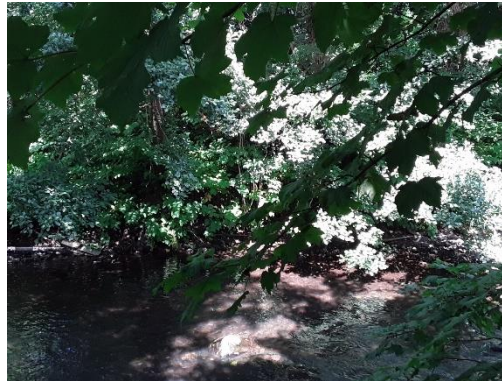
Riparian vegetation was dominated by scrubs and deciduous woodland, with many overhanging trees (Figure A.7 and Figure A.8). No 'in-channel' aquatic vegetation was observed.

Invasive species included Japanese Knotweed which predominantly populated the left bank and Himalayan Balsam which was observed on both banks.

**Figure A.7: View of right bank vegetation.**

**Figure A.8: View of left bank vegetation.**

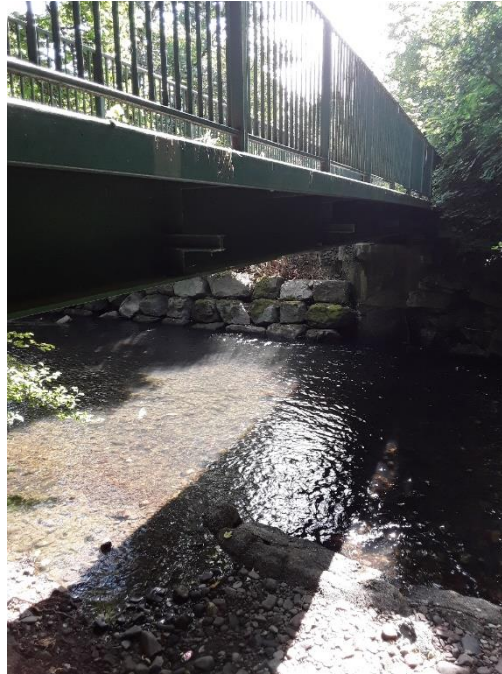
**Figure A.10: View of footbridge at the upstream extent.**

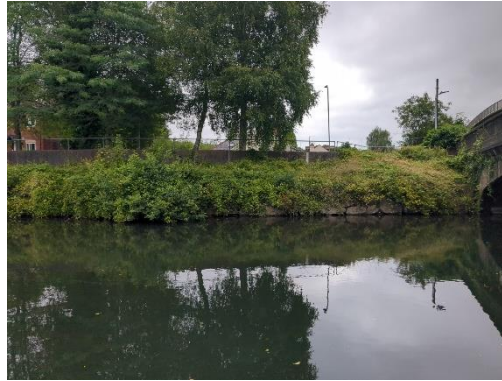
Reach 2 had a relatively low-gradient, with water levels controlled by a weir at the downstream extent (Figure A.13). The channel was over-deep (Figure A.14) and lacked natural flow diversity. The planform appeared artificially straight. Flow was mostly relatively slow and dominated by glides. The channel has a bankfull width of ~20m, a wetted width of ~17m, a bankfull depth of 4m and a wetted depth of 1.5m.

**Figure A.13: Upstream facing view of Reach 2.**

**Figure A.14: Downstream facing view from upstream end of Reach 2.**

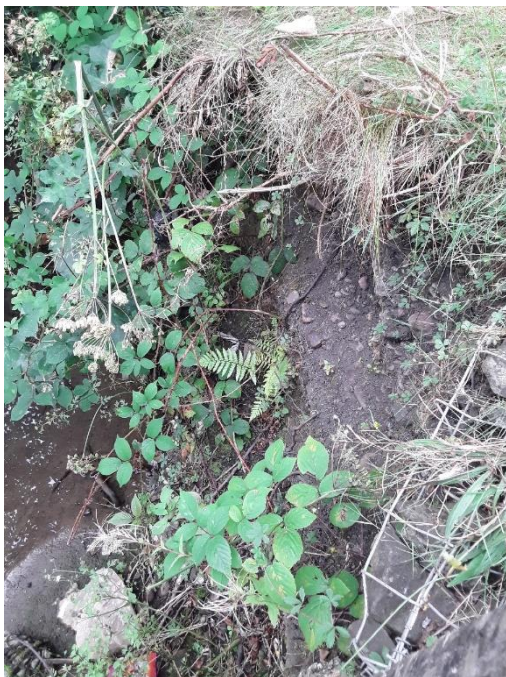
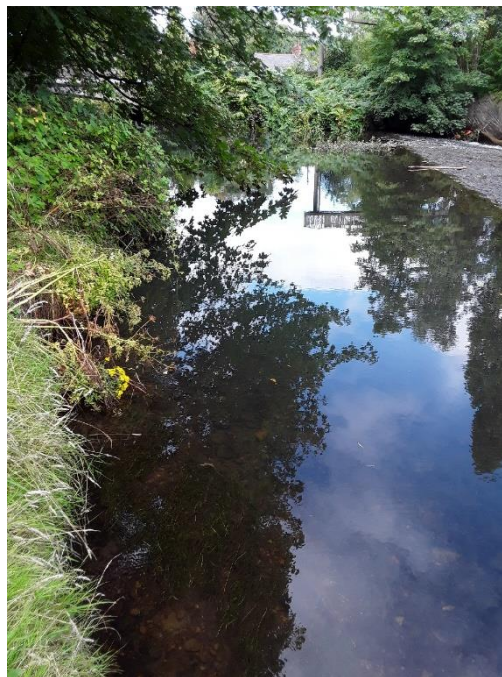
Banks were relatively high (bankfull height of ~4m) and as such the river is notably disconnected from the surrounding floodplain, which has been developed for housing. Banks were composed of a composite mixture of silt, sand, gravel and cobble (Figure A.15). There were less visible instances of erosion on this reach compared to others, largely due to the extensive bank protection and impounded flow. The notable exception to this is at the old bridge where the right bank had experienced visible scour undercutting the right pier and undercutting near a footpath at the upstream end. Substrate was less visible, with cobble and gravel where visible (Figure A.16).

**Figure A.15: View of Reach 2 bank materials near eroded area.**

**Figure A.16: View of substrate at downstream end of Reach 2.**

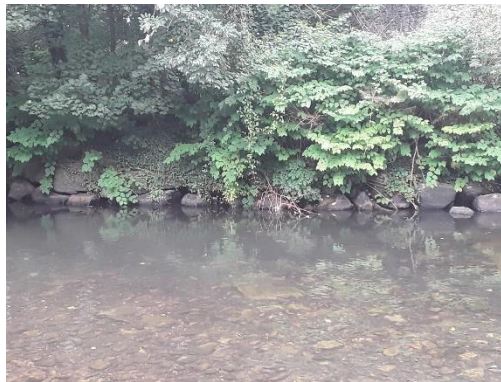
Riparian vegetation comprised improved grassland and scrub on both banks with sparse tree cover. No in-channel vegetation was visible. Invasive species were prevalent along both banks (Figure A.17 and Figure A.18).

**Figure A.17: View of right bank vegetation, including Himalayan Balsam.**

**Figure A.18: View of left bank vegetation, including Japanese Knotweed.**

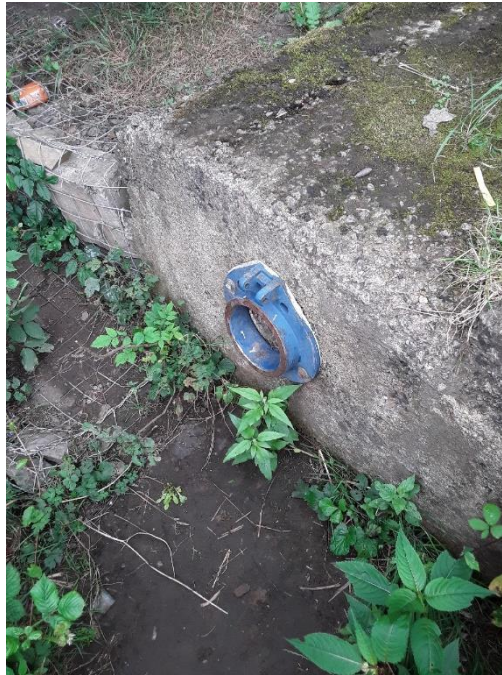
This reach is constrained by many physical modifications, including bank protection, outfalls, bridges, and the impoundment caused by a downstream weir (Figure A.20). Natural flow diversity has been significantly reduced by the occurrence of the weir which has artificially raised the river level, causing upstream impoundment. One outfall was observed, presumably related to road drainage. The old Bassaleg Bridge shades the channel, with the right bank pier appearing to have undergone scour (Figure A.19; Figure A.21). Bank protection and stabilisation is extensive, and the river is confined by riprap and concrete walls which line both banks (Figure A.22).

**Figure A.20: View of drainage outfall.**

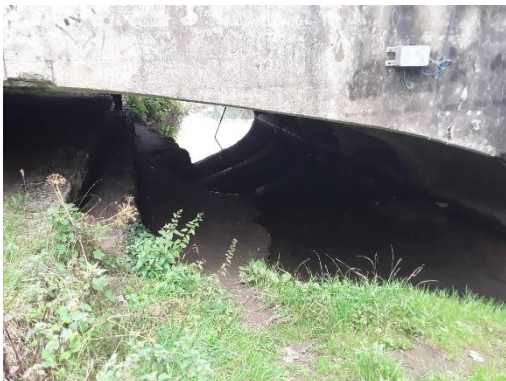
**Figure A.21: View of gabion baskets beneath Bassaleg Bridge.**

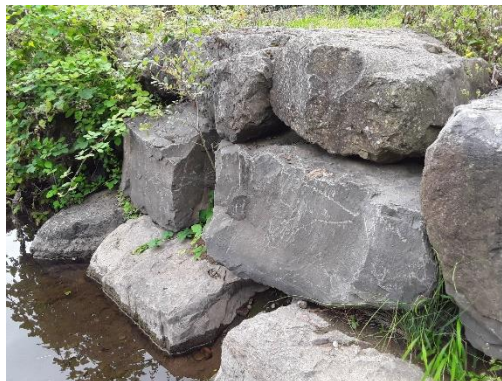
**Figure A.22: View of blockstone reinforcing both banks**

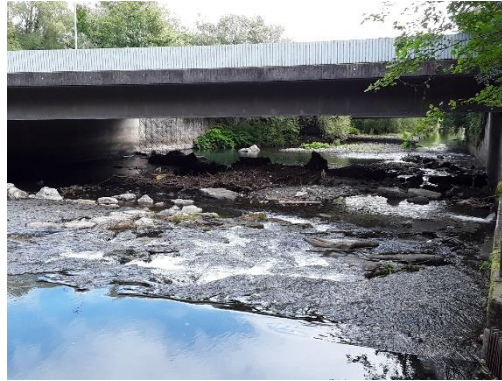
Reach 3 begins at the weir where there is an artificial cascade which drops the bed level by about 1.5m. This passes into a moderate gradient section with high flow diversity (Figure A.23). The planform is straight and confined by walls, but a range of flow types were recorded including riffles, runs, and pools (Figure A.24). Due to the high walls forming the bank, bankfull depth was ~6m compared to the 0.5m wetted depth.

**Figure A.23: Upstream facing view of Reach 3.**

**Figure A.24: Downstream facing view from upstream end of Reach 3.**

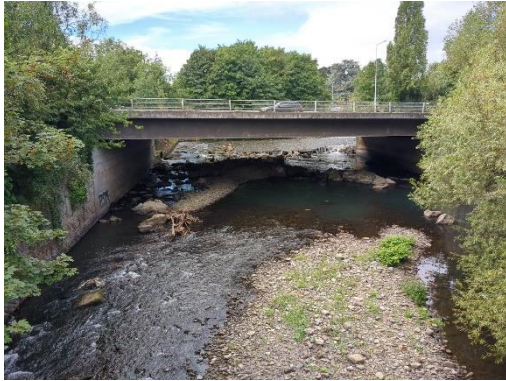
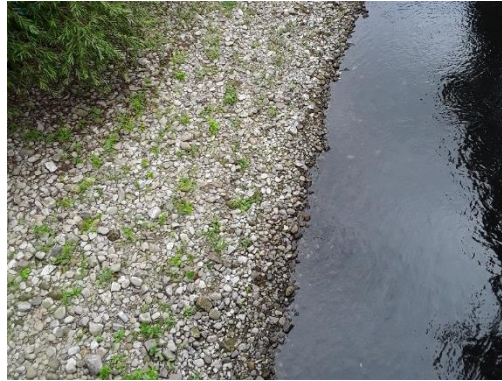
Depositional features included a lateral bar and two mid-channel bars (Figure A.26; Figure A.27). These were partially vegetated and created flow diversity within the channel, forming regions of pools and riffles.

**Figure A.26: Upstream view showing both mid-channel bars.**

**Figure A.27: Example of a smaller bar on left bank.**

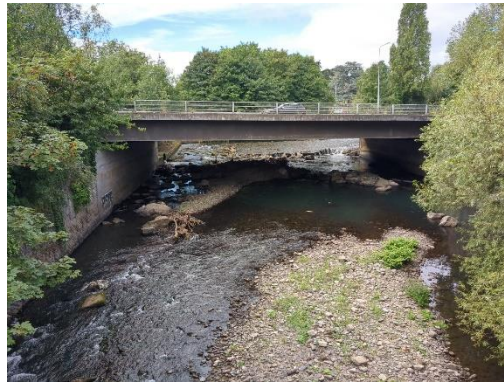
**Figure A.31: View of motorway bridge.**

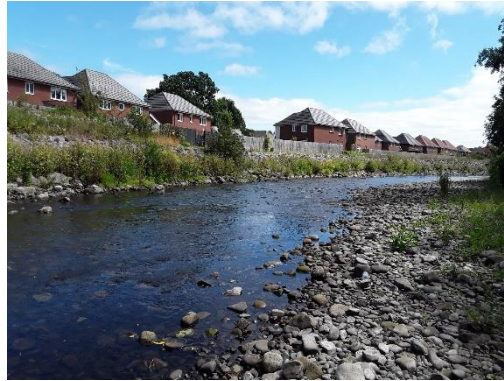
Reach 4 is characterised by a wider channel with relatively high flow diversity, moderate gradient, and a return to a more sinuous planform (Figure A.32). Geomorphological features were more natural and pool riffle sequences were observed. These provide flow diversity, including runs, glides and riffles and pools (Figure A.33). Flow appeared to be relatively energy in places but at the time of survey, turbidity appeared to be low. Bankfull width is notably wider at c.34m. The wetted channel width is c.15m, bankfull depth c.1m, and wetted depth c.0.3m.

**Figure A.32: Upstream facing view from upstream end of Reach 4.**

**Figure A.33: Downstream facing view from downstream stream end of Reach 2.**

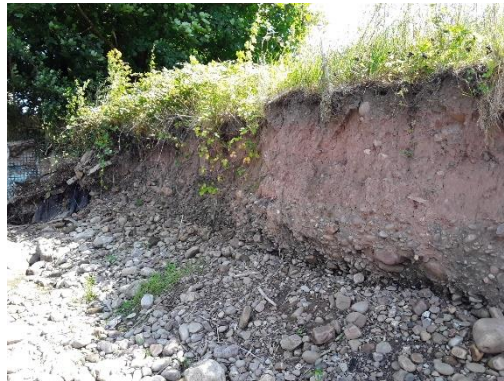
Reach 4 appeared connected to its floodplain on the right bank, which is not substantially raised above the water level. The left bank is comparatively disconnected due to the presence of rip-rap and gabion baskets protecting a housing estate (Figure A.34). Active fluvial bank erosion was observed on the right bank on the outside bend of a meander (Figure A.35). Substrate was mostly composed of cobble-sized clasts.

**Figure A.35: Example of eroded bank at unprotected downstream area of Reach 4.**

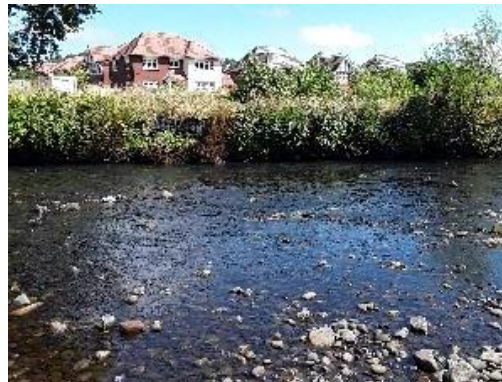
Riparian vegetation mostly comprised scrub, with deciduous woodland lining the right bank, which extends into a large woodland area. Notably, this area had a very large amount of Himalayan balsam near the banks, as well as on the floodplain (Figure A.39). Japanese knotweed was also visible on the right bank (Figure A.38). No in-channel vegetation was visible.

**Figure A.38: View of right bank vegetation, including Himalayan balsam and Japanese knotweed.**

**Figure A.39: View of left bank vegetation.**

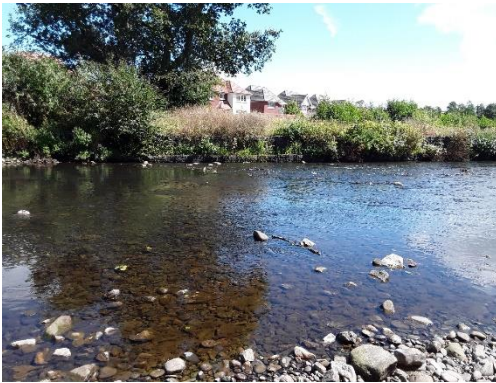
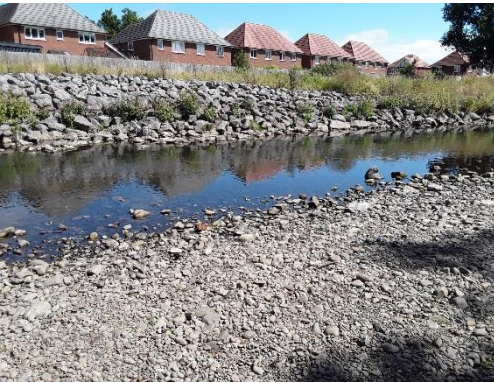
The main modification on Reach 4 was the bank protection lining much of the left bank (Figure A.40; Figure A.41). This included rip-rap along the housing estate itself, and gabion baskets along the less populated section of the reach.

**Figure A.40: View of gabion baskets further downstream on left bank.**

**Figure A.41: View of rip-rap on left bank.**
