2401-05/ELM

## ST WOOLOS CATHEDRAL, NEWPORT: FALL PROTECTION TO NORTH GULLY

### DESIGN & ACCESS STATEMENT:

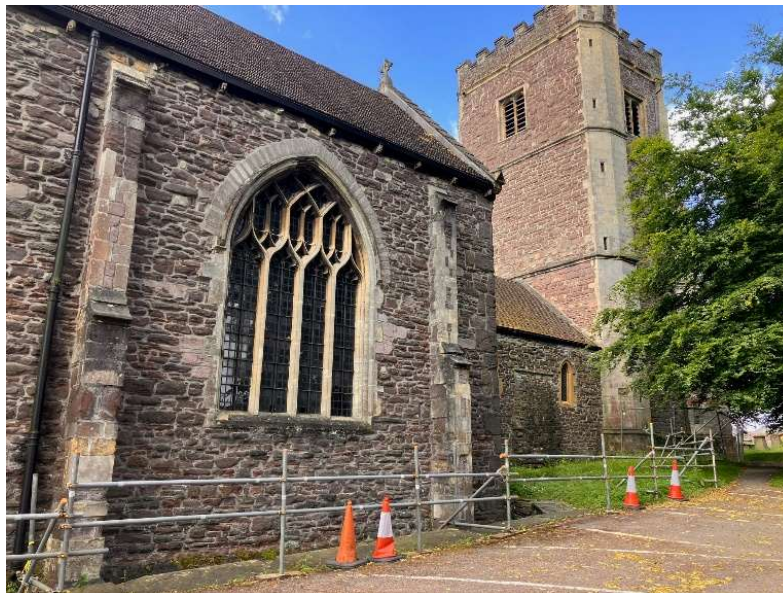
*North side of North Aisle and Galilee Chapel with temporary cordons.*

- 3.1.4 There was an unfortunate incident of public injury in December 2023, when someone fell into the drainage channel on the north side of the North Aisle during darkness, when visiting the Cathedral for an event. Temporary cordons were immediately put in place (seen in photo on previous page). They have been effective at preventing further accidents.

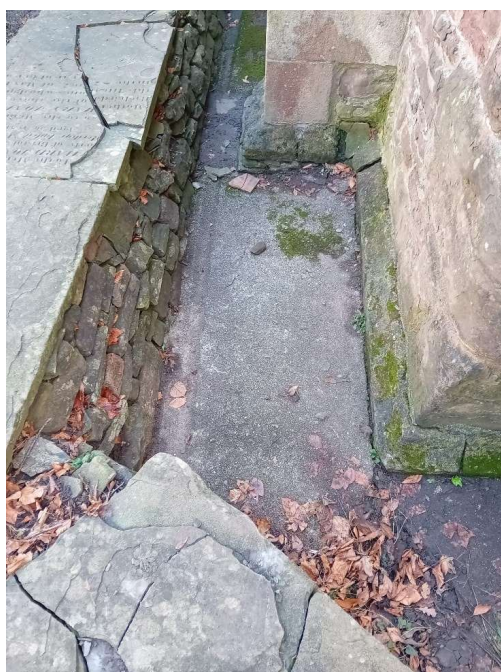
*Example of broken ledgers at edge of drainage channel and condition of retaining wall beneath.*

- 3.2.1 The proposal seeks to lift the ledger slabs along the edge of the parking area. These ledgers are very badly broken up. They are insufficiently supported by the stone retaining wall under, in places. The retaining wall is red sandstone; as seen throughout the site. However, the wall is in parlous condition and was identified as in need of repair in the quinquennial inspection

report in November 2021. The poor condition of the fabric is a contributing factor toward the health and safety risk this area poses, as the edge ledgers are unstable.

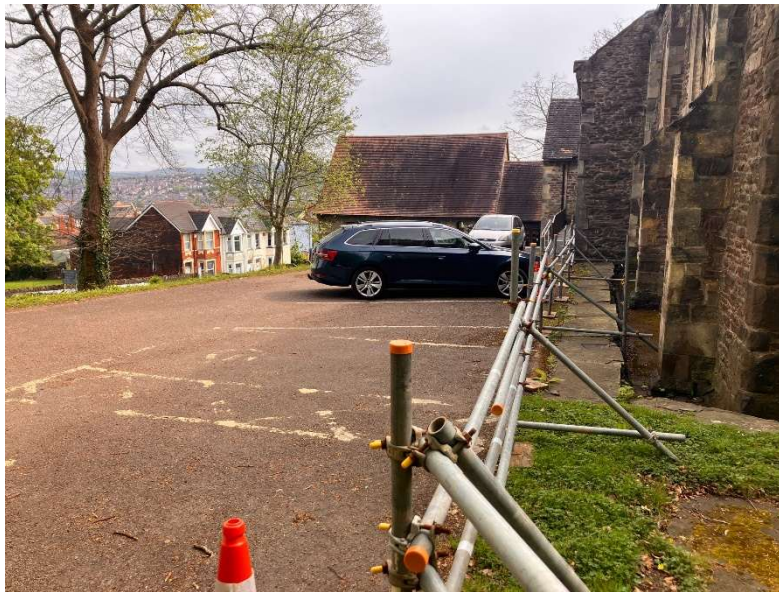
*Parking area separated from the North Aisle by sunken drainage channel, edged with ledger stones. Note the temporary fall protection currently in place.*

- 3.2.2 The proposal includes lifting all the ledger slabs and forming a new concrete slab with integral vehicular upstand, consolidating the retaining walls and all drainage grilles beneath. The ledgers will be re-set in their existing positions and metal railings of simple and slender profile, will be added to the upstand, to provide pedestrian and vehicular fall protection.

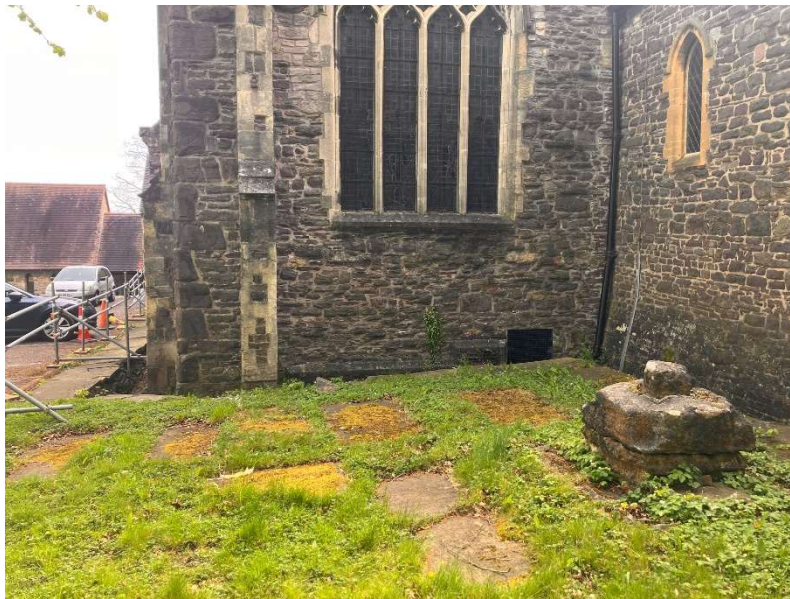
*Area of grass in front of the Galilee Chapel, with gravestones and part of a memorial statue. This area will have railings positioned around the edge of the grass, clear of the ledger stones that edge the drainage channel.*

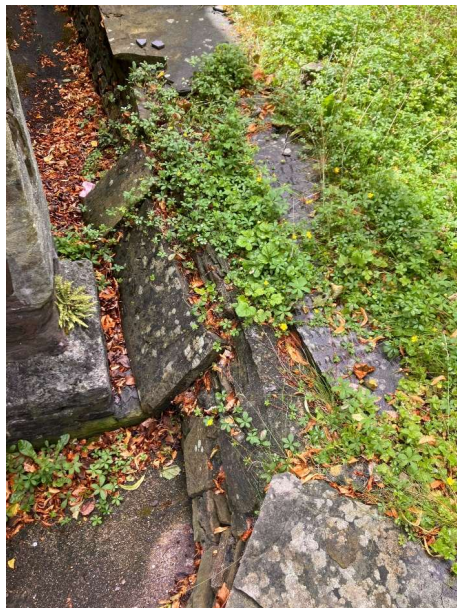
*Condition of ledgers at NW corner of North Aisle.*
