## **ECOLOGICAL INSPECTION OF 10 CLARENCE PLACE, PROPOSED FOR EXTERNAL AND INTERNAL REDEVELOPMENT.**

Ecology Wales were commissioned by Aled Jones to inspect and advise on a redundant building proposed for external and internal redevelopment at 10 Clarence Place, Newport, Grid ref: ST 31404 88461 (See plans in Appendix II below). The updated inspection was required to allow for external and internal redevelopment of the existing 4 storey building (see Appendix II). The building is constructed from bricks, with a clay tile pitched roof over bitumen felt. The windows and doors are wooden framed, the frames are well fitted to the walls, with some windows and doors covered with wooden boards. There was also a single storey extension at the rear of the building with a flat roof (See building photos in Appendix I).

As the original building inspection was undertaken on 28<sup>th</sup> June 2023, an updated inspection was undertaken on 27<sup>th</sup> August 2025, to allow re-roofing and internal redevelopment. The building inspection was undertaken by Chrispian Lee Snell BSc Hons (MCIEEM) (NRW bat licence holder S095131/1).

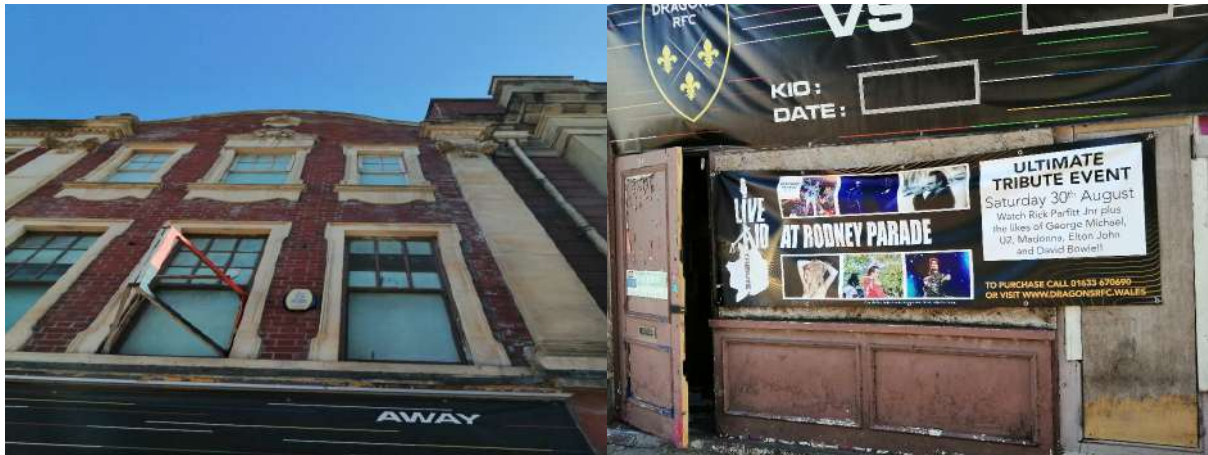
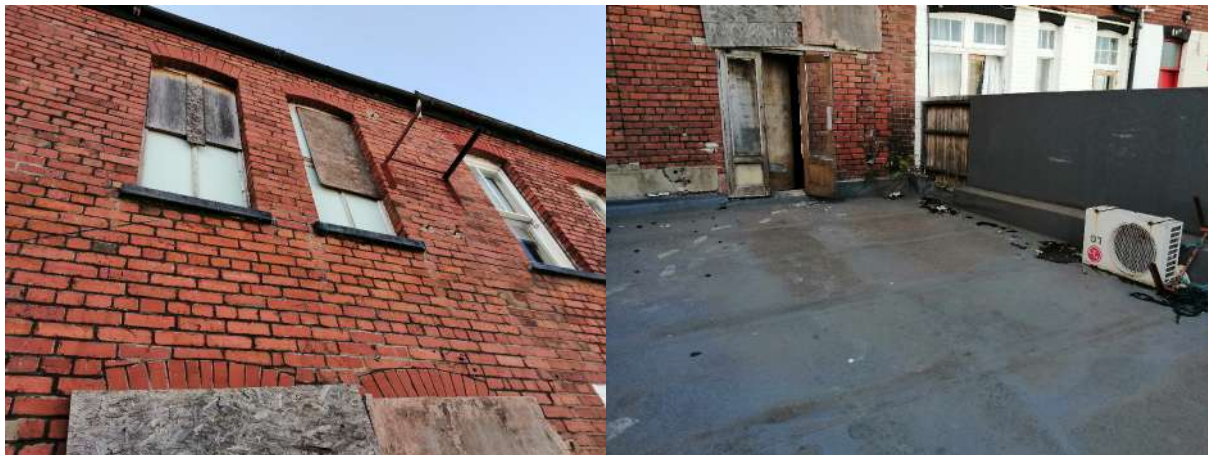
The four storey building is constructed from bricks, with a clay tile pitched roof over bitumen felt and wooden beams. The windows and doors are wooden framed, the frames are well fitted to the walls, with some windows and doors covered with wooden boards. There was also a single storey extension at the rear of the building with a flat roof. There were gaps under a few roof tiles and under boards over the window panes where bats could access the building interior or roost under boards (See building photos in Appendix I).

Front and rear elevations of building

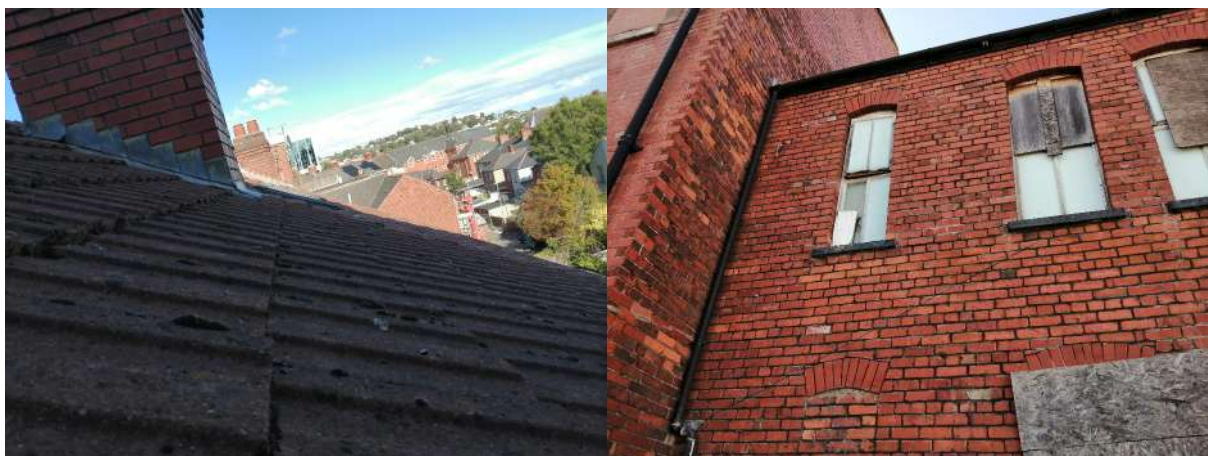
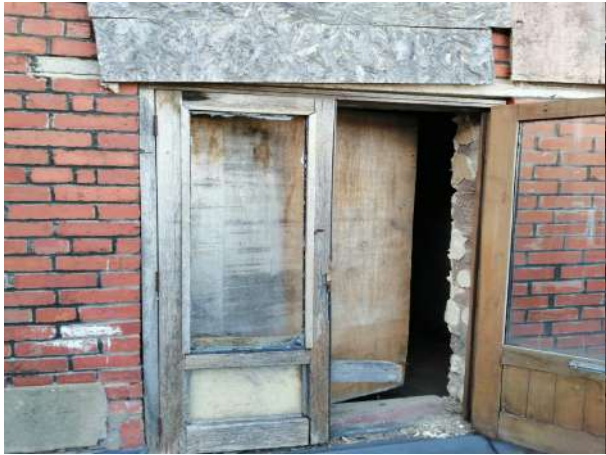
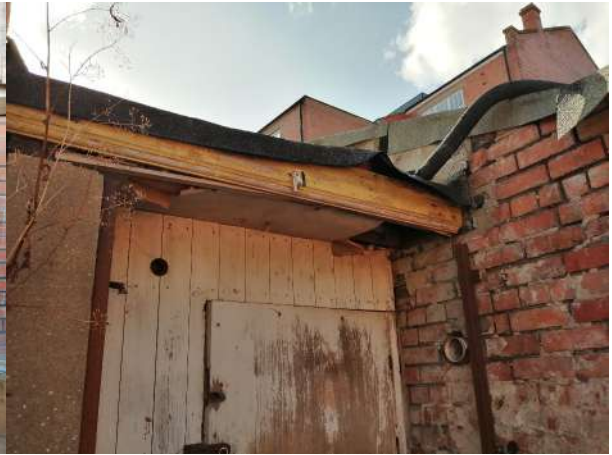
No evidence of bats or nesting birds including droppings was identified on the building exterior, although the building had some potential for roosting bats and nesting birds.

Bat roost potential features on building exterior

Due to the roof parapet at the front of the property, it would be impossible to see if any bats emerged from under the roof tiles during a bat emergence survey. As previously discussed with Matthew Harris (Newport City Council Ecology Officer) in 2023, it was agreed that a bat licenced ecologist will be present during roof tile removal and during removal of window boards. If any bats are encountered during works, works must stop and an NRW species development licence for work affecting bats will be required before works can commence.

It is also advised that a bat box such as a Beaumaris wood stone self cleaning bat box is

purchased and securely installed on the rear wall of the building, under guidance by the bat licenced ecologist during works.

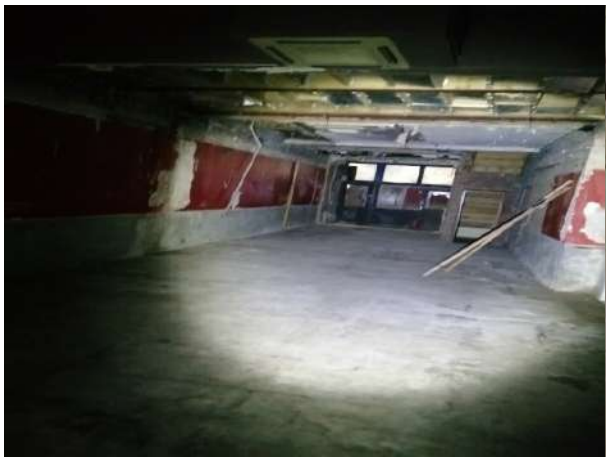
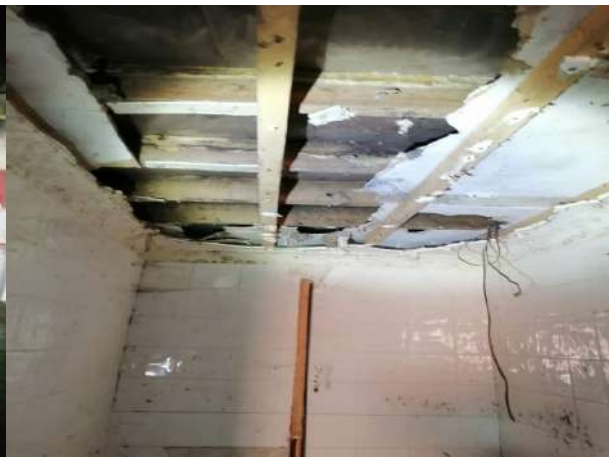
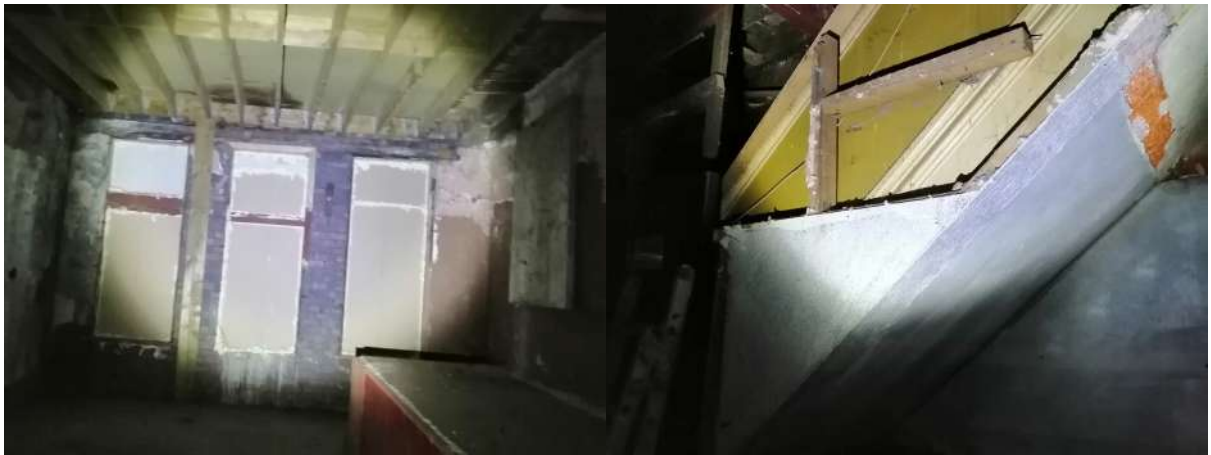
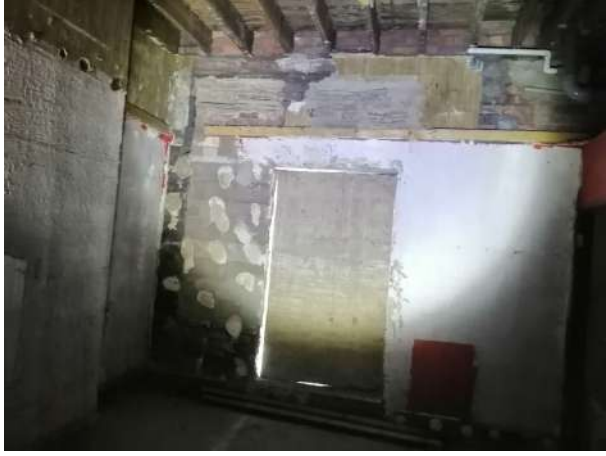
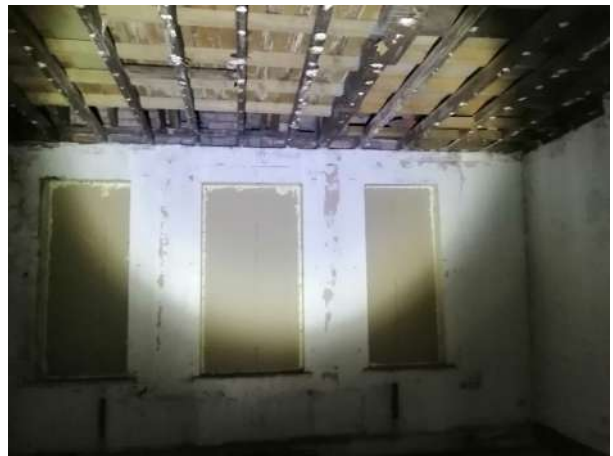
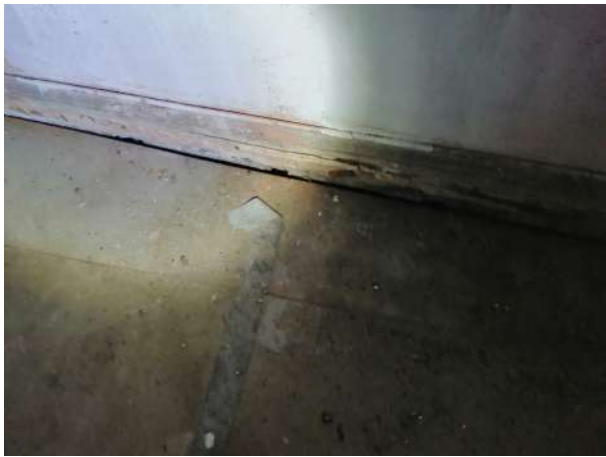
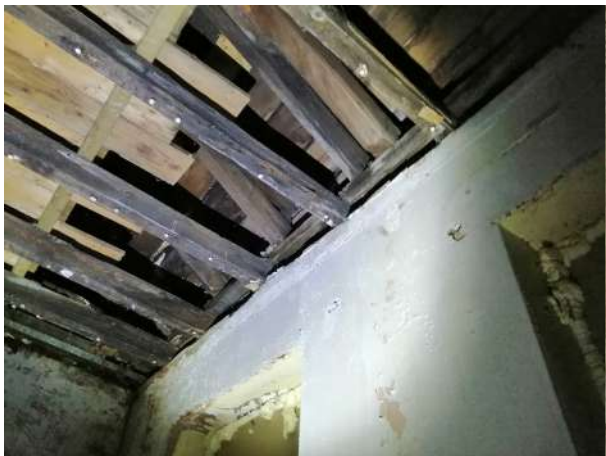
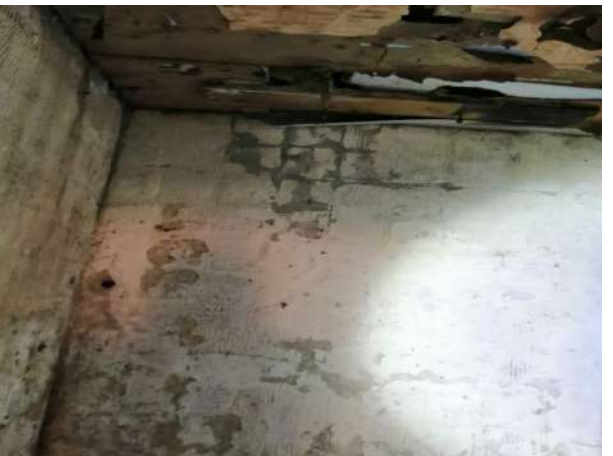
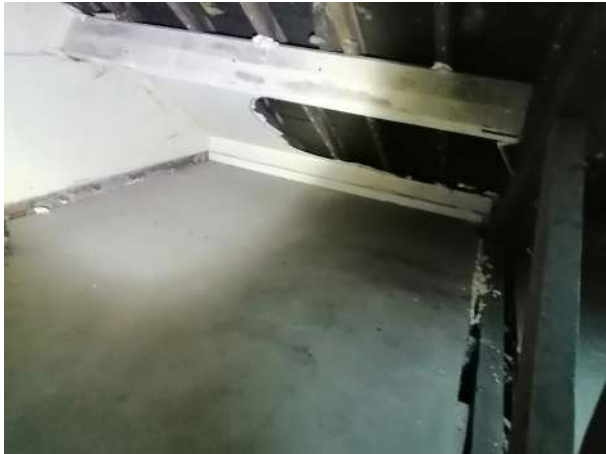
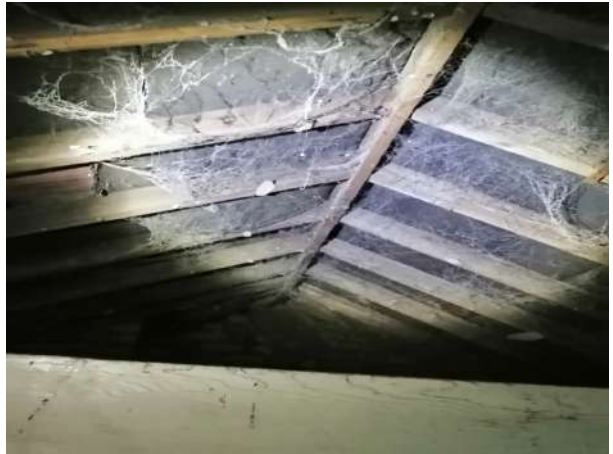
During the internal inspection, no evidence of nesting birds or bats including bat droppings was identified within the building. The 3rd floor converted loft room was considered light and airy due to the roof skylights with lots of cobwebs. The ground floor, 1<sup>st</sup> and 2<sup>nd</sup> floor rooms were dark (See photos in Appendix I).

Building interior
