**GOLYNOS FARM COTTAGE, NEWPORT**

**BUILDING INSPECTION & BAT EMERGENCE SURVEY REPORT**

November 2025

Document Reference: E25135401 / Doc 01 – November 2025

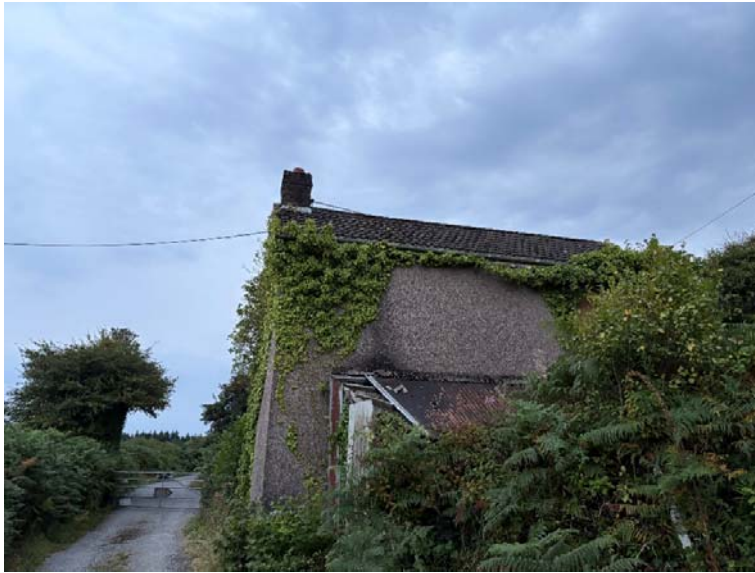
**Plate 1** Surveyor View, Northern Gable

- the intensity of use (e.g., likely number of bats, time and duration of use).
- 2.10. The dusk survey commenced 15 minutes before sunset at (20.15h) and extended for 90 minutes after sunset (22.00h). Surveys were conducted using broad-band Peersonic bat detectors. Any bat calls were either identified in the field or using computer-based sonogram analysis software (e.g., Wavesurfer or Analook Insight). Surveyors were positioned so as to allow coverage of the southern and northern gable ends as well as the window boards to the eastern elevation. Surveyor views at the start of the survey are shown in Plates 1 & 2.

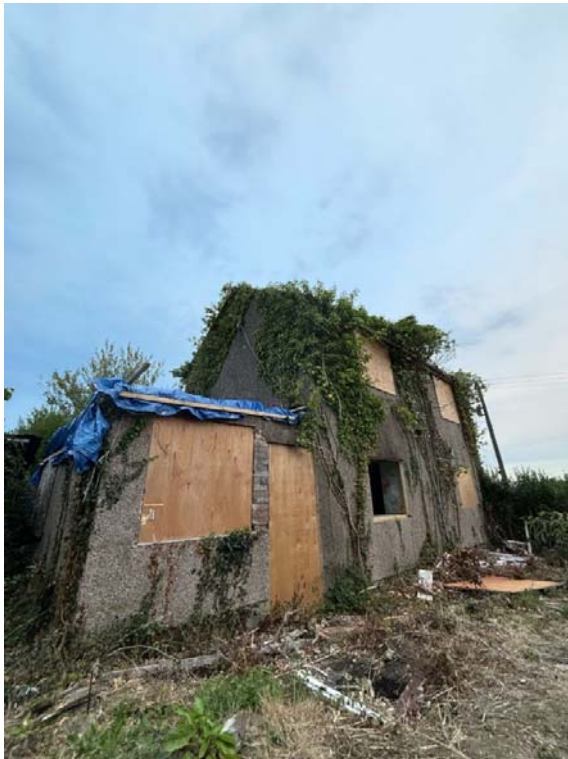
**Plate 2** Surveyor View, Southern Gable

- 2.11. To supplement the surveyor observations, a Night Fox Whisker night vision camera was positioned next to the surveyor at the southern gable end. The camera was set up to record over the duration of the survey.

- 3.16 No bats were seen to emerge from the Cottage by either of the surveyors at south eastern and north western corners of the building over the course of the survey. Similarly, a review of the Nightfox camera footage confirmed that no bats were noted emerging from the southern gable end (where camera was focused).

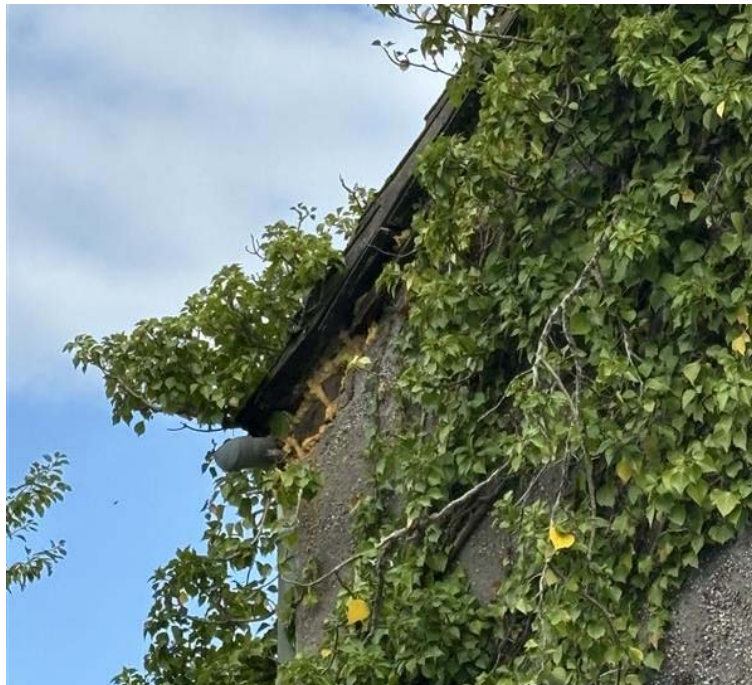
**Plate 3** Infilled crack in wall, surrounded by dense ivy cover

- 3.7 The main cottage building had some potential roosting features (PRFs) as described in Appendix III, including gaps around the fascia boards although these were often completely or partially obscured by Ivy. The flat roof extension on the southern side has had its roof covered by tarpaulin and there is a gap surrounding the boarded up door, however, there was no external evidence of bats. On the southern gable end gaps around the fascia had been infilled using expanding foam, but several small cracks still remain (Plate 3). On the western elevation, the fascia was obscured by ivy and there was a lean-to timber frame with corrugated metal sheet roof. The roof and ridge tiles as viewed from the east and west appear generally sound with no obvious damage or missing tiles, mortar etc.

- 3.8 No external evidence of use by bats as identified and the cottage was considered of **Low potential** for roosting bats based on a combination of the condition of the building and the limited number of PRF's.
- 3.9 Other buildings or structures at the site included the former Coal Store, lean to structure on the western elevation of the cottage and a derelict Garage building in the south eastern corner of the plot (see Appendix III). Each of these structures was **considered of Negligible potential** for roosting bats although both the Coal Store and lean-to had old bird nests associated with them, although no recent or current evidence of nesting was noted. None of the on site or boundary trees supported features that could be used by roosting bats – i.e. **No Potential**.

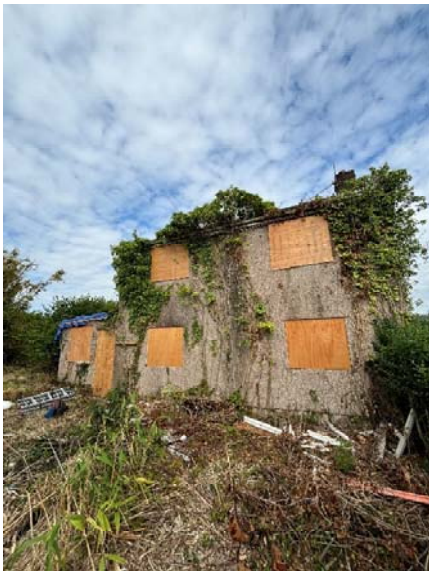
| RECORD OF SITE VISIT | |
|---|---|
| <b>General</b> | <p>Two-storey detached cottage and gardens proposed for demolition and redevelopment. Property is vacant/derelict and has been boarded up. Derelict outbuildings present to south of the cottage and in south east corner of the site. Former garden areas are overgrown in parts and colonised by ruderal vegetation/scrub – some occasional management by strimming/cutting evident.</p> <p>Site is located along Mountain Road, Risca in a predominantly agricultural area with Newport Golf Course on the eastern side of Mountain Road and agricultural fields to the north, south and west. There is no street lighting along Mountain Road with a belt of semi-mature trees present on the eastern side of Mountain Road and the boundary of the Golf Course. The immediate surrounding area is likely to support foraging/commuting bats and the surrounding hedgerows and tree lines provide good habitat connectivity to the surrounding landscape.</p> |

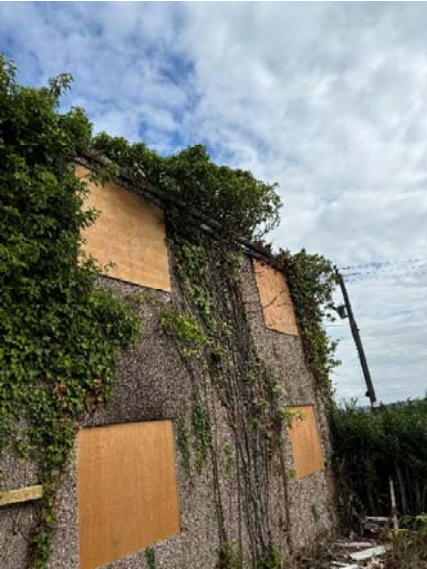
| <b>Golynos Cottage</b> | <p>2 storey detached cottage with rendered finish. Flat roof extension to southern side with roof missing and covered in tarpaulin. Clay roof and ridge tiles remain and seem in reasonable condition. Extensive ivy growth to walls and over fascia/guttering. Windows and doors all blocked and no internal access (for surveyors) possible.</p> <p><i>East elevation:</i></p> <p>Gaps noted along fascia but these are covered or at least partially obscured by Ivy. No gaps noted around door or window boards and no external evidence of bats noted (inc. ladder inspection of fascia).</p> <p><i>Flat roof extension and southern gable</i></p> <p>Gap around door board noted but no external evidence of use by bats. Roof covered in tarpaulin.</p> <p>Southern gable end with some ivy cover to fascia and walls. Gaps to apex have been infilled with expanding foam although some small gaps remain but these partially obscured by ivy. No external evidence of bats noted (ground check using binoculars).</p> |

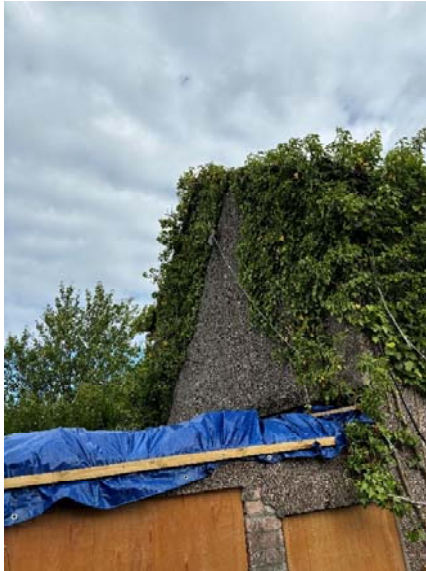
*Western Elevation*

Fascia is completely obscured by Ivy with window board sound to south west corner. No external evidence of bats (or birds) noted and no obvious means of access. Roof and ridge tiles are sound with no obvious missing or damaged areas.

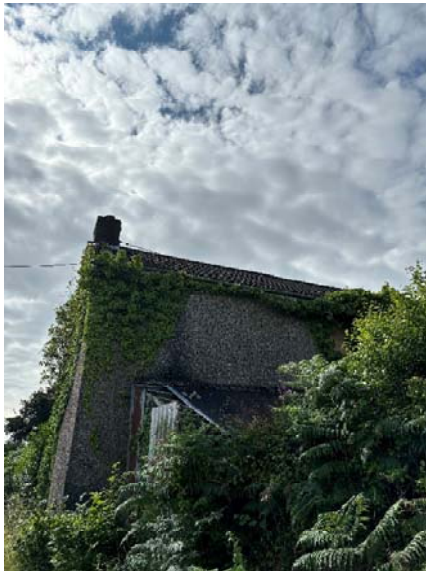
Corrugated metal lean-to structure on timber frame present to ground floor of cottage which is open to southern side. Easy access for birds or bats – no evidence of bats noted but old bird nest amongst ivy at south west corner of the structure.

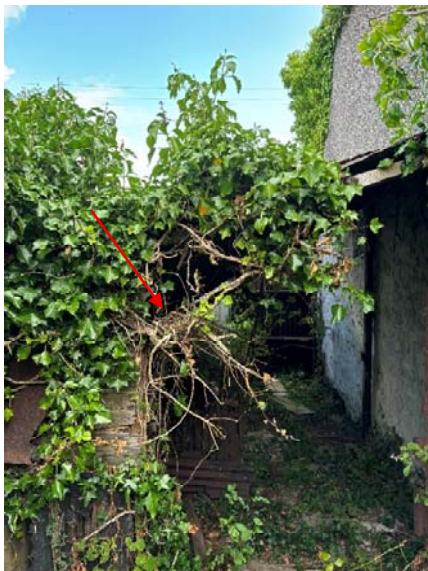
#### *Northern gable end*

Similar to southern gable with fascia overgrown with Ivy. Some small gaps noted but at least partially obscured by Ivy. Small gaps also noted around lead flashing to chimney.

**Overall Building considered of Low bat roost potential**

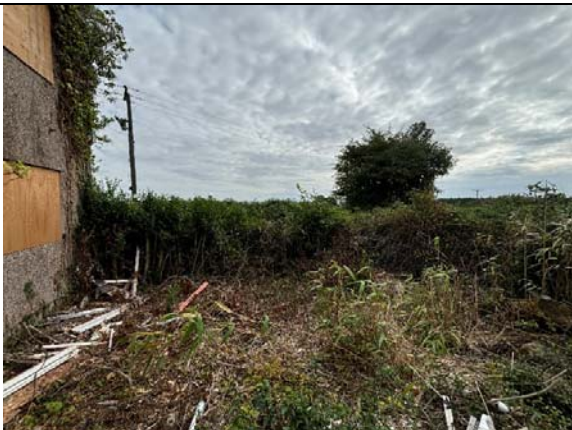
#### **H1 – Garden Hedge**

Graden hedgerow to north eastern and eastern boundary of property. Mainly comprised of Privet but with Hazel and Holly also present with Bramble filling gaps between woody shrubs. Some bamboo also present. Potential for nesting birds

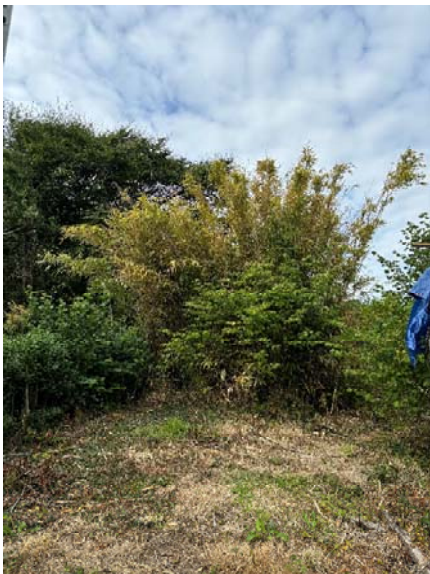
| <b>1 – Bamboo</b> | <p>Large stand of Bamboo to south east of Cottage. Individual stems also present to boundary hedgerow and former garden area east of the Cottage.</p> |

- 5.7 Removal of the bamboo and Spanish Bluebell would also be recommended and the advice of a suitably experienced invasive weeds contractor should be sought to confirm the best approach for the site. Any

contaminated soil could be retained on site and incorporated as part of the redevelopment although removal and safe disposal of the Bamboo and rootball would be recommended.

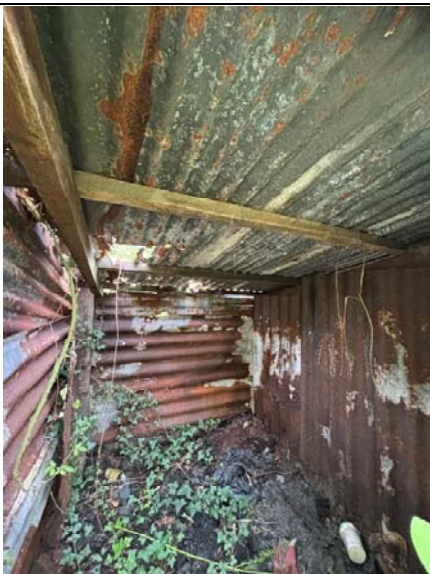
| <b>B2 – Coal Store</b> | <p>Corrugated metal structure on timber frame. Holes to roof and open to eastern side allowing easy access or birds or bats. Old bird nest noted on timber frame to north side. No evidence of bats and considered of Negligible potential.</p> |

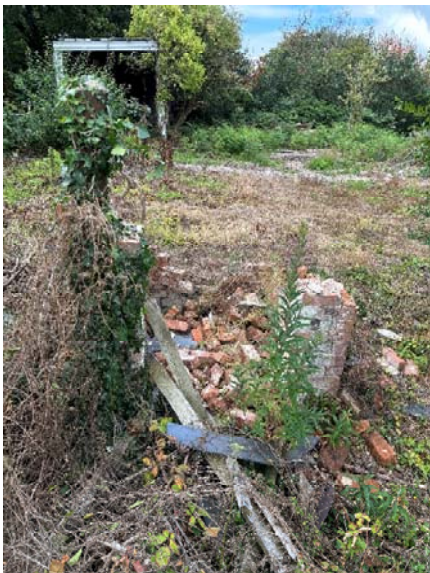
| <b>4 – Ruderal vegetation</b> | <p>As for Note 2 with additional species including Ground Elder, Bramble and Bracken. Some building rubble and remains of brick walls for small outbuilding/shelter also noted.</p> |

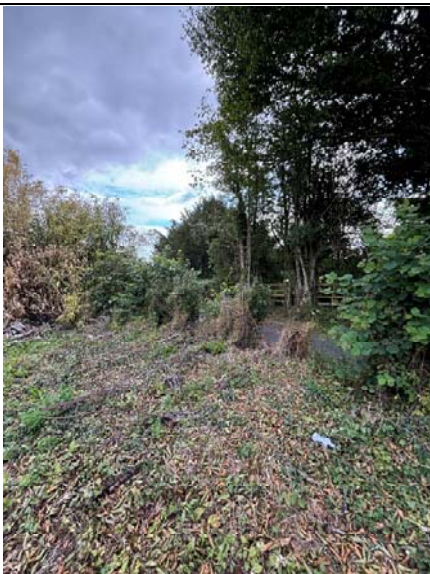
| <b>H2 – Eastern hedge</b> | <p>Continuation of garden hedge but more gappy – Hazel, Privet, Holly Sycamore and Beech noted. Ivy is main ground cover at base along with Cleavers.</p> |

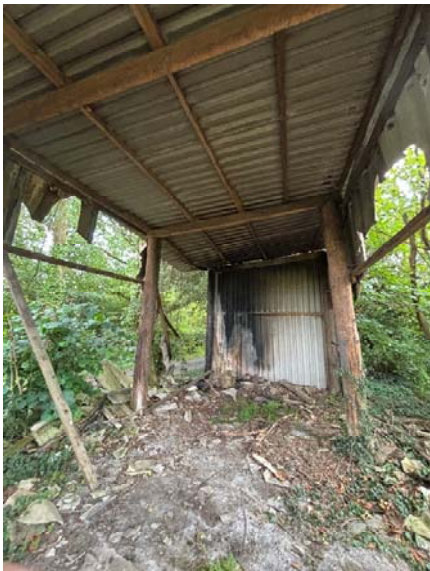
| <b>Garage</b> | <p>Derelict, open sided garage to south east corner of plot. Corrugated metal sheet wall with corrugated cement (asbestos?) panels as remaining walls. Some fire damage to timber frame noted. Part overgrown with Ivy – some potential for nesting birds but Negligible bat potential.</p> |

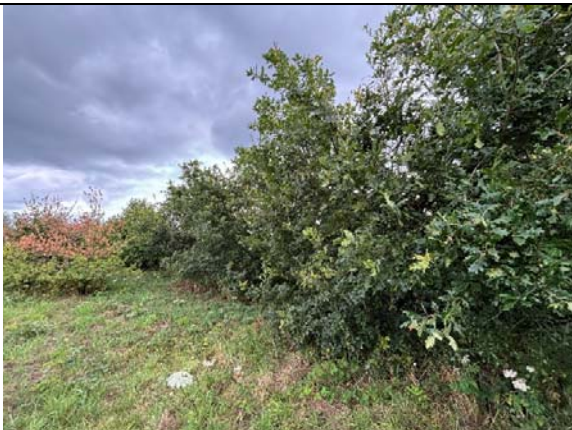
| <b>H3 – Garden boundary</b> | <p>Line of young Oak trees along western side of plot – may define garden boundary. Oaks less than 5m high interspersed with Bracken and ruderal vegetation.</p> |

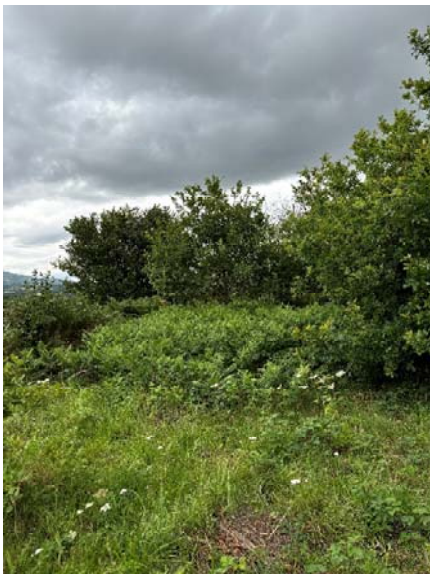
| <b>5 – Bracken scrub</b> | <p>Dense bracken scrub to NW corner interspersed with some Oak, Willow and Hazel shrubs</p> |

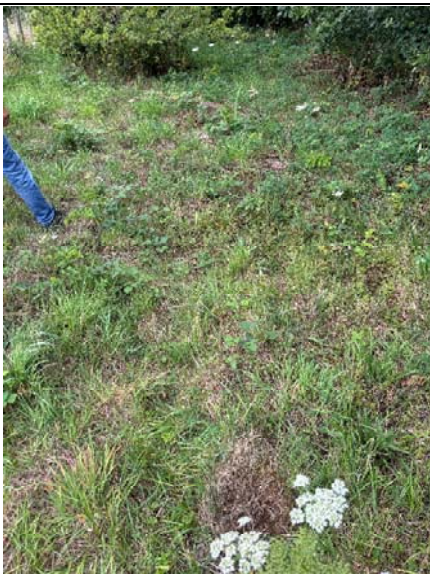
| <b>6 – SI Grassland and scrub</b> | <p>Strip of grassland and scattered scrub to west of line of Oaks with post/wire fence separating this strip from the agricultural field (cut for hay or silage) to the west. Grassland in the strip is a mix of poor SI with ruderal vegetation and scattered scrub including Tufted vetch, Meadow Vetchling, Hogweed, Blamble, False Oat Grass, Ribwort Plantain, Creeping Buttercup, Willowherb, Yorkshire Fog, Common Bent and Red Fescue. Irregularly managed. Some reptile potential.</p> |

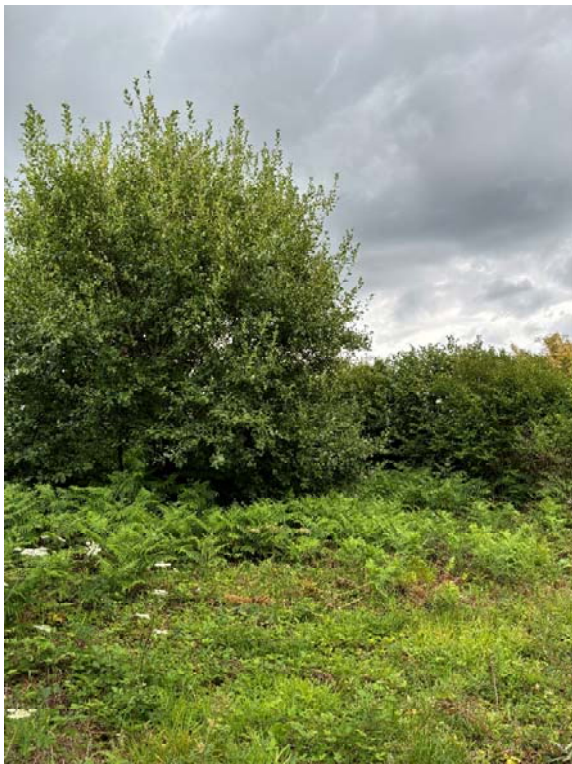
| <b>7 – Bracken &amp; ruderal</b> | <p>Bracken, scrub and ruderal vegetation to south of Cottage.</p> |

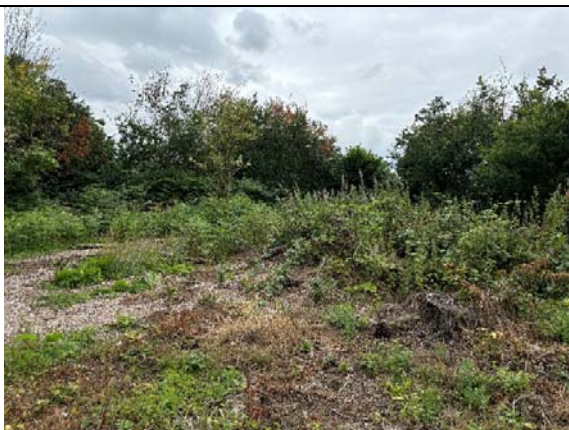
| <b>8 – Bramble stands</b> | <p>Two no. large stands of Bramble and brash amongst ruderal vegetation in southern part of the plot. Some reptile potential although none seen during survey.</p> |
