Project name: The Crescent, Corporation Road (ref: 18/0973)  
Technical note title: Interim verification report  
Author: Kurt Gilmore BSc (Hons) FGS  
Approval: Matthew Holbourn MSc BSc (Hons) FGS  
Revision: P01 Date 17/02/26

### **Stantec review of works undertaken**

Annex A – Photographs

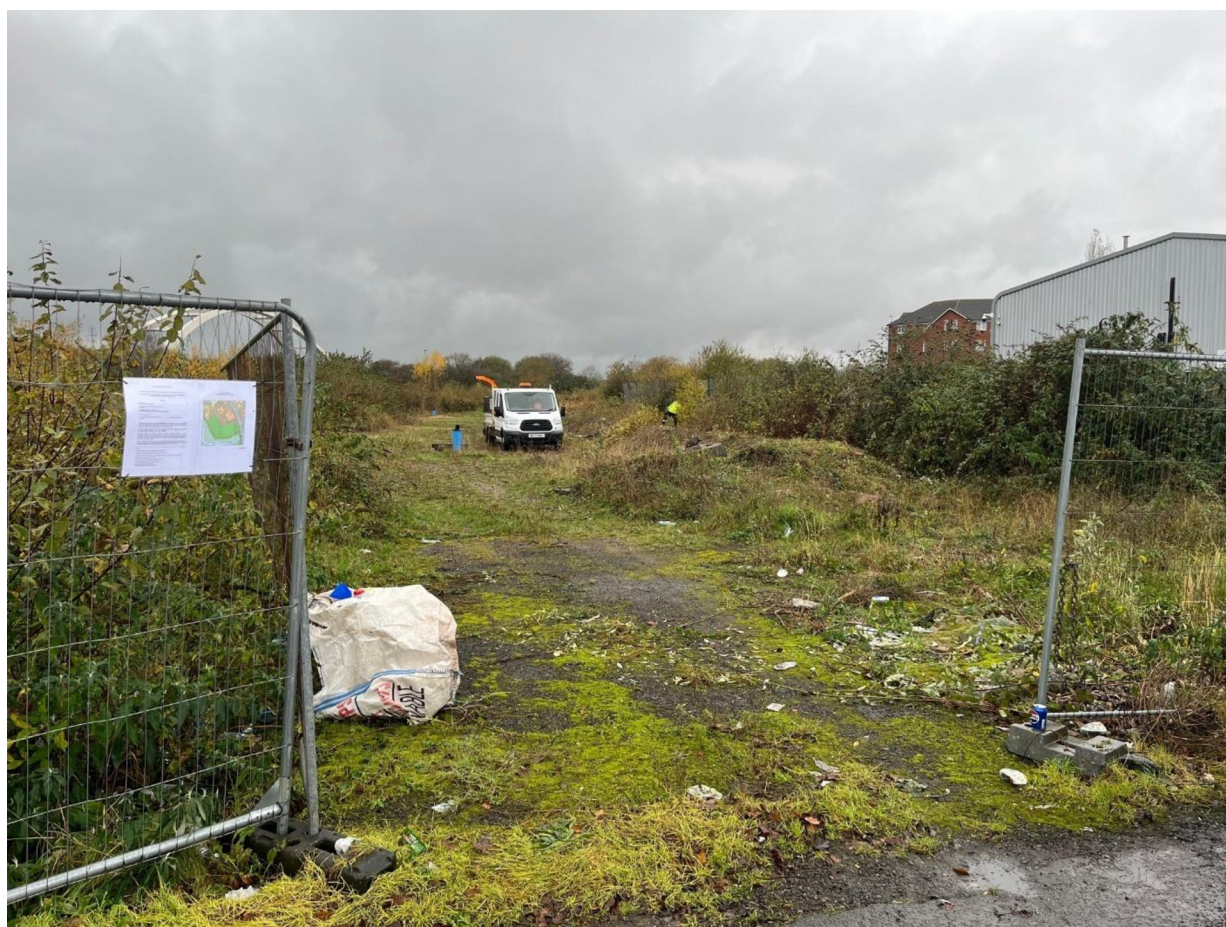
*Figure 1: Start on site 18/11/24 – original site conditions*

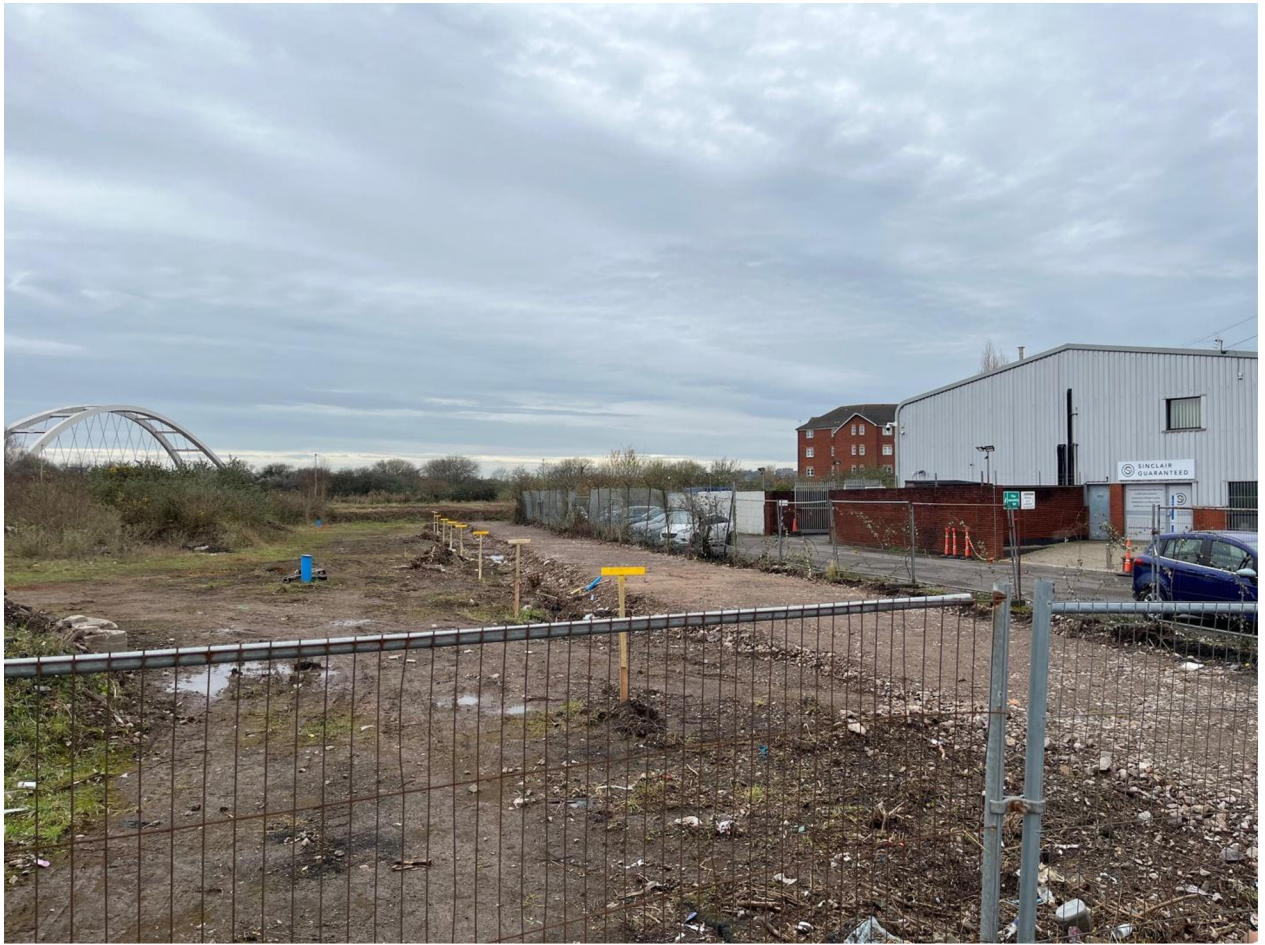
The client confirmed that their contractor (DT Civils) undertook vegetation clearance in the area of the proposed access route / temporary haul road and subsequently set out the line of the approved access road within the site using GPS data and profile boards at a 3m offset. A tracked excavator was used to grade high spots along the route and remove the top 100mm of material to allow for the formation of a temporary haul road.

*Figure 2: Completion of commencement works and subsequent creation of temporary haul route*

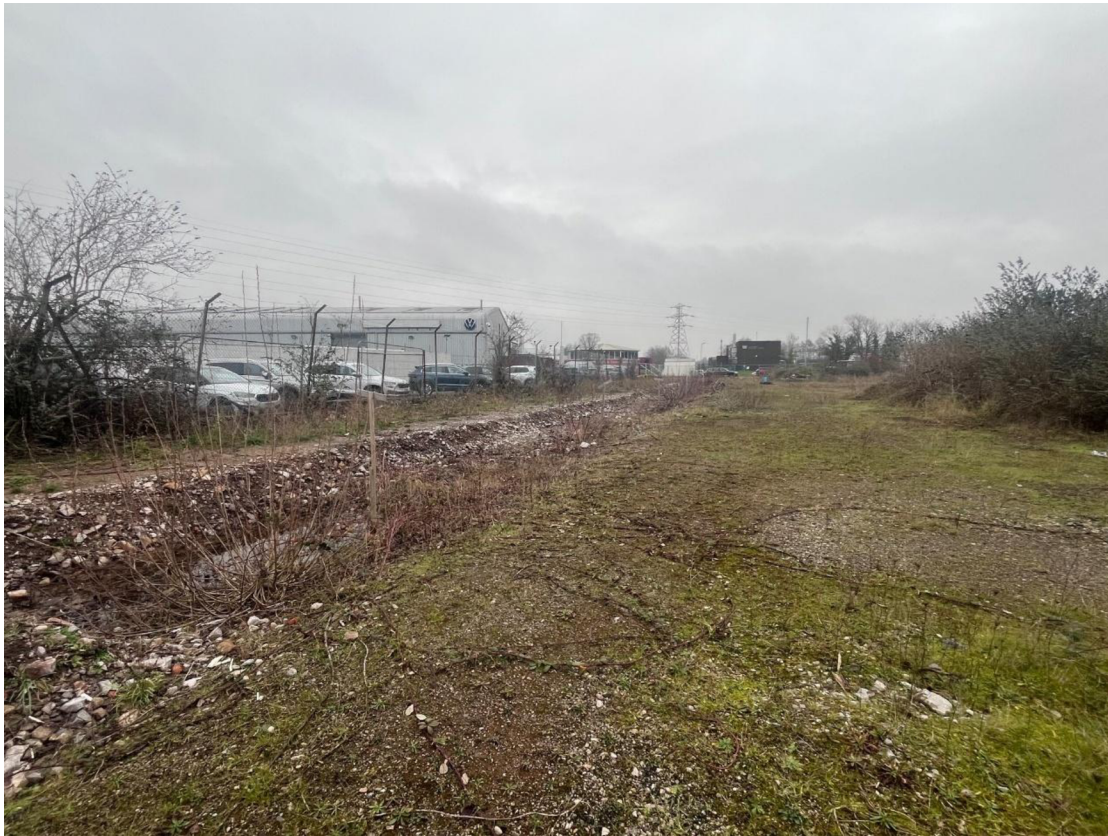
Stantec inspected the temporary haul road surface and stockpiled material during their site visit on 26/01/26, with photos included in Annex A.

Stantec has not identified any material change in the overall ground model that could impact receptors at the site as part of the access route enabling works, with no material being imported to site and only minor removal and stockpiling of existing site soils.

*Figure 3: Stantec site visit 26/01/26 - extent of works and haul road*

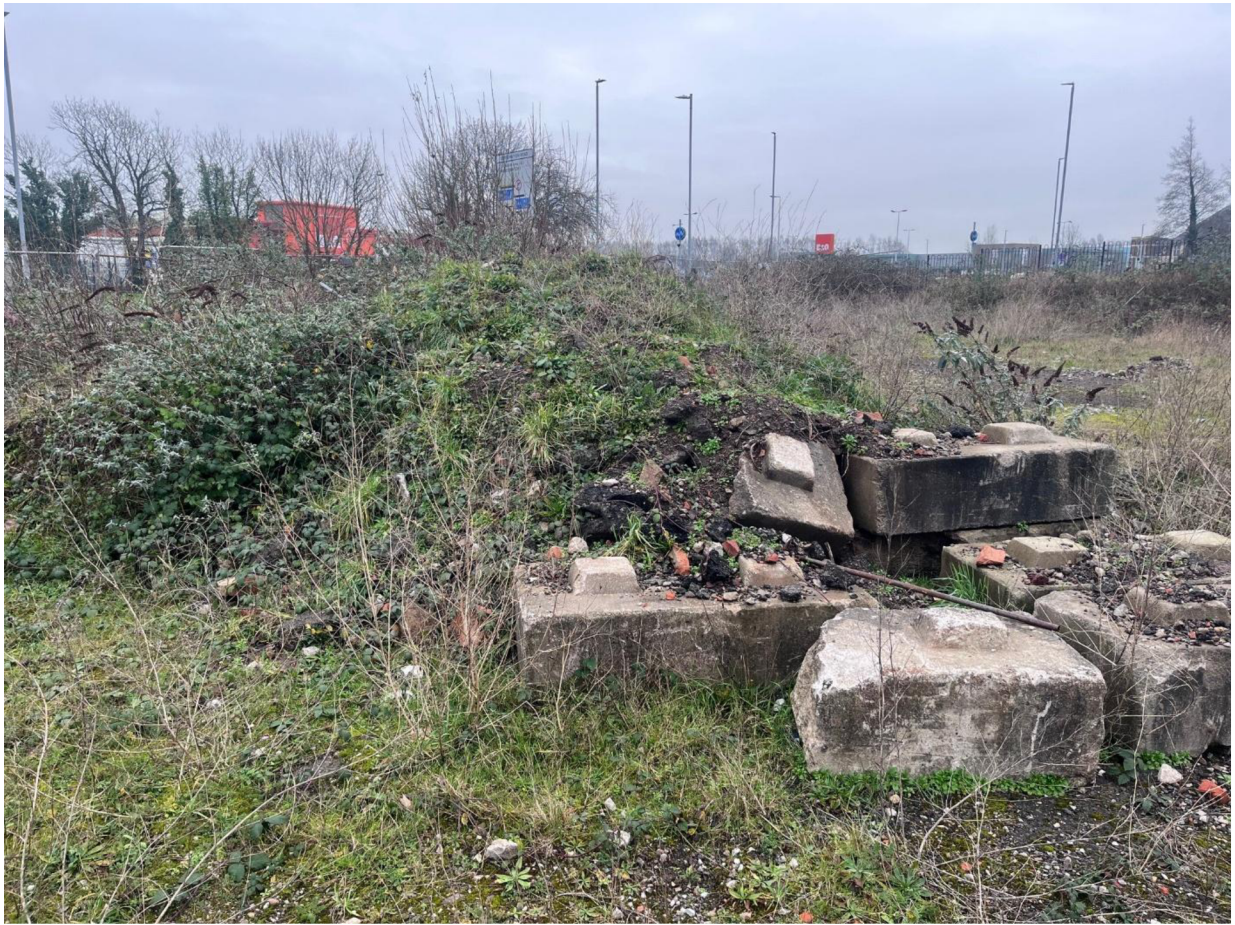
Excess material removed from the temporary haul road has been stockpiled on site near the site access point.

*Figure 4: Stantec site visit 26/01/26 - stockpile of material removed from haul road levelling*

Stantec understands that the materials excavated from the area during enabling works are scheduled for removal off site as a waste prior to the main earthworks and surcharging phase, and therefore an MMP is not required. Evidence of removal of this material will be required to form part of the final Verification Report.

All soils removed during the operational work / road formation have been stockpiled on site pending off-site disposal as waste; evidence of removal will be included within the final Verification Report. In accordance with the agreed approach with NRW, baseline groundwater monitoring is scheduled for March 2026 and will be completed prior to commencement of the main earthworks phase.
