**Bat Survey:** Plough House, Druidstone Road, Old St Mellons, CF3 6XD

**Reported by:** Ecological Services Ltd  
10 Mount Pleasant, Llanelly Hill, Abergavenny, Monmouthshire, NP7 0NT

| Author | Date | Version |
|---|---|---|
| Richard Watkins | November 2025 | V2.0 |

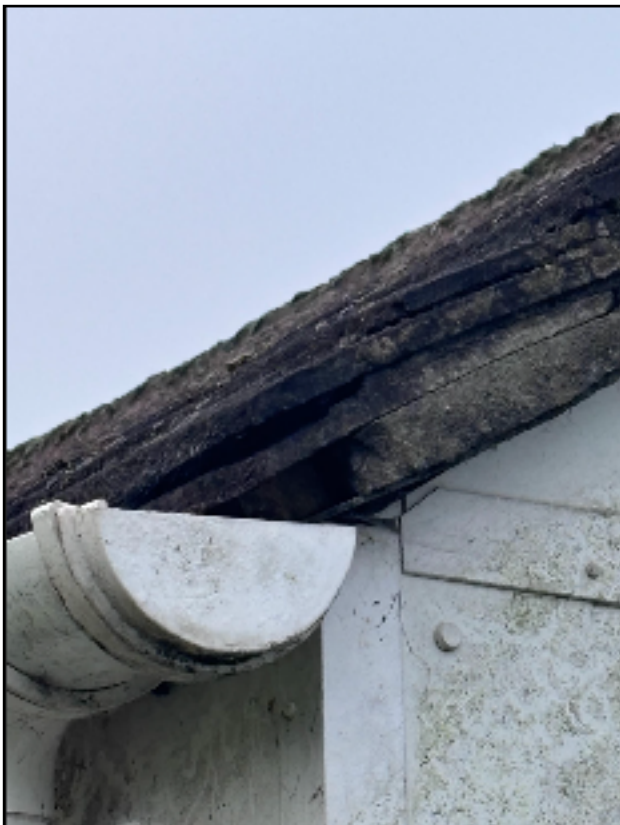
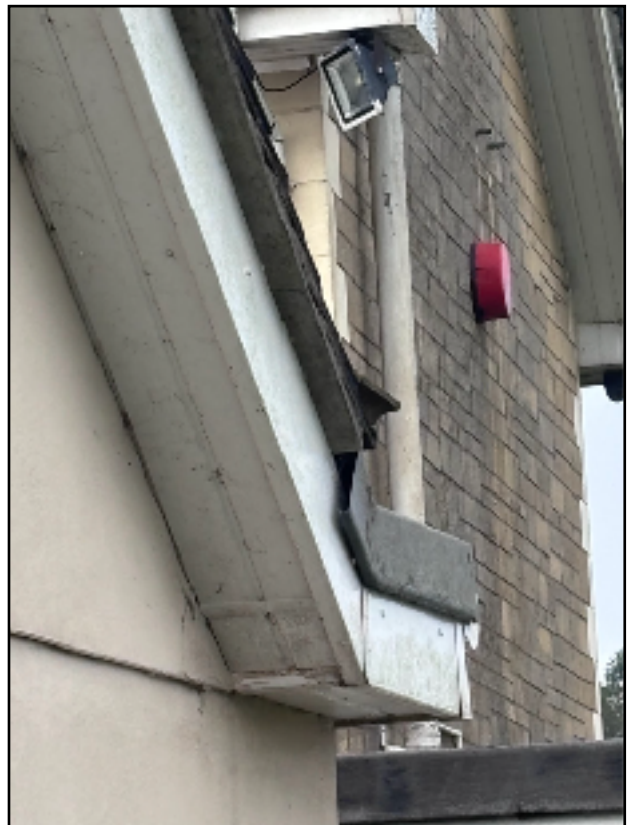
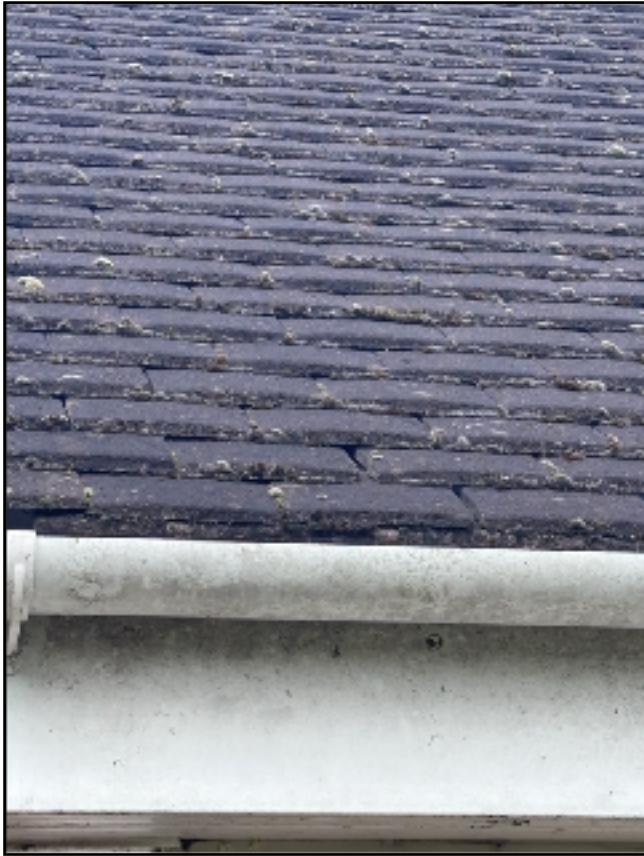
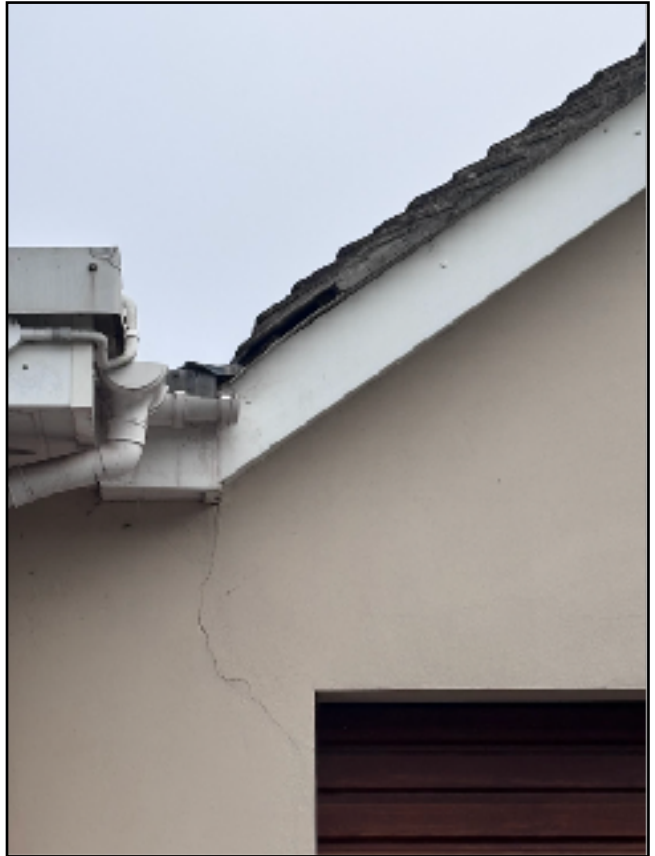
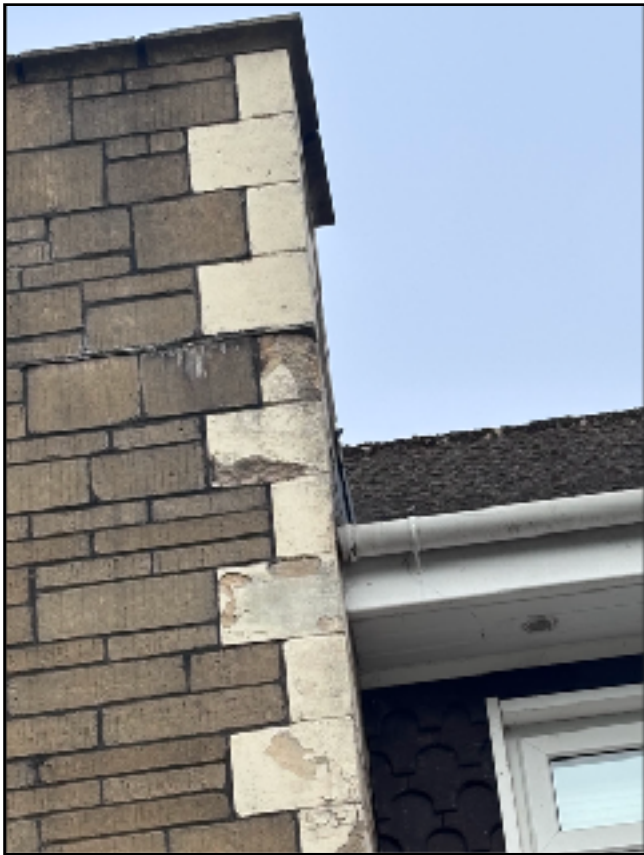
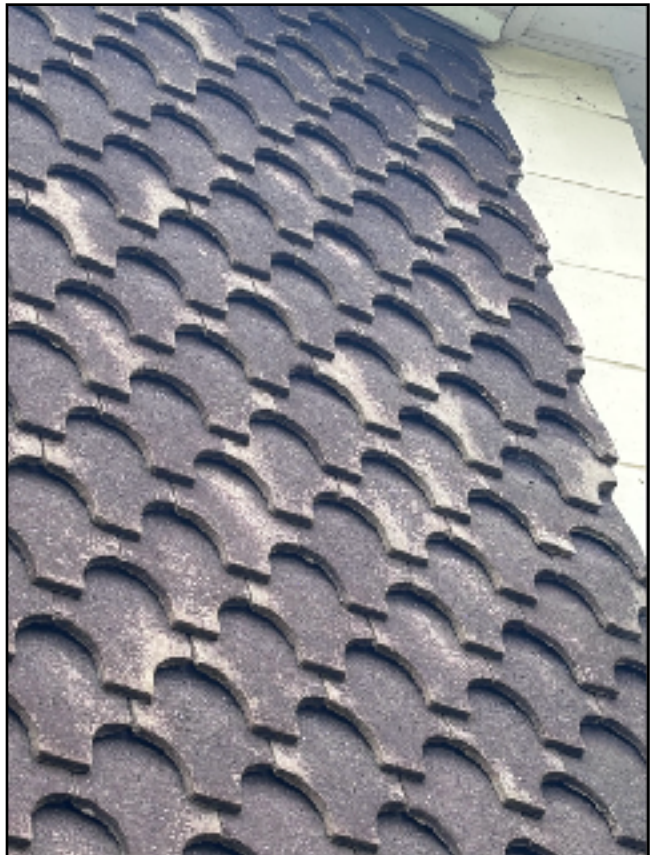
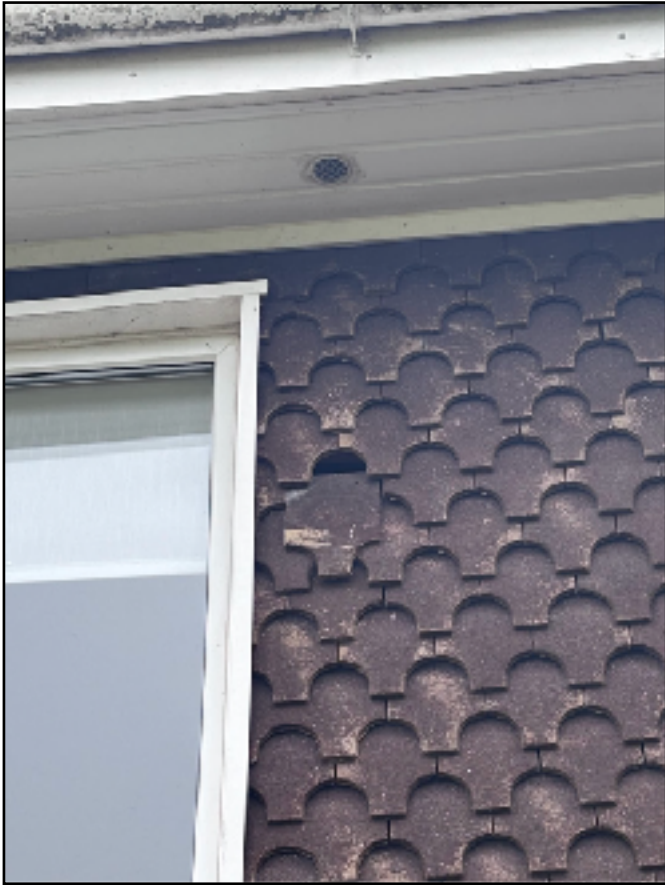
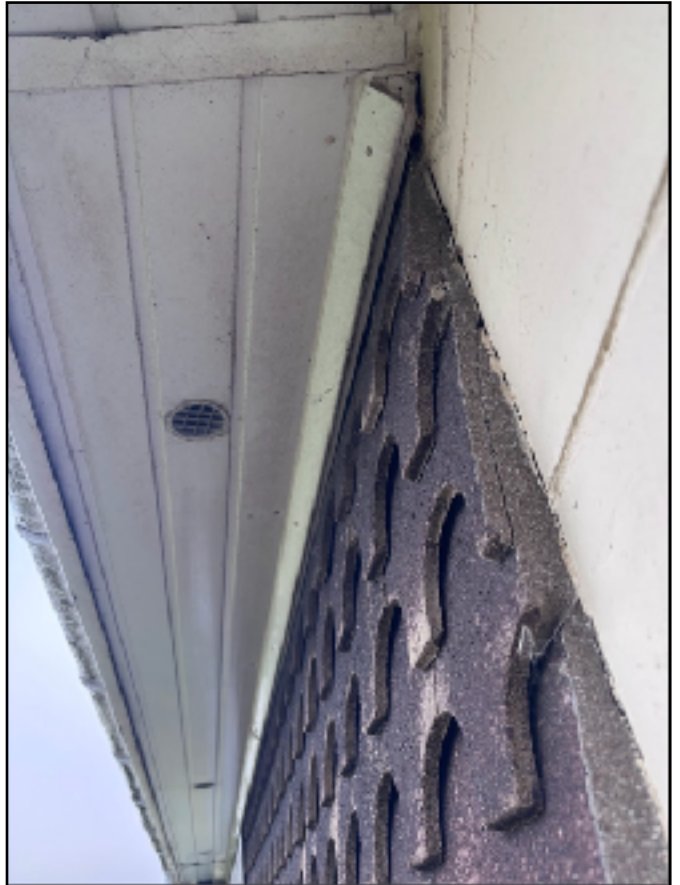
**6.3 Due to the age and condition of the building, there were a small number of opportunities present for bats to access and use the building and those that were available were deemed as having moderate potential for roosting bats. There were**

**6.6 Examples of apertures allowing access to cavities in the building:**

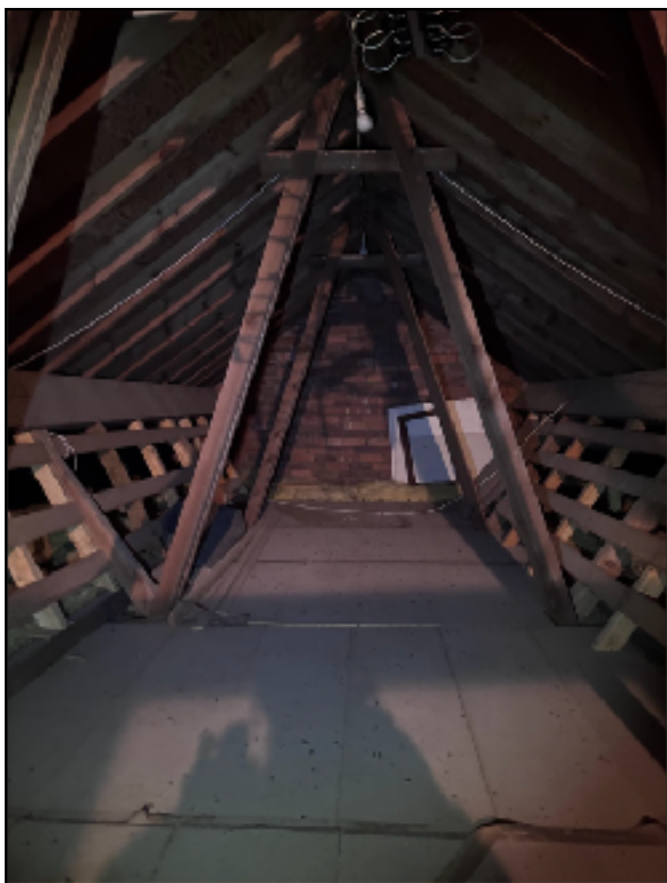
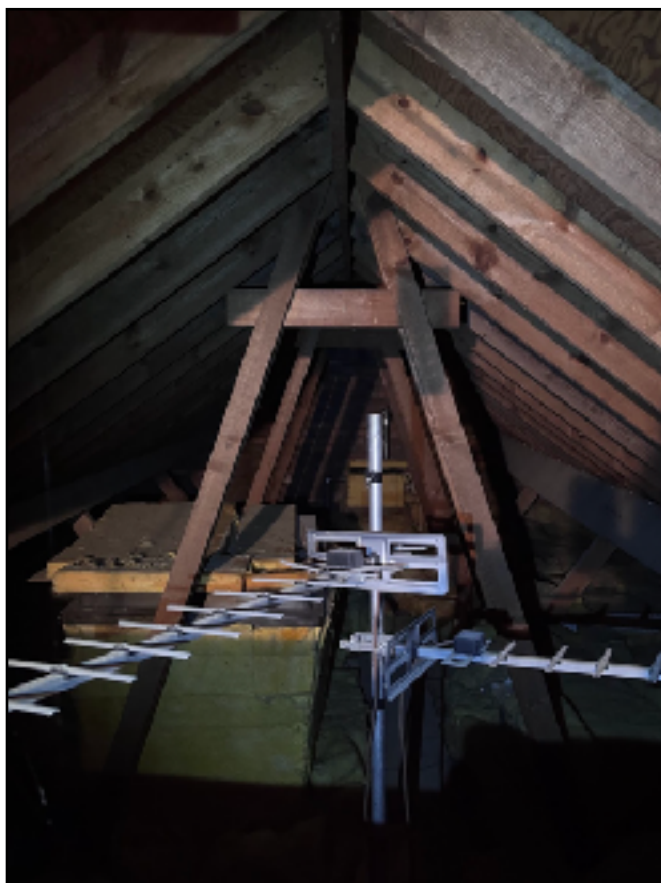
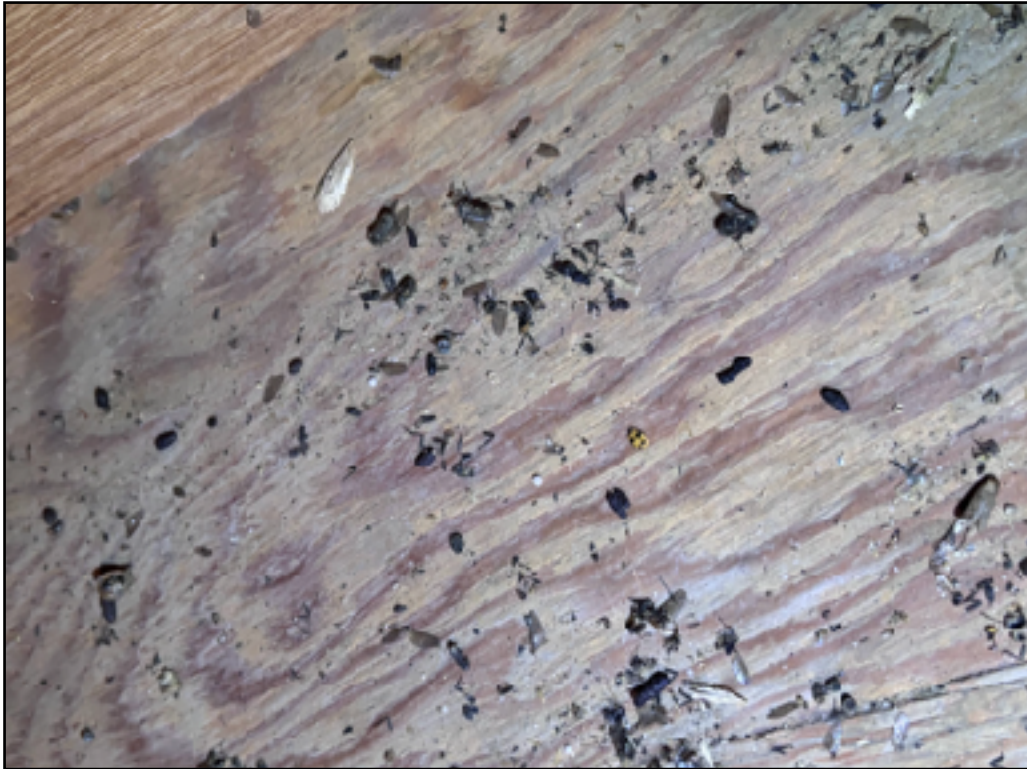
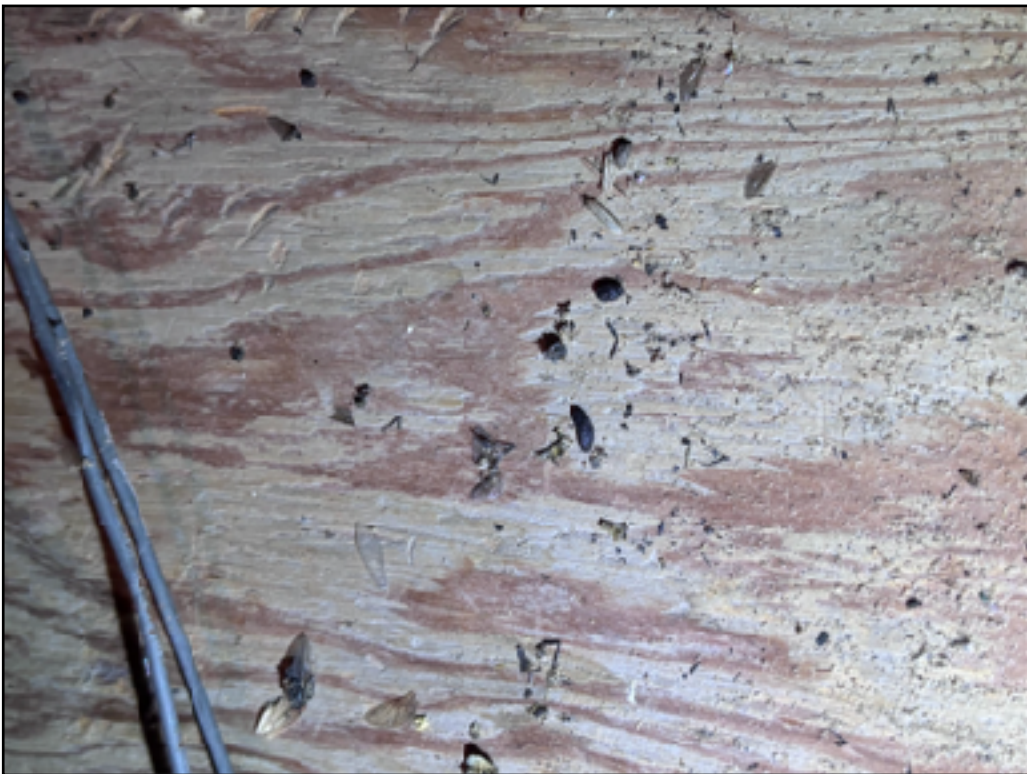
**7.2** There was an attic space within the property. The space was partially boarded out; lined with plyboard and of a trussed design.

**7.3** There were a mixture of mouse droppings and bat droppings indicative of a Pipistrelle Species (*Pipistrellus sp.*) of bat within the attic space.

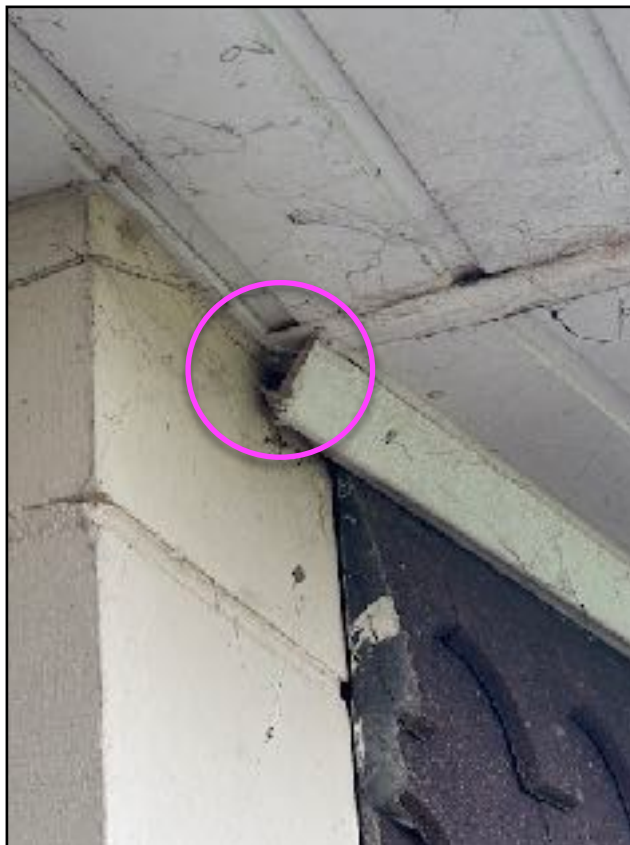
**1 Common Pipistrelle (*Pipistrellus pipistrellus*) was observed emerging from an aperture to the western elevation of the building.**

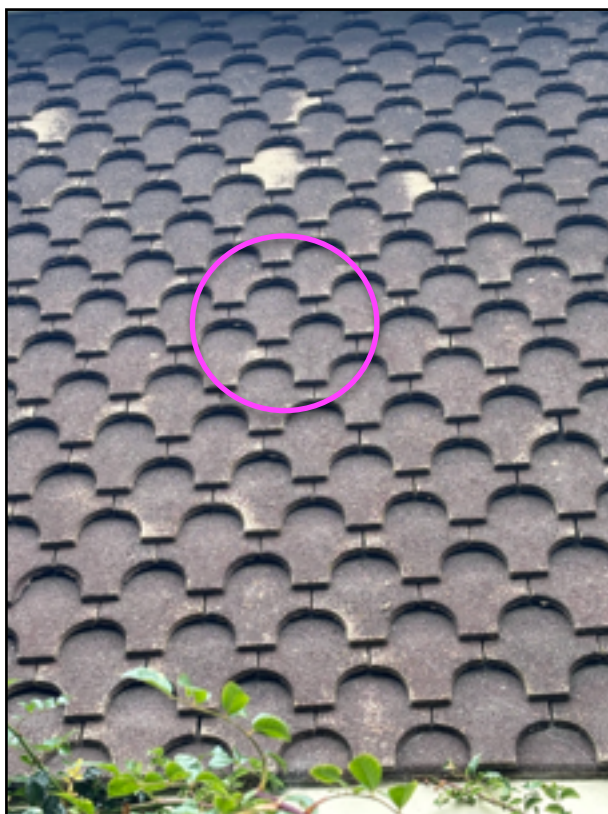
**3 Common Pipistrelles were observed emerging from underneath the tile cladding to the eastern elevation of the building.**

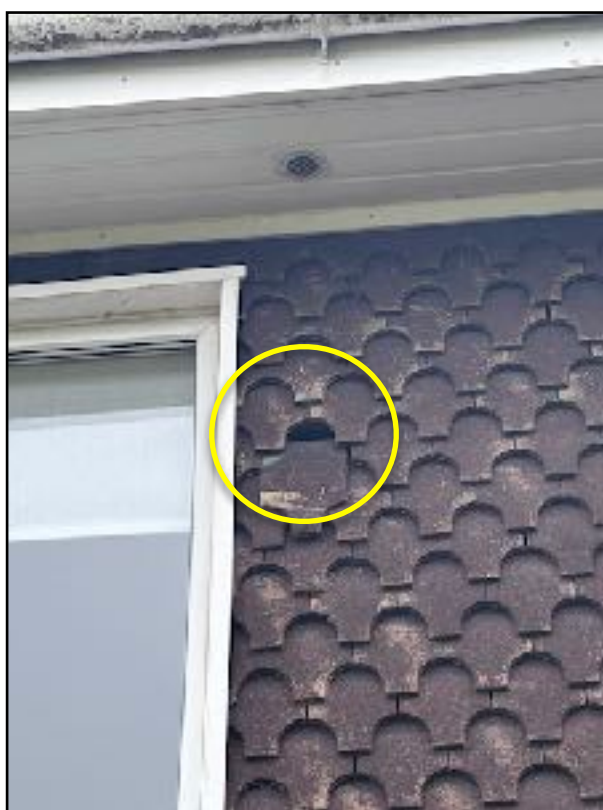
**2 Soprano Pipistrelles (*Pipistrellus pygmaeus*) were observed emerging from an aperture in the tile cladding to the western elevation of the building.**

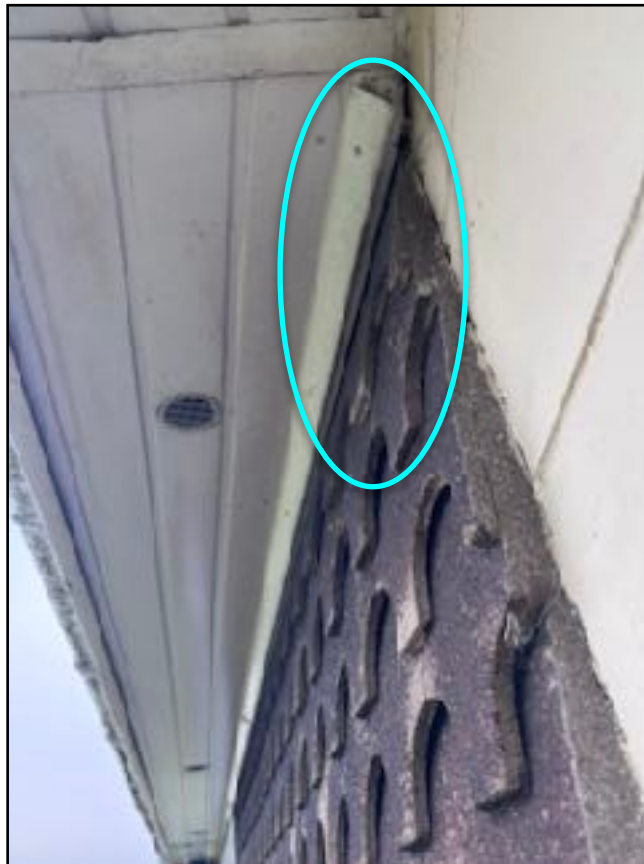
**2 Brown Long Eared Bats (*Plecotus auritus*)** were observed emerging from an aperture to the western elevation of the building.
