# **USW Caerleon Environmental Statement**

## **Chapter I: Cultural Heritage**

29 November 2019

**EDP**

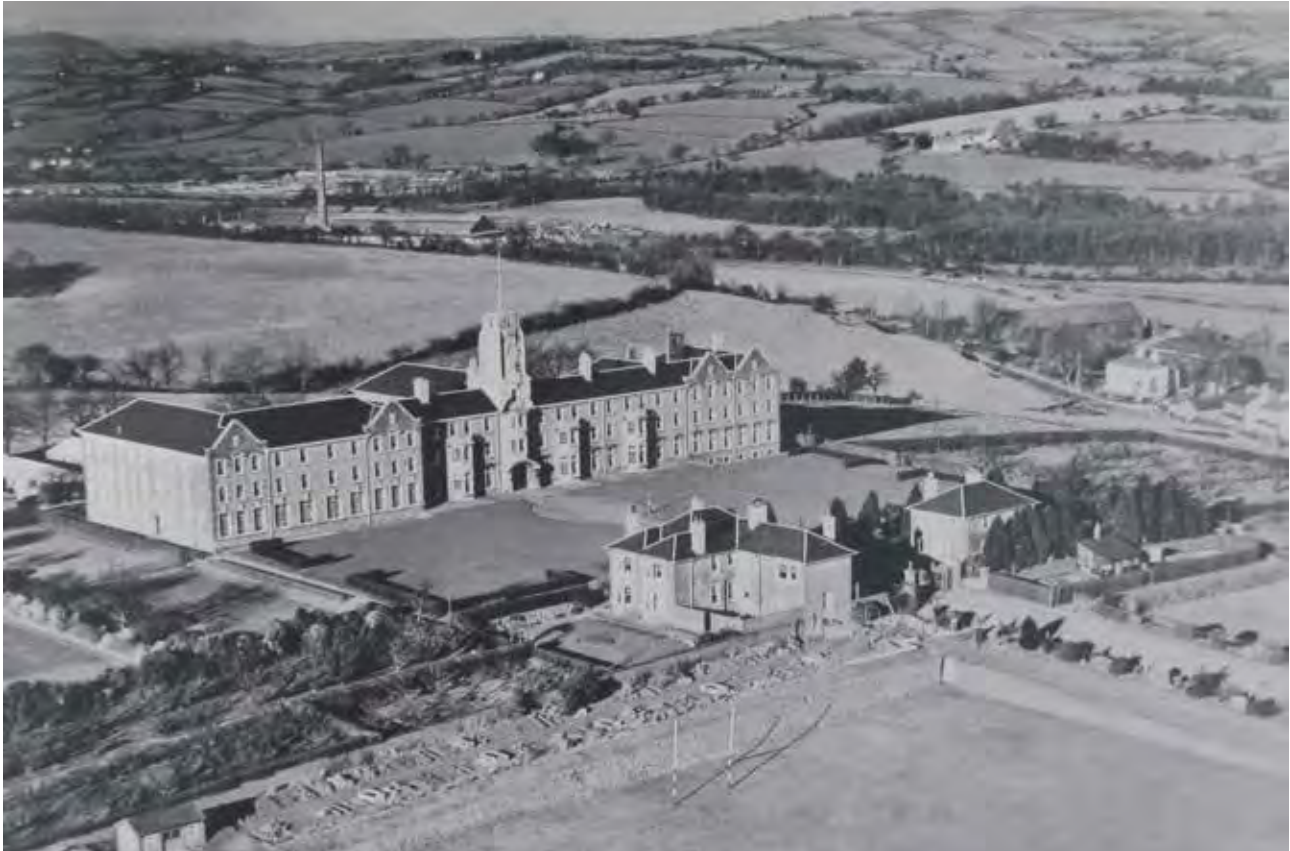
*Black & White Aerial Photo showing original Alfred Swash design*

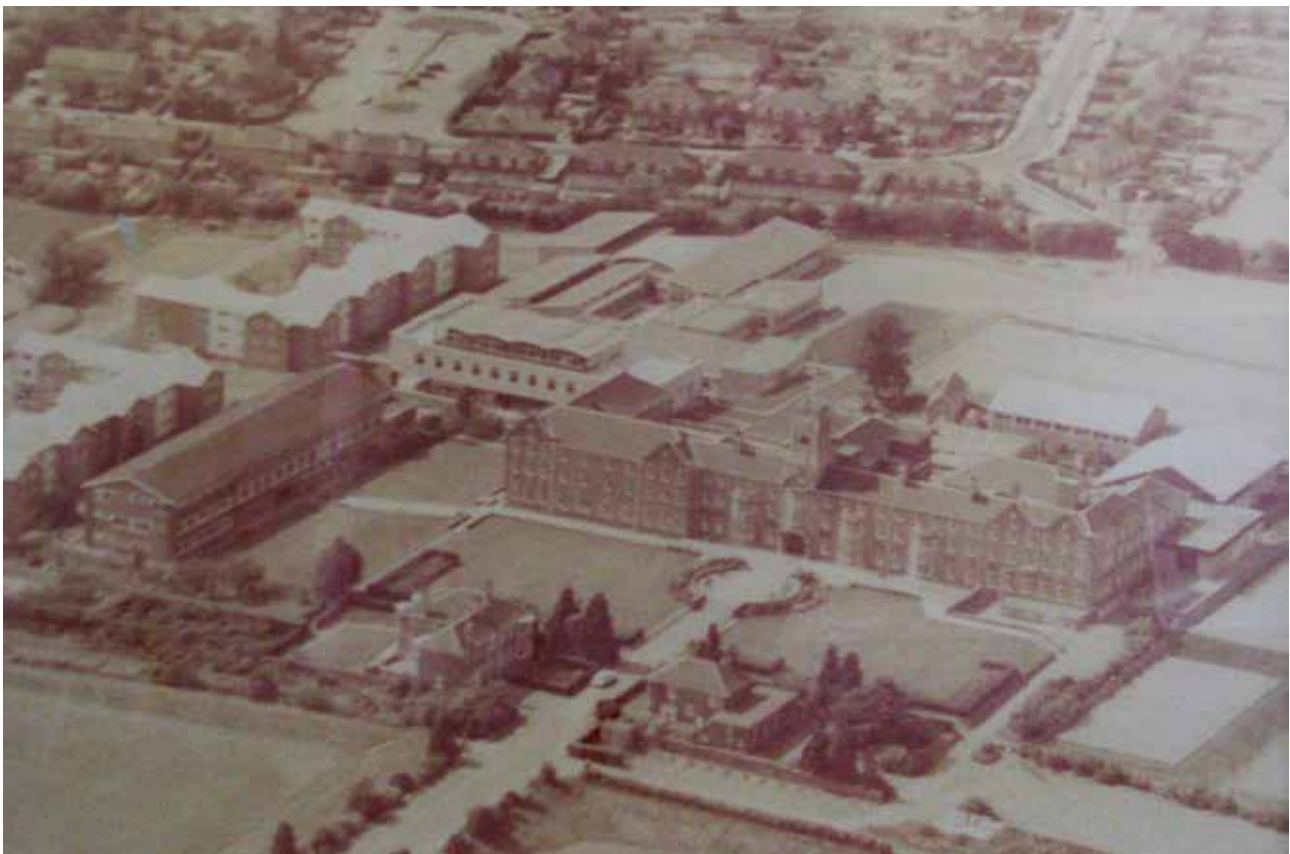
*Black & White Aerial Photo showing early expansion to north & east of Main Building*

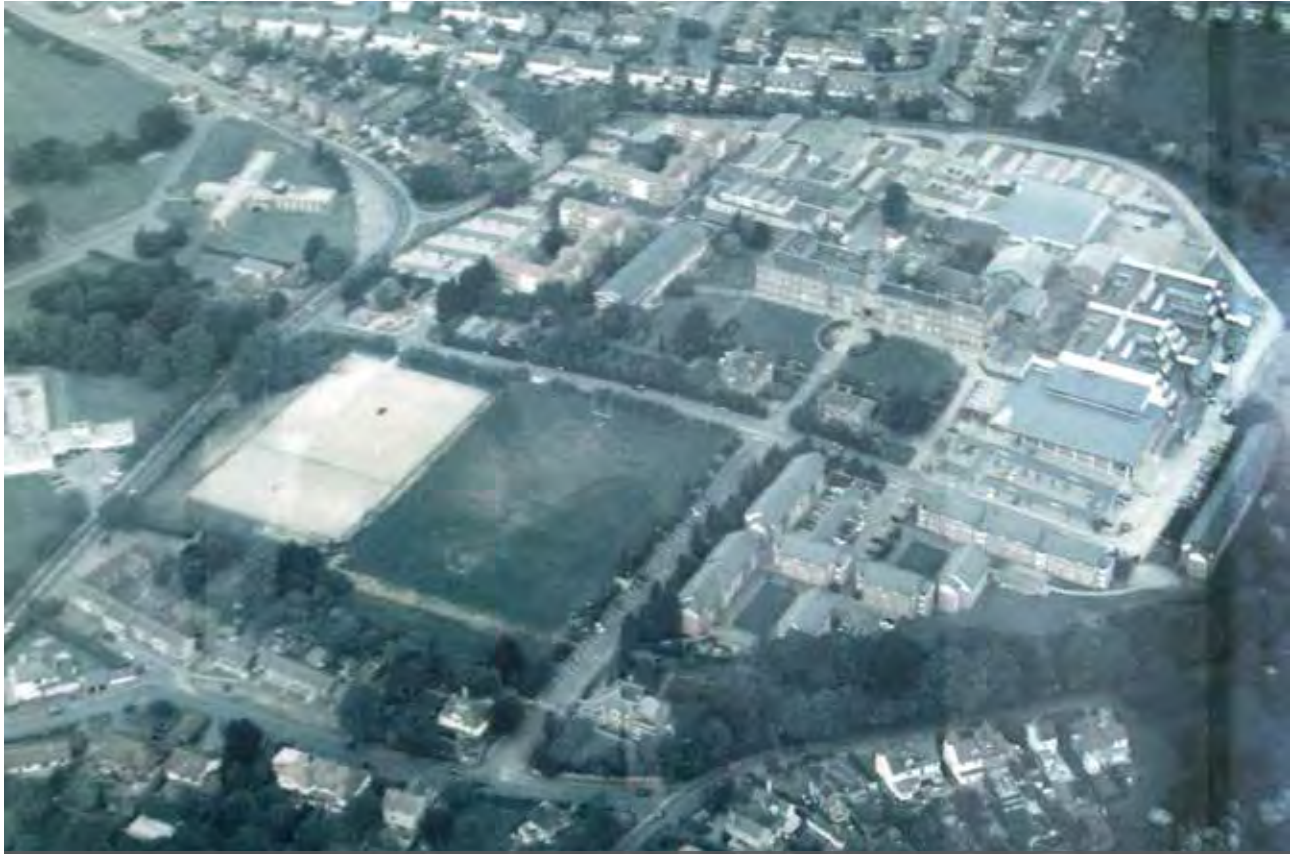
Colour Aerial Photo showing continued expansion to west and south of Main Building

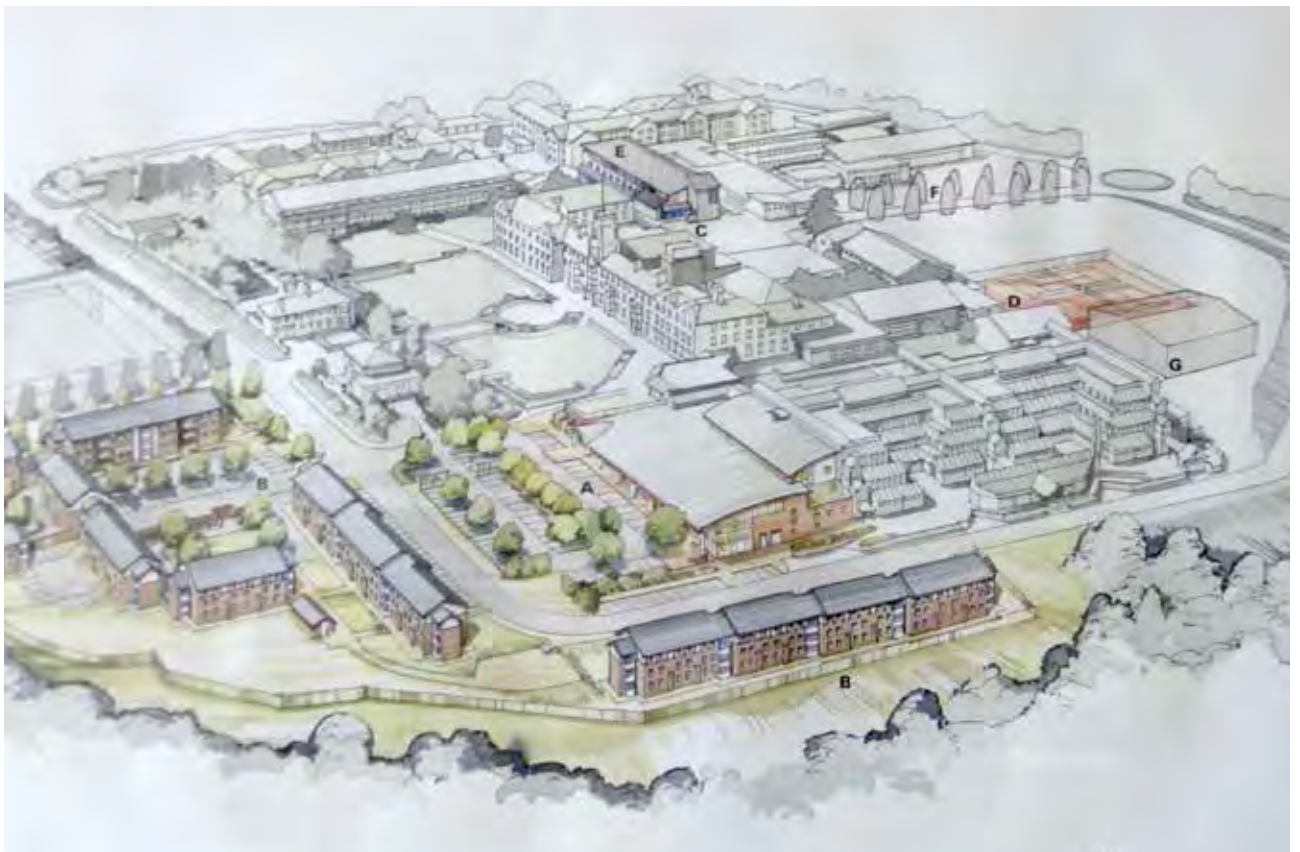
Colour Aerial Perspective showing continued expansion to west and south of Main Building

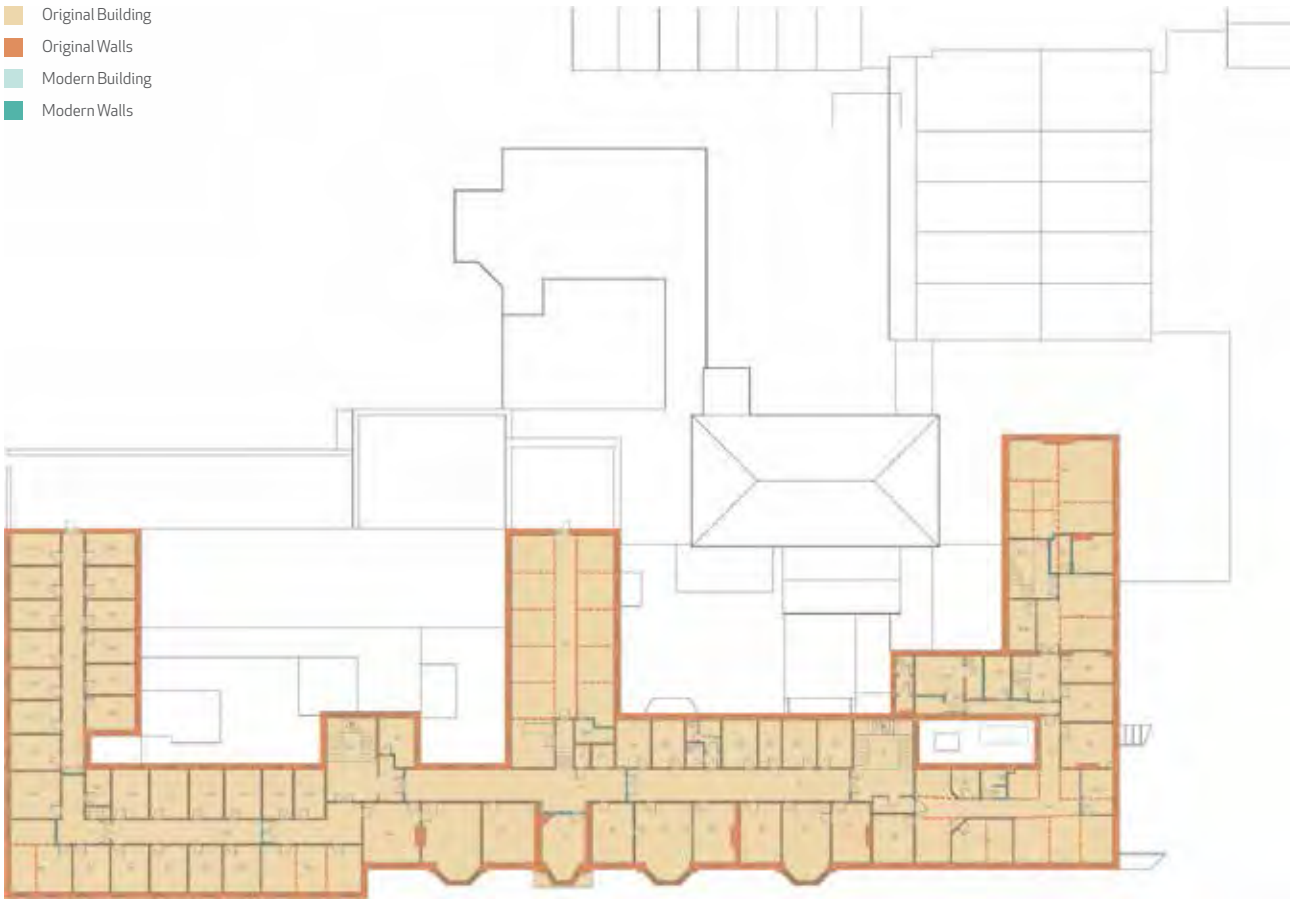
Main Building, Existing First Floor Plan

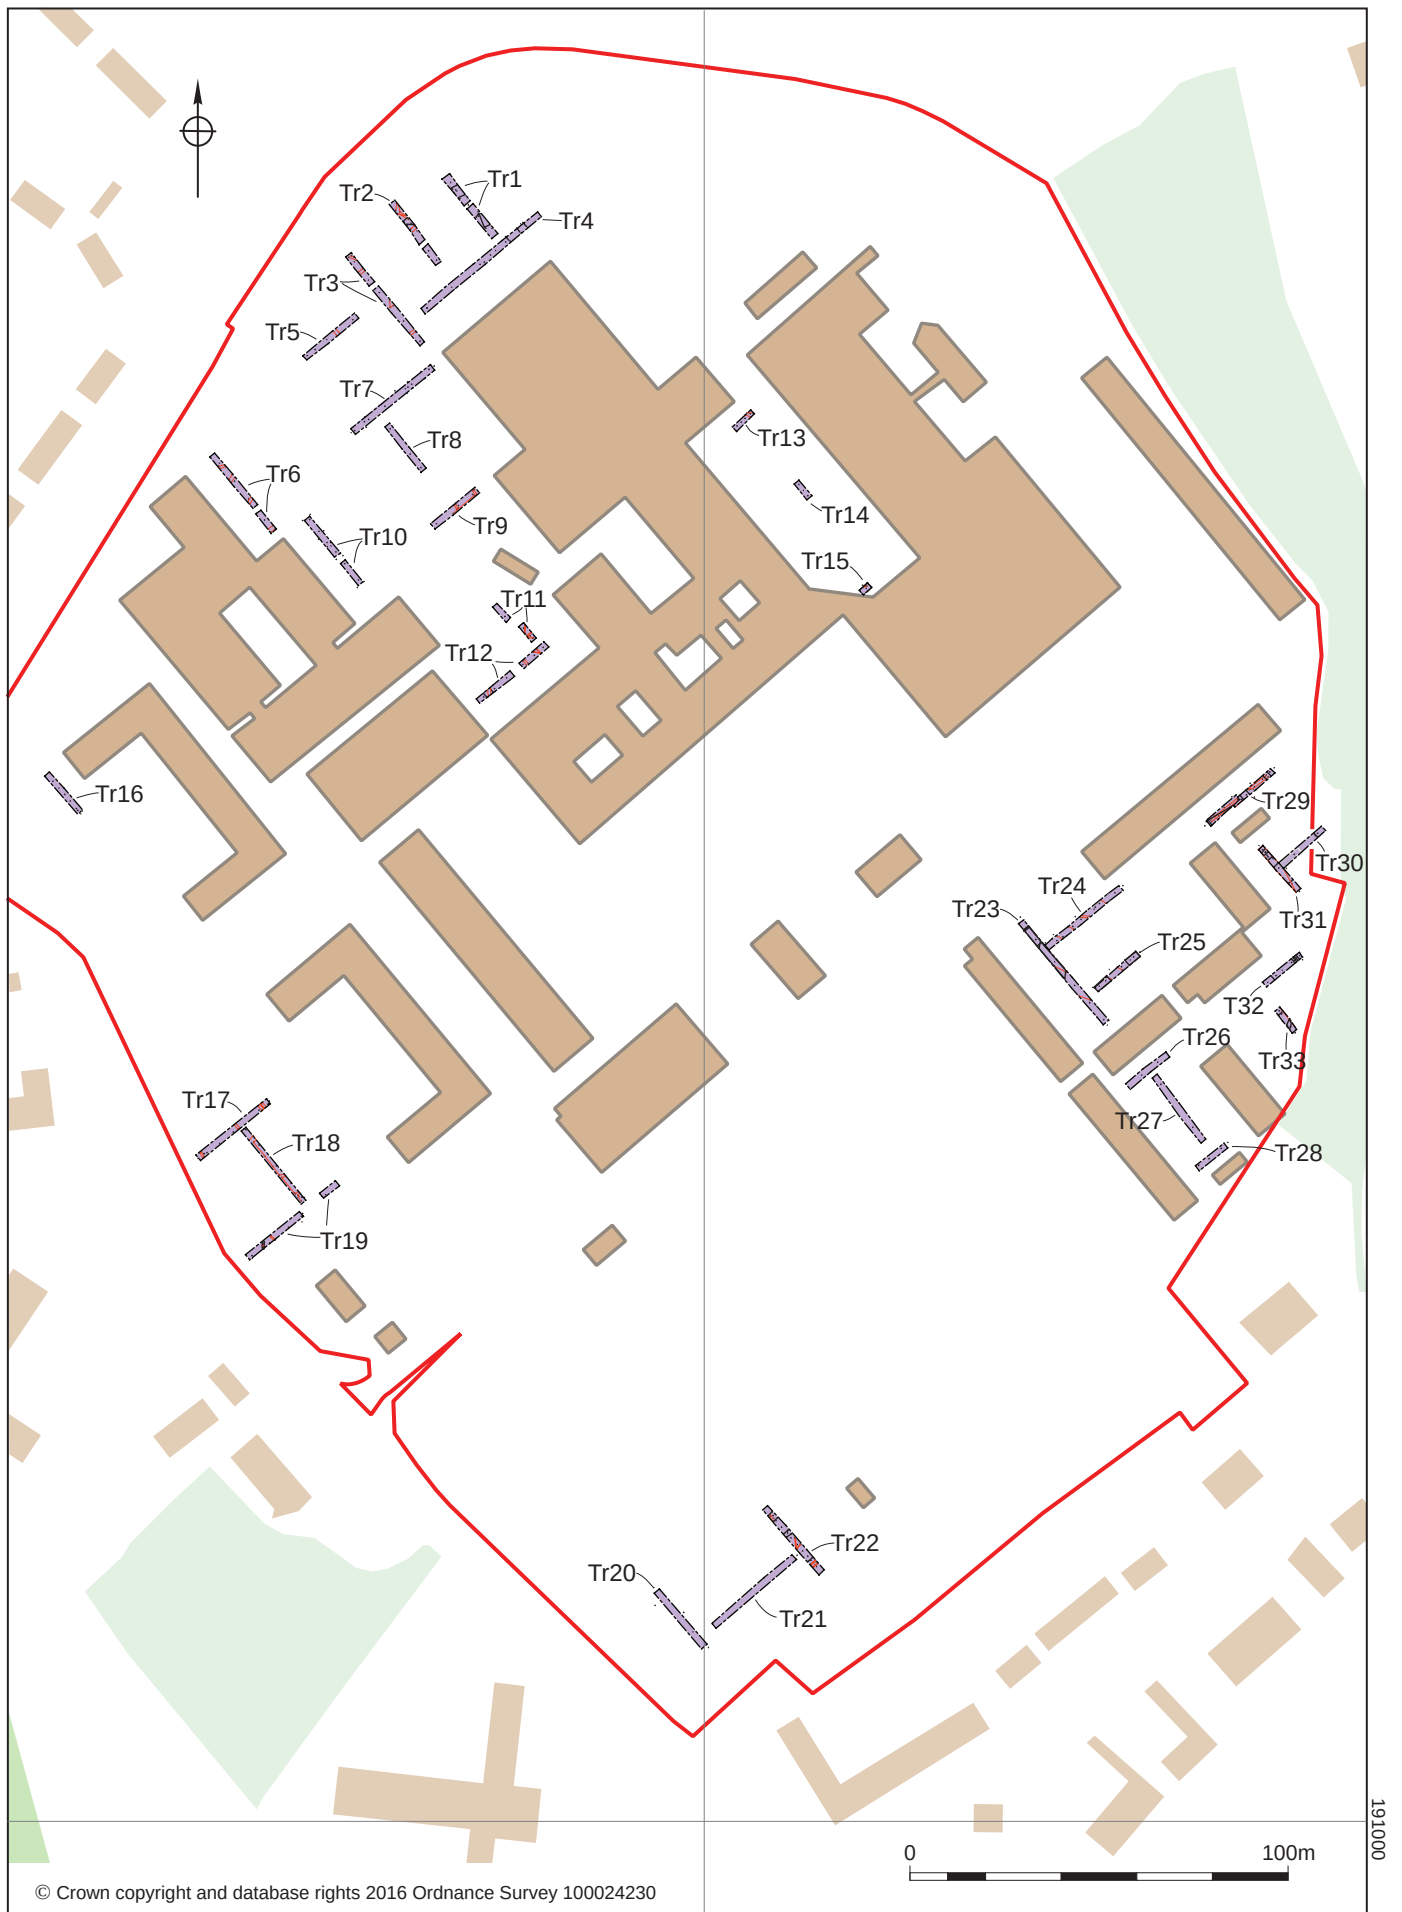
Figure 2

333500  
Trench location plan

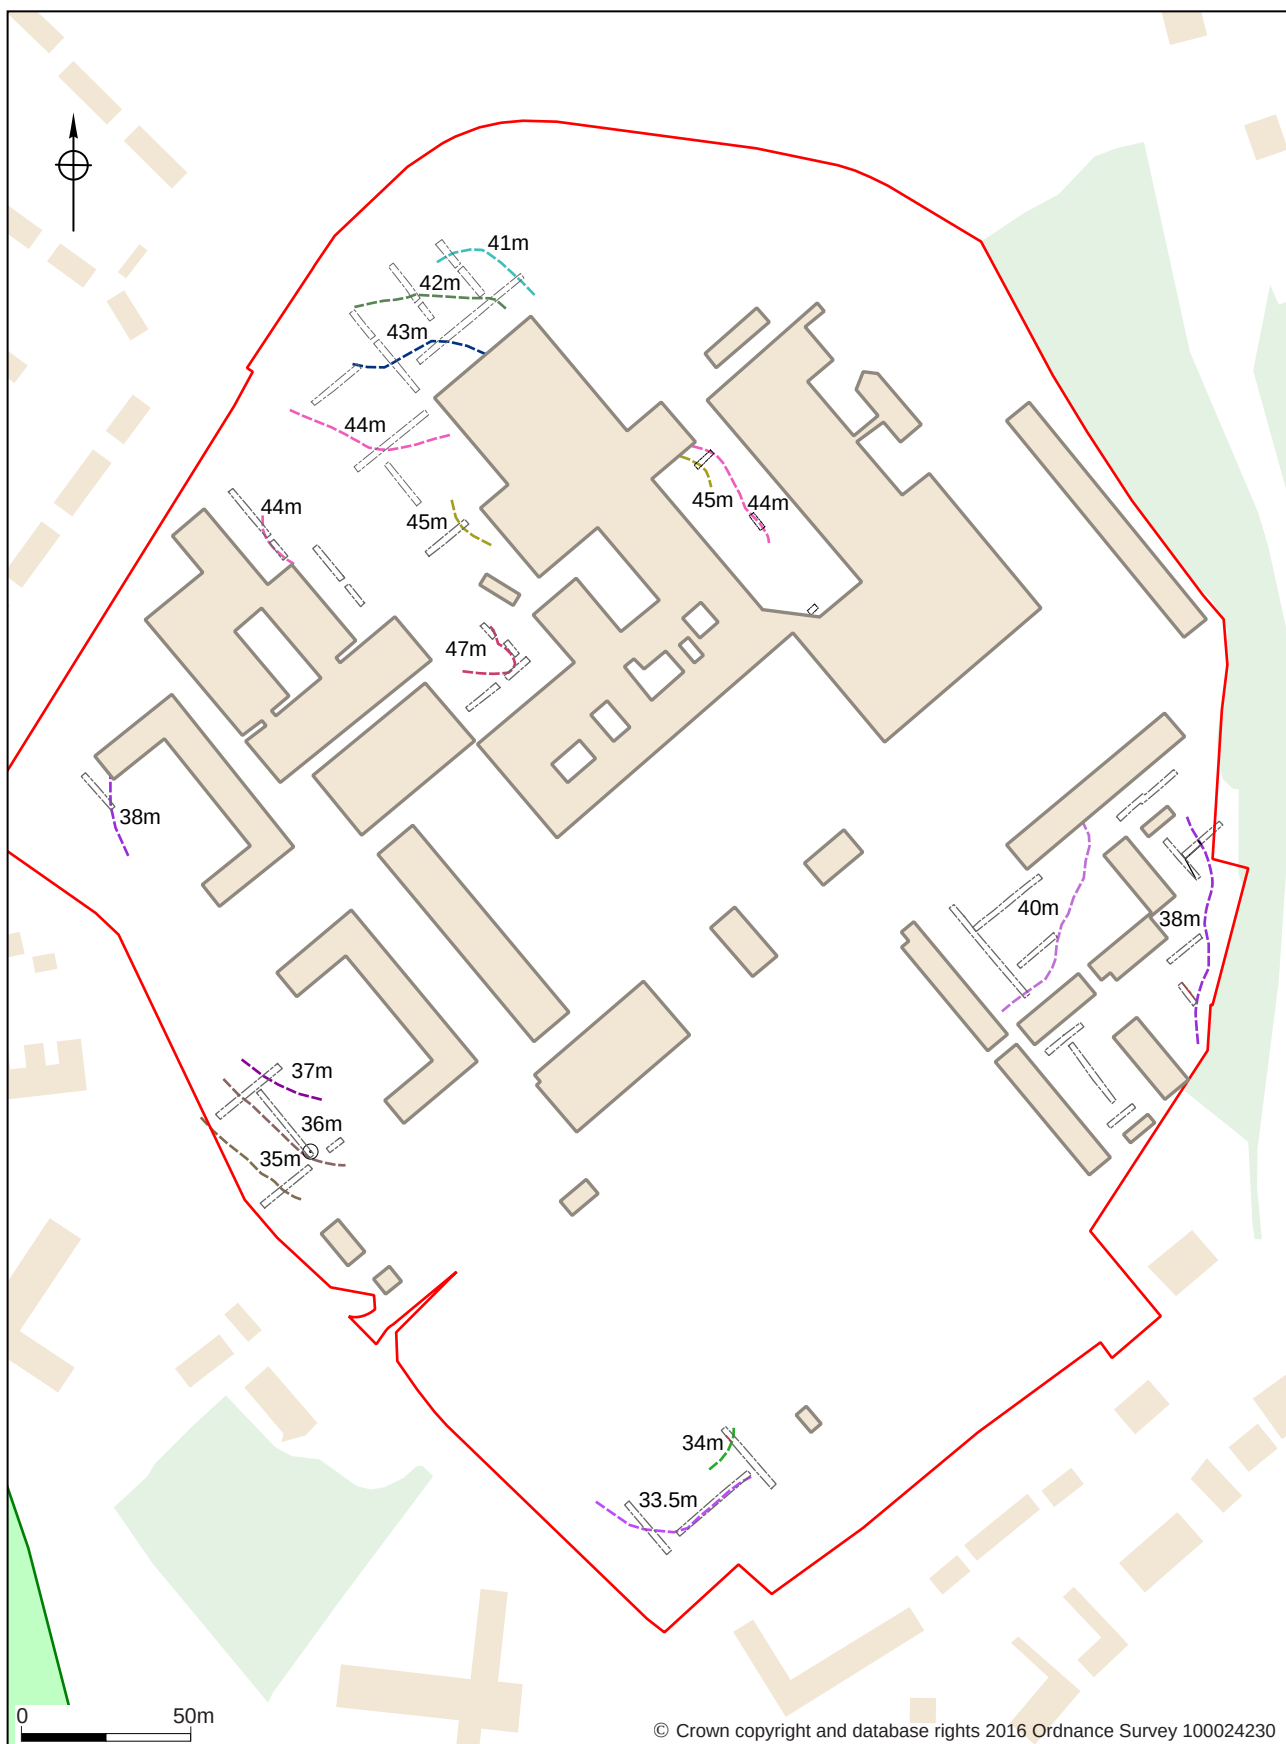
Figure 5

Contour plan

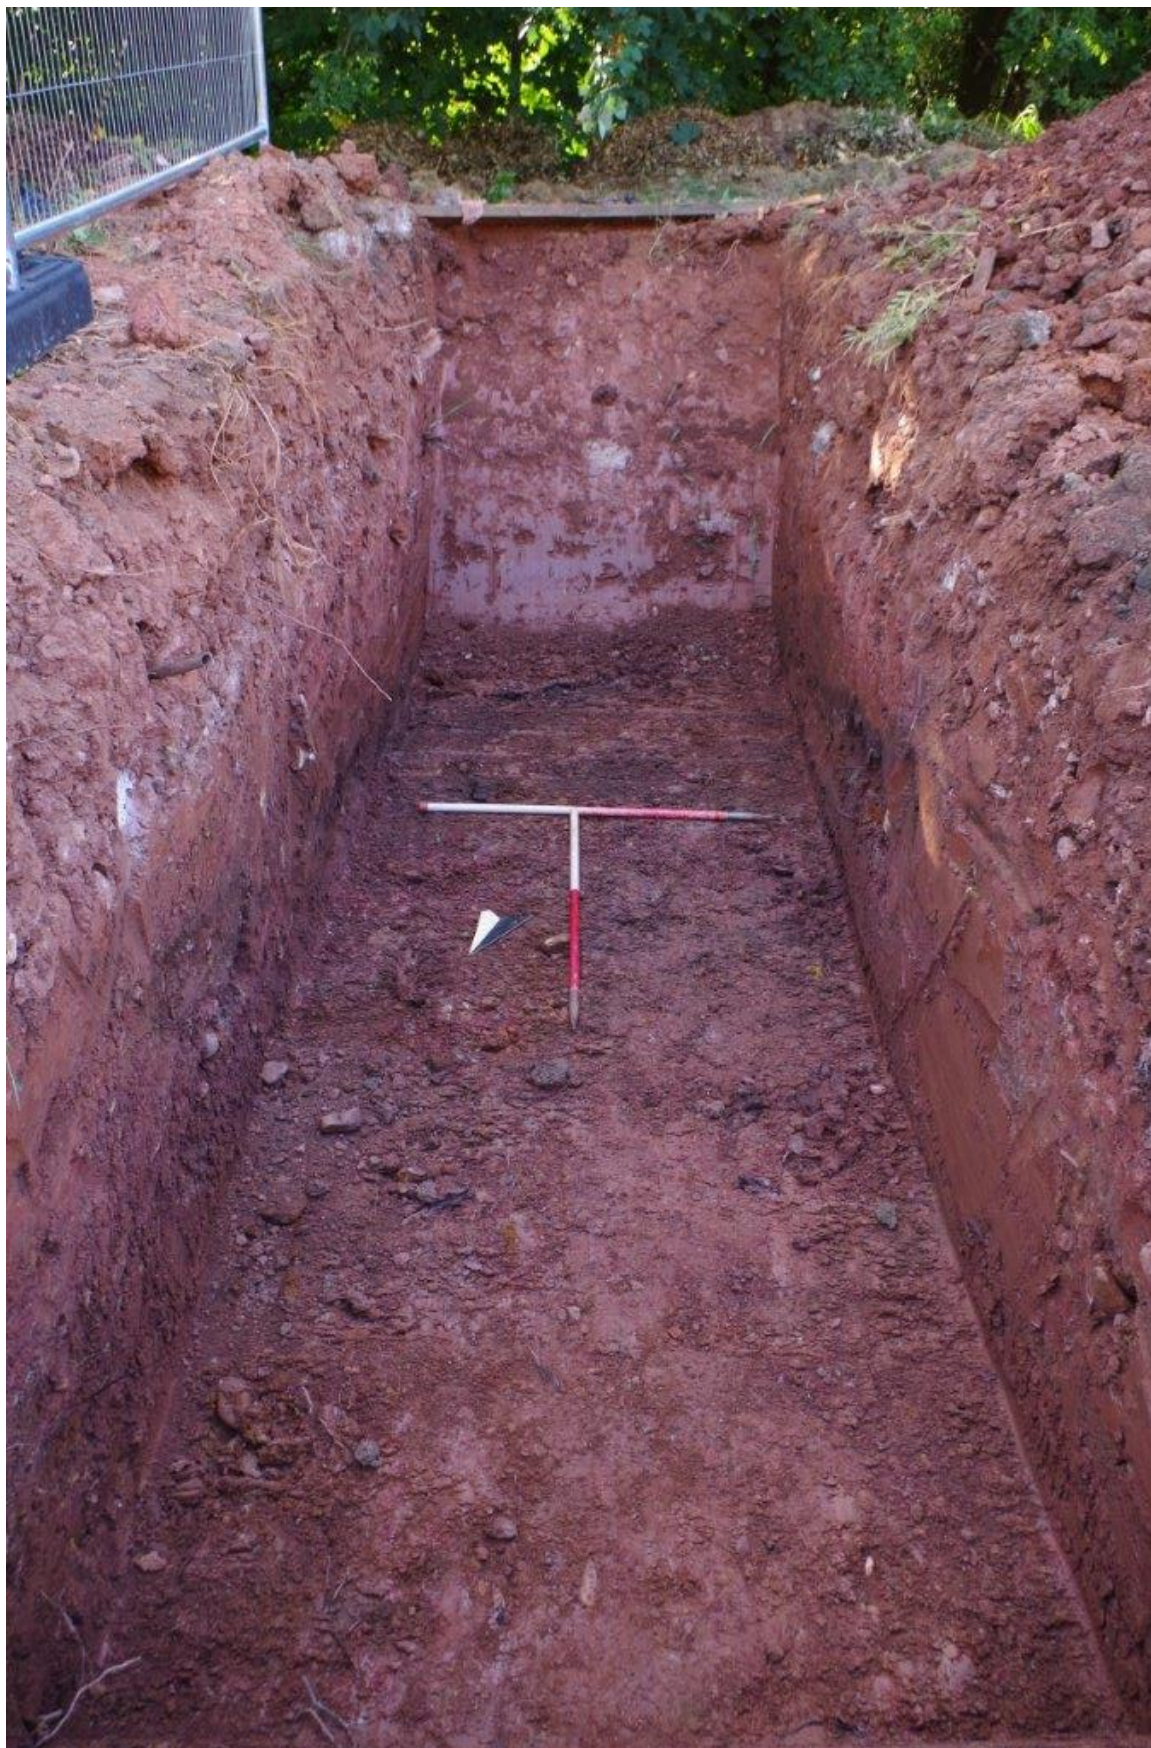
*Plate 3 Trench 33, looking south-east (1m scales)*
