# **Bassaleg Bridge**

## **Arboricultural Impact Assessment**

March 2025

**Document reference:** P01 | 100119581-MMD-XX-XX-RP-EN-0001

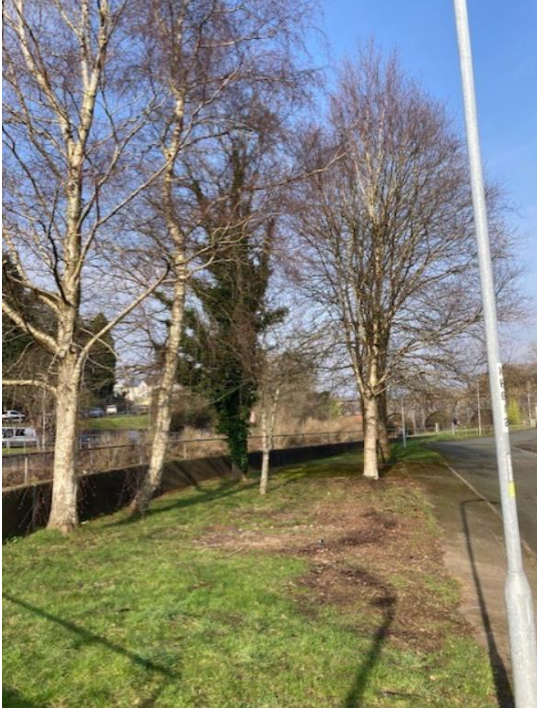
**Photo 1:** Image showing Trees 1 to 8 facing north with the river Ebbw in the background.

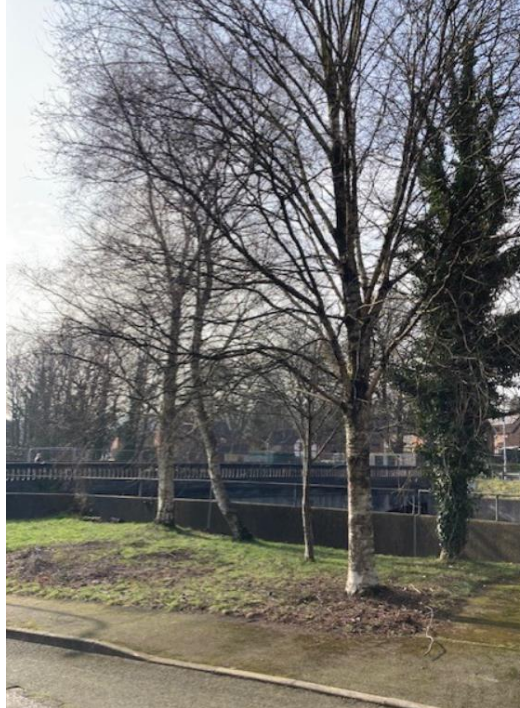
**Photo 2:** Image showing trees 4-8 facing west with the river Ebbw in the background.

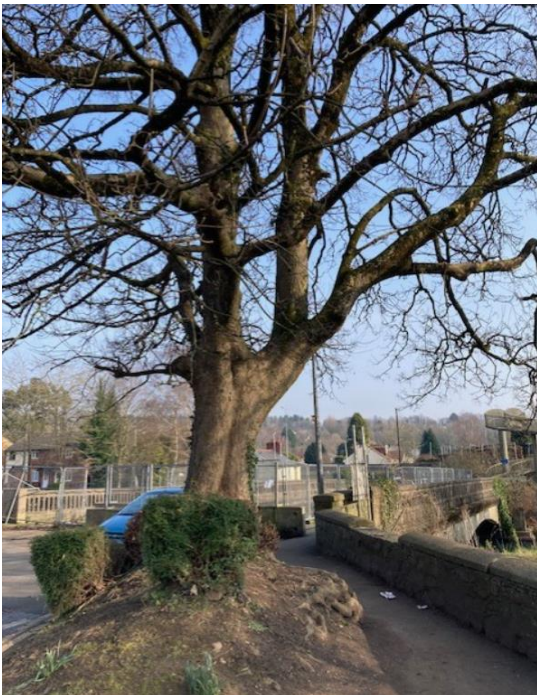
**Photo 3:** Showing Tree 9 facing north east.

Tree 9 is planted in a small, raised planting area surrounded on all sides by hard standing. This tree has long outgrown its available space and has exposed roots and is causing damage to the surrounding paved area.

| Tree Ref. | Species | Life Stage | Height (m) | Crown Spread (m) | | | | Crown Height (m) | | | | | No. Stems or Trees | Stem Diameter (mm) | RPA (m) | Condition | | | | Retention Category | Life expectancy (years) | Comments |
|---|---|---|---|---|---|---|---|---|---|---|---|---|---|---|---|---|---|---|---|---|---|---|
| 9 | Sycamore | Mature | 17 | 7 | 7 | 7 | 7 | 4 | 4 | 4 | 4 | 4 | 1 | 900 | 10.8 | Good | Good | Good | Good | A2 | 40+ | This tree is located within a grass island surrounded by hard standing on all sides. The tree's roots have become exposed and gnarled due to constrained location. There is reactive epicormic growth at base which has been recently pruned. The crown is displaying excellent strong vitality. |

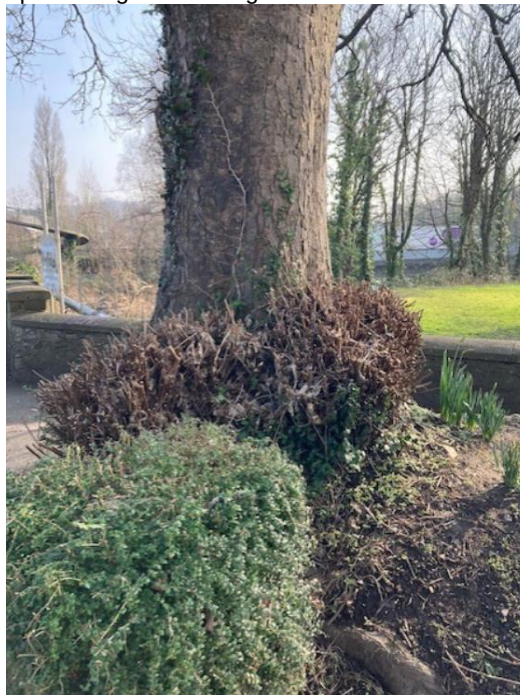
**Photo 4:** Showing Tree 9 and recently trimmed epicormic growth facing east.
