## Arboricultural Implications Assessment and Arboricultural Method Statement

In accordance with  
BS: 5837:2012

**Parc y Coleg Phase 2**  
Caerleon Former University Campus

On the instructions of  
**Redrow Homes**

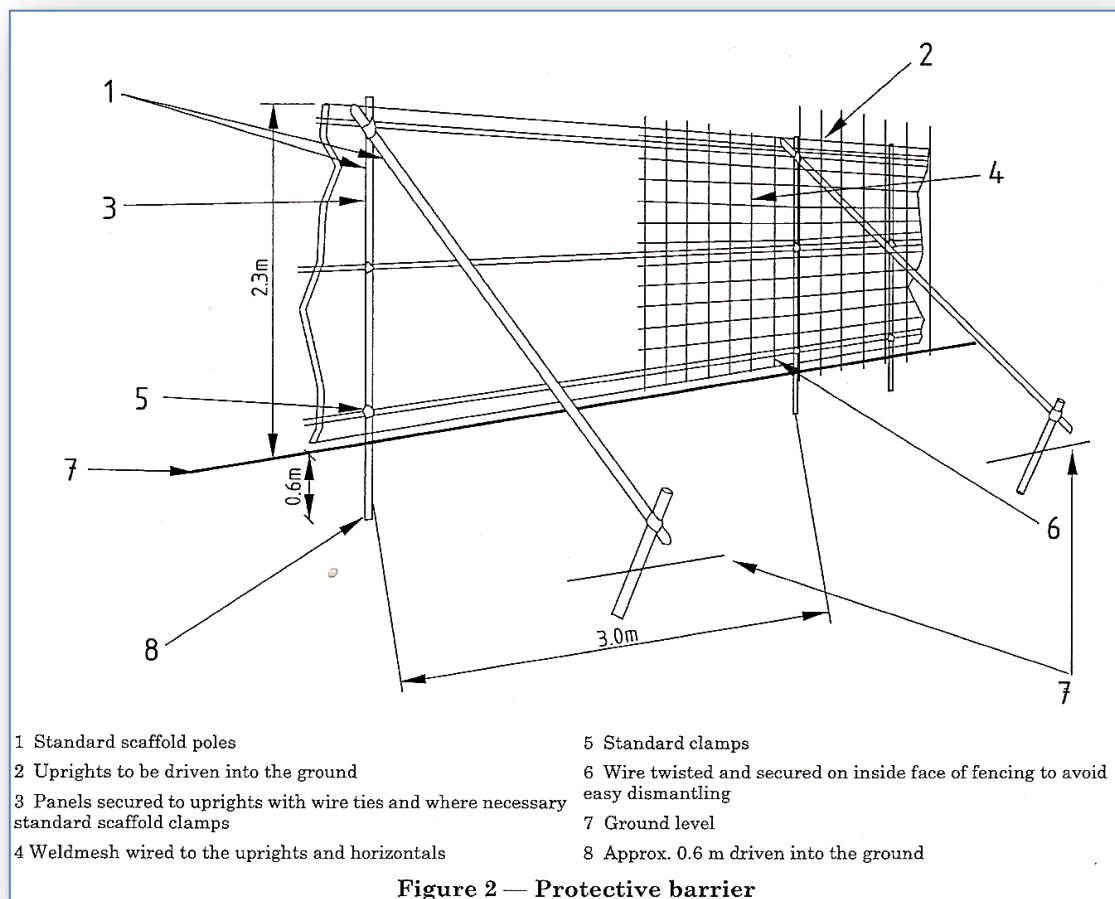
The default tree protection fencing specification should consist of a vertical and horizontal scaffold framework, well braced to resist impacts. The vertical tubes should be spaced at a maximum interval of 3 metres and driven securely into the ground. Onto this framework, welded mesh panels should be securely fixed. Care should be exercised when locating the vertical poles to avoid underground services and, in the case of the bracing poles, also to avoid contact with structural roots. If the presence of underground services precludes the use of driven poles, an alternative specification should be prepared in conjunction with the project arboriculturist that provides an equal level of protection. Such alternatives could include the attachment of the panels to a free-standing scaffold support framework.

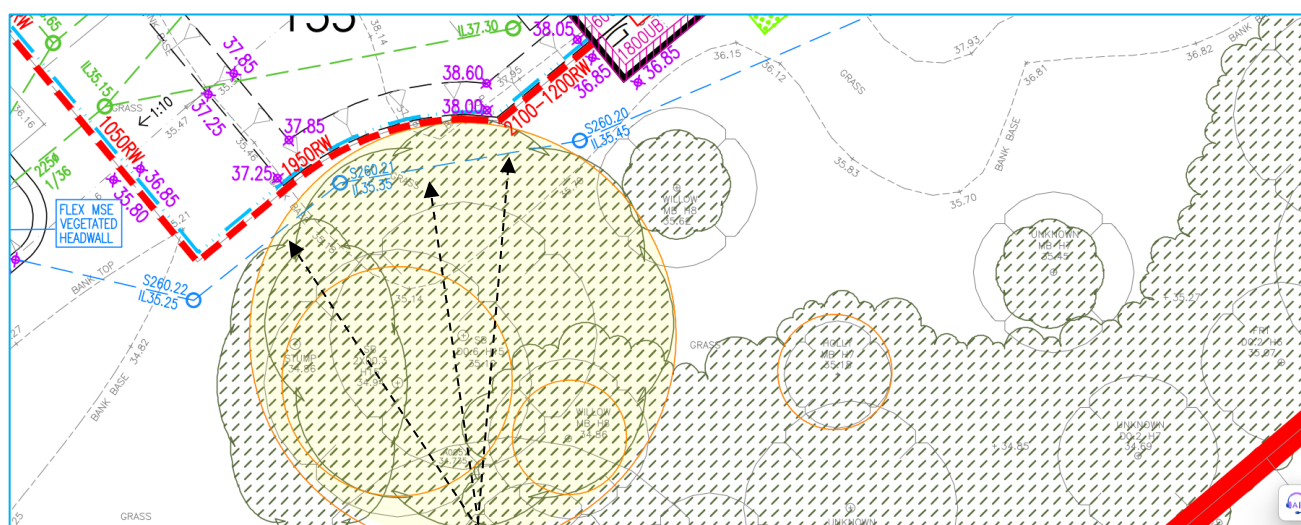
The tree highlighted in yellow below is identified as T10. A drain is proposed within its RPA and is shown as a dashed blue line which is highlighted in the plan extract below using 3 black dashed arrows. Open trenching to install drainage will sever all roots present along the line of the trench and so must be avoided.

**Recommendations –Tree 10 - follow the method statement below for trenchless technology.**

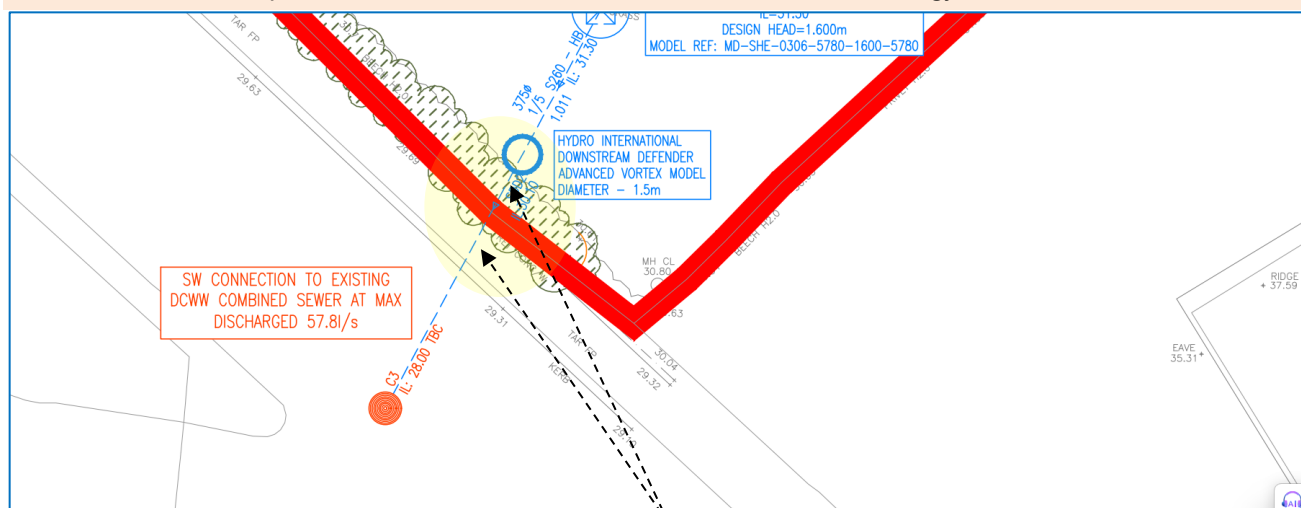
- **Conflict with G3**

The area of hedgerow highlighted in yellow below is identified as G3. A drain is proposed within its RPA and its position is shown as a dashed blue line which is highlighted in the plan extract below using 2 black dashed arrows. Open trenching to install drainage will sever all roots present along the line of the trench and so must be avoided.

**Recommendations –Group 3 - follow the method statement below for trenchless technology.**

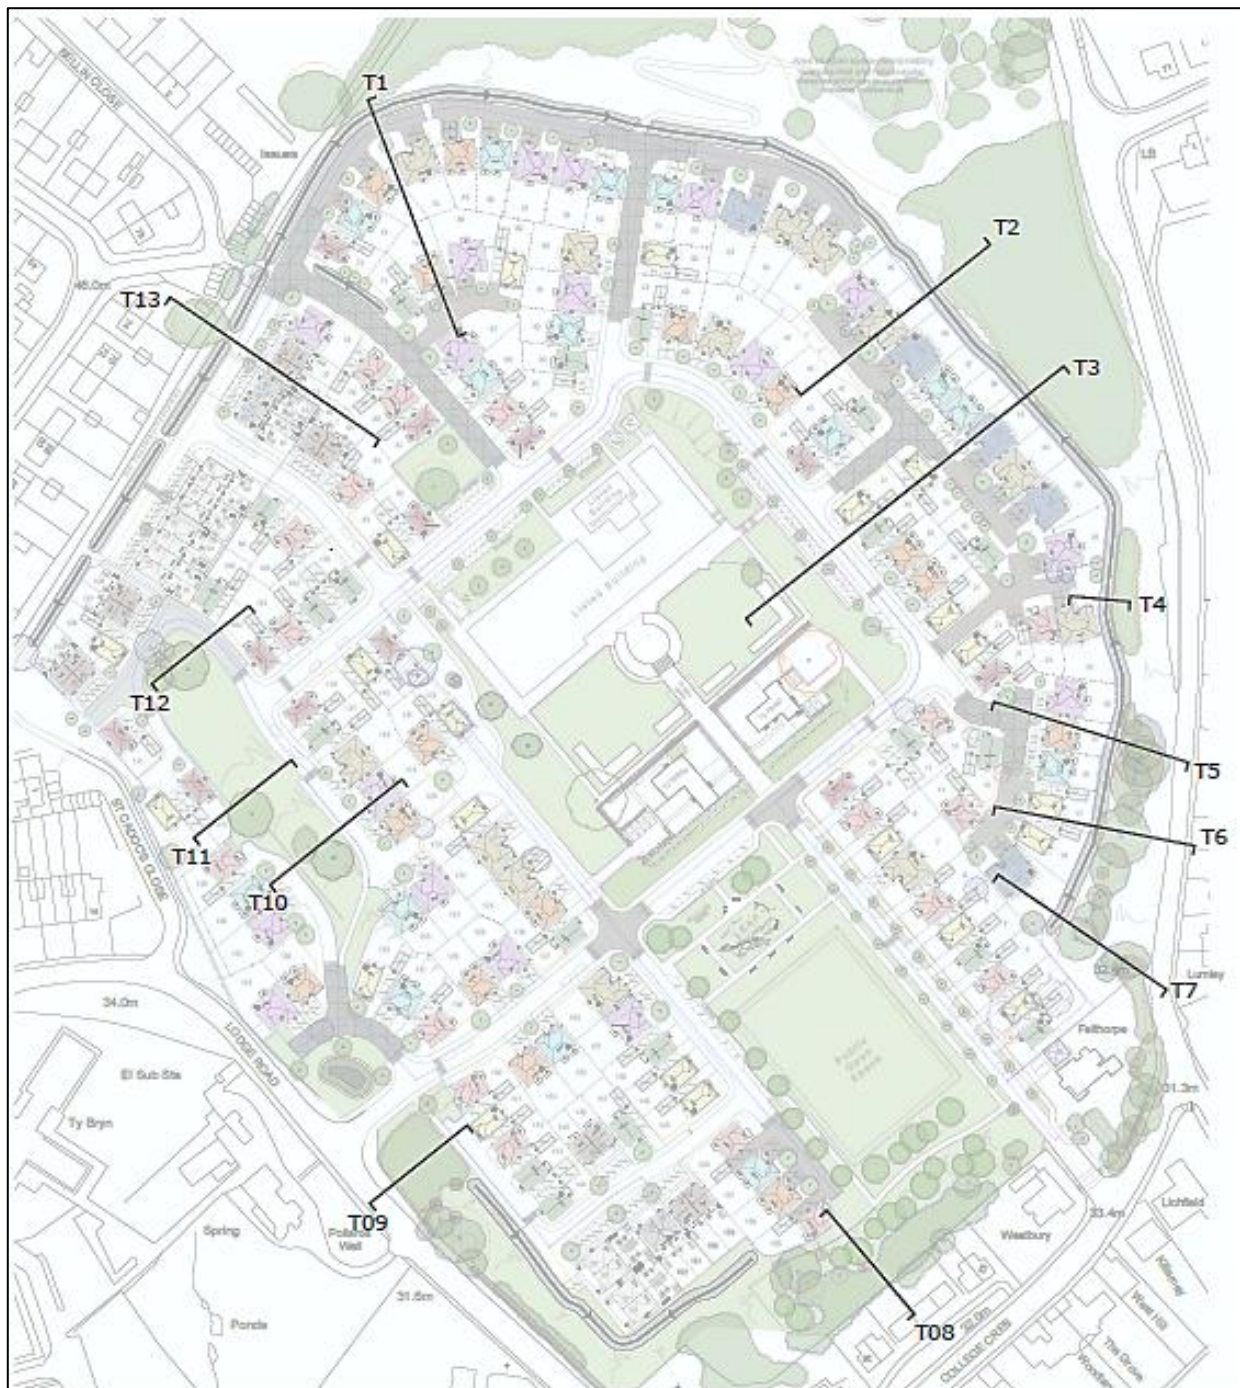
### Engineering Cross Sections Plan

The relevant cross-sectional plans depicting swales near trees, are shown below.

Plan Extract 7a. Section T1 - Swale abutting south-west of G23.

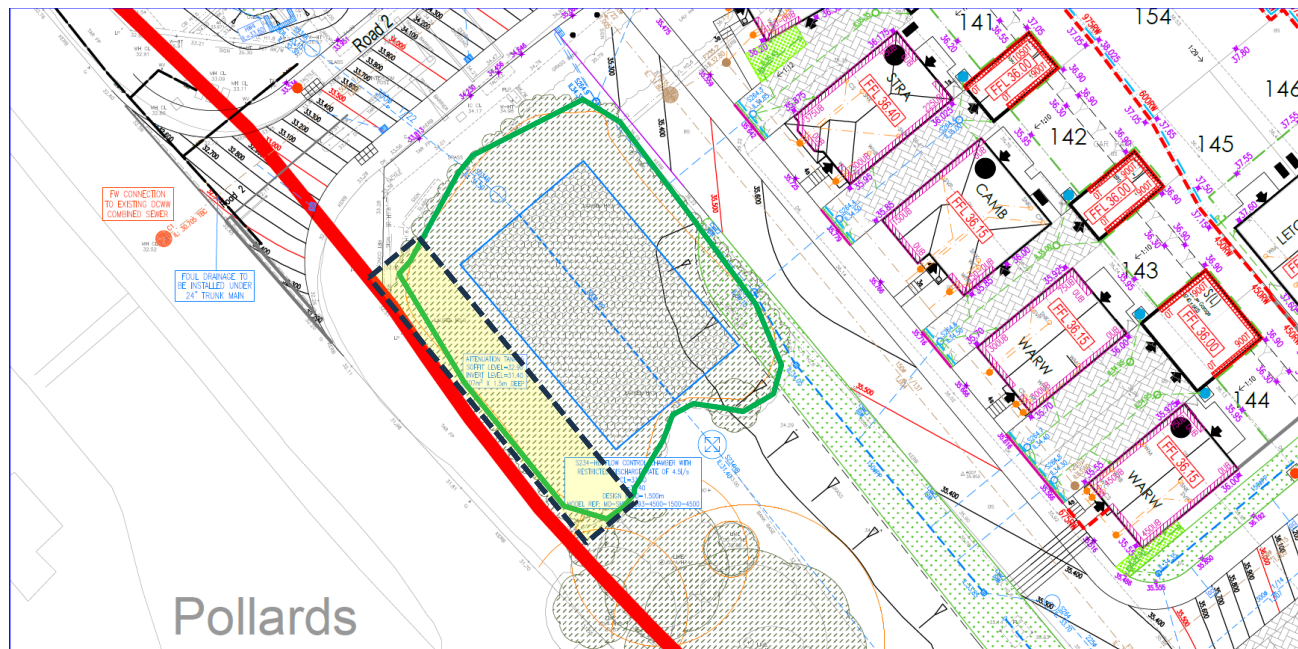
In the screenshot below, the area highlighted with a solid green line is Group 1 and comprises of the shrubs Cherry laurel, Japanese spotted laurel and Pittosporum. They are classed as Category. The proposed attenuation tank will result in the loss of around 80% of the shrub cover. The remaining 20% against the boundary should be retained to provide visual screening.

Group 1 to be assessed by the PA.

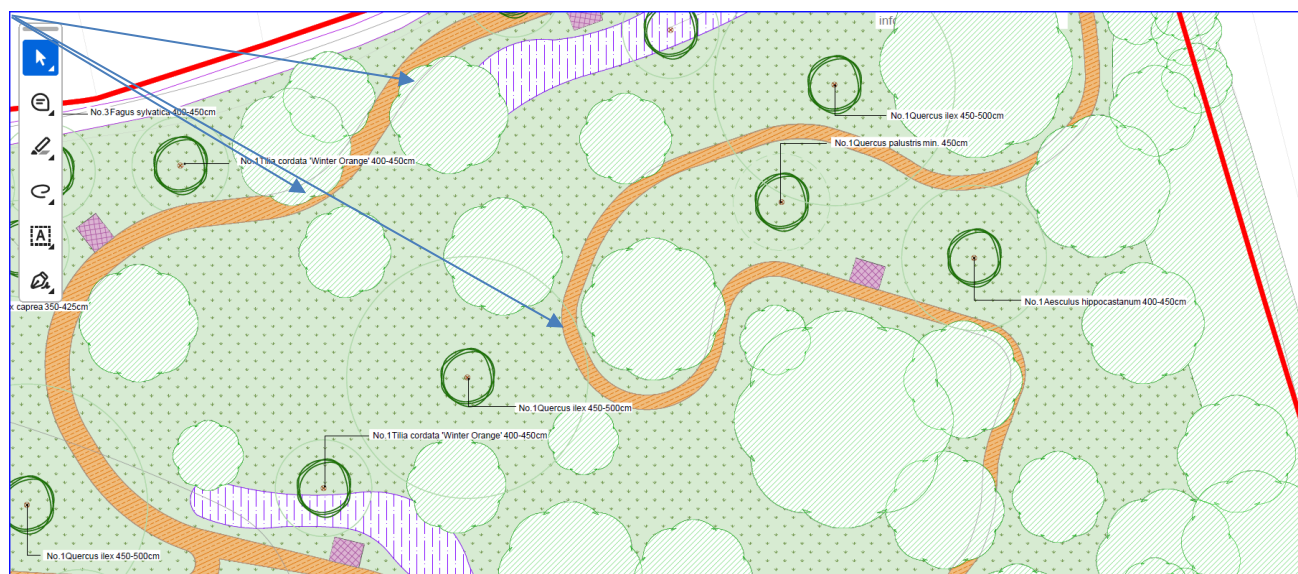
**Plan Extract 8. Orange solid line - Upgrade & new path network within G23.**

An upgrade in part (from Saint Cadoc's Close to Bellin Close) of the existing Public Right of Way will see the footpath/cycle-path created at a width of 3-m which will involve a widening of the existing. Trees within influencing distance of this path include those on-site and adjoining the site (primarily T116 and possibly T117). An upgraded / new footpath is noted within G23 as per the Landscape plan (EDP 5061), extract below: -

The upgrade should be of a no dig tree friendly construction ideally utilising the existing surface as a sub-base (refer to Arboricultural Method Statement – Footpaths/Cycle-path below).

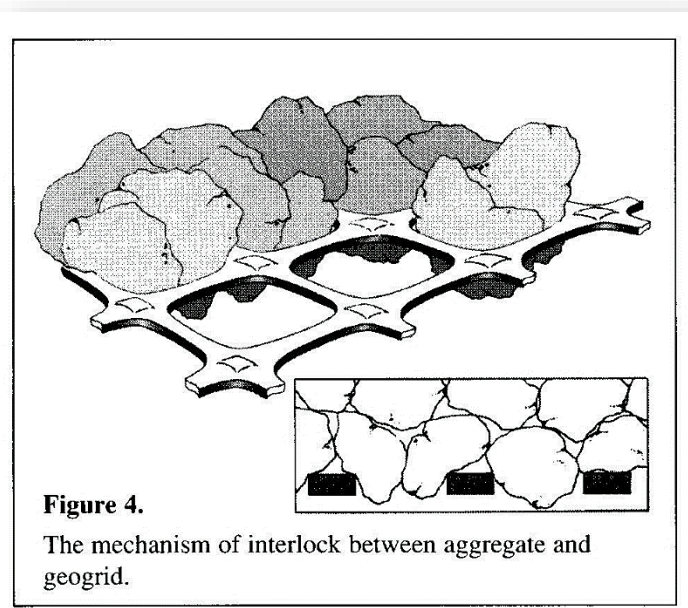
15. When placed on a **two-dimensional grid**, appropriate, no-fines granular sub-base material penetrates the mesh, but is unable to pass through it, forming a positive interlock (refer to Figure 4). This interlock between aggregate and grid

provides a reinforced platform and efficient load spread into the ground over a wider area than the footprint of the wheel on the surface. A suitable geogrid/aggregate combination constructed with the grid under tension should prevent rutting of the ground beneath construction.

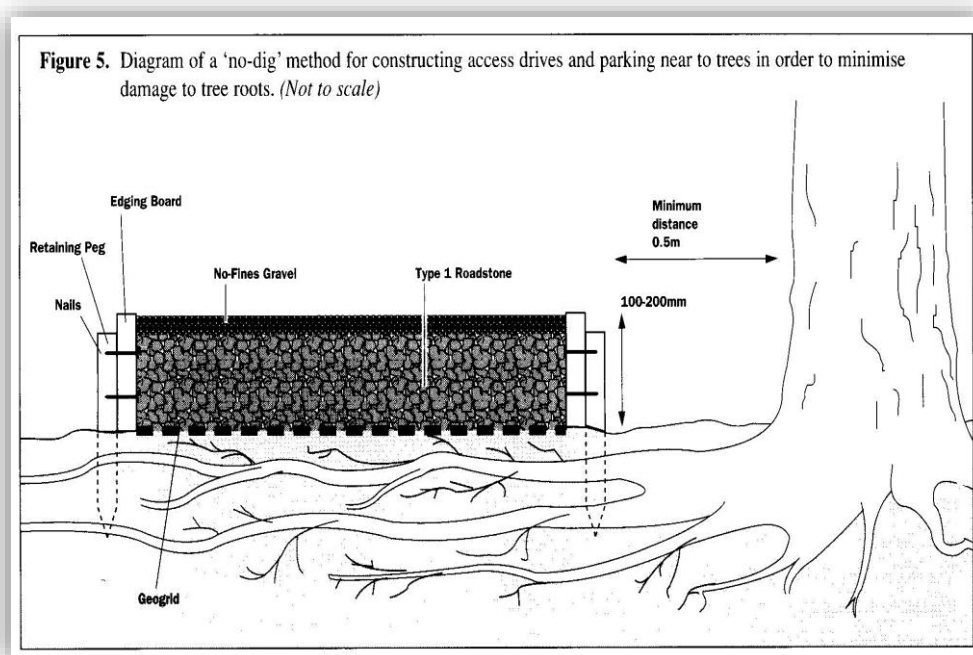
16. The granular sub-base material should have a 'no-fines' content which means that even when it is compacted it should be freely draining and will allow oxygen to diffuse into, and damaging gases (e.g. carbon dioxide and methane) out of the soil.
17. An example of a no dig path construction is offered in Figure 5.

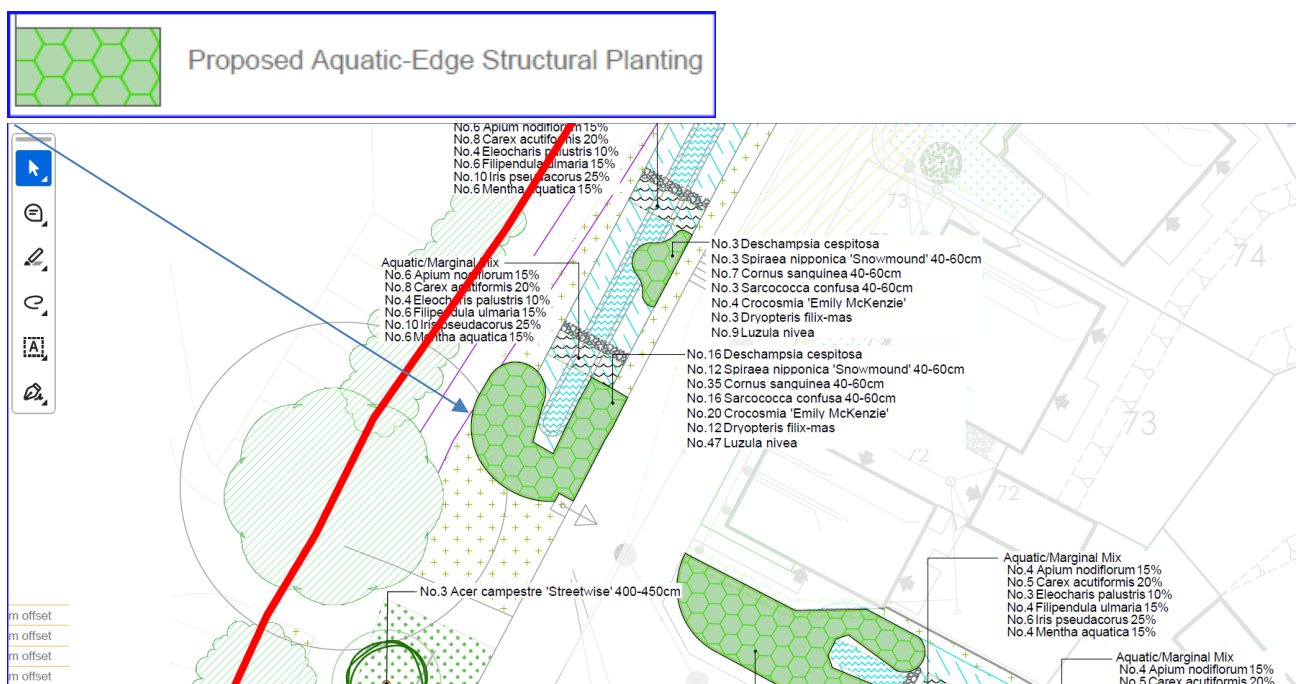
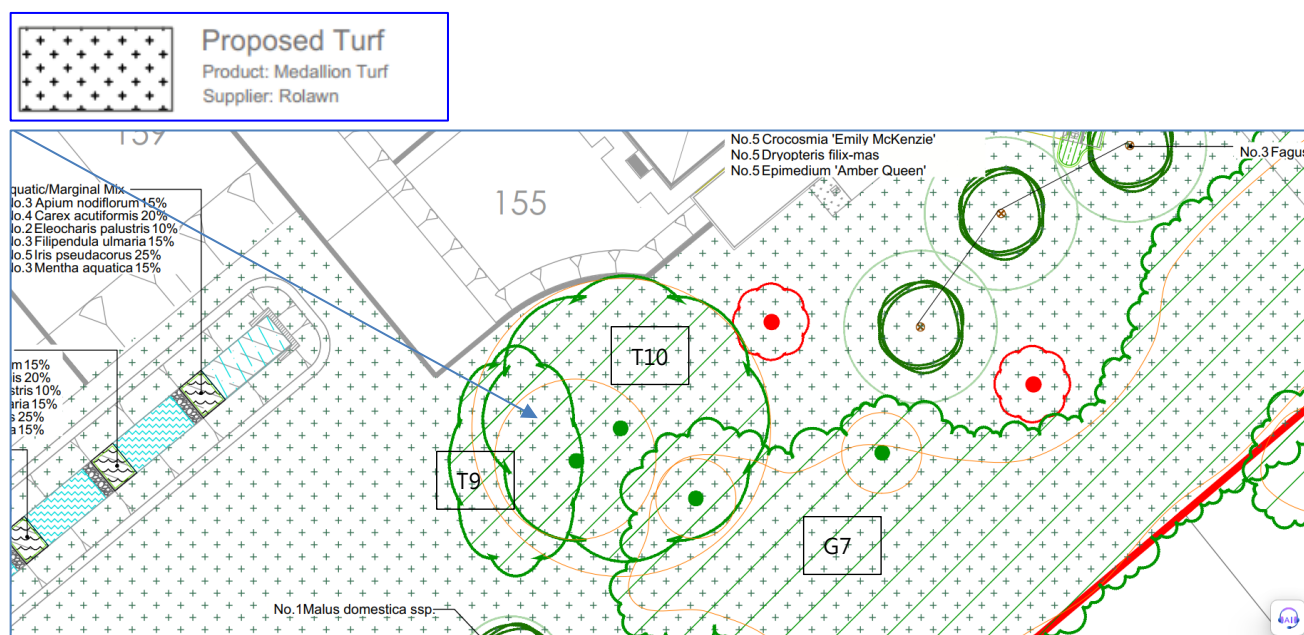
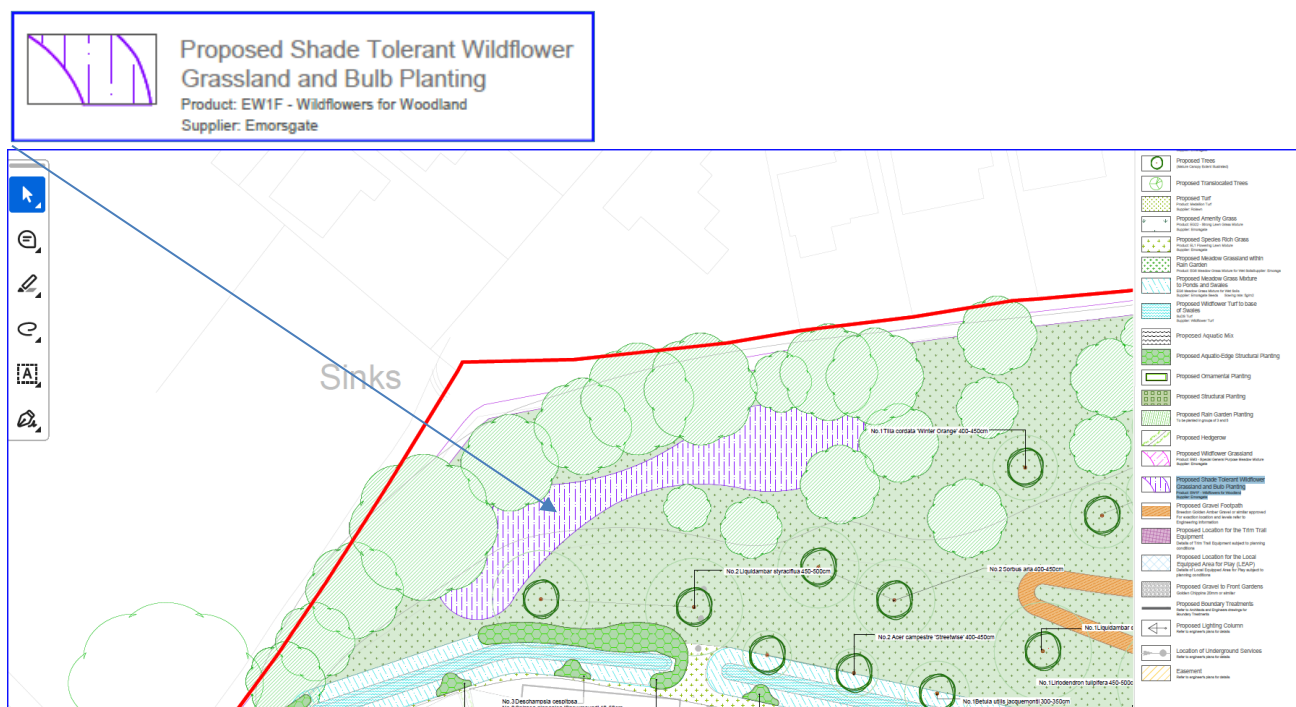
Planting, turfing and wildflower seeding is proposed within the Root Protection Area of retained trees (refer to screen grabs below). Planting should not occur within the RPA as it requires digging and will damage roots 90% of which occur within the top 300-mm of the soil surface. Turfing is also damaging to tree health due to the raising of existing levels which is unavoidable and with the ground preparation works required. Turfing should be avoided in favour of seeding operations. Wildflower seeding is proposed and both should follow the method statement below.
