# CONSTRUCTION ENVIRONMENTAL MANAGEMENT PLAN

**Proposal:** Slurry Lagoon at Henton Farm

**Title:** Construction Environmental Management Plan: Slurry Lagoon at Henton Farm

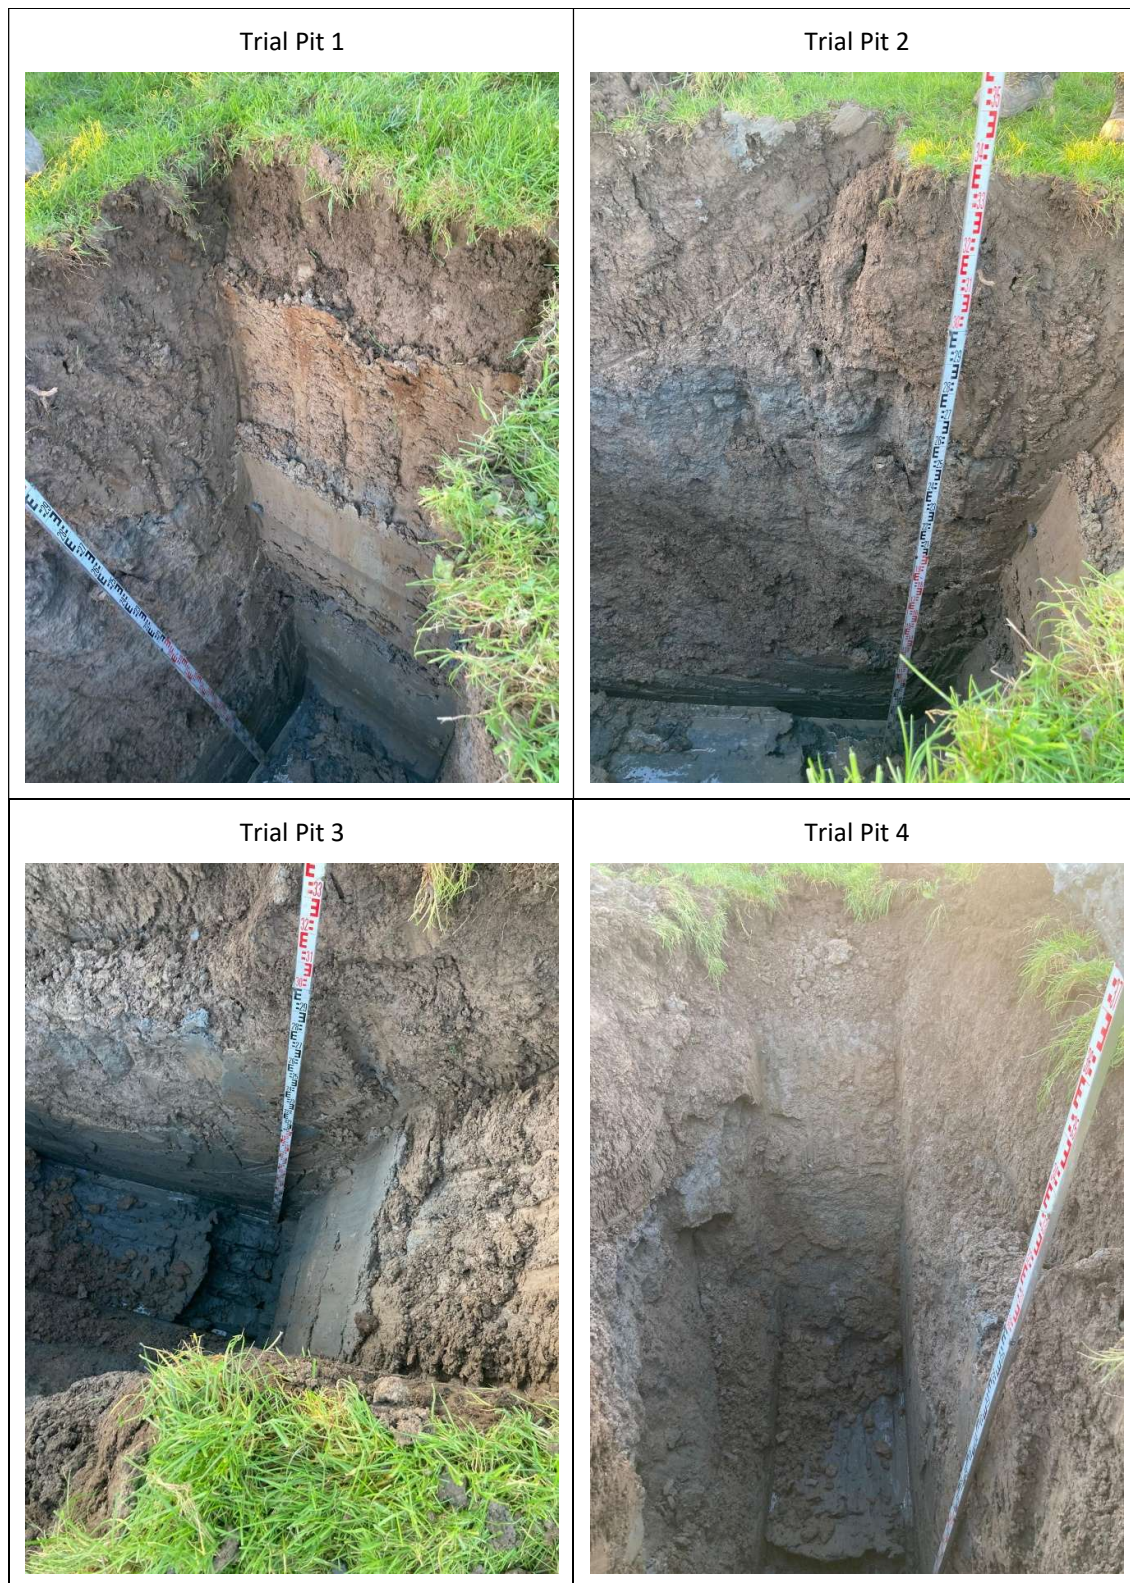
Figure 2: Trial pit photographs

The trial pits illustrated distinct layers through the soil profile, as illustrated in Figure 4. All five trial pits were largely consistent across the site. The profile can be described as:

| 0 - 0.25m | Dark greyish brown, slightly mottled stoneless silty clay. |
| 0.25 - 0.8m | Greyish brown, mottled, stoneless silty clay. |
| 0.8 – 3.0m | Brown, mottled, stoneless silty clay. |
| 3.0 – 3.5m | Blue grey, stoneless clay. |
| Below 3.5m | Mudstone |

Trial pits were dug using a JCB 4CX excavator at the perimeter points of the proposed lagoon area.

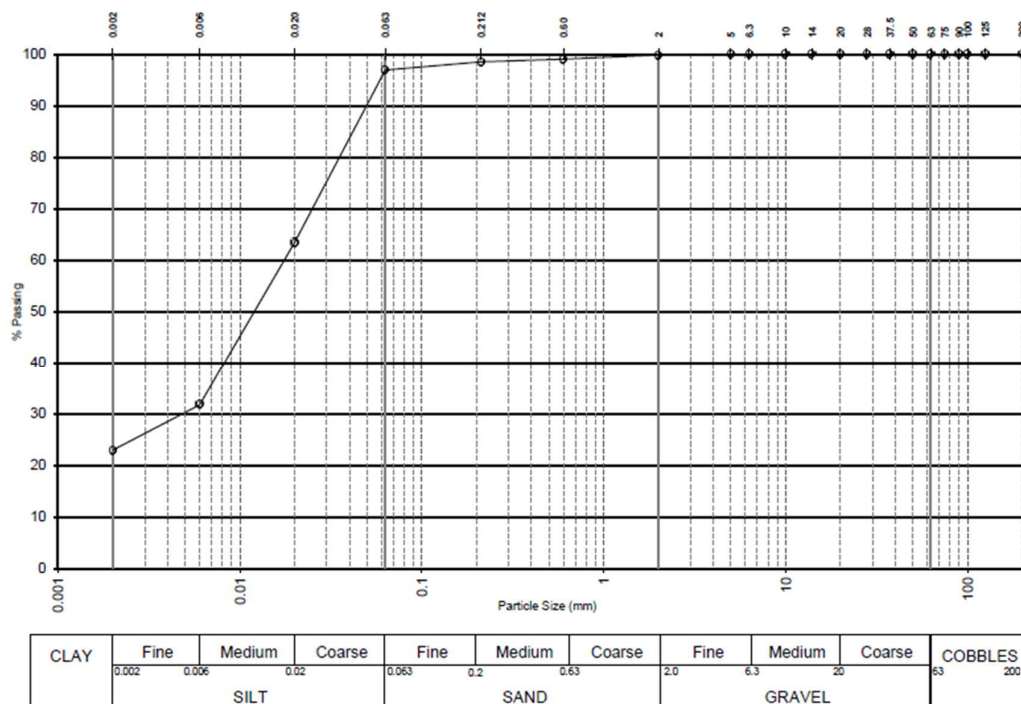
To determine the Particle Size Distribution (PSD) of a soil sample-  
washing and sieving method in accordance with **BS1377-Part2-1990 Clause 9.2**  
Sedimentation by pipette method to **BS 1377: Part 2: 1990: clause 9.4.**

| Method of pre-treatment: | | N/A | | | |
|---|---|---|---|---|---|
| 100 | 100 | 0.212 | 99 | Clay | 23.0 |
