| <b>Appendix EDP 1</b> | Proposed Site Plan<br>(Drawing Number: 18137(05) 1101 Rev AA, Powell Dobson, May 2022) |
| <b>Appendix EDP 2</b> | Detailed Soft Landscape Plan<br>(edp5601_d025ac 12 December 2024 LCH/DR) |
| <b>Appendix EDP 3</b> | Detailed Landscape Proposals for the Residential Plots<br>(edp5601_d031z 12 December 2024 LCH/DR) |
| <b>Appendix EDP 7</b> | Bat Mitigation Plan<br>(edp5601_d034b 27 September 2021 DJ/EW) |

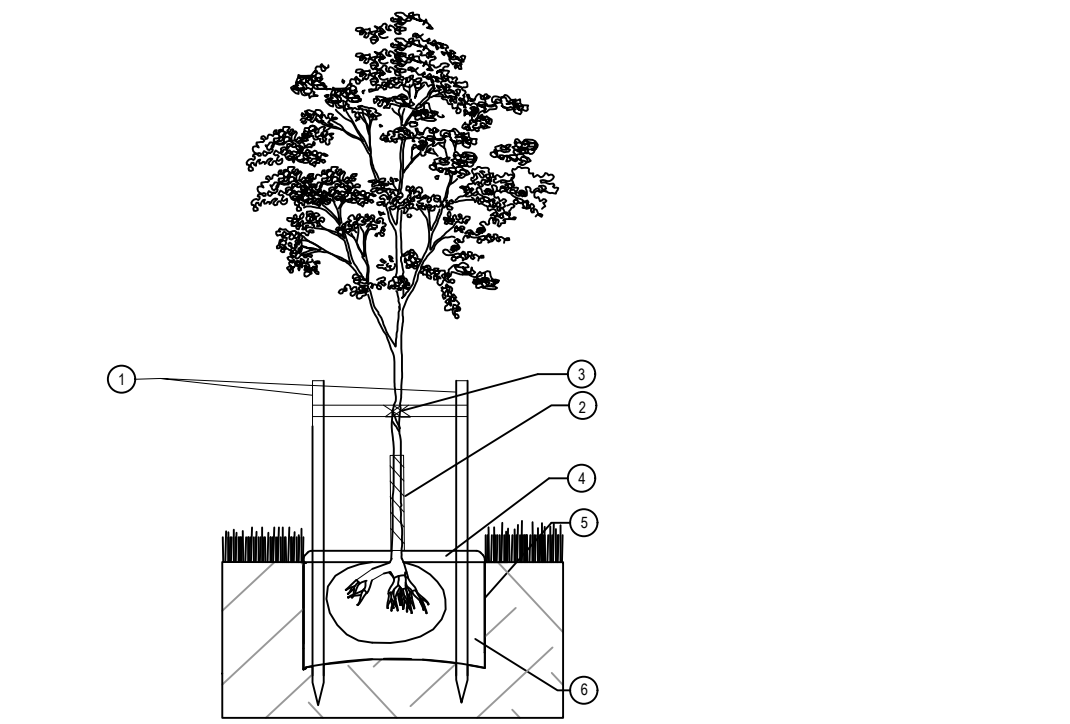
Tree Pit Detail

1. 2x tarasised timber tree stakes 2m, 75mm Ø and crossbar driven into backfilled pit to provide support to the tree. Where trees are to be installed within navigational/bioretention features, stakes to be installed to a maximum depth of 750mm to ensure the liner is not compromised.

4. 75mm deep bark mulch layer to be spread evenly over a circular area 1000mm Ø around the tree to prevent weed growth and retain moisture. Alternatively, a suitable mulch mat can be used covering the same area.

5. Excavate tree pit to sufficient size to accommodate tree root ball. Loosen any compaction in base of excavated pit to aid drainage. Tree to be planted at a depth where the root flare is still visible, just breaching the soil surface, following backfilling.

Immediately following planting, the tree will be watered thoroughly. Following this, and with regard to prevailing weather conditions, newly planted trees are to be watered regularly during periods of dry weather. If the tree pit has been specified with an irrigation pipe, this will be used as the primary method of watering. If no irrigation pipe is specified, the square metre of ground around the tree will be soaked to field capacity (refer to BS8545:2014 for further detail) by surface watering. Watering frequency is more important than quantity to prevent the root ball of the newly planted tree from drying out.

All trees are fitted with protective guards to prevent animal damage. These are to be checked regularly to ensure they remain in place and are providing adequate protection against the animals in the area. If damage to trees from browsing by animals still occurs, additional measures will be required.

A formal assessment of young tree health and development must be carried out annually by a qualified arborist who will be able to advise on problems should any problems be picked up. During this assessment, any stakes and ties will be checked to ensure they are providing support but not damaging the tree and that the tree is still firmly seated in the ground. If the tree has become loose in the ground, the soil around the base will be re-firmed and stakes and ties adjusted accordingly.

Tree stakes and ties are to be removed once the tree has established a strong enough root system to support itself, likely to be 1-2 years after planting. Tree guards, are only be removed if they are beginning to restrict tree growth or if it is felt the risk of damage has significantly reduced due to strong tree growth and development or changes in the surrounding environment.

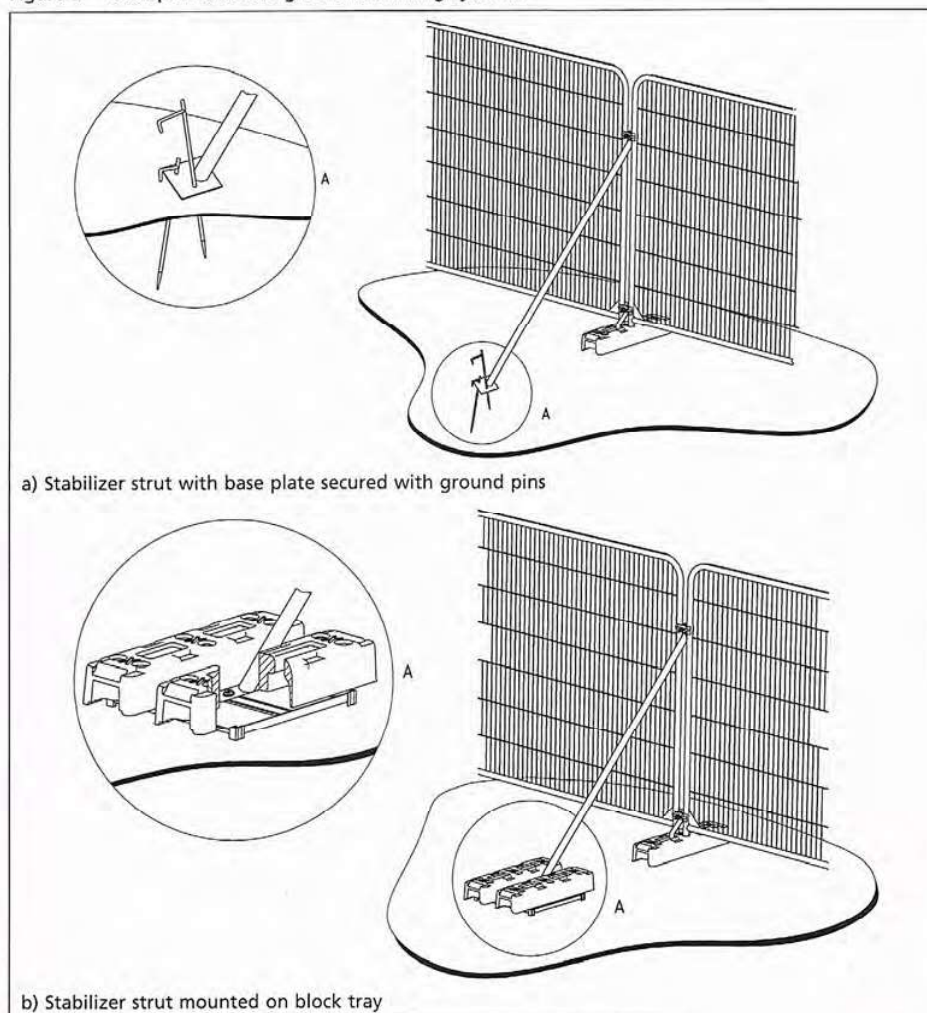
Figure 3 Examples of above-ground stabilizing systems

Where the site circumstances and associated risk of damaging incursion into the RPA do not necessitate the default level of protection, an alternative specification can be applied. Erect 2-metre-tall, welded mesh panels on rubber or concrete feet might provide an adequate level of protection from cars, vans, pedestrians and manually operated plant. In such cases, the fence panels should be joined together using a minimum of two anti-tamper couplers, installed so that they can only be removed from inside the fence. The distance between the fence couplers should be at least 1 metre and should be uniform throughout the fence. The panels should be supported on the inner side by stabilizer struts, which should normally be attached to a base plate secured with ground pins (Figure 3a). Where the fencing is to be erected on retained hard surfacing or it is otherwise unfeasible to use ground pins, e.g. due to the presence of underground services, the stabilizer struts should be mounted on a block tray.

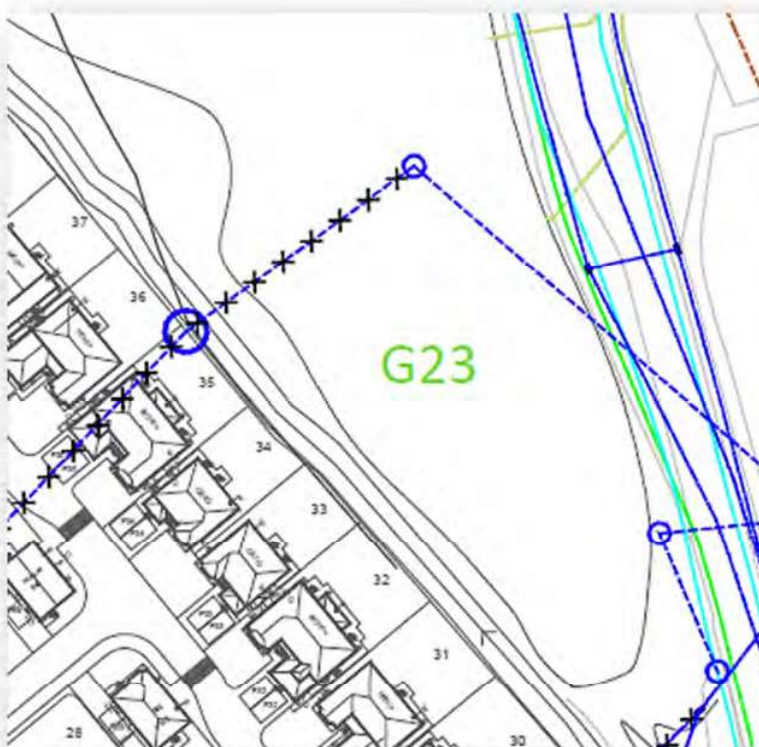
Plan Extract 2. Group 23 (southern section) Intermittent blue line are overhead BT Cables.

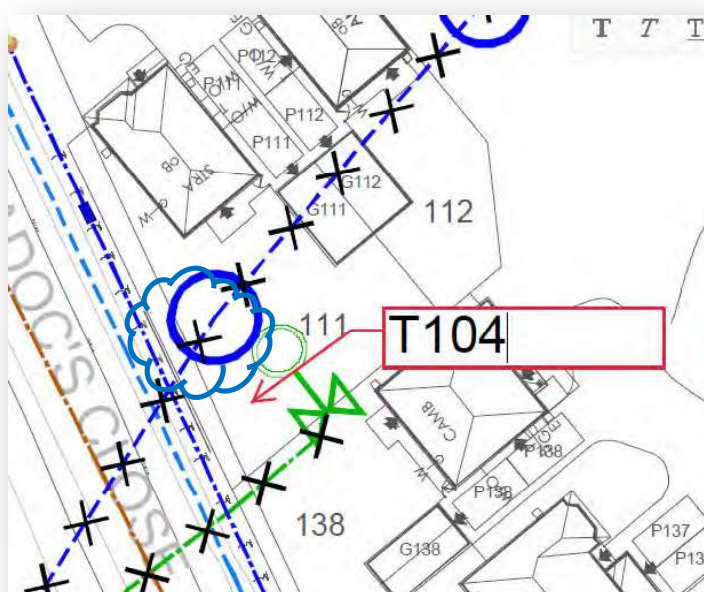
Plan Extract 3. Tree 104 with gas mains and apparatus (green lines)

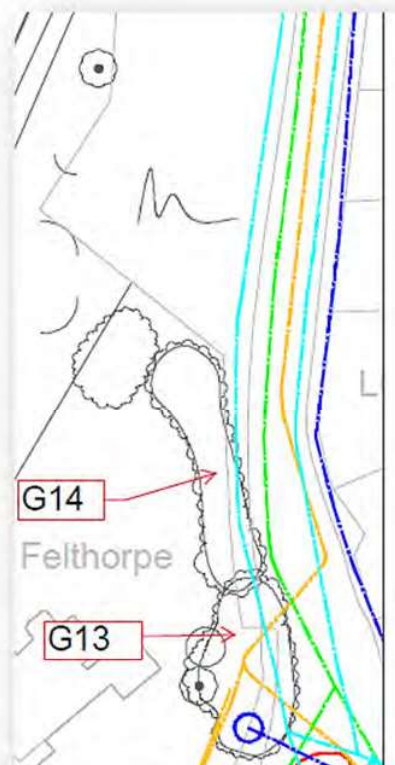
**Plan Extract 6.** Water mains at toe of bank, north of Lodge entrance (pale blue line)

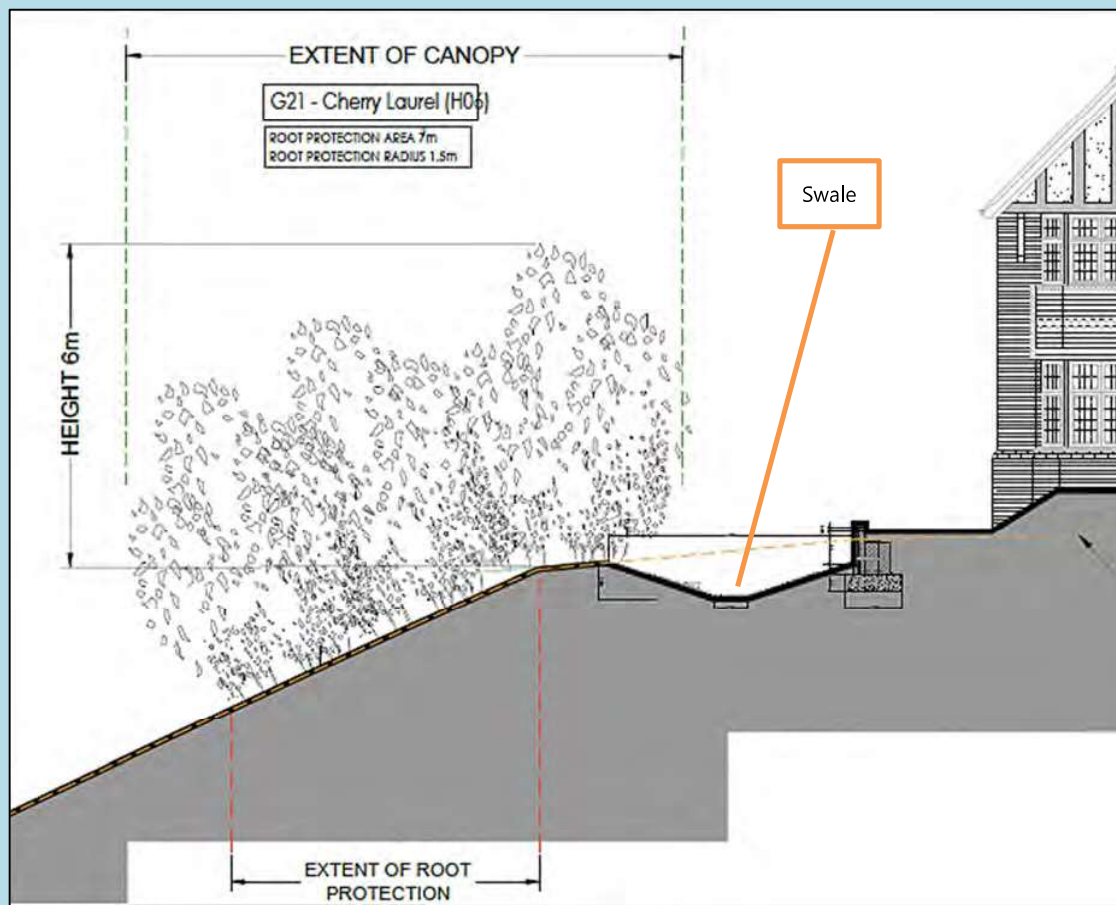
Plan Extract 7c. Section T3 - Swale abutting west of G21.

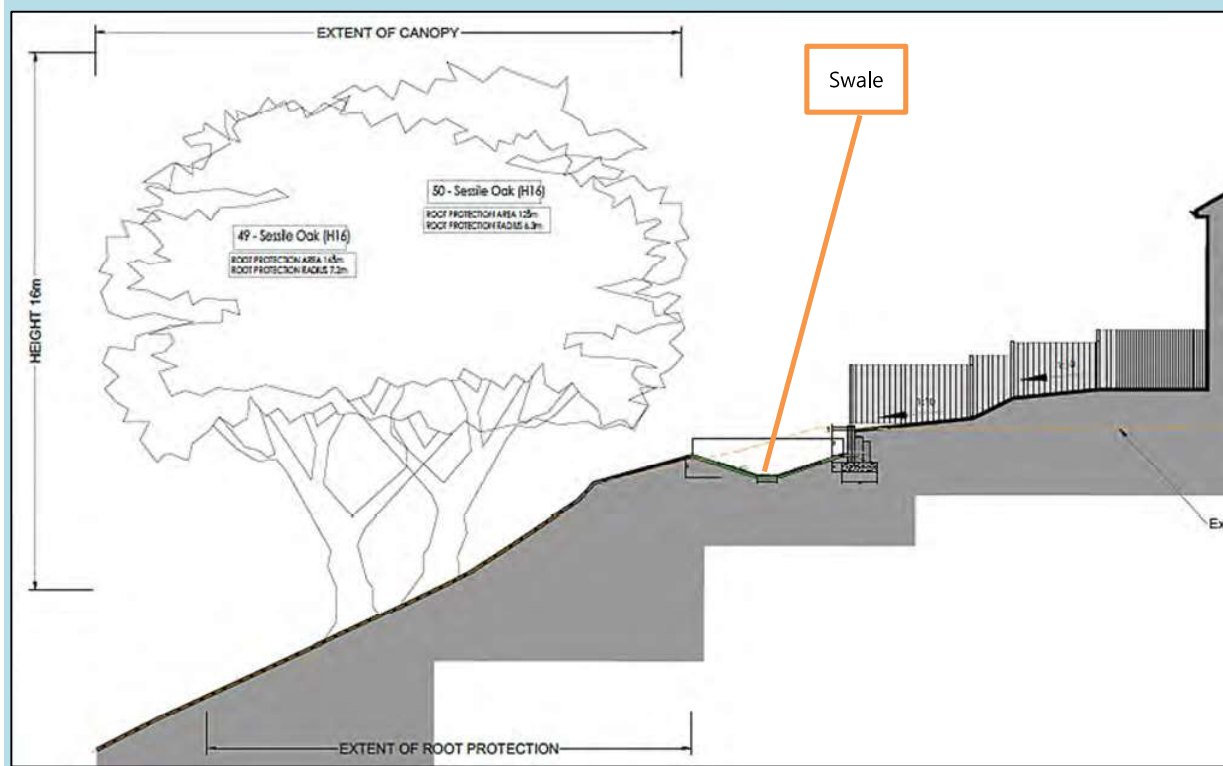
Plan Extract 7d. Section T4 - Swale abutting west of Tree 49 & 50.

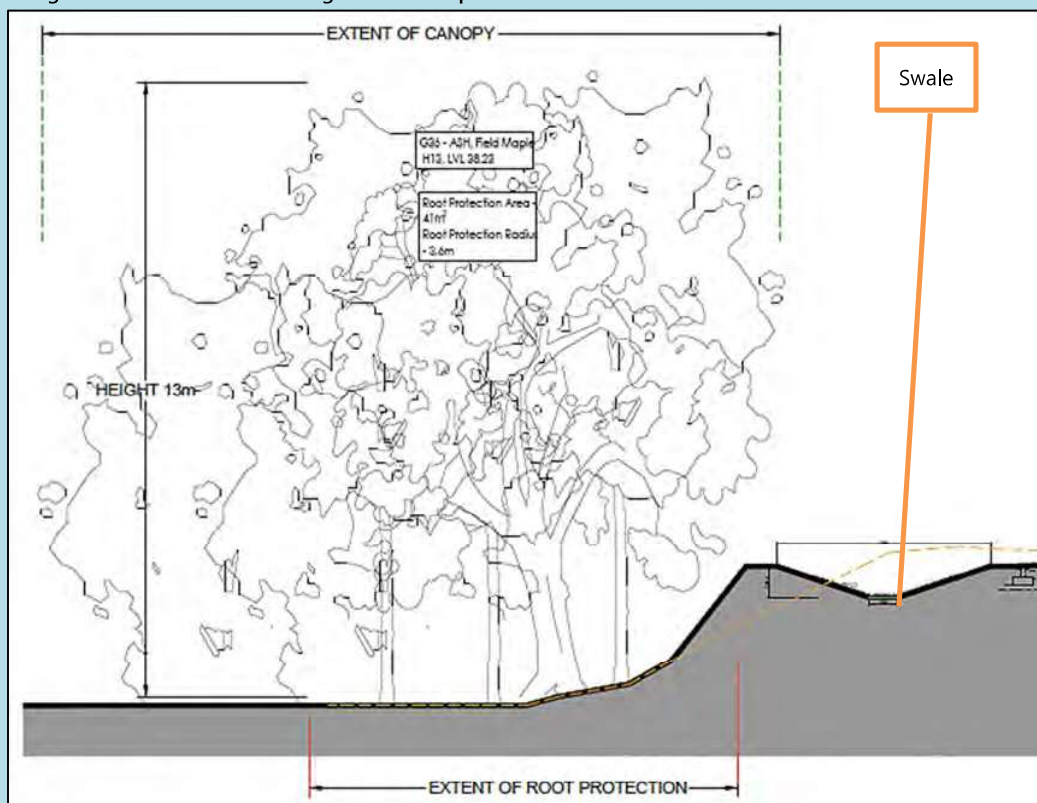
Plan Extract 7g. Section T7 - Swale abutting east of Group 36.

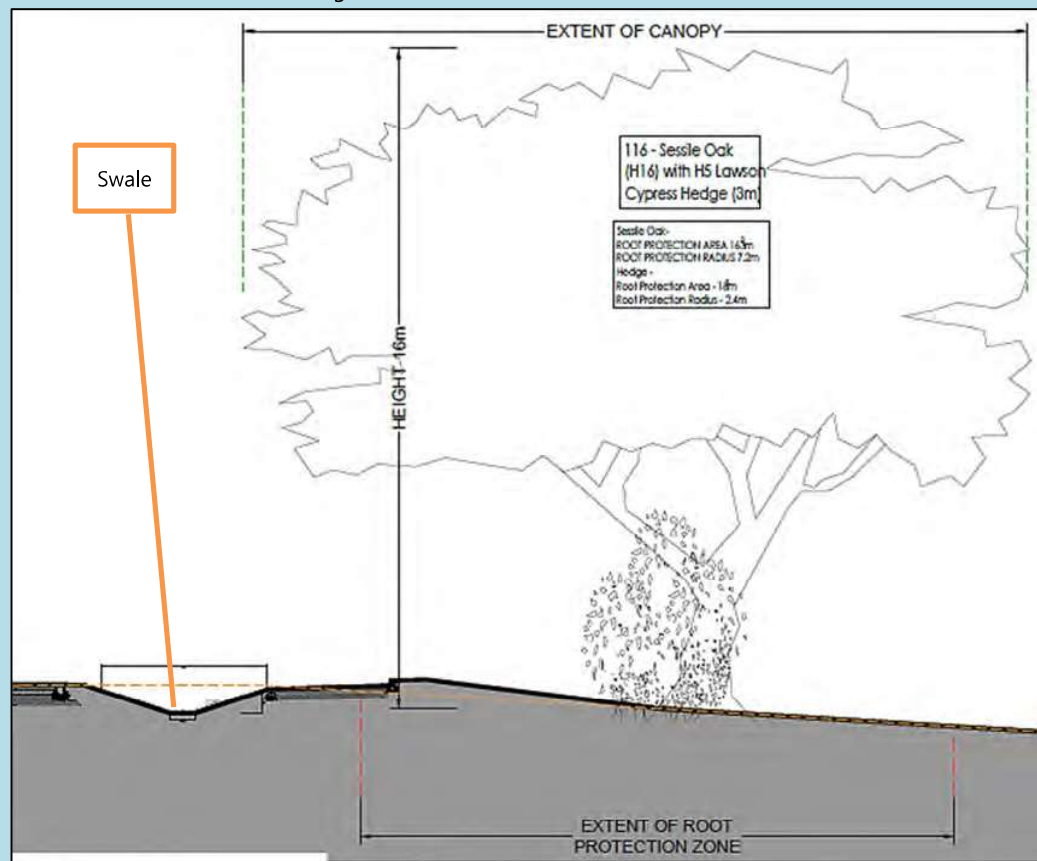
Plan Extract 7h. Section T13 - Swale abutting east of Tree 116.

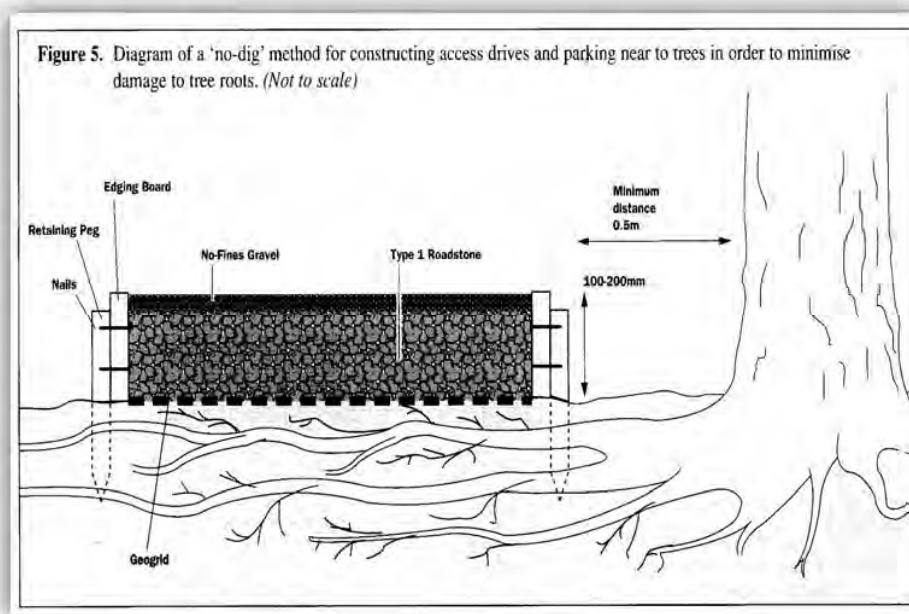
16. The granular sub-base material should have a 'no-fines' content which means that even when it is compacted it should be freely draining and will allow oxygen to diffuse into, and damaging gases (e.g. carbon dioxide and methane) out of the soil.
17. An example of a no dig path construction is offered in Figure 5.

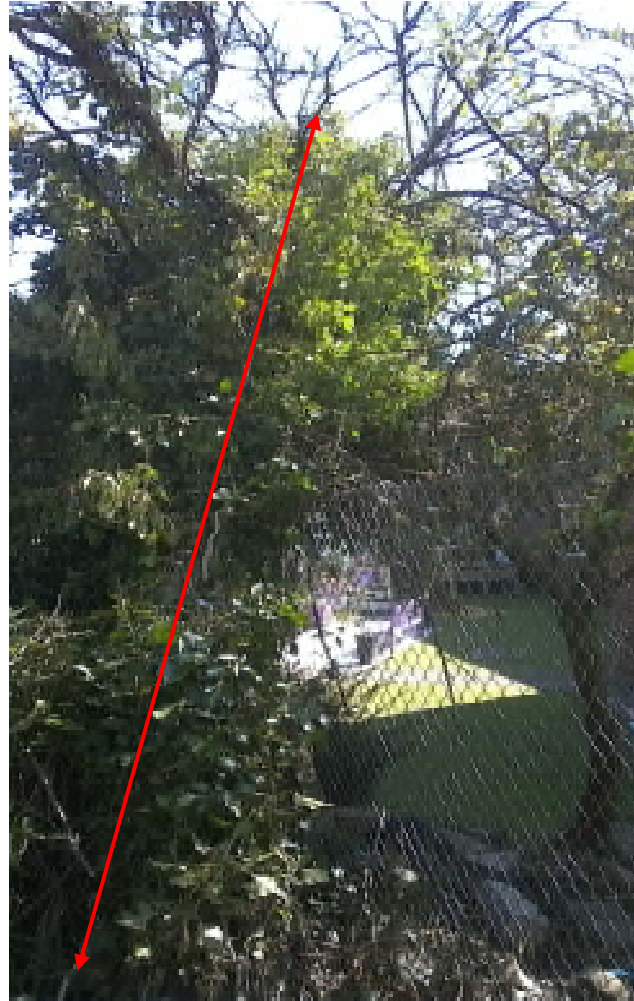
Photograph 21d. Group 5. Tree 129 – Apple with root-plate failure with tree resting on boundary fence and overhanging Isca Court.

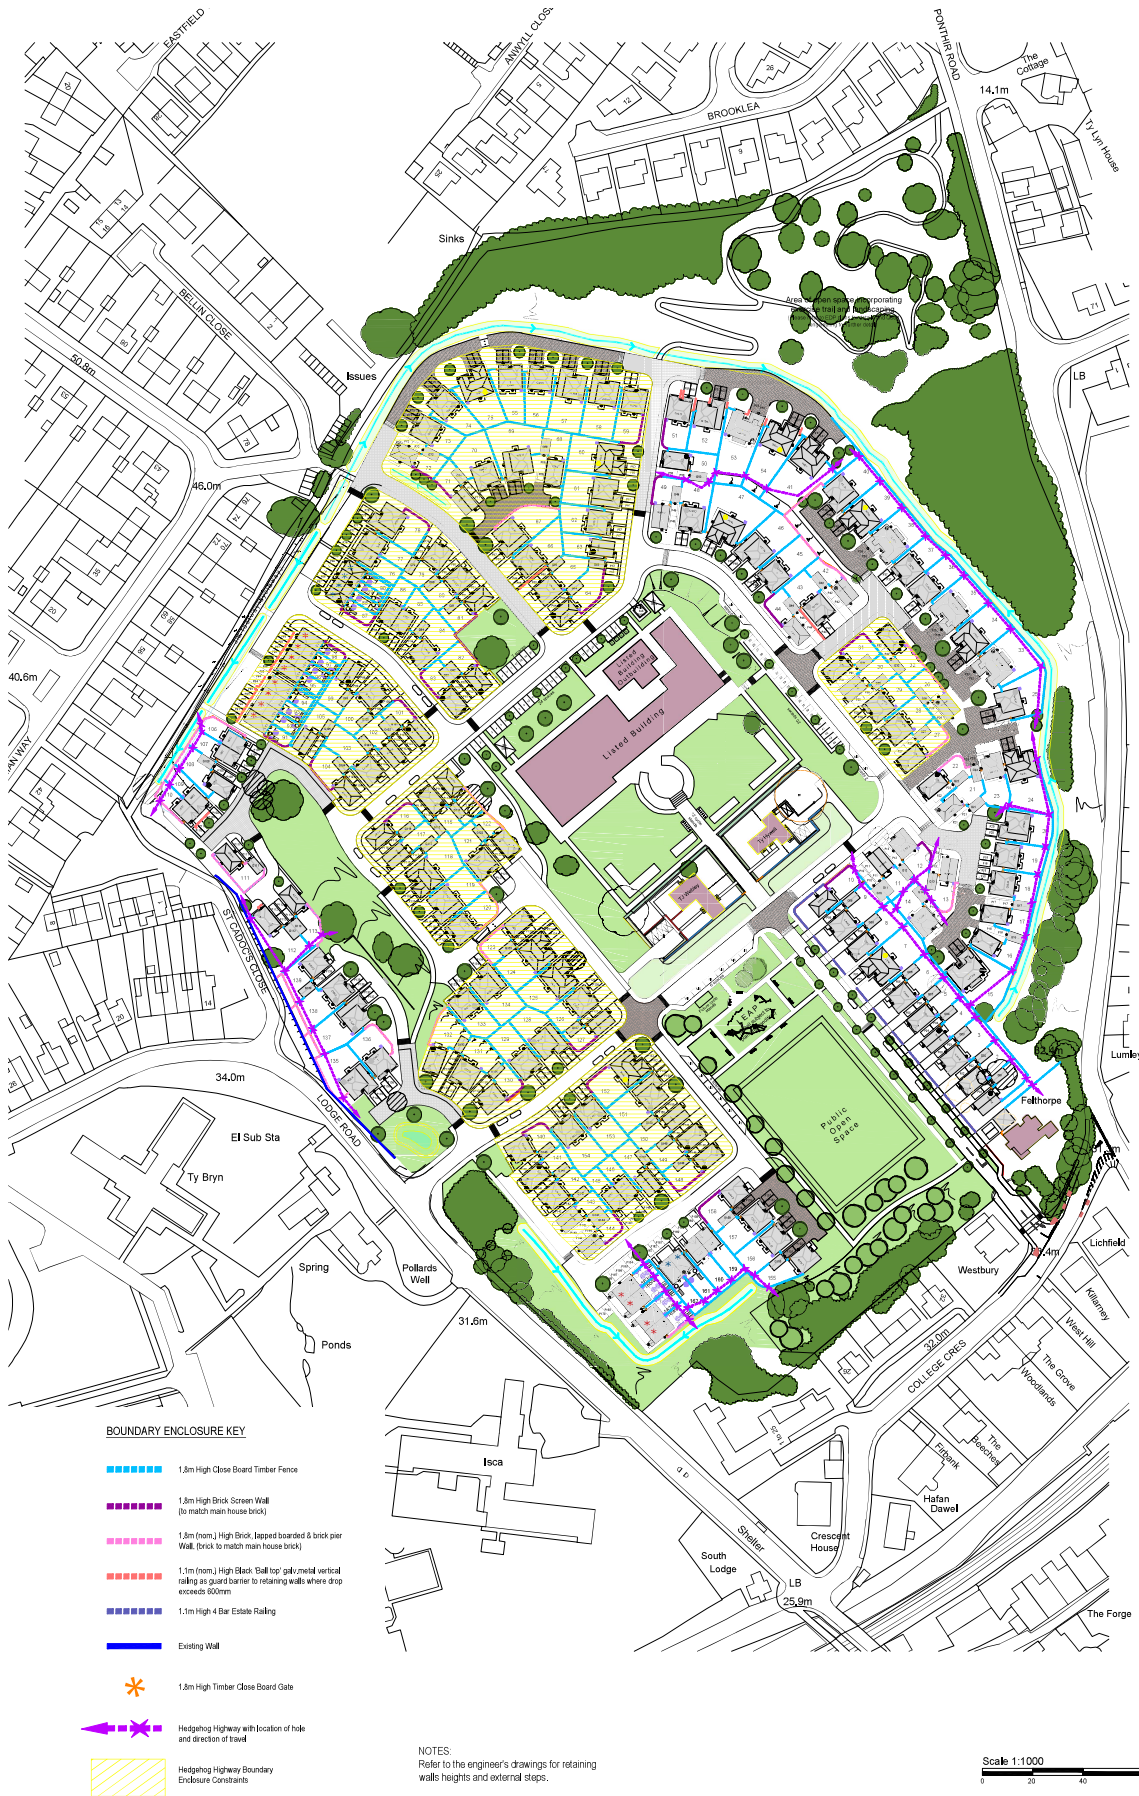
**Appendix EDP 8**  
**Enclosures Layout (includes Hedgehog Highway Information)**  
**(Drawing Number: 18137(05) 1104 Rev H, Powell Dobson)**

- 1.2m High Close Board Timber Fence
- 1.2m High Brick Screen Wall (to match main house brick)
- 1.2m (nom.) High Brick, tapered boarded & brick pier Wall (brick to match main house brick)
- 1.1m (nom.) High Black Ball top galv. metal vertical railing as guard barrier to retaining walls where drop exceeds 600mm
- 1.1m High 4 Bar Estate Railing
- Existing Wall
- 1.2m High Timber Close Board Gate
- Hedging Highway with location of hole and direction of travel
- Hedging Highway Boundary Enclosure Constants
