# Geoenvironmental Appraisal

## Land at Royal Victoria Court, Mendalgief Rd, Newport, south Wales

### For LNT Care Developments

Report no: 5088/1

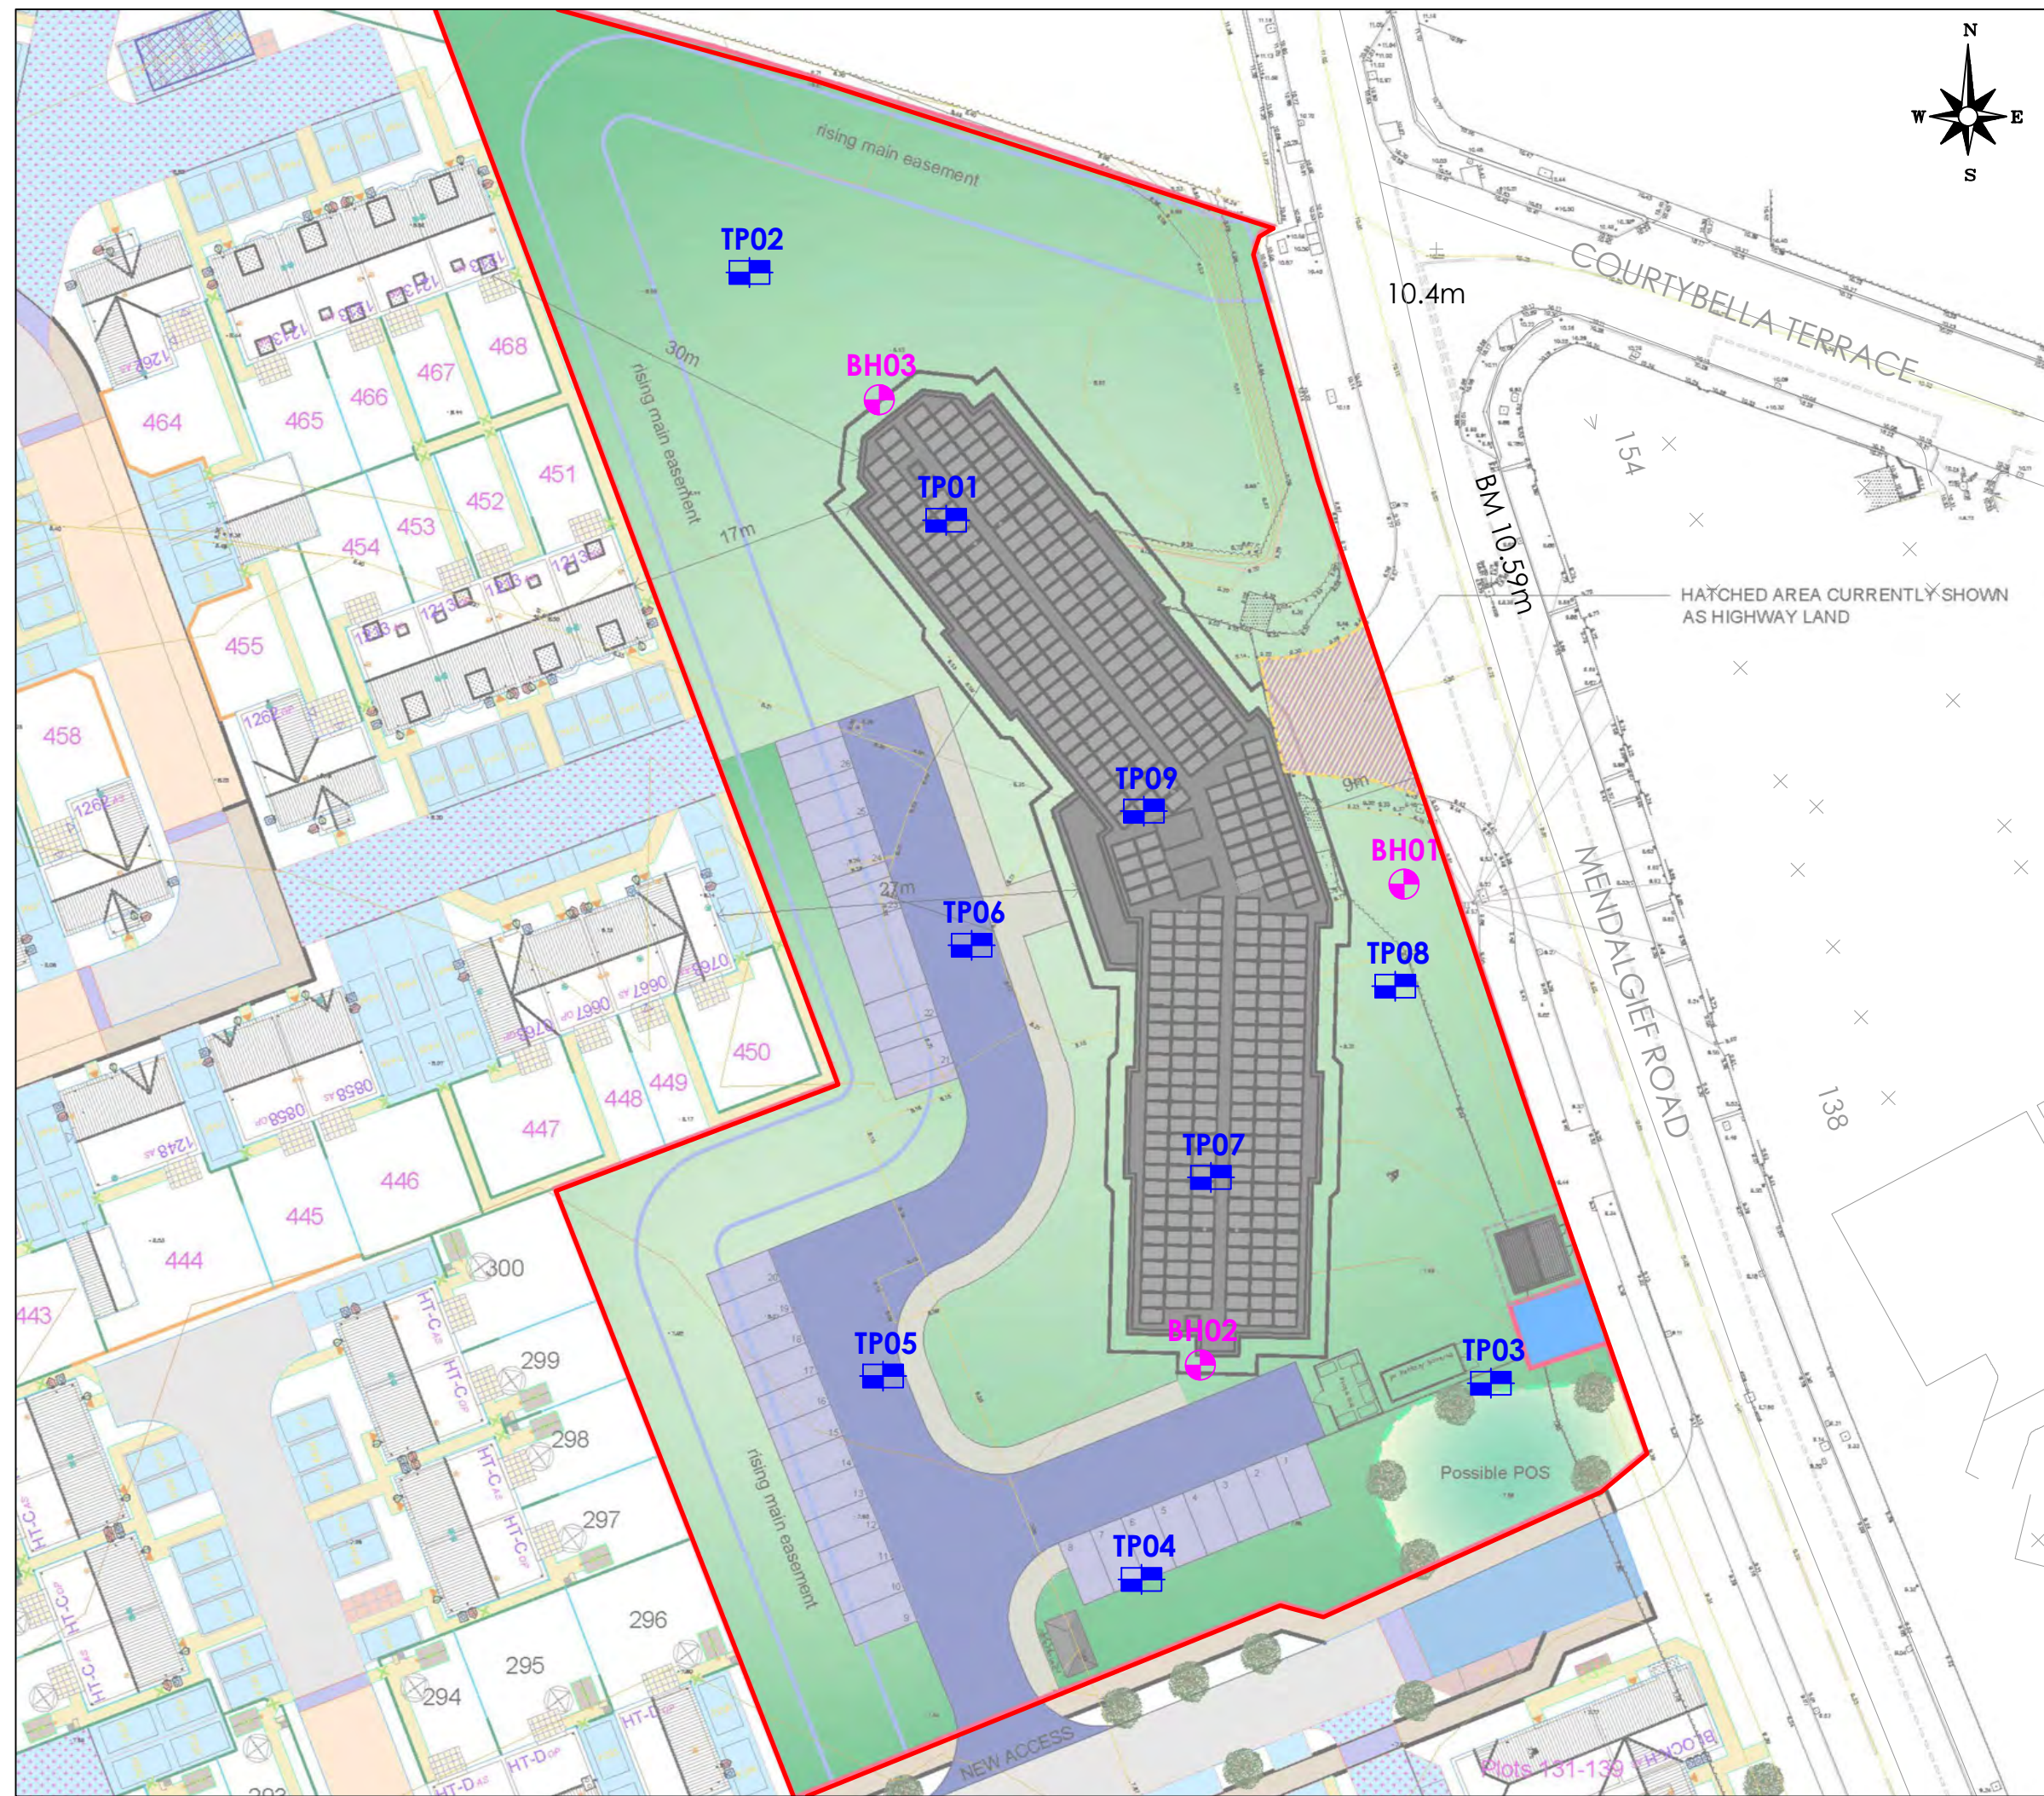
| SCALE | 1:500 | SHEET | A3 | DRAWING NO. | 5088/6 | REVISION | |

- TRIAL PIT LOCATION
- BOREHOLE LOCATION
- APPROXIMATE SITE BOUNDARY

7.2.2 Proposed exploratory hole locations were selected to provide a representative view of the strata beneath the site and to target potential areas of interest identified in Section 6 above. A nominal 30m grid spacing was proposed. Additional exploratory locations might be scheduled by the site engineer in light of the ground conditions actually encountered.

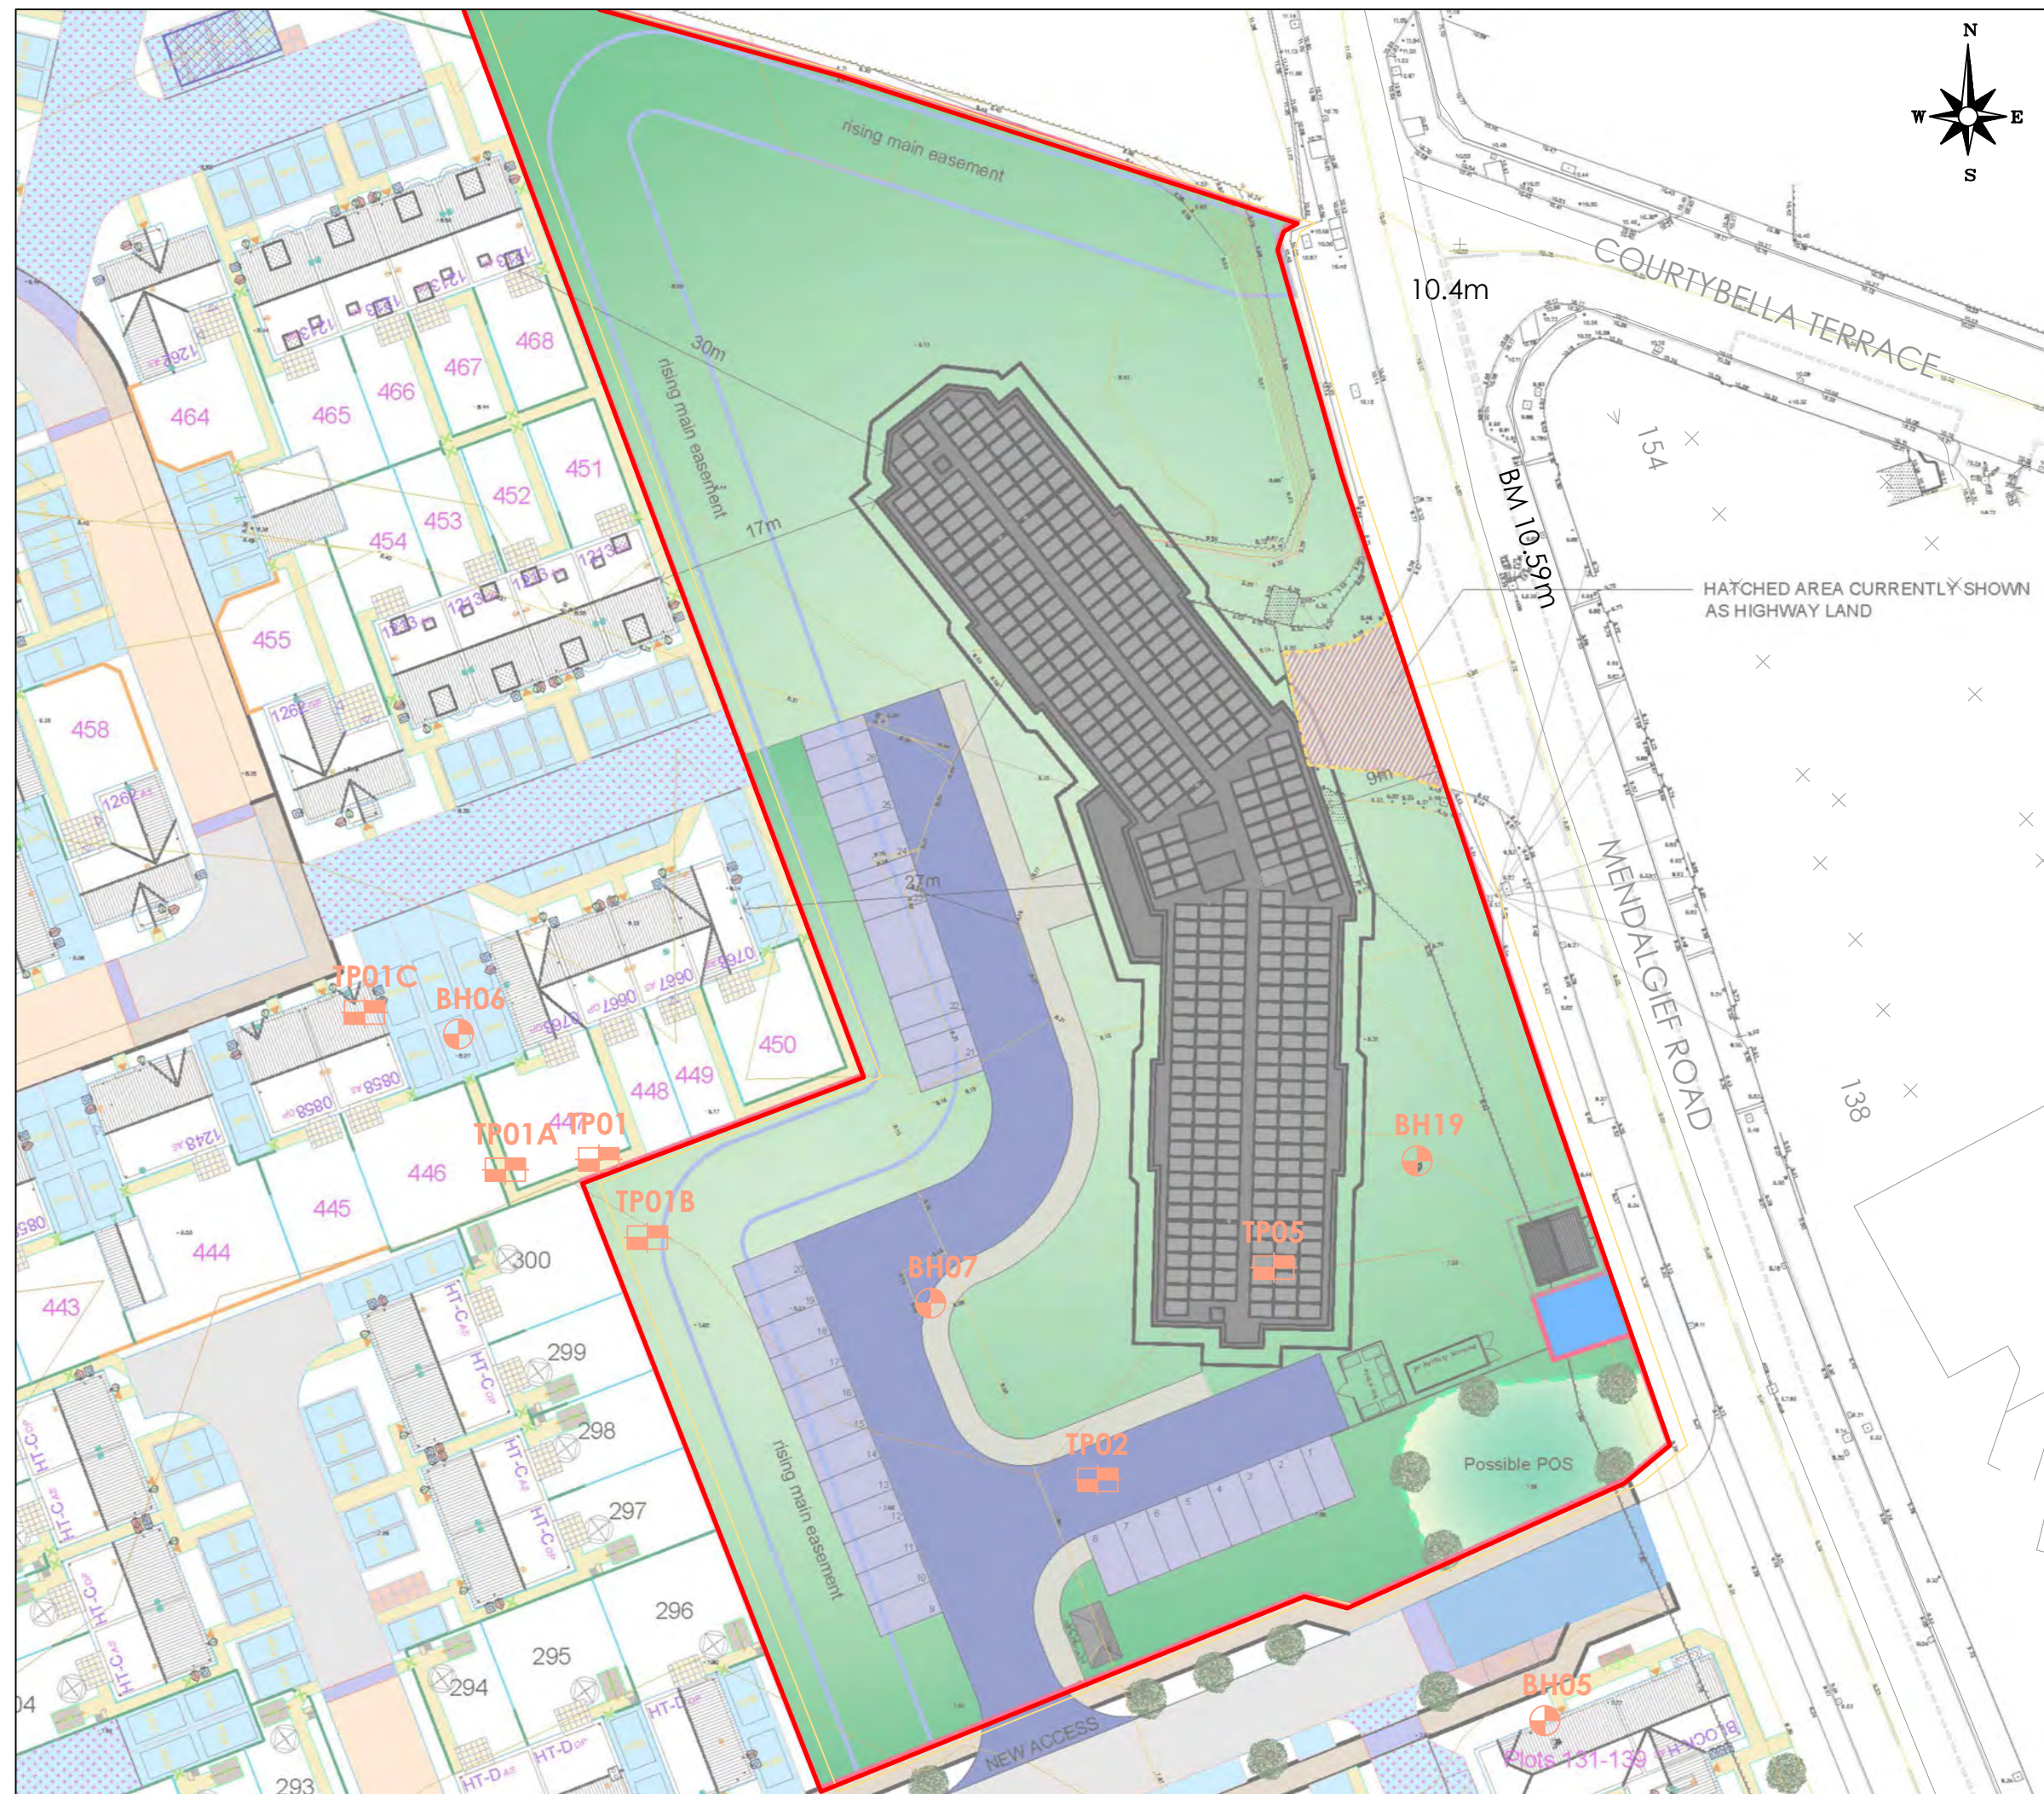
| SCALE | 1:500 | SHEET | A3 | DRAWING NO. | 5088/6A | REVISION | |

**ARUP 2014 EXPLORATORY HOLES**
