**Bat Scoping Survey:** The Barns at Chapel Farm, Chapel Lane, Llandeuvaud,  
Newport

**Instructed by:** Newport Norse

**Reported by:** Ecological Services Ltd  
10 Mount Pleasant, Llanelly Hill, Abergavenny, Monmouthshire, NP7 0NT

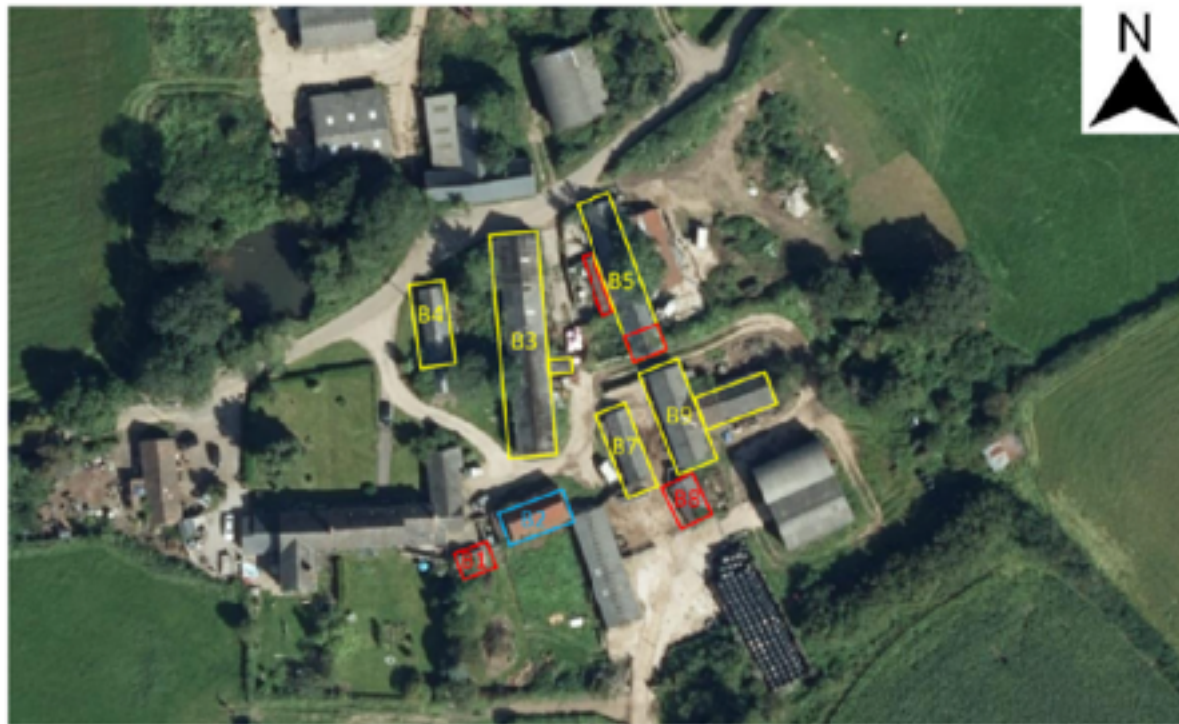
Figure 1 – Aerial photograph indicating potential scope of demolition (red) and repair (blue) at Chapel Farm, Llandeud

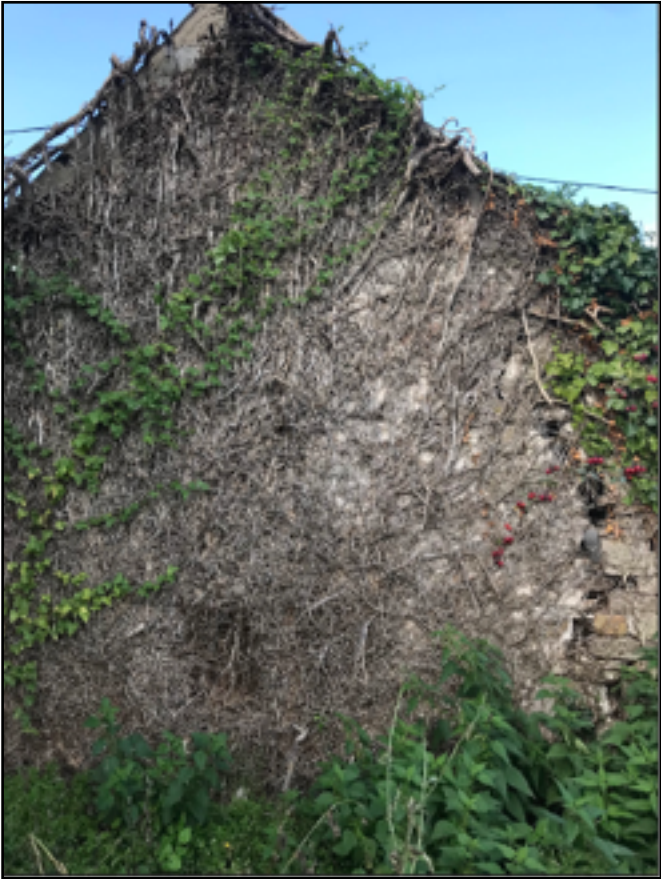
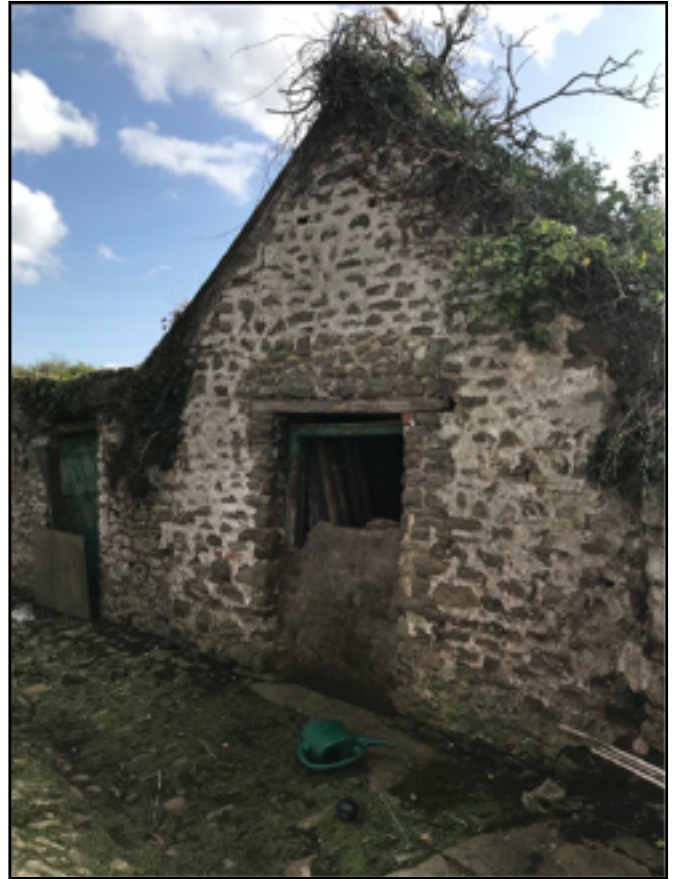
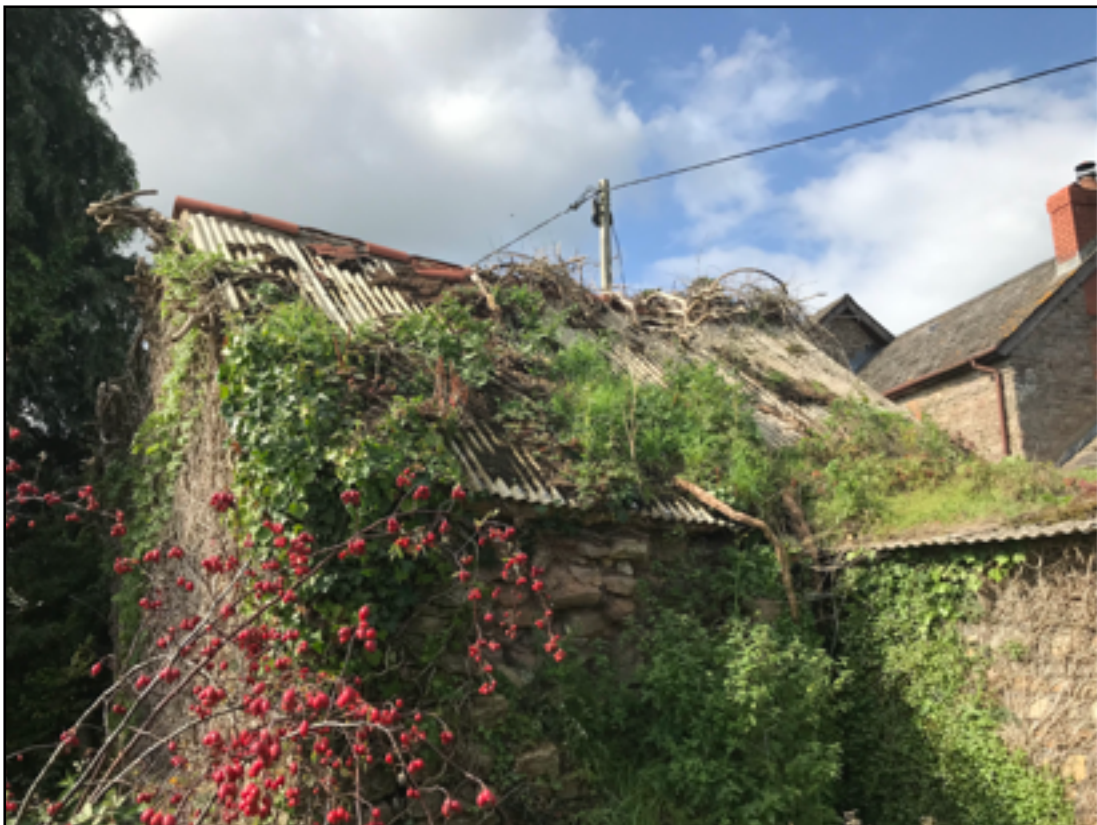
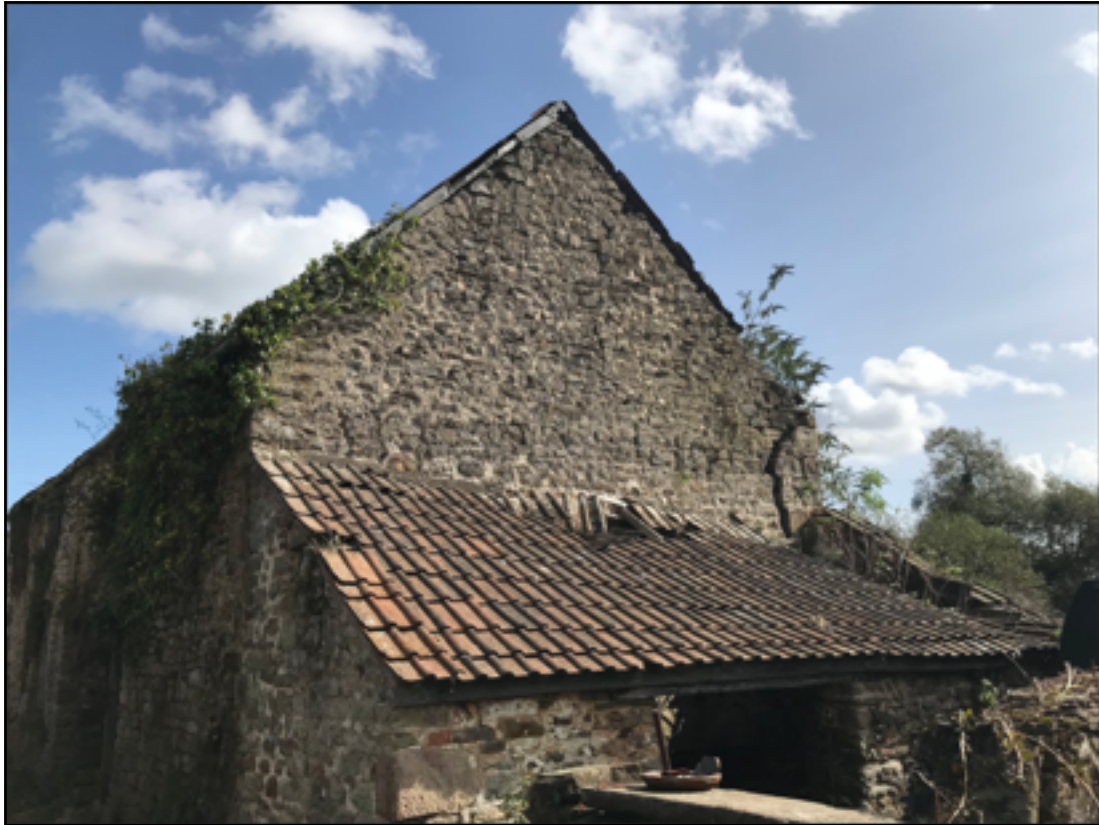
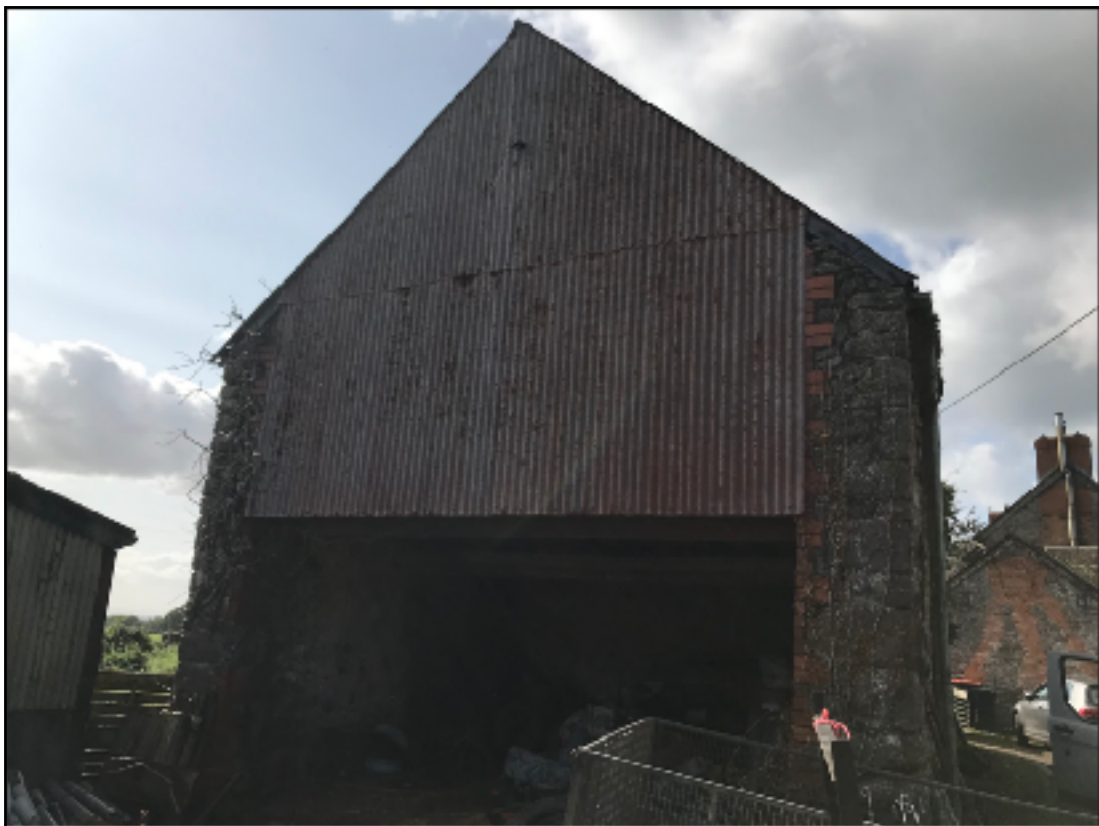
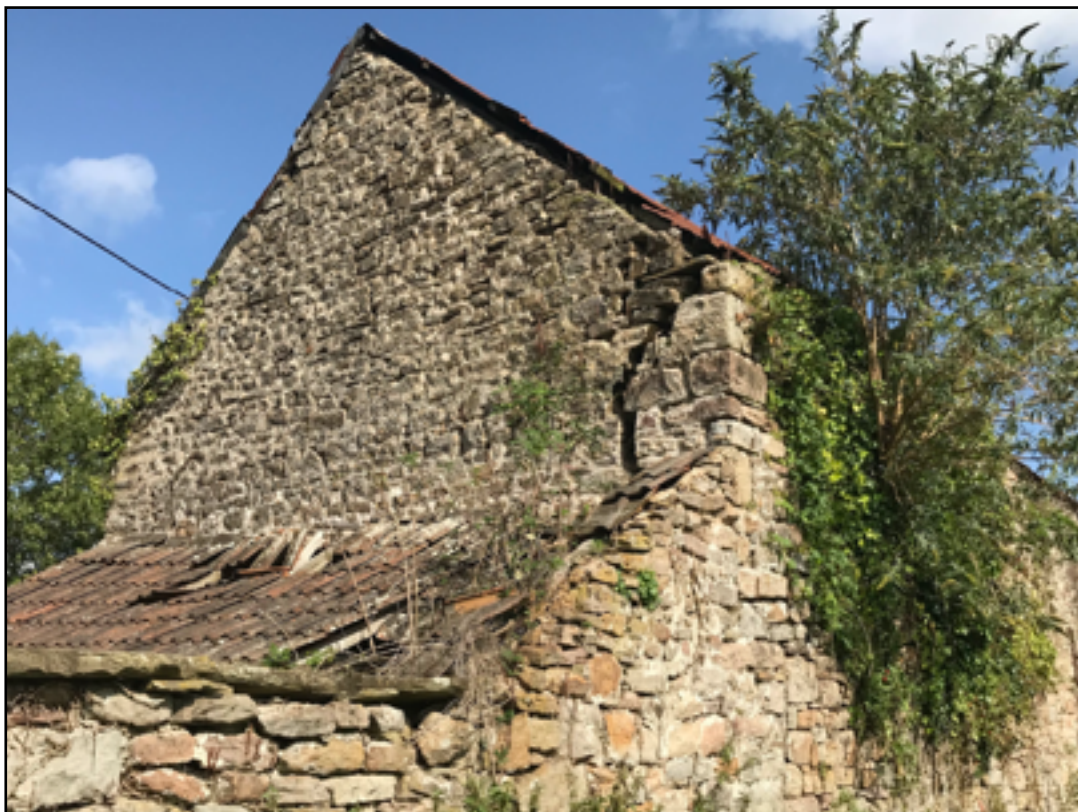
Barn 1

The corrugated sheet roof is likely to suffer from temperature fluctuations during the summer months, making the building less suitable for bat roosting use. There are open doorways; apertures in the stonework; areas of vegetation; apertures at the apexes; apertures underneath the roofing sheets and several missing and slipped ridge tiles. The building is also missing a large section of the wall to the eastern elevation. The building is classed as having **moderate** potential for roosting bats.

**6.6** Examples of apertures allowing access to cavities in the buildings:

**8.5 Barns 1 and 5 were assessed as having moderate potential for roosting bats. Both buildings offered numerous opportunities for bats to access and use the buildings. Whilst these buildings are in a poor state of repair, their structural integrity is not as compromised as Barns 2 and 8. It is recommended that at least two bat activity surveys are completed on the buildings.**

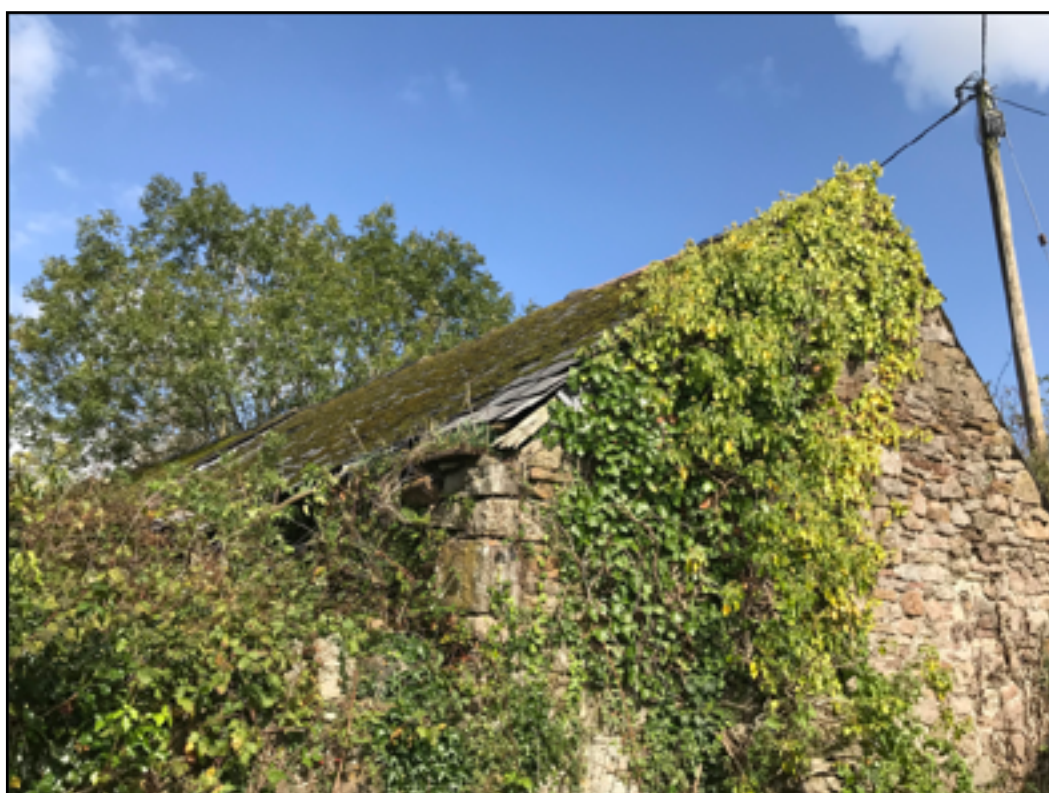
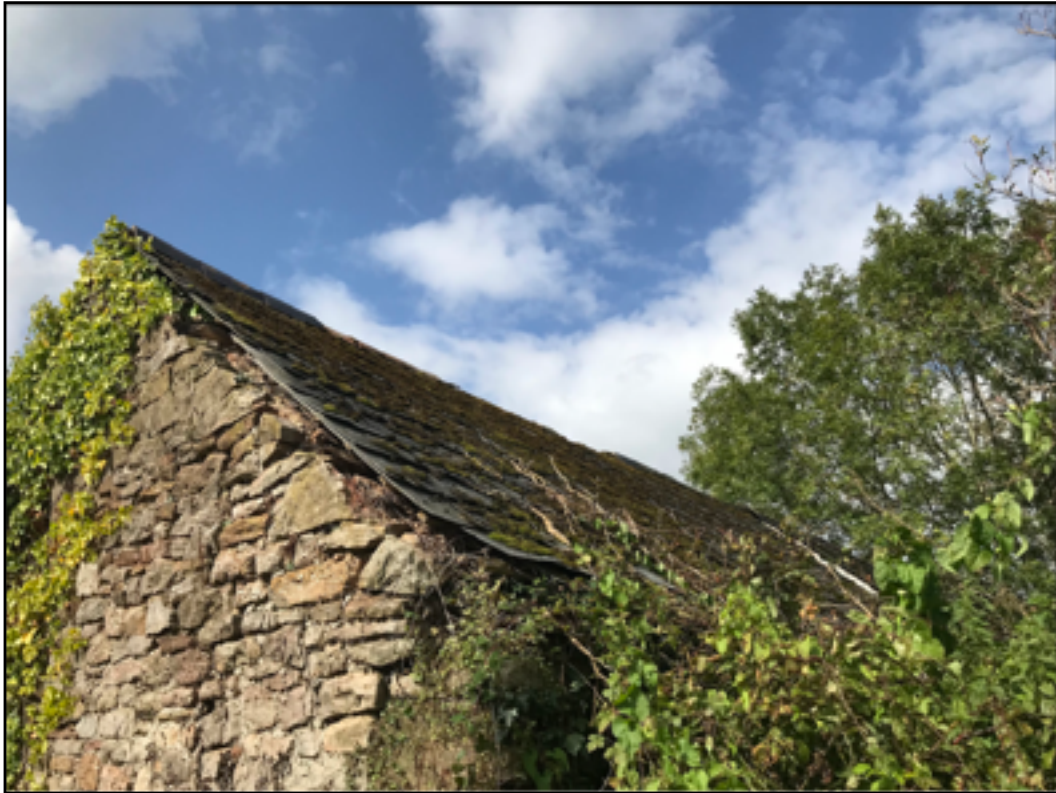
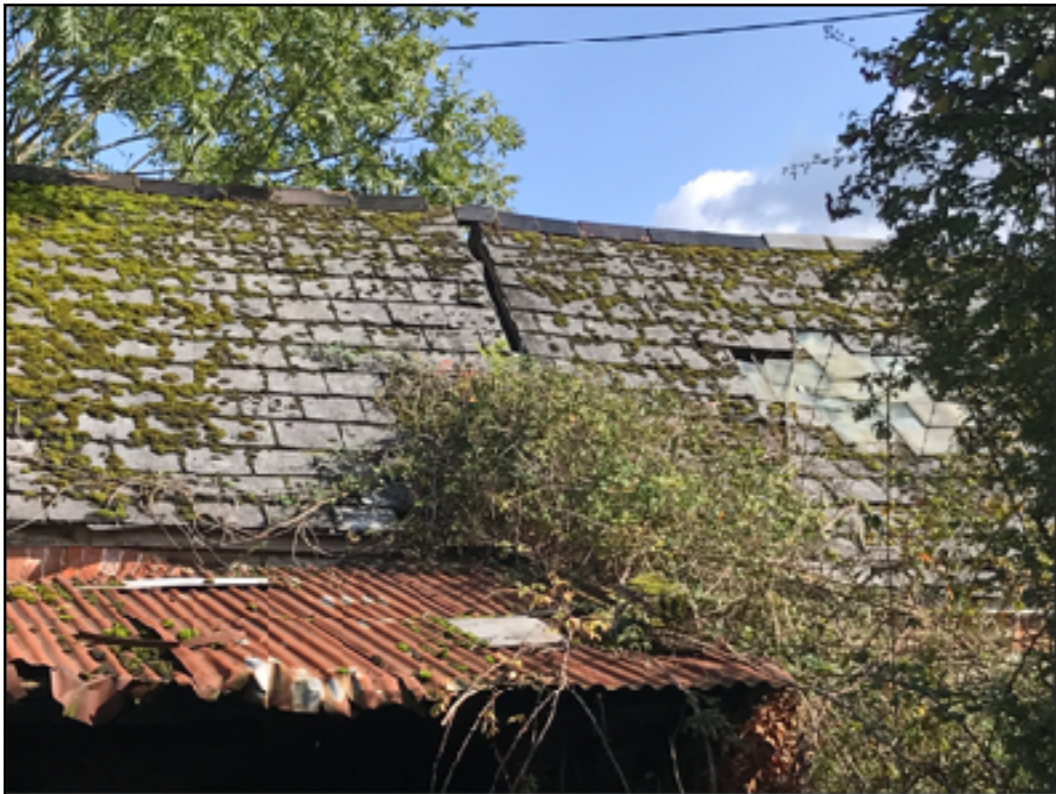
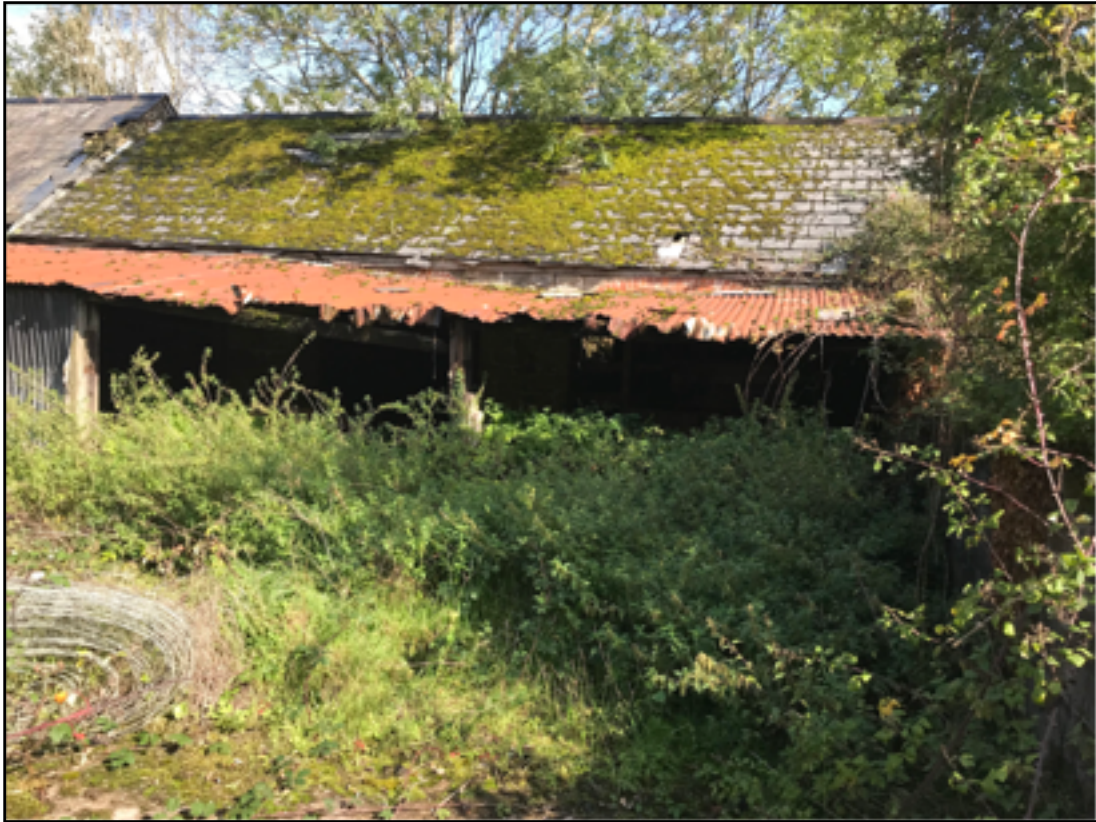
Barn 5

There are raised slates and ridge tiles; apertures in the stonework; areas of vegetation and missing slates. The building is classed as having **moderate** potential for roosting bats.

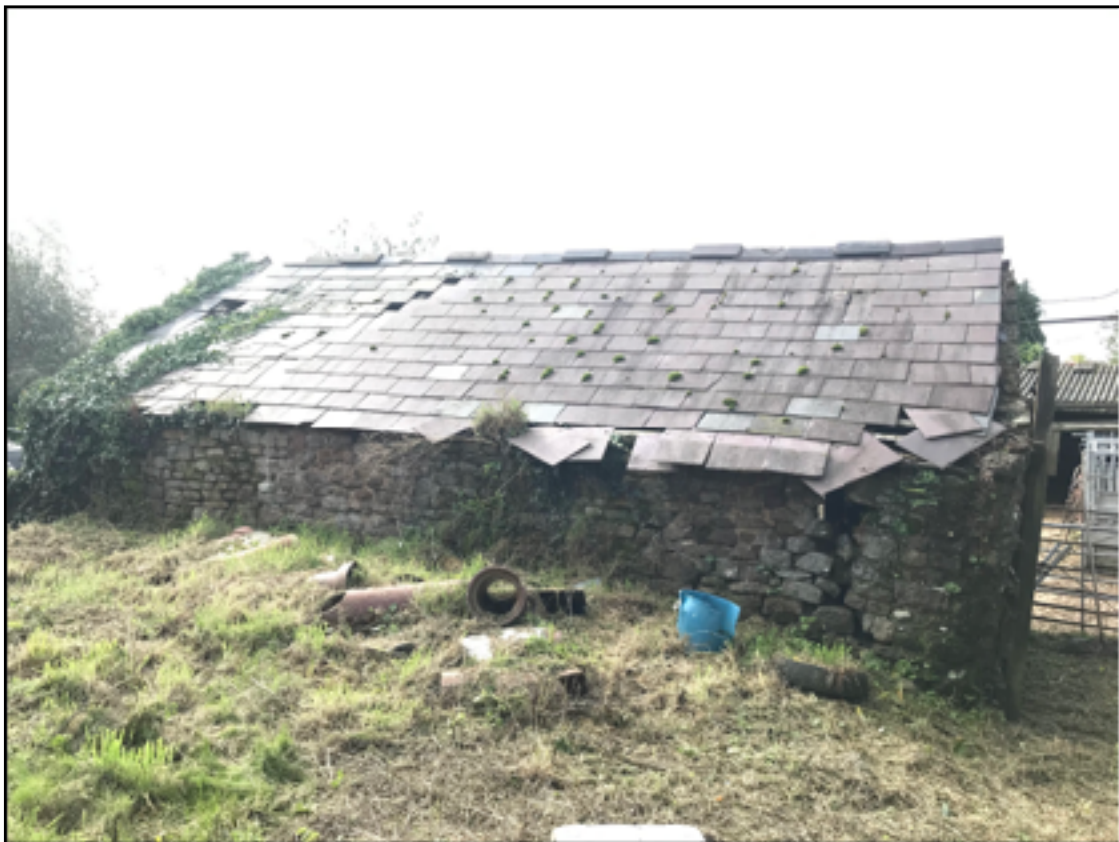
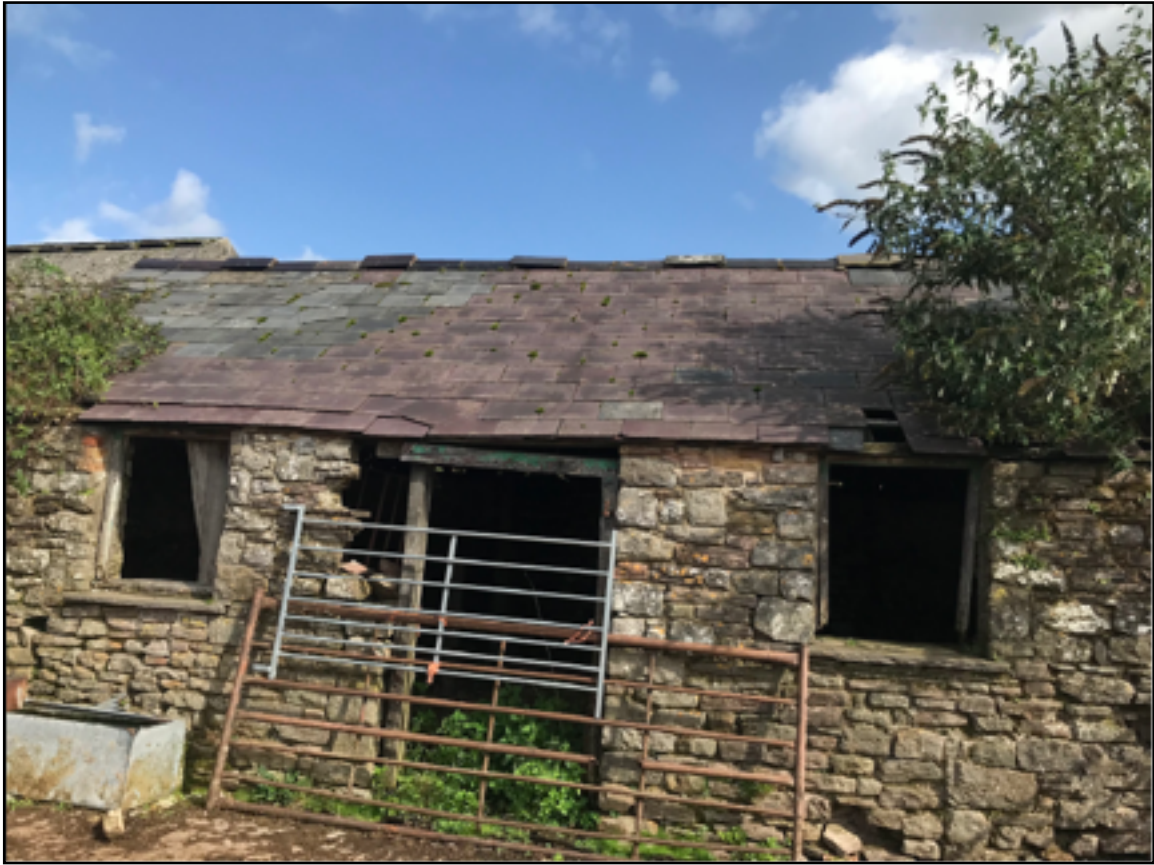
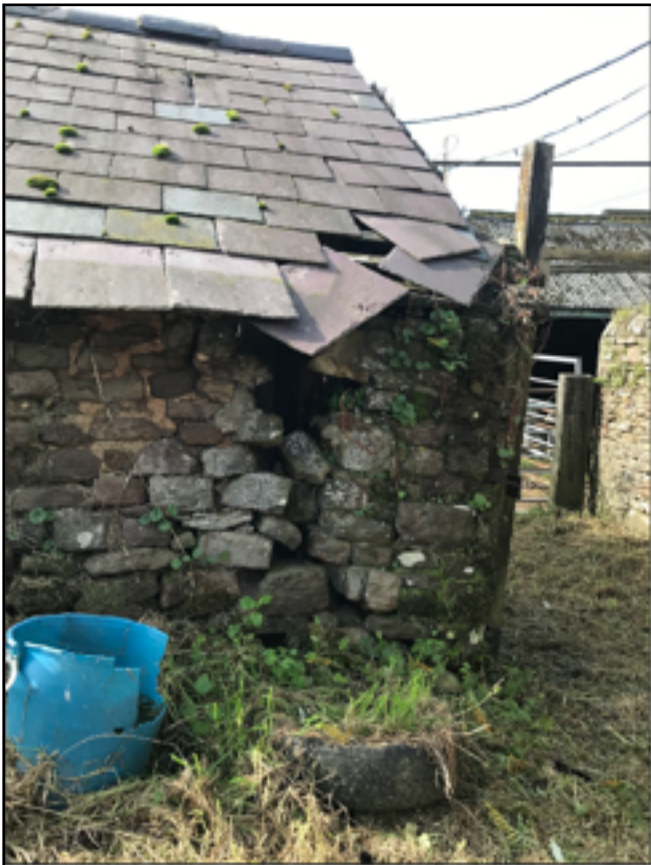
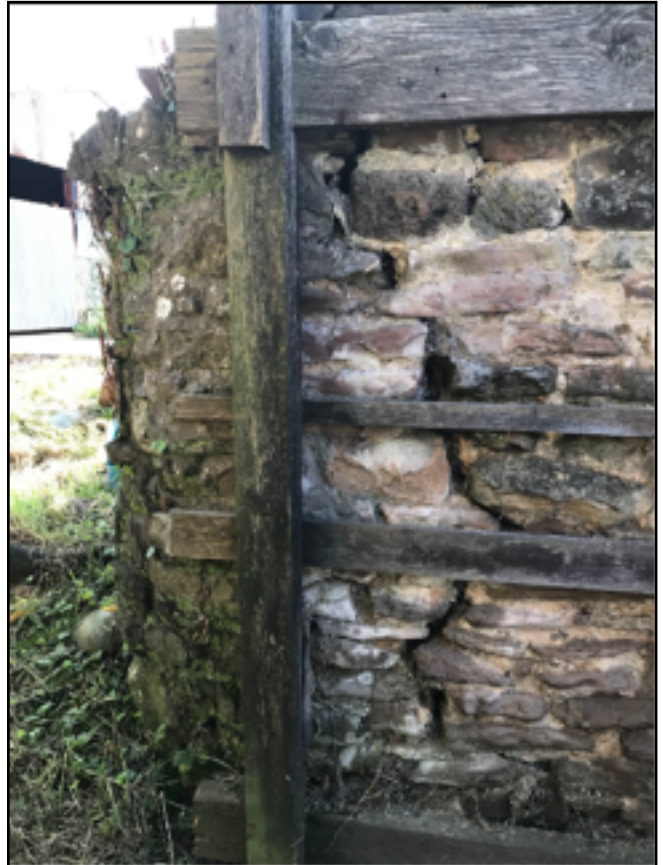
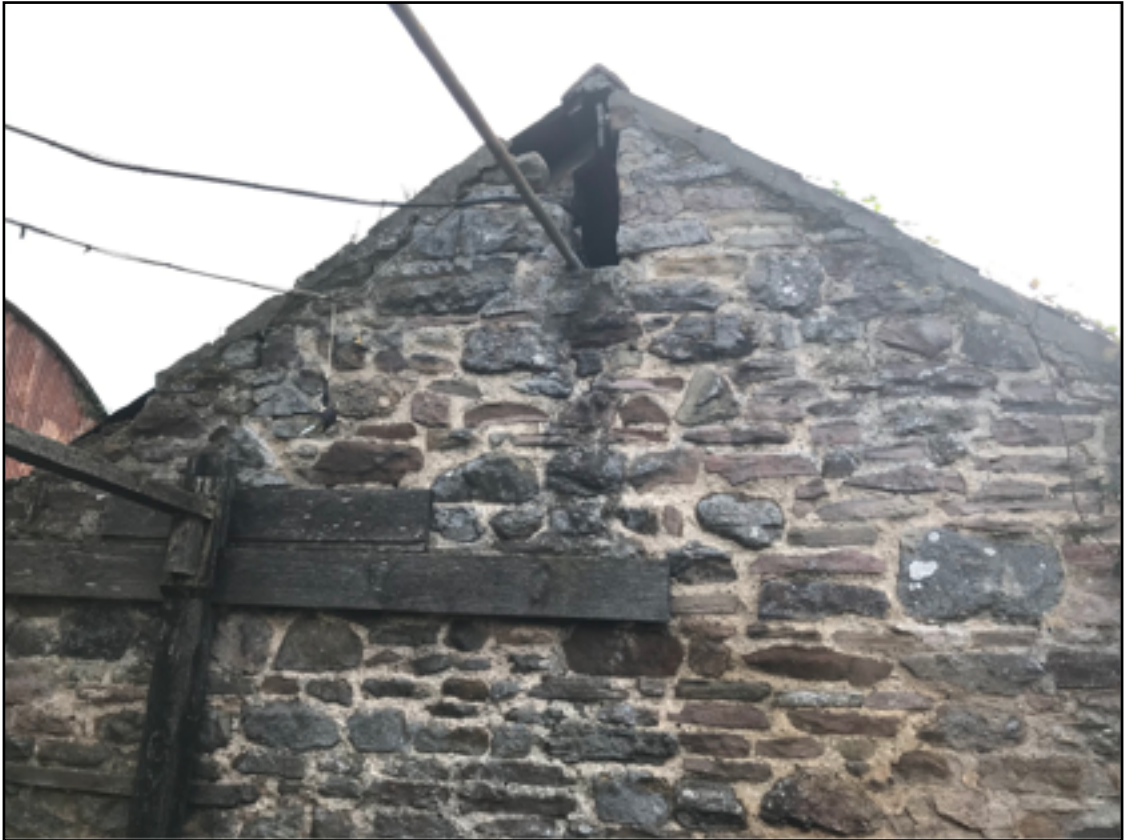
*Barn 8*

There are several missing and slipped slates; raised ridge tiles; apertures and cracks in the stonework; a vertical slit in the stonework at the gable end; areas of vegetation and all windows and doors are missing. The building is classed as having **moderate** potential for roosting bats. There is a large crack in the north east facing wall from ground level to the eaves which is starting to pull away from the building causing slates to collapse from the roof. The unsafe roofing slates are at risk of blowing off and injuring cattle and farm workers.

**8.4 Due to the imminent health and safety risk to livestock and farm workers, it is recommended that the repair works to Barn 2 be carried out immediately and that Barn 8 be demolished immediately. The repair works to Barn 2 are localised and will only affect the stone walls to the southern elevation of the building. An endoscopic inspection of any cracks in the stonework will be undertaken on both barns immediately prior to the repair works and demolition works being carried out. Prior to Barn 8 being demolished, the roofing slates and timbers will be hand removed under direct supervision of a suitably qualified ecologist. If bats or any evidence of bats are discovered, then all works will cease and activity surveys may be recommended or a development license from Natural Resources Wales will be required.**

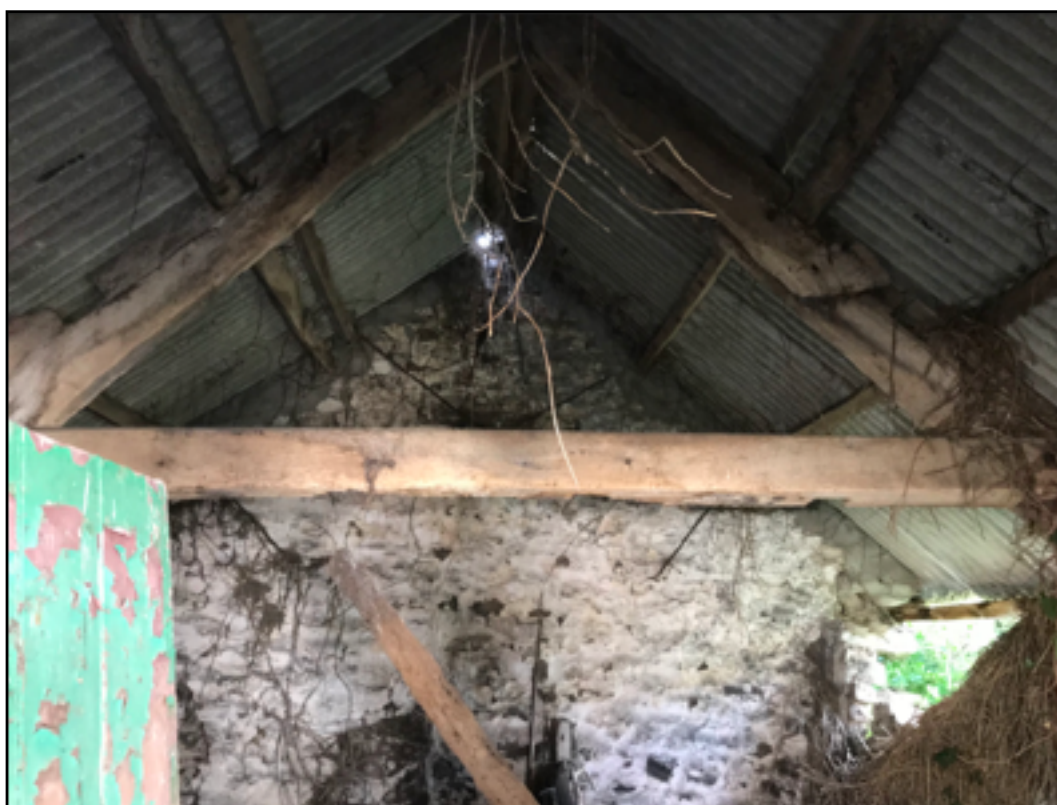
### **Barn 1**

**7.2** There were no internal attic spaces within any of the buildings. All of the buildings were unlined and open to the roofs. The underside of the roofing materials could be seen in all accessible areas of the buildings. An internal inspection of the southern half of Barn 5 could not be undertaken due to the dense scrub in front of the doors, however, there was no internal attic space within the building. Internal access in the northern half of B5 was possible.
