**Bat Survey:** The Barns at Chapel Farm, Chapel Lane, Llandeud, Newport

**Instructed by:** Newport Norse

**Reported by:** Ecological Services Ltd  
10 Mount Pleasant, Llanelly Hill, Abergavenny, Monmouthshire, NP7 0NT

| Author | Date | Version |
|---|---|---|
| Richard Watkins | August 2024 | V4.0 |

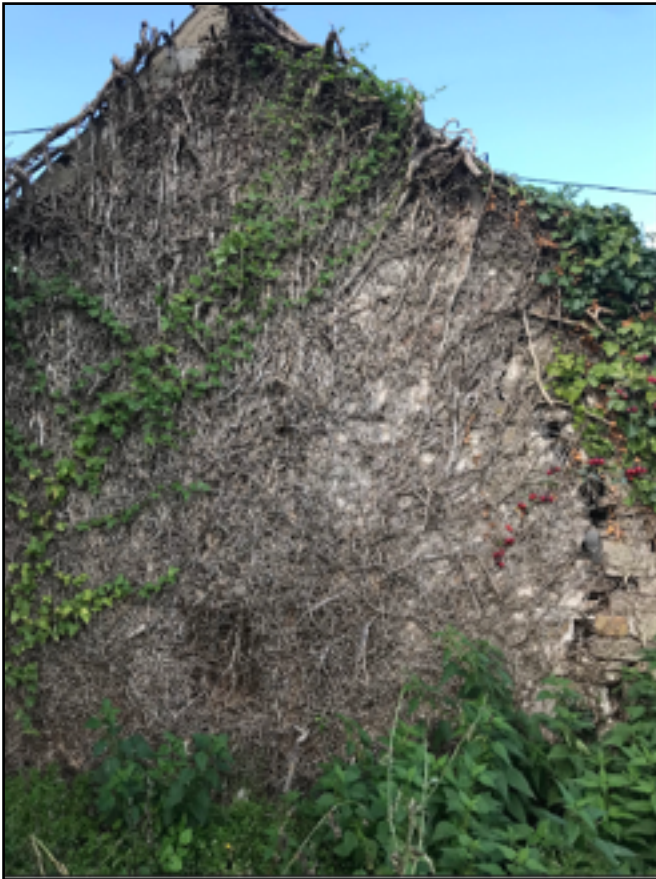
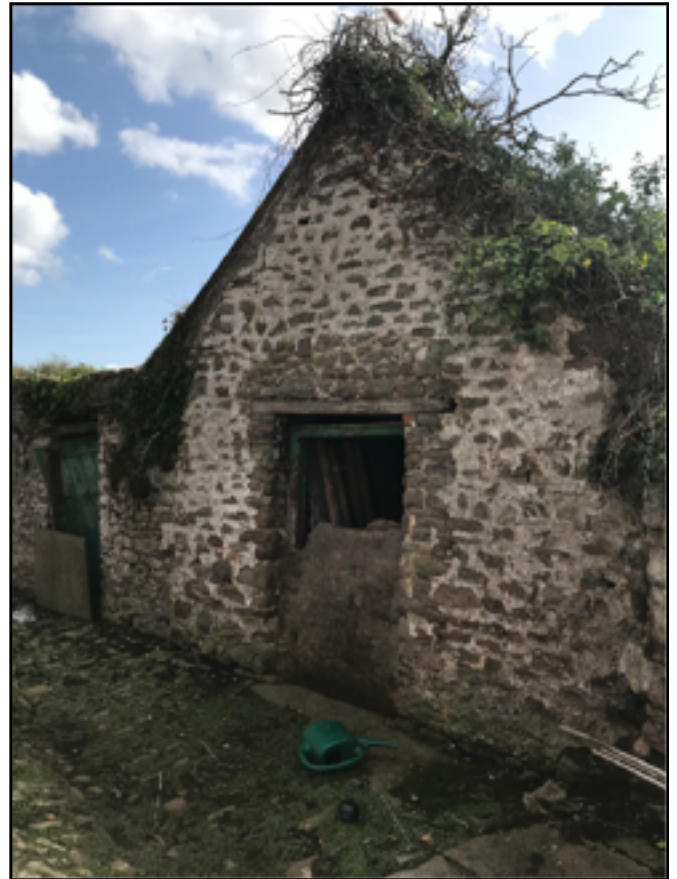
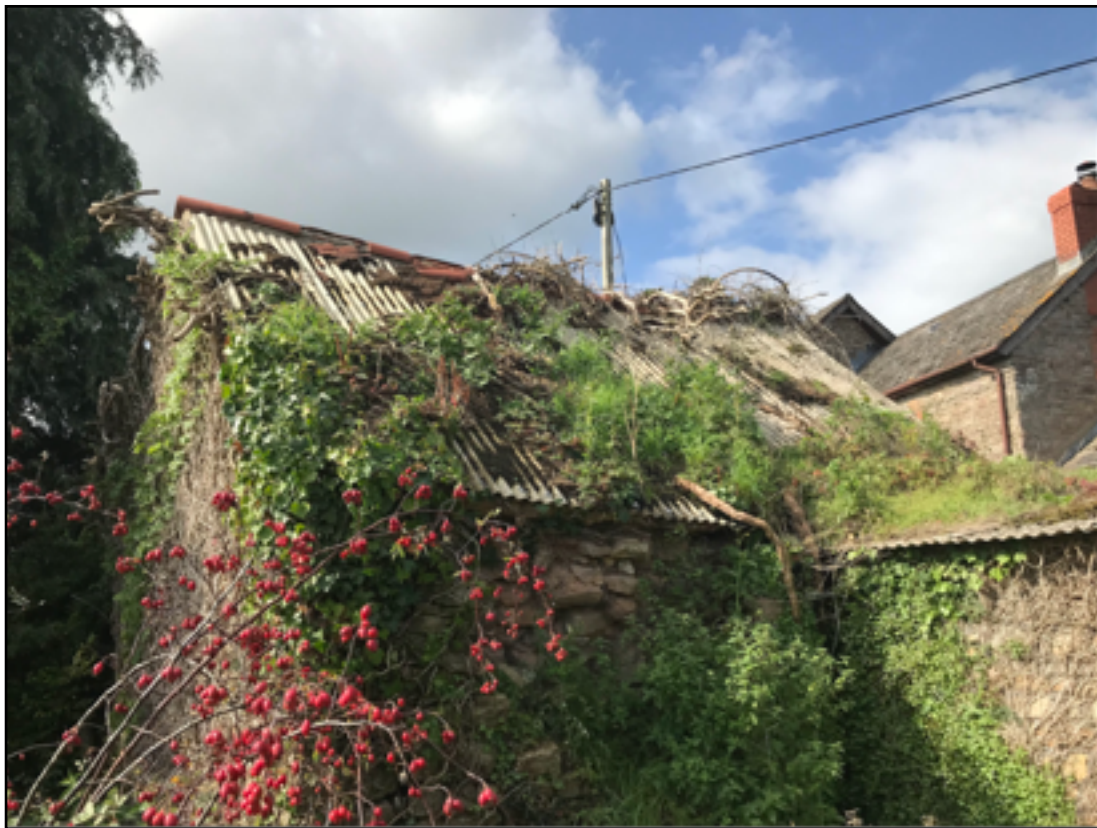
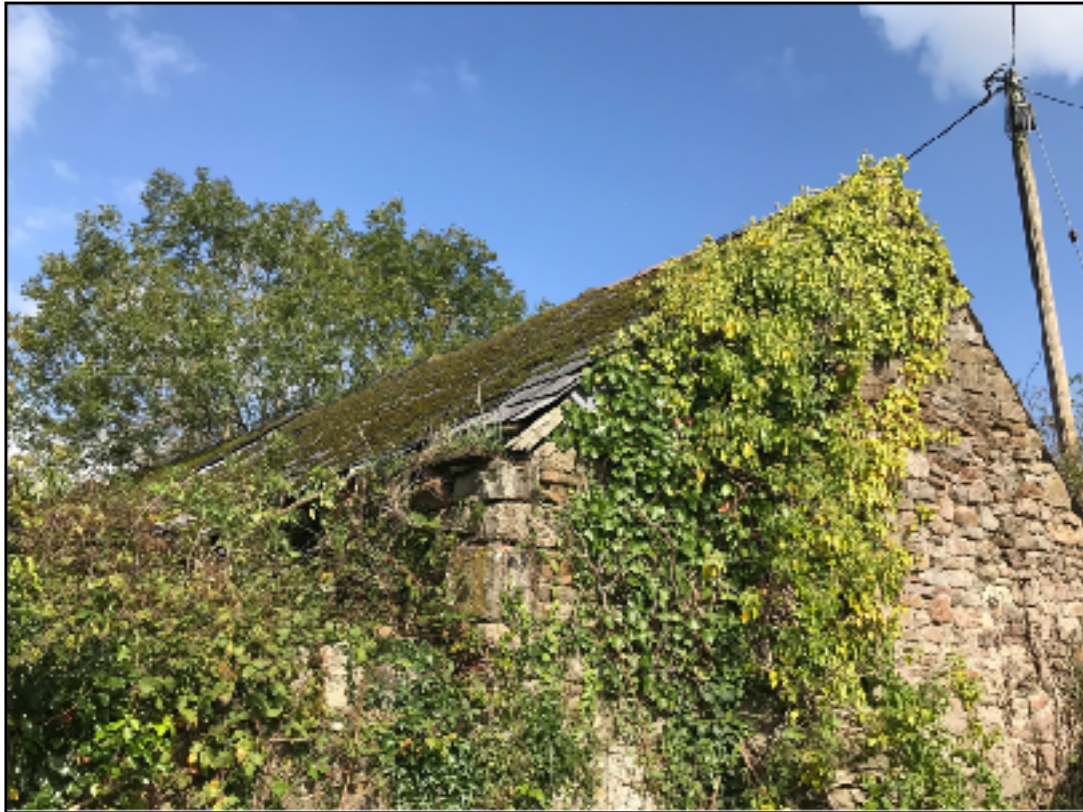
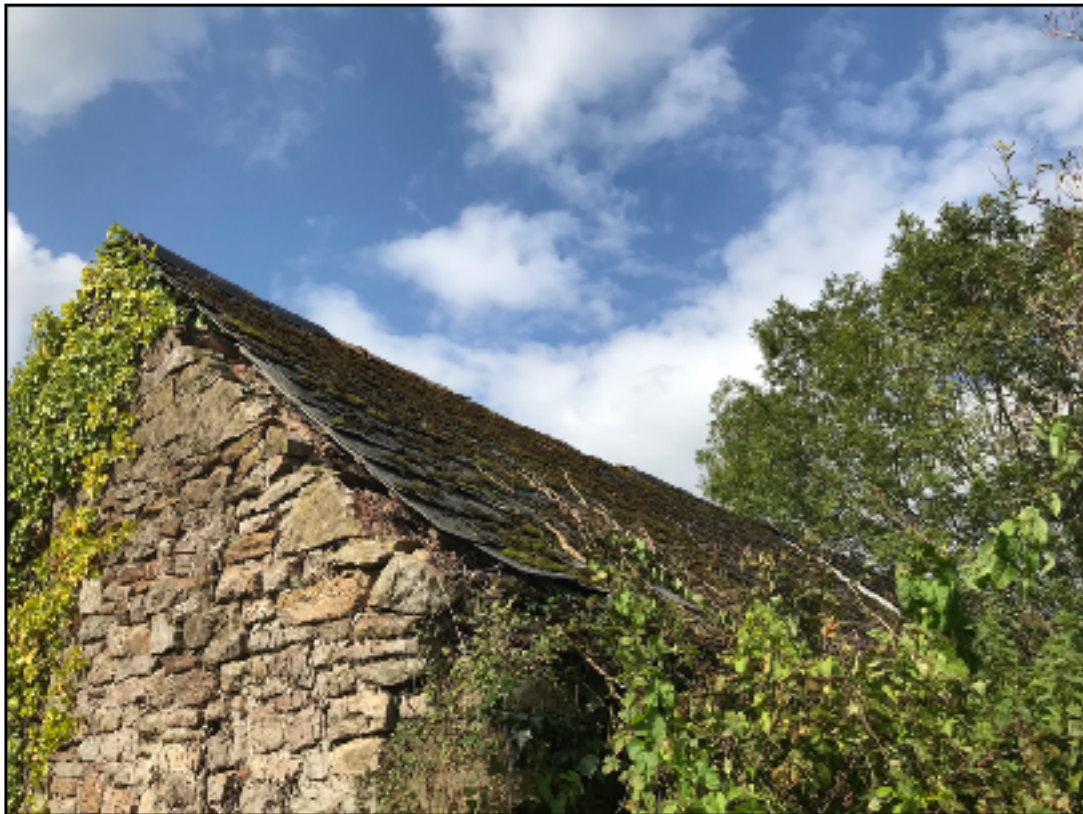
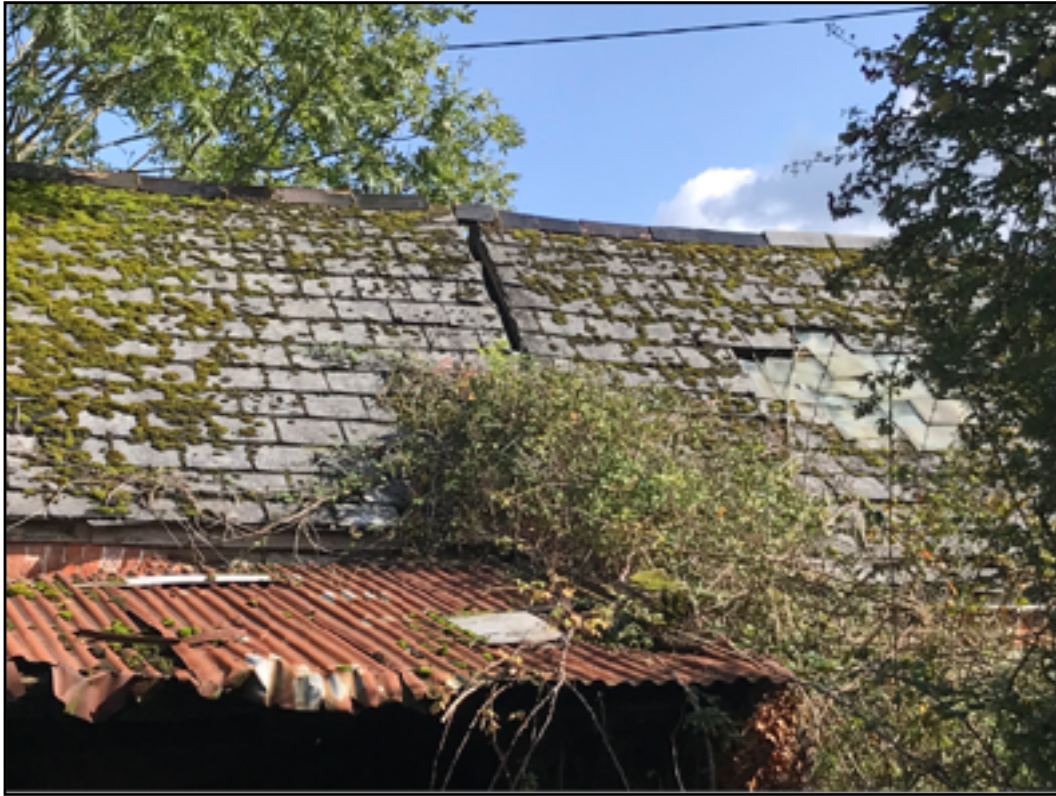
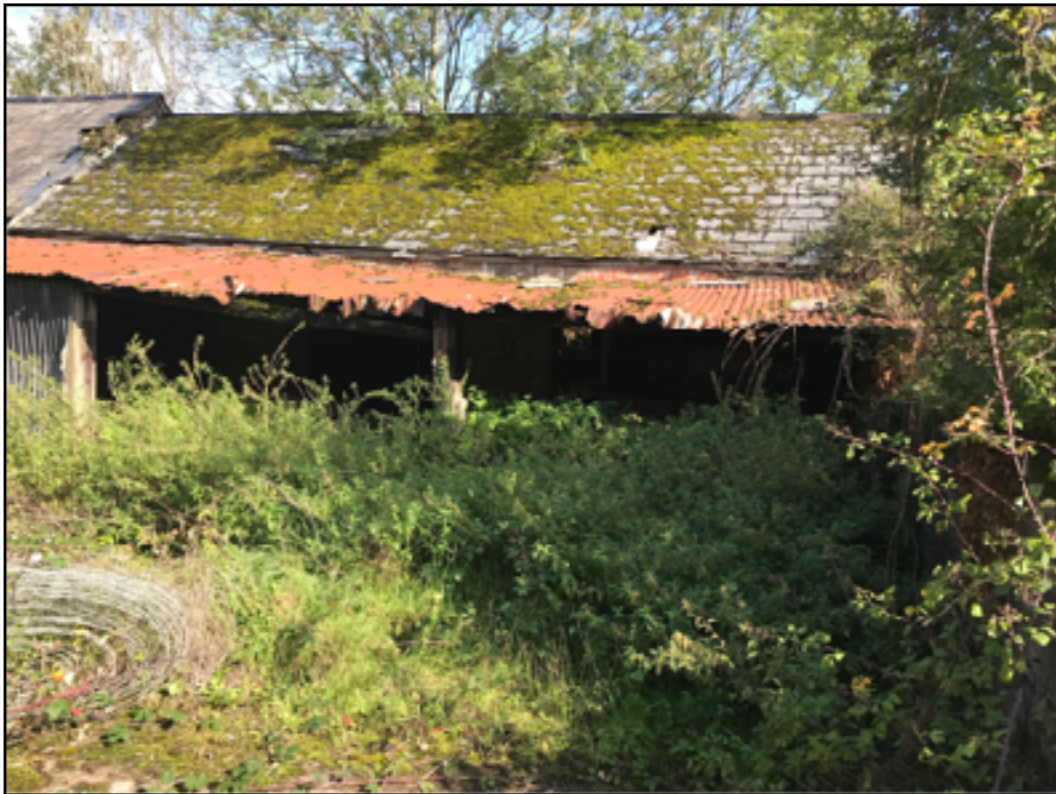
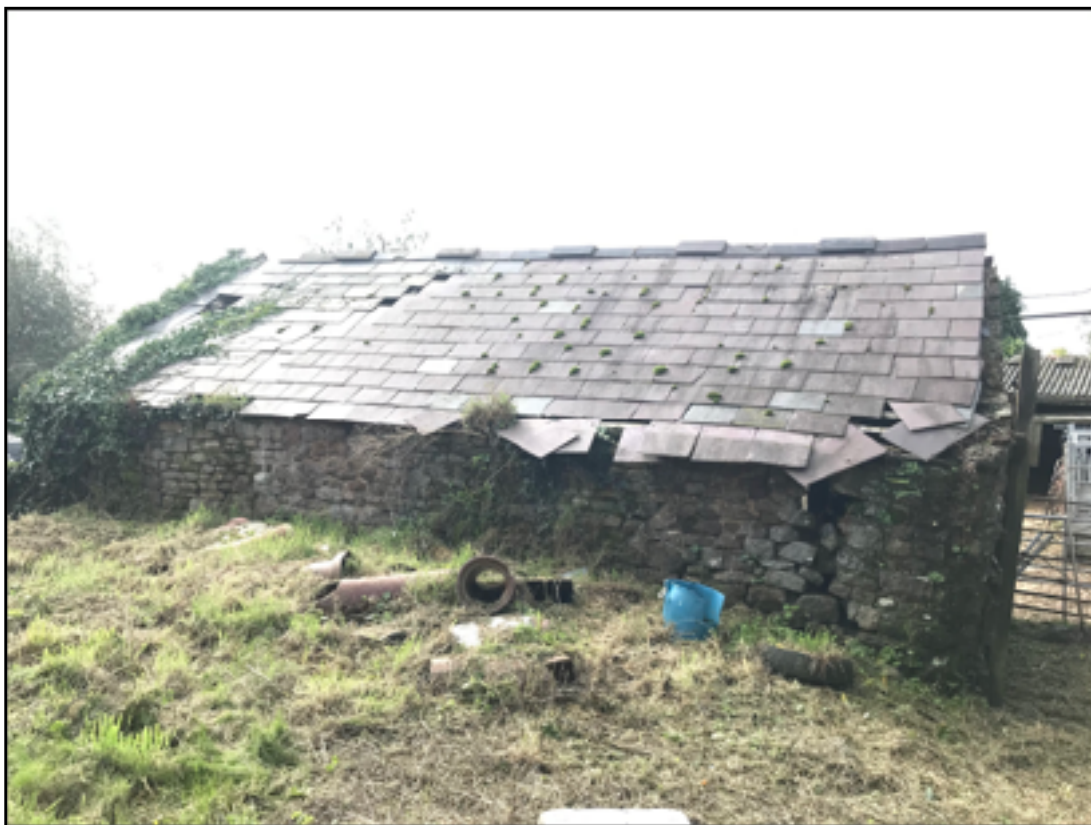
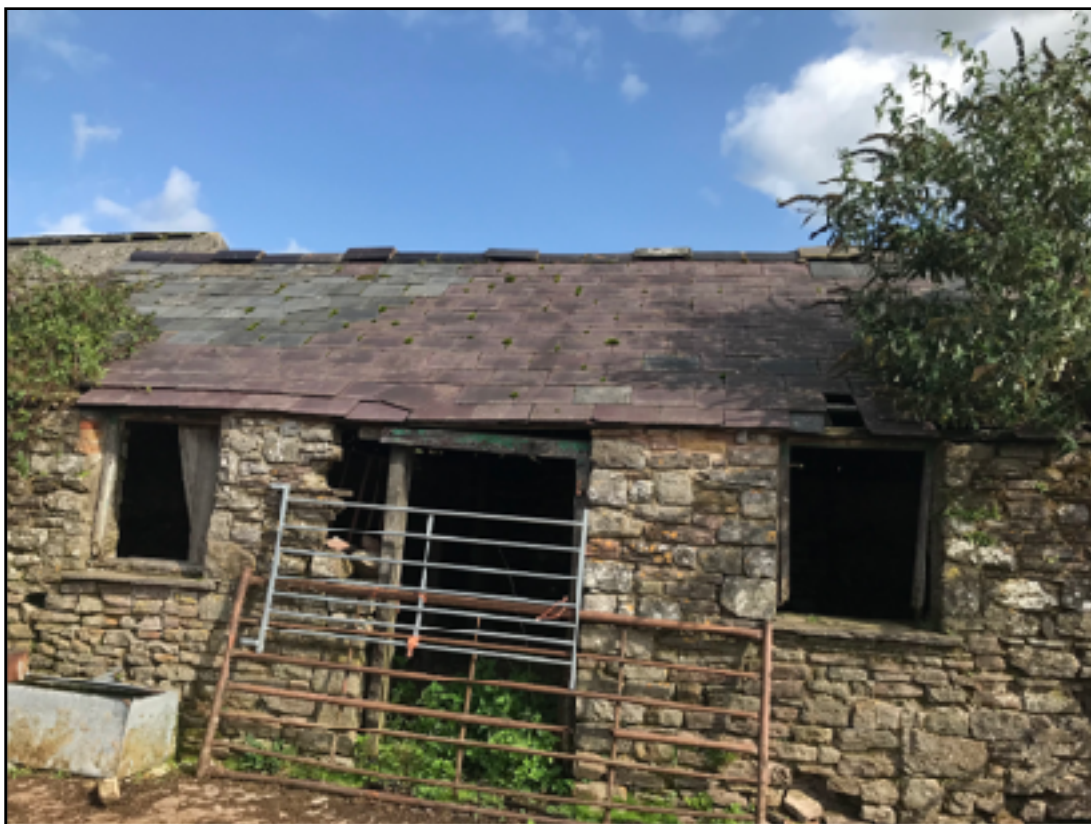
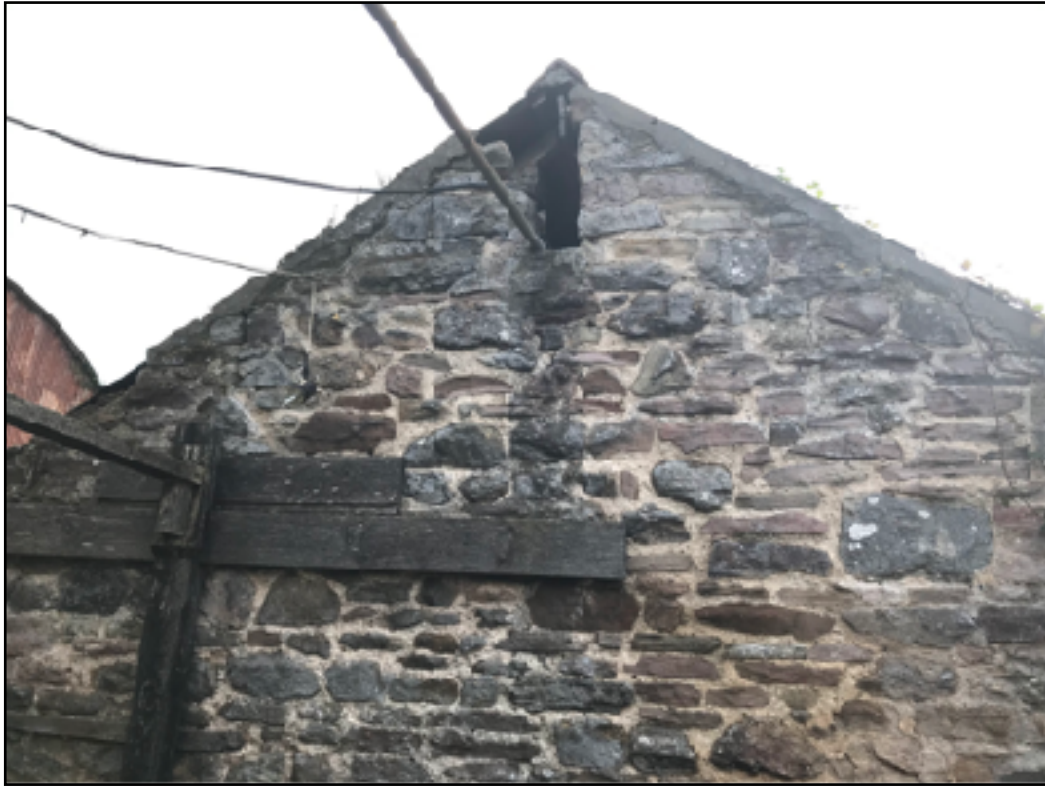
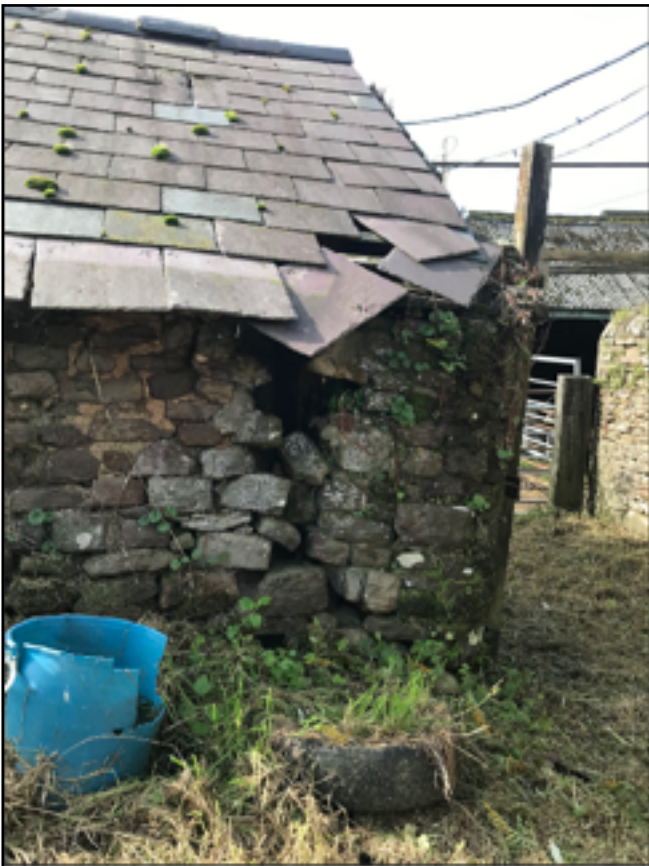
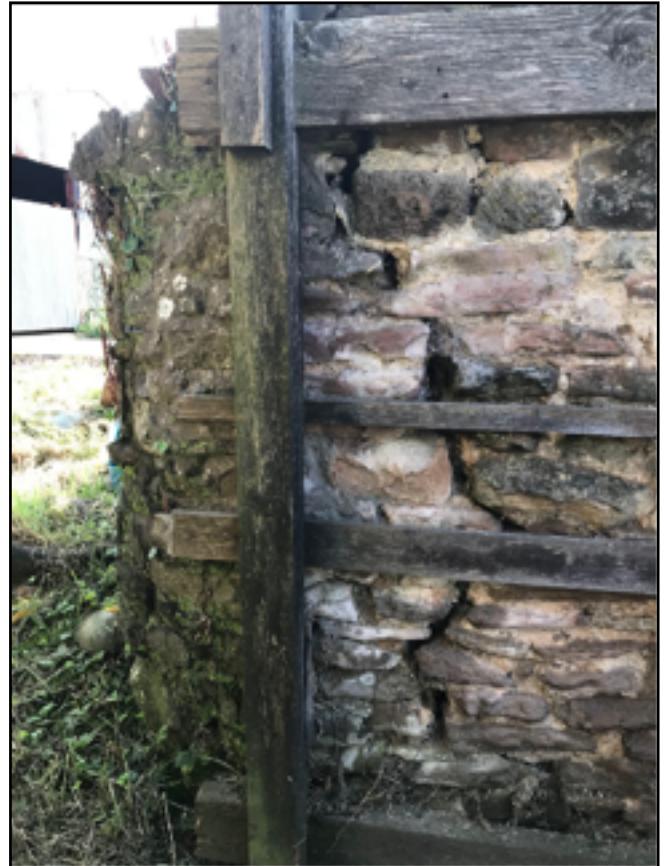
Barn 1

**6.6** Examples of apertures allowing access to cavities in the buildings:

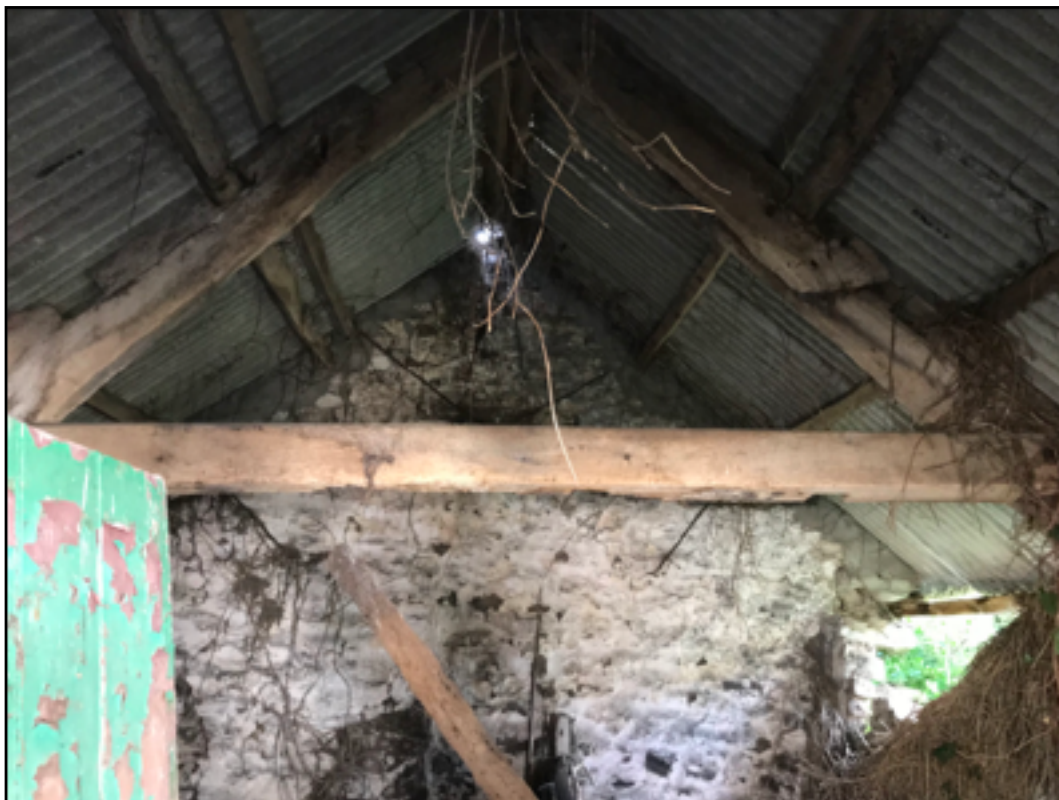
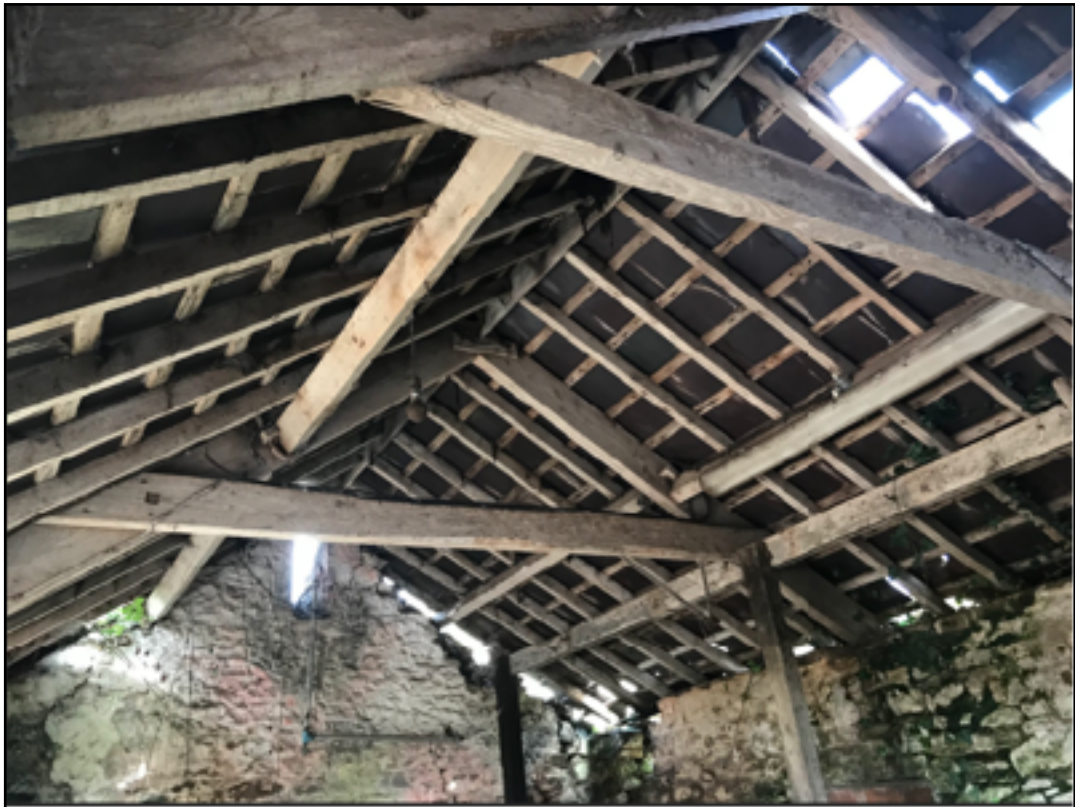
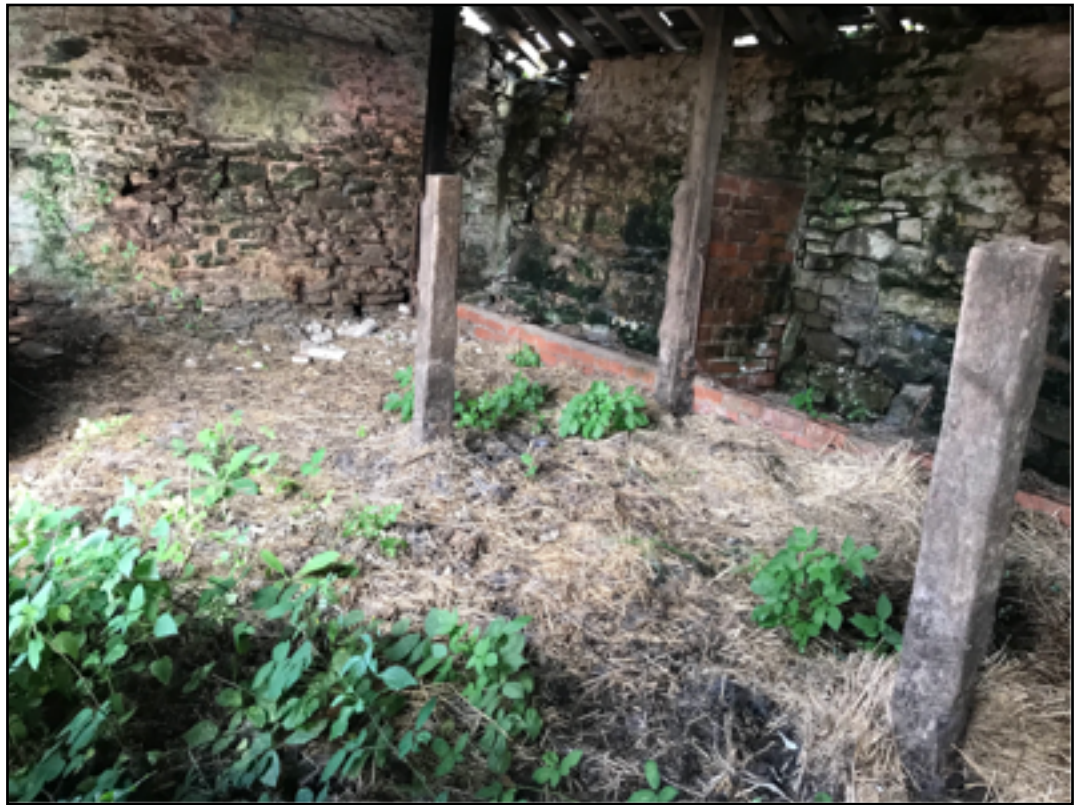
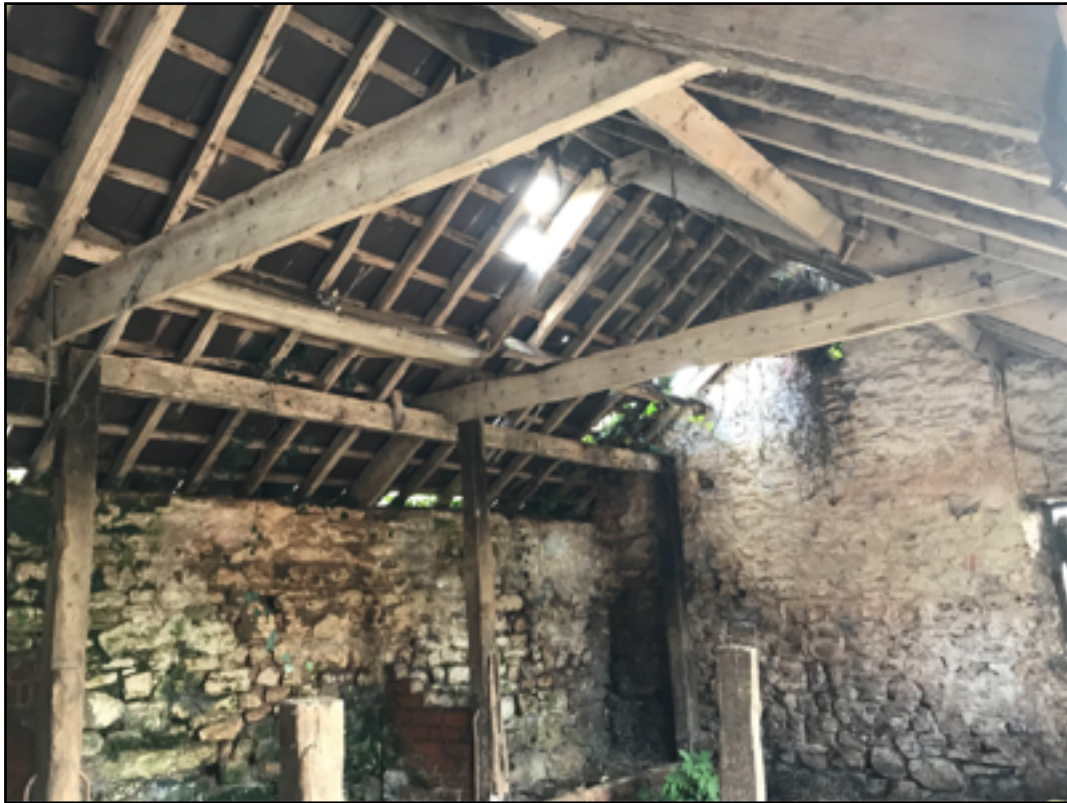
### **Barn 1**

**7.2** There were no internal attic spaces within any of the buildings. All of the buildings were unlined and open to the roofs. The underside of the roofing materials could be seen in all accessible areas of the buildings. An internal inspection of the southern half of Barn 5 could not be undertaken due to the dense scrub in front of the doors, however, there was no internal attic space within the building. Internal access in the northern half of B5 was possible.

**7.3 No droppings or evidence of bats were discovered on any internal features.**

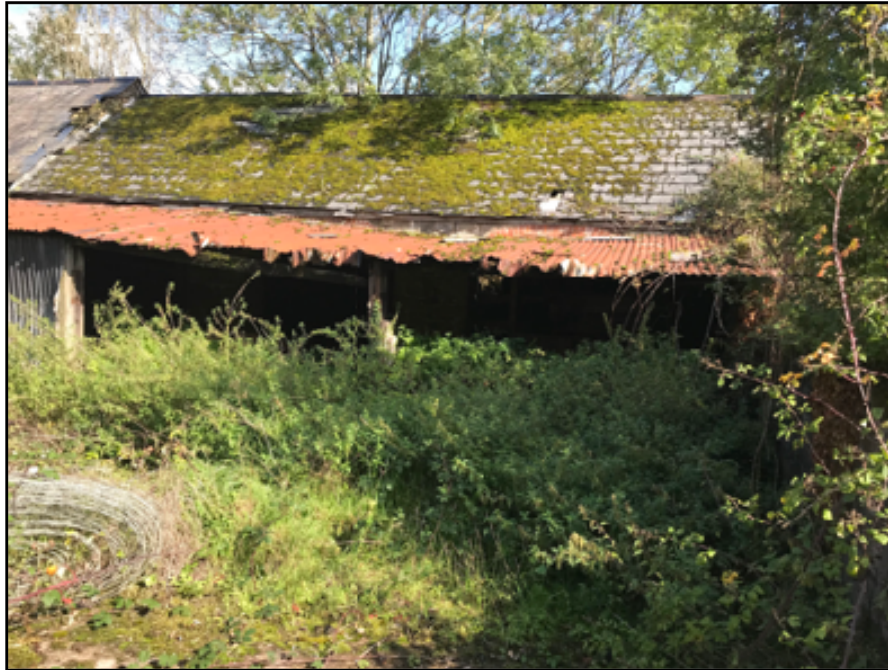
**1 Common Pipistrelle (*Pipistrellus pipistrellus*) was observed emerging from the open side to the western elevation of Barn 5 at 21:54.**

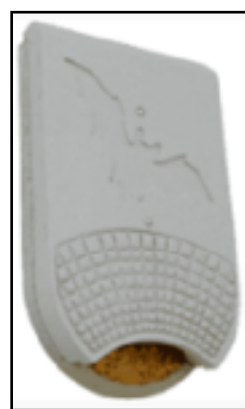
**10.2** It is proposed that new roosting for bats be created by fitting four Schwegler 1FQ surface mounted bat boxes. **The locations of these will be decided by a suitably qualified ecologist and these will be fitted on site under direct supervision of a suitably qualified ecologist.**

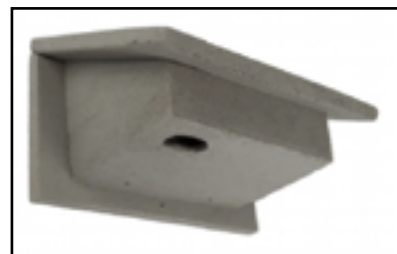
**10.4** Four Vivara Pro WoodStone Swift Nest Boxes will be surface mounted on suitable buildings. **These will not be situated on south facing elevations. The locations of these will be decided by a suitably qualified ecologist and these will be fitted on site under direct supervision of a suitably qualified ecologist.**

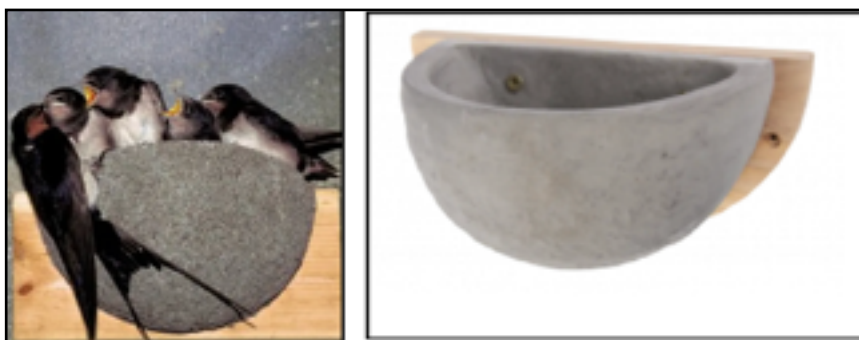
**10.5** Four Swallow cups will be placed at eaves level on a suitable building. **These will not be situated on south facing elevations. The locations of these will be decided by a suitably qualified ecologist and these will be fitted on site under direct supervision of a suitably qualified ecologist.**
