**Bat Survey:** The Rectory, Cardiff Road, Coedkernew, Newport, NP10 8TY

**Reported by:** Ecological Services Ltd  
10 Mount Pleasant, Llanelly Hill, Abergavenny, Monmouthshire, NP7 0NT

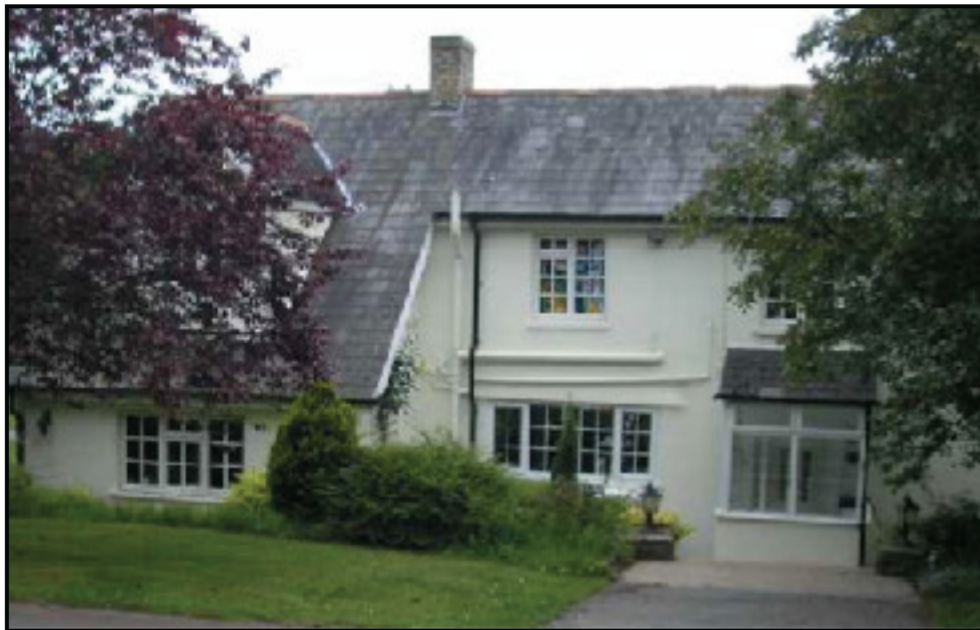
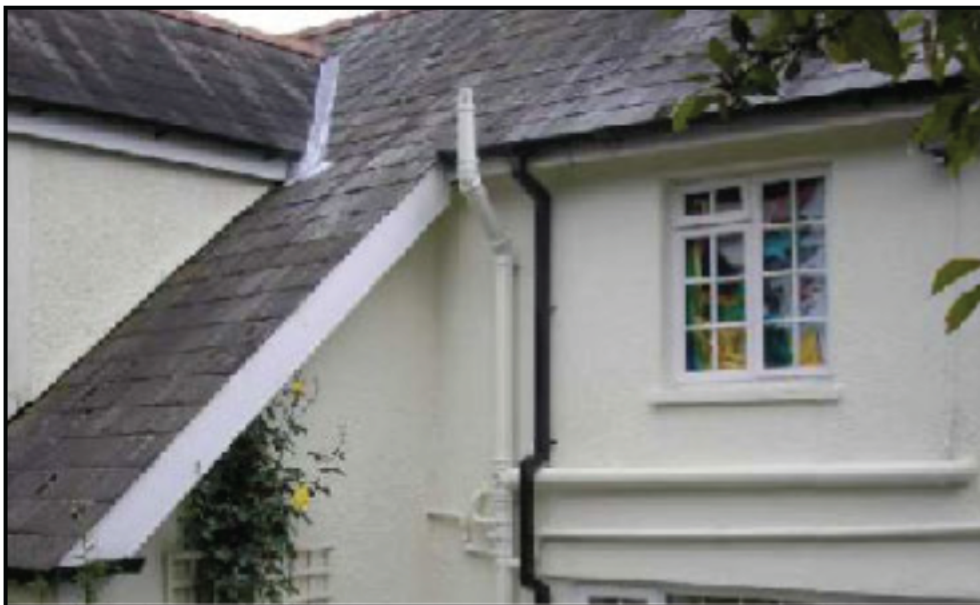
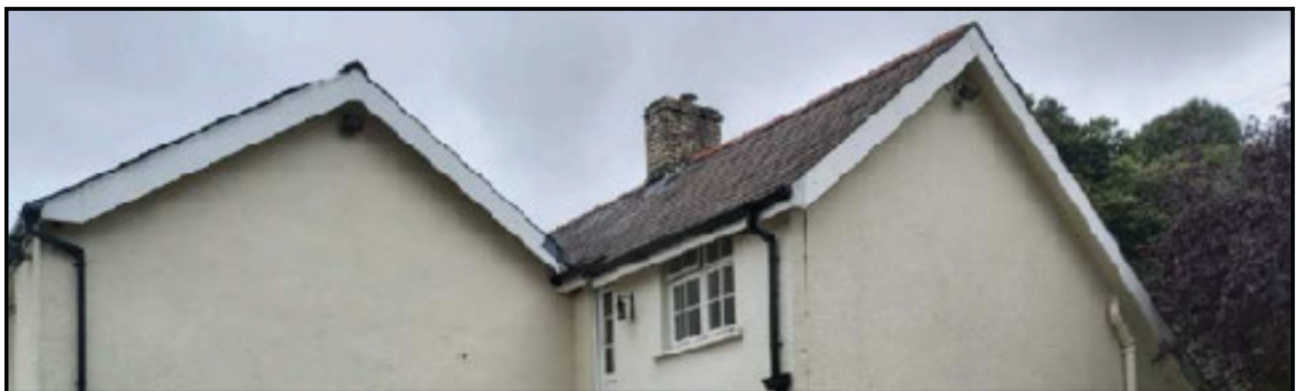
**6.3** Due to the age and condition of the building, there were a limited number of opportunities present for bats to access and use the building and those that were available were deemed as having low to moderate potential for roosting bats. A number of loose and raised slates and raised ridge tiles were observed around the building and a missing ridge tile offered limited access points for bats. The roofline was very tight.

**6.4 No droppings or evidence of bats were discovered on any external features.**

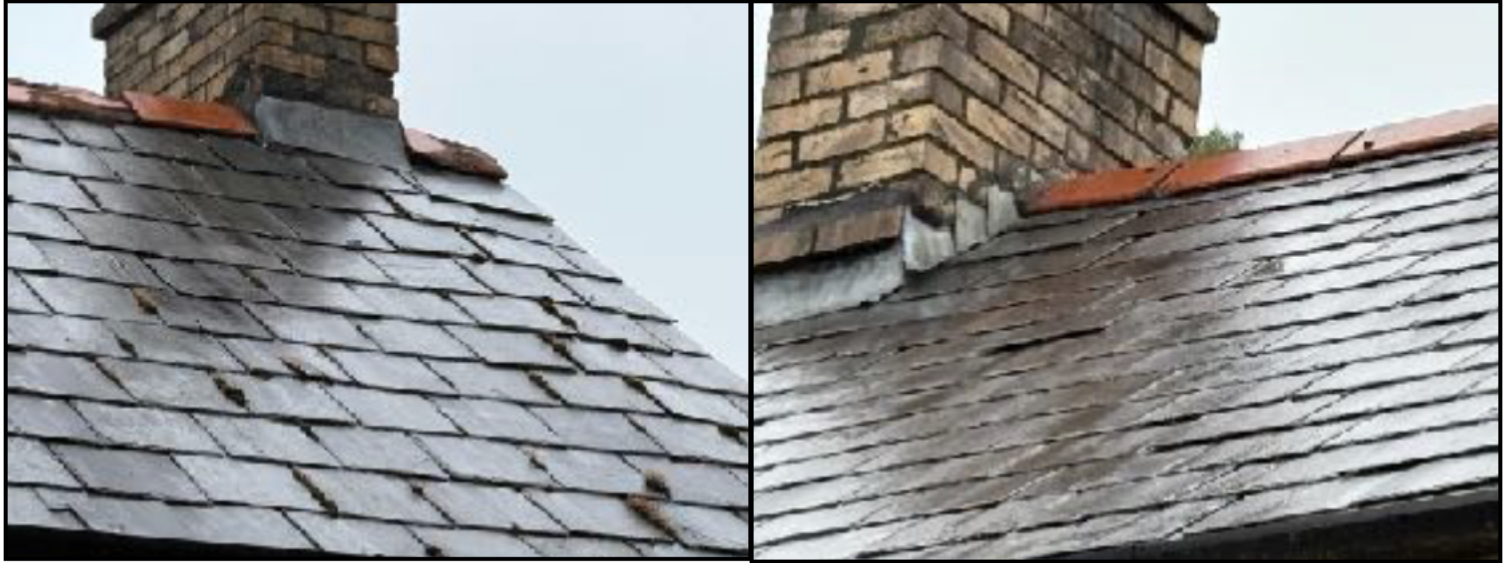
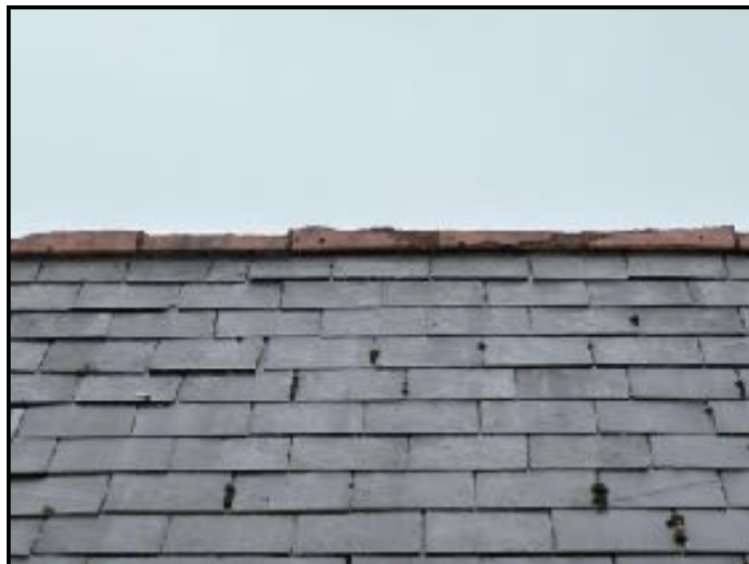
**6.7 A small number of additional features or obvious signs of damage or deterioration of the building were noted during the 2025 survey visit.**

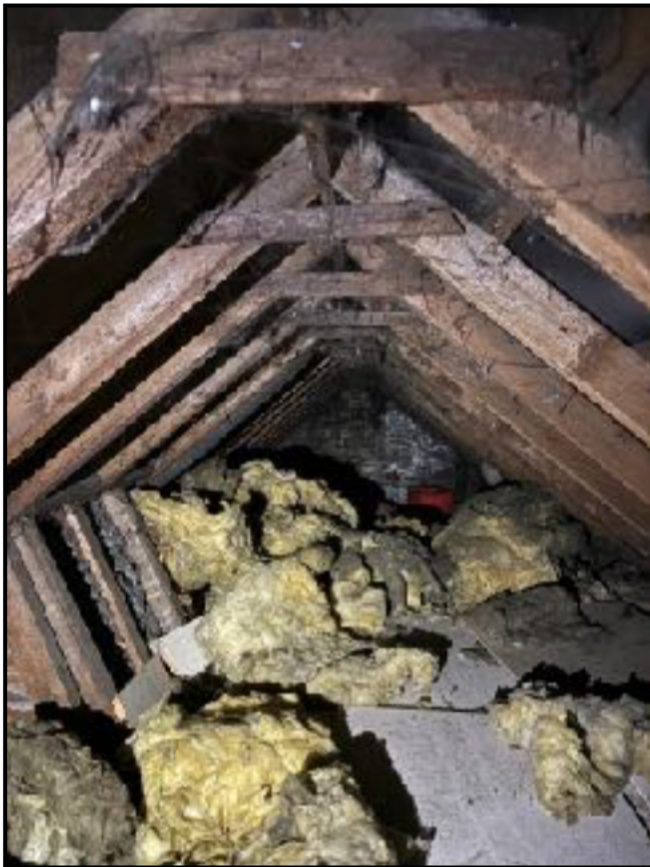
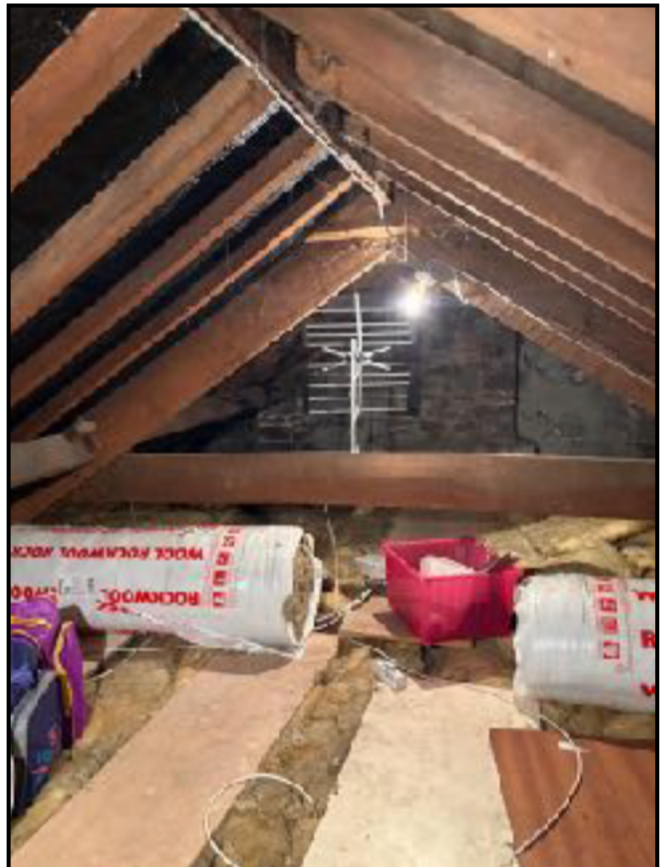
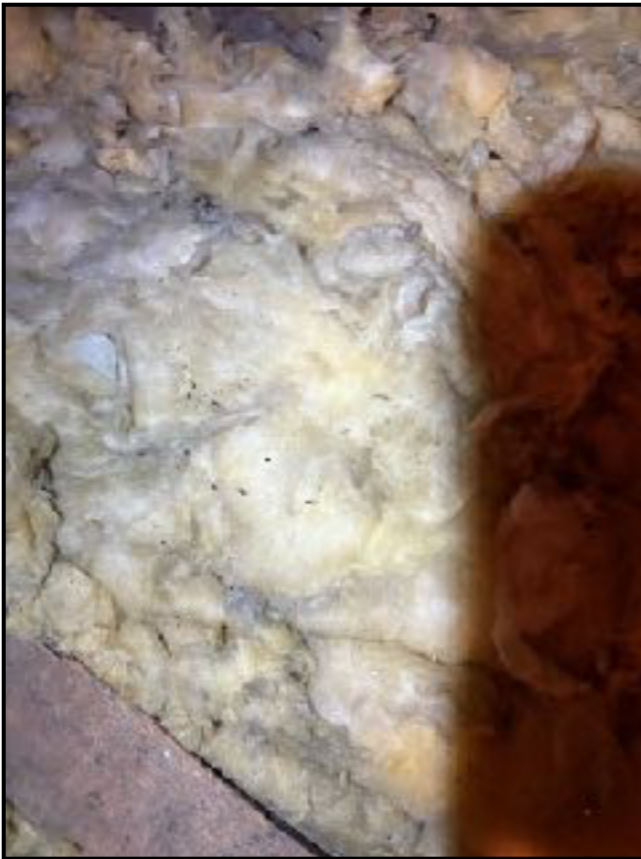
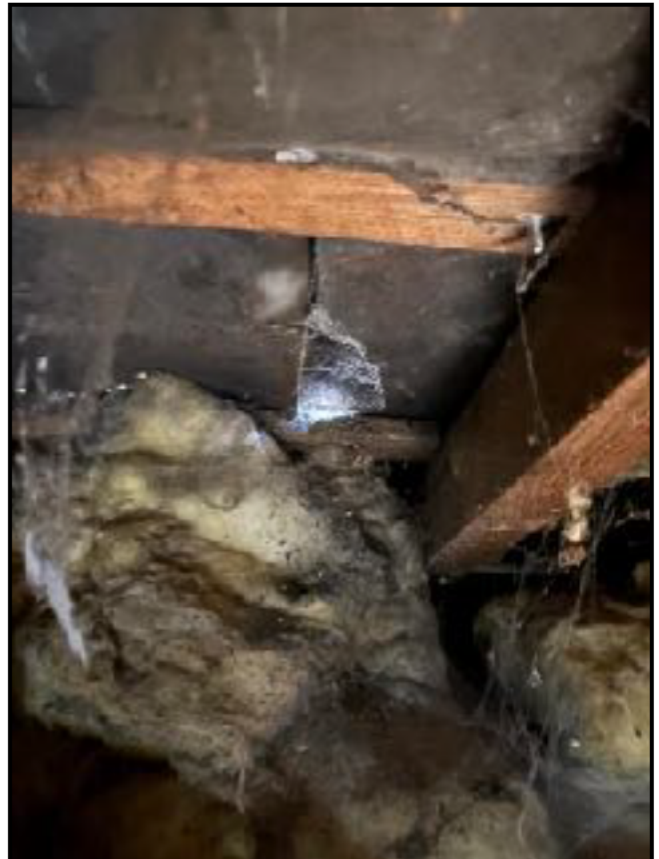
**7.2** There were two attic spaces within the property. The front smaller attic space was of a traditional cut design; lined and partially boarded out with insulation covering the majority of the floor. This space was not fully accessible due to the size. The larger attic space was fully accessible and was of a traditional cut design; lined and partially boarded out with insulation covering the majority of the floor. There were small areas of light ingress within the spaces.

**7.3** A small number of bat droppings indicative of a Pipistrelle Species (*Pipistrellus sp.*) of bat were observed within the larger attic space.

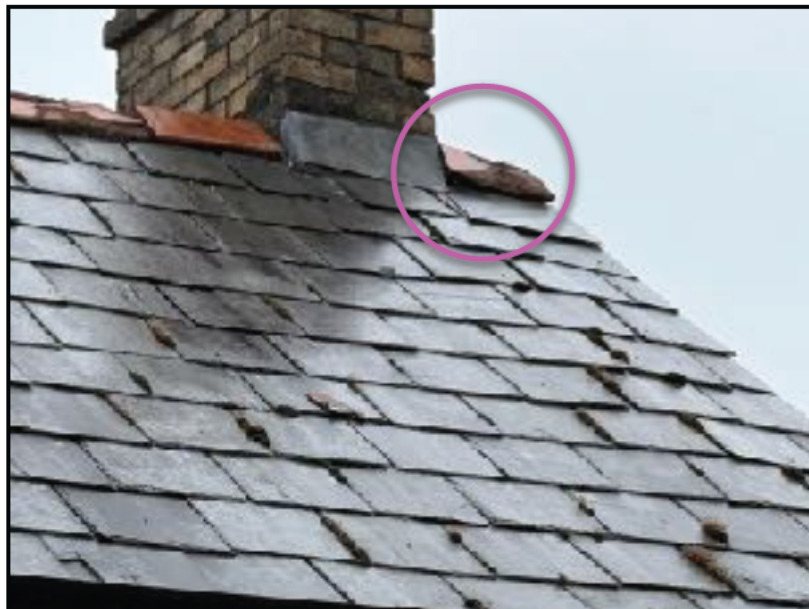
**1 Common Pipistrelle (*Pipistrellus pipistrellus*) was observed emerging from underneath a raised ridge tile to the western elevation of the building.**

**9.11 As the building is proposed to be re-roofed, the confirmed bat roosting location will be destroyed. Therefore a European Protected Species Licence, issued by Natural Resources Wales will be legally required to destroy the roost.**

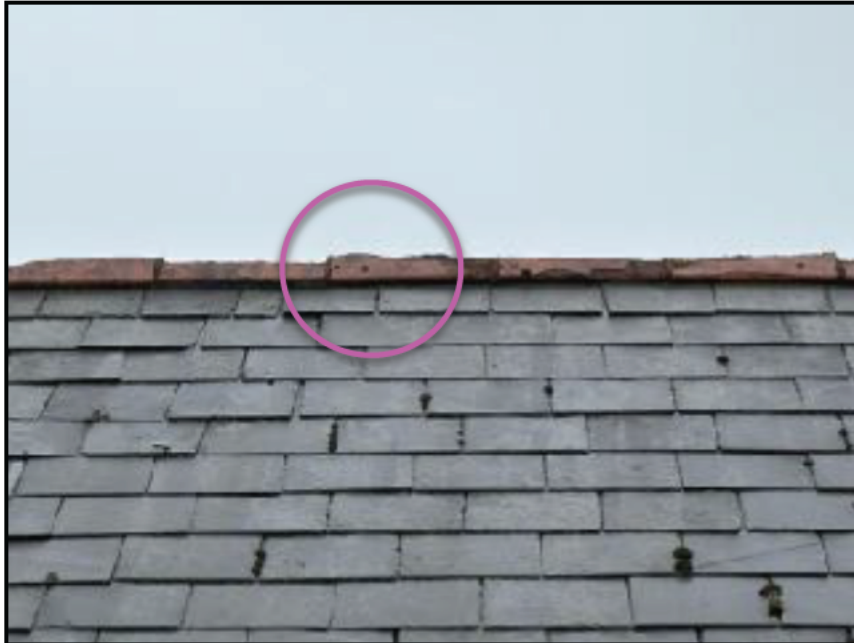
**1 Common Pipistrelle was observed emerging from underneath a raised ridge tile in the centre of the roof.**

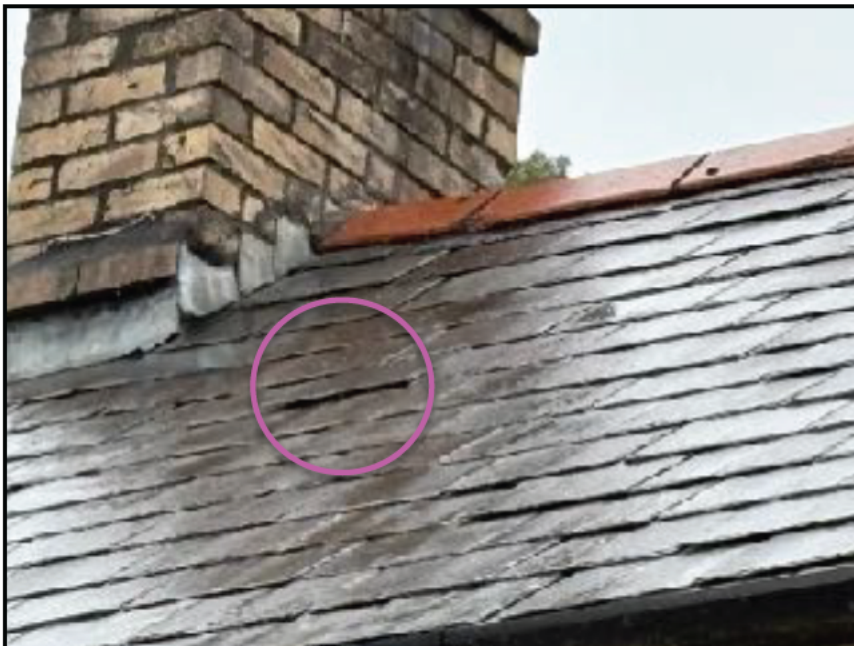
**1 Common Pipistrelle was observed emerging from underneath a raised slate to the southern aspect of the roof.**

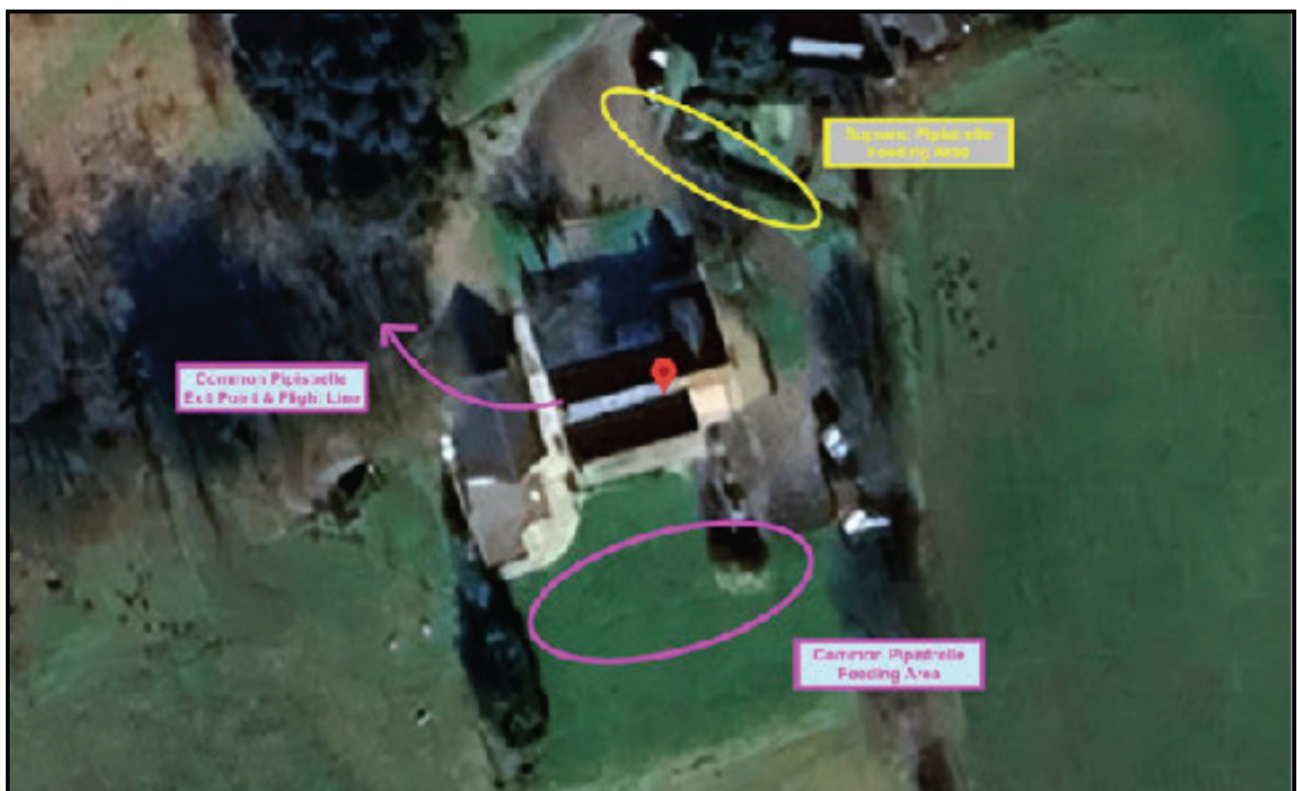
8.10 During the 8th June 2025 emergence survey, a very low number of bat calls were recorded. 1 Common Pipistrelle was observed emerging from the building. A small number of Common and Soprano Pipistrelles were observed foraging around the building.

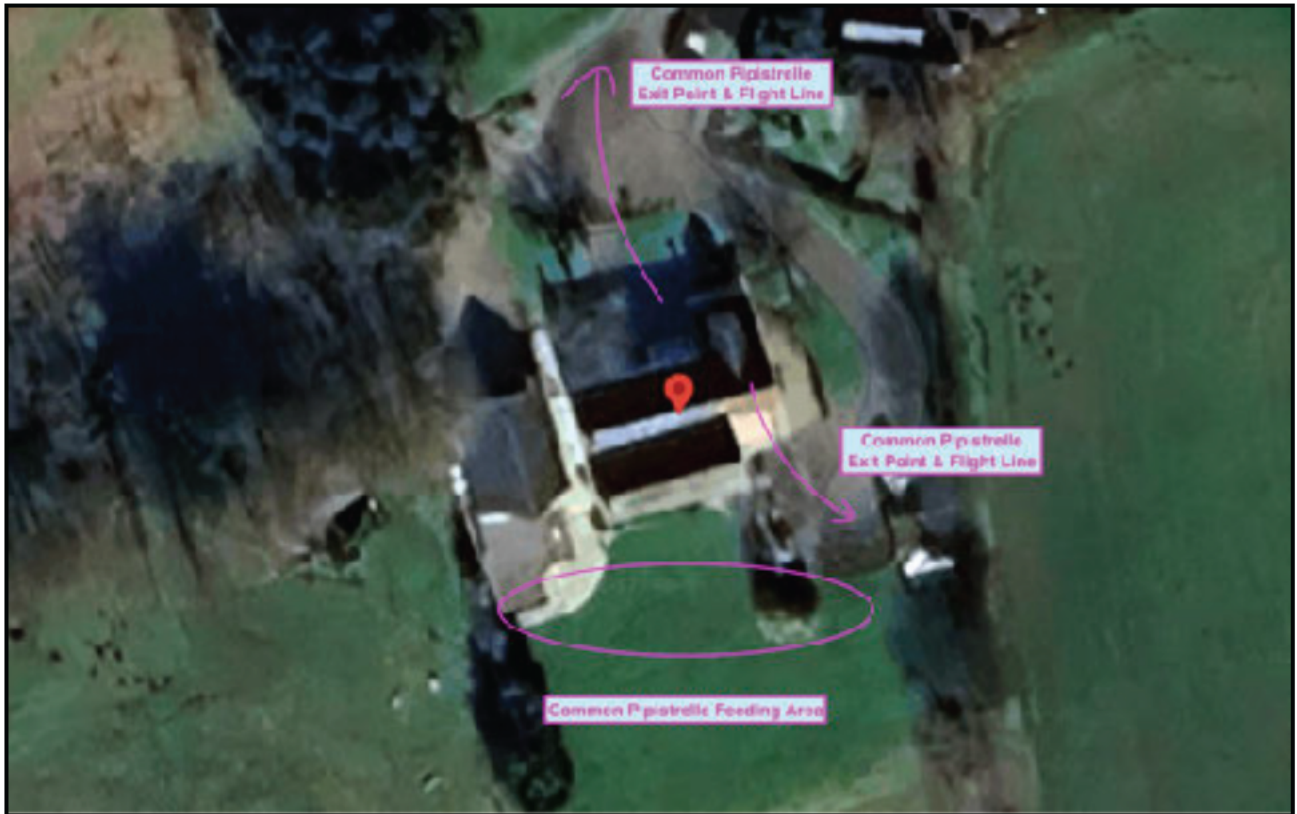
**8.11** During the **25th July 2025** emergence survey, a very low number of bat calls were recorded. 2 Common Pipistrelles were observed emerging from the building. A small number of Noctule's were observed foraging high over the site and a small number of Common Pipistrelles were observed foraging around the building.

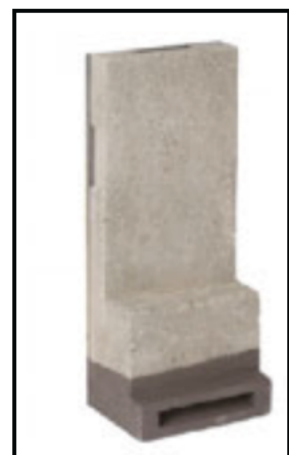
**10.2** It is proposed that new roosting for bats be created by building two Vivara Pro WoodStone Bat Boxes into the block work; one on the eastern elevation and one on the western elevation. **Care must be taken not to obstruct the access slots.**

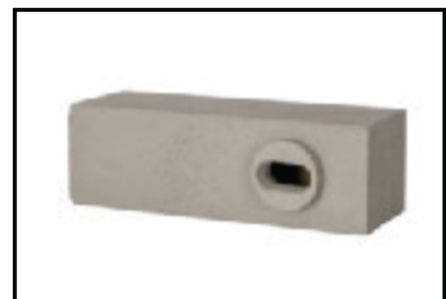
**10.4** One PRO-UK Rendered Build-In Swift Box will be built into the block work on the northern elevation of the building. **This will not be situated on a south facing elevation. Care must be taken not to obstruct the entrance hole.**

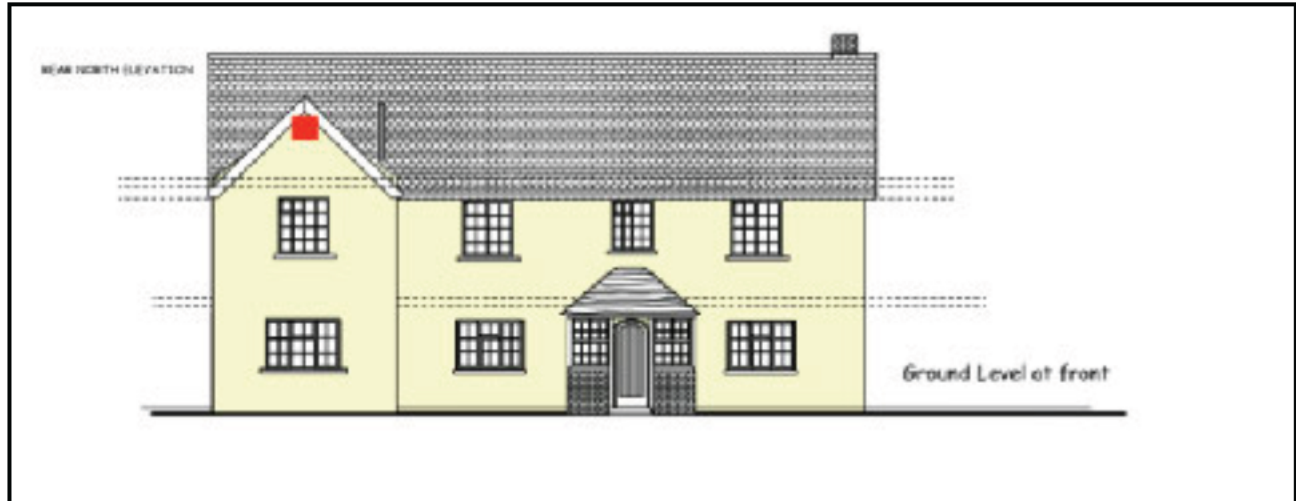
#### 10.9 Recommended Locations of Bat and Bird Mitigation:

**Location of PRO-UK Rendered Build-In Swift Box**
-

**Location of Vivara Pro WoodStone Bat Box**
