**Planning Statement:**

Land adjacent to the River Ebbw –

At Jubilee Park:

Jubilee Park Management Company

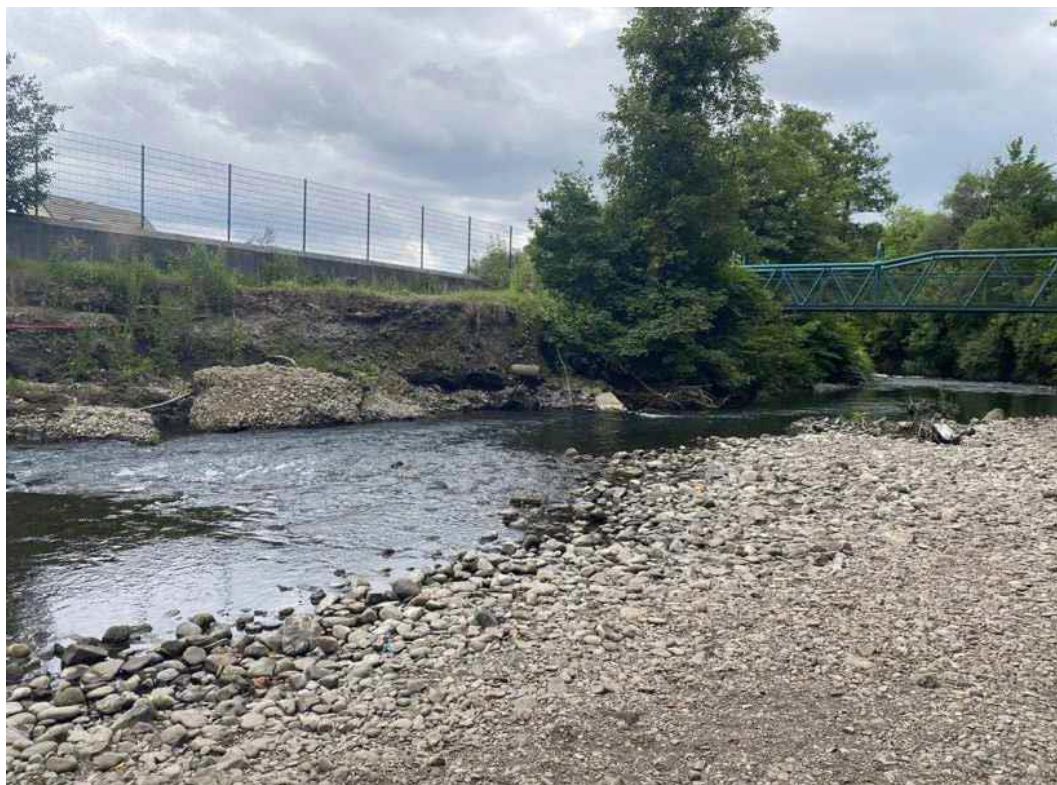
**Photograph 1:** View from west bank of river

- 1.14. The two photographs below show the extent of the collapse. Photograph 1 is a view from the west bank looking south-eastwards towards the footbridge. It clearly shows the eroded bank collapsed into the river.

- 1.16. The positions from which the photographs were taken is shown on the Existing Survey Plan (Ref: 17957\_101\_r04).
- 1.17. The flood wall is a mass gravity structure founded on alluvial gravels and any further erosion in front of the wall will impact its stability. A solution is proposed to both reinstate the bank and protect it from further erosion without adversely impacting on protected species or local environmental considerations.

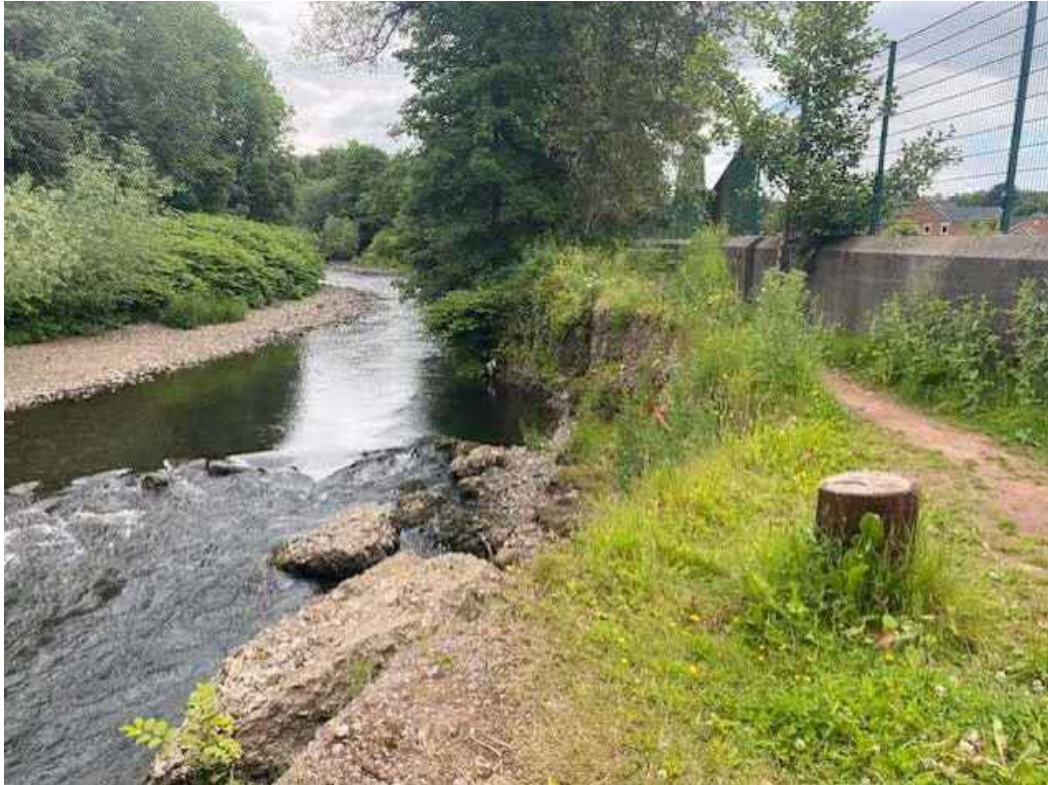
**Photograph 2:** View northwards

- 1.15. Photograph 2 is a view northwards along the collapsed bank. The narrowness of the remaining bank running alongside the floodwall can clearly be seen, as can some of the debris from the river bank that remains in the now widened river.

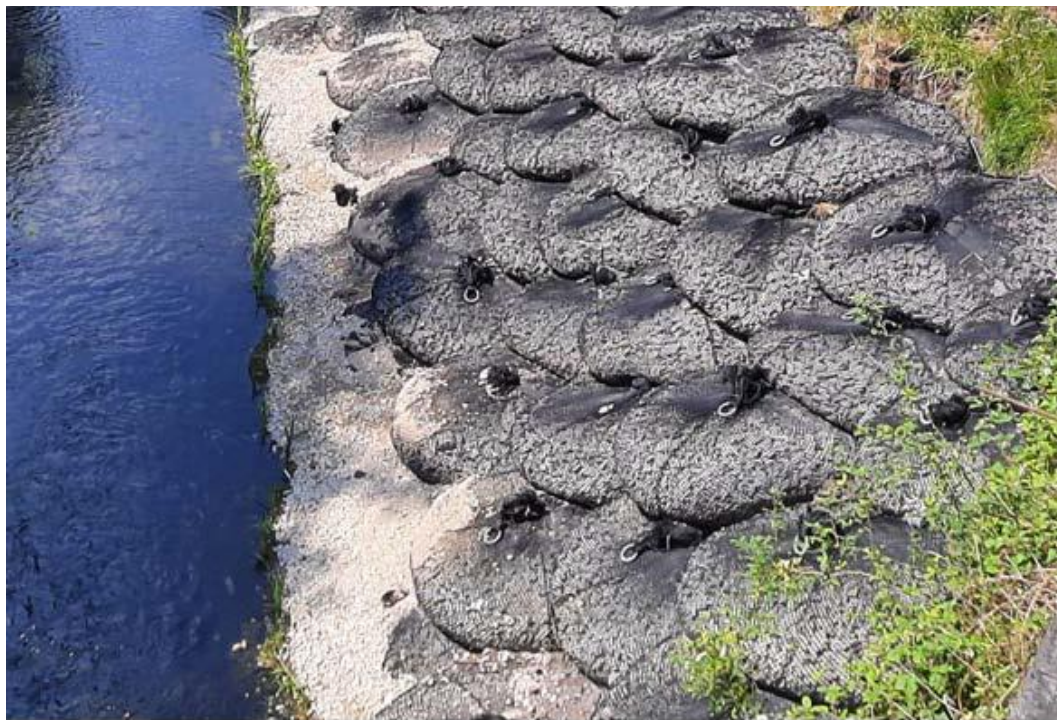
**Photograph 3:** Aquabags

- 3.13. The bags will fill the eroded area to reinstate the riverbank to its former extent to protect it and prevent any further erosion. They have lifting rings which enable fast placement with a mobile crane capable of lifting and slewing the bags from the laydown area on the other side of the flood wall.
- 3.14. The bottom Aqua Rock bag will be anchored to form a secure base, with the remainder being tied together to provide a flexible and sustainable engineering solution. The use of these bags allows for a safe, quick and efficient installation in flowing water which is not reliant on large scale equipment and manpower.

- 3.15. The Aqua Rock bags provide a strong defence against water erosion and high-water levels. They have a long-term material strength and durability which will provide a permanent solution. The angular stone filling provides an interlocking fit but will also provide an ecological benefit by creating a habitat for invertebrates.
- 3.16. Salix Rock Mattresses will be fixed to the aqua bags along the base of the slope (See Proposed Sections plan Ref: 17957\_504\_r07). They are a tubular shaped high strength polyethylene net bag filled with small stones. They will provide additional protection against erosion. The small stone size in the filled bags allows water to flow but also traps sediment; which

- 3.10. Pre-filled 2 tonne "AquaRock" bags (2m diameter and 500mm high) will be laid on the filter cloth. The bags are made of a high strength, UV-resistant, high density polyethylene (HDPE) material. HDPE is long-lasting with exceptional resistance to degradation.

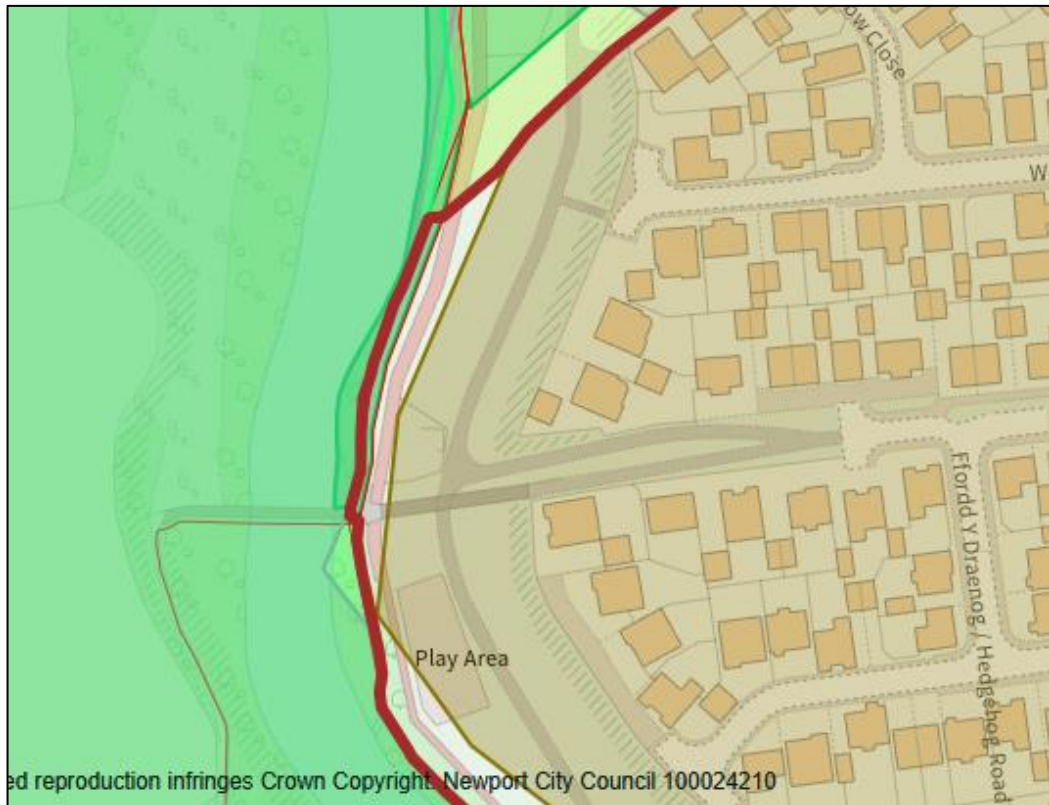
**Figure 5:** Extract from LDP Proposals Map

- 4.26. It also identifies the application site as being part within the Special Landscape Area, **Policy SP8(ii)**. Jubilee Park is shown as a housing commitment, **Policy H1(54)**, with the area between the flood wall and the river as being an environmental space that is part of the Ty Du (Rogerstone) Recreation Ground.

- 4.27. The footpath is identified as part of the network of long distance walks or cycleways, **Policies T14, ED15, CF6 and CF10**.

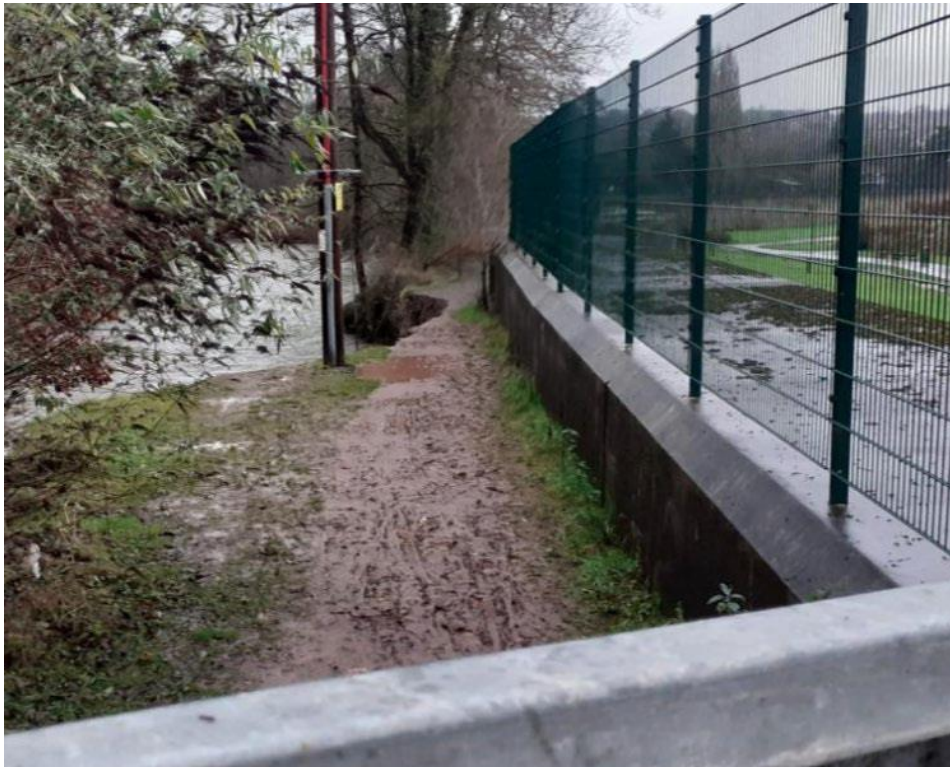
**Photograph 4:** View upstream from the footbridge along the flood wall

- 5.5. Both photographs clearly show that the remains of the footpath are unsafe to use and yet are still in regular use. Photograph 4 also clearly shows that further damage to the flood wall is simply a matter of time.
