Glan Llyn, Newport

Phase 5E1

Chemical Validation Report

18669-RLL-22-XX-RP-O-0348

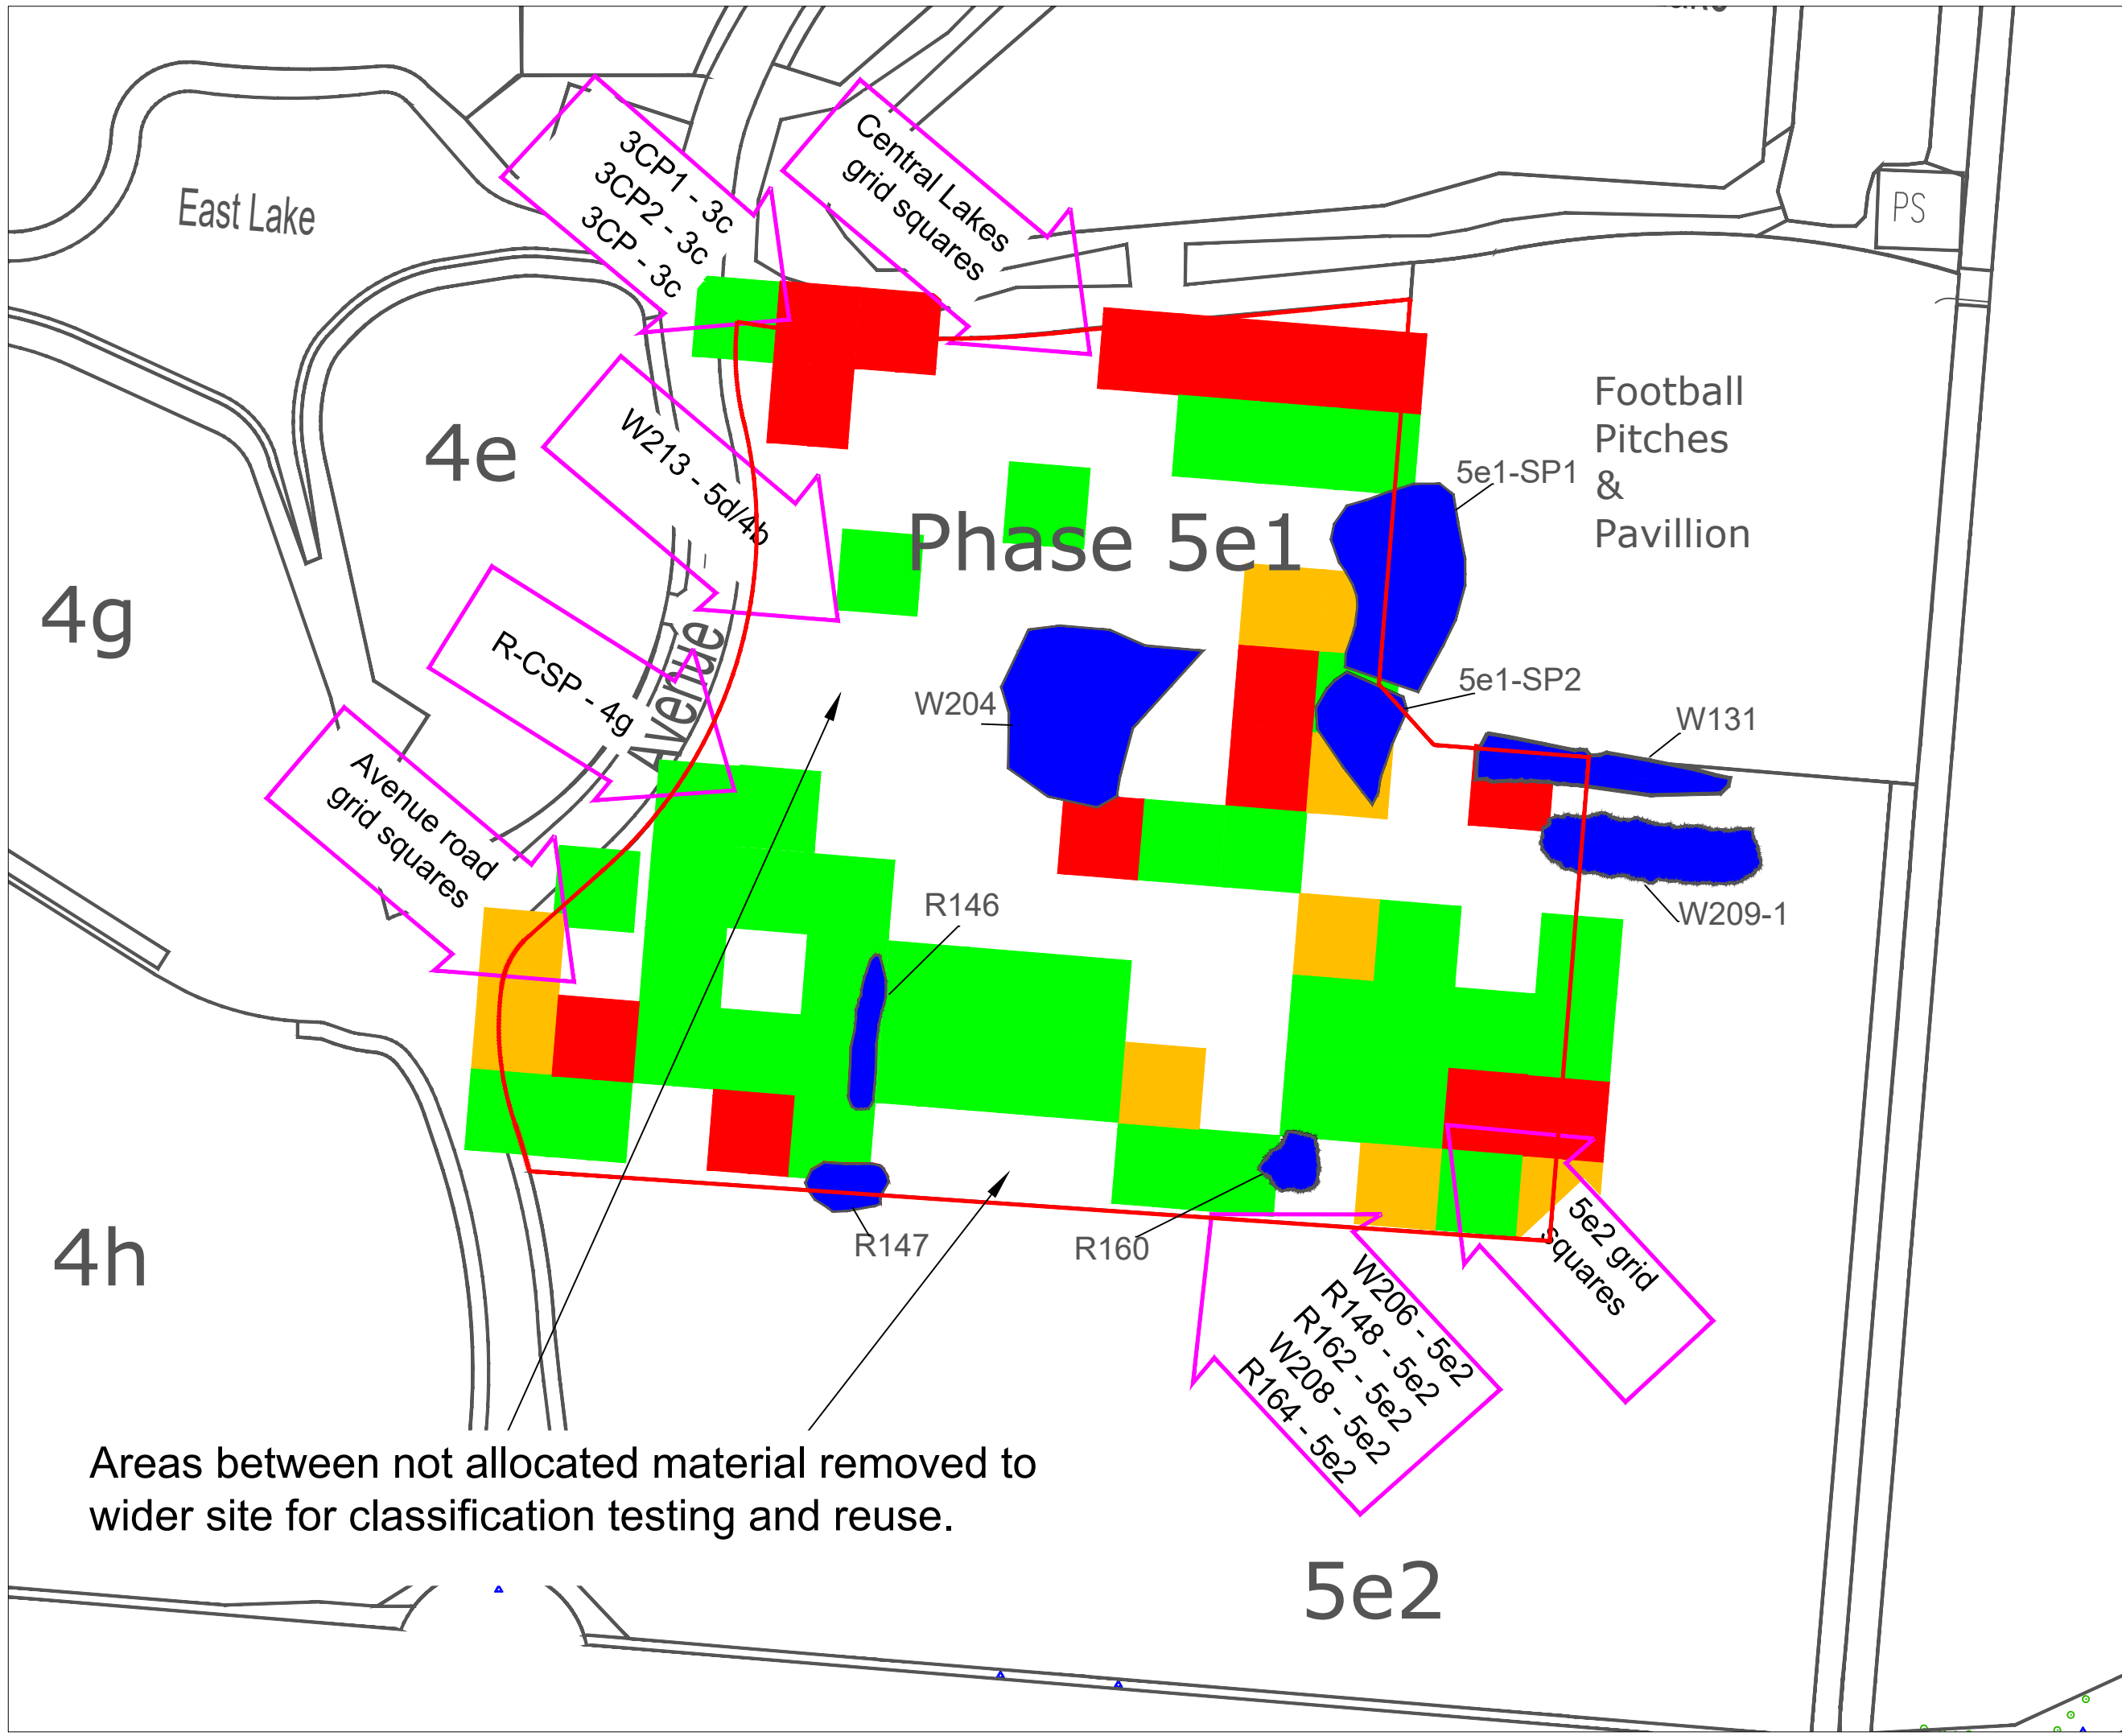
Drawing 18669-RLL-23-XX-DR-O-0443-P01 located in Appendix A shows the materials tracking. Material was verified in 25m<sup>2</sup> squares. No material was disposed off site. There were a number of locations where chemical unsuitable material was located within 30m of the watercourses, this material was subsequently relocated outside of the 30m zone. Additionally, there were a number of 25m<sup>2</sup> squares where material failed the site acceptance criteria for metals, however this material was retained on site.

- Key**
- Site boundary
  - Material suitable for residential
  - Material only failing metals
  - Material relocated to >30m from proposed watercourse
  - Reused stockpiles
  - Material from wider site
  - Material name and phase of origin
- W104 - 5e1
