**Bat Survey:** The School House, Charles Williams Church in Wales School, High Street,  
Caerleon, NP18 1AZ

**Instructed by:** Charles Williams Charity

**Reported by:** Ecological Services Ltd  
10 Mount Pleasant, Llanelly Hill, Abergavenny, Monmouthshire, NP7 0NT

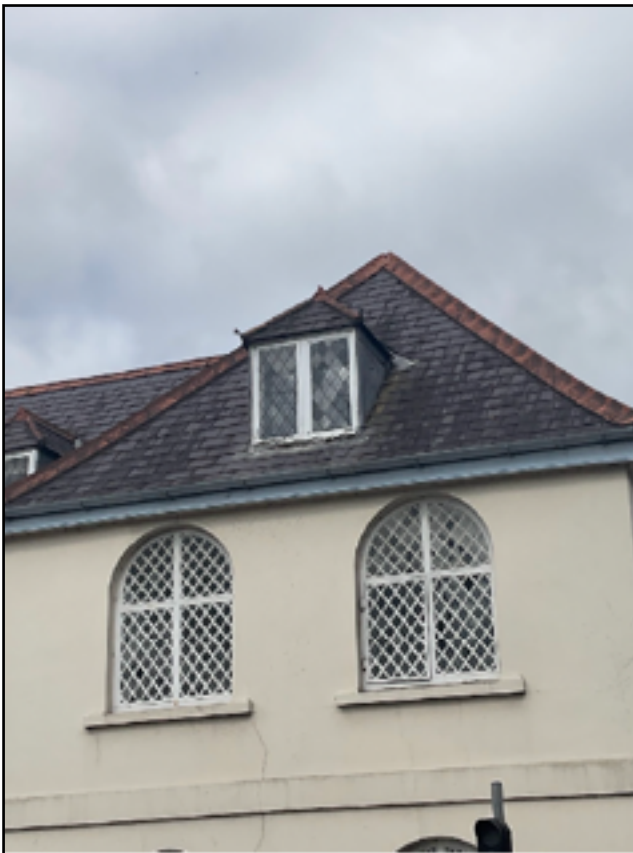
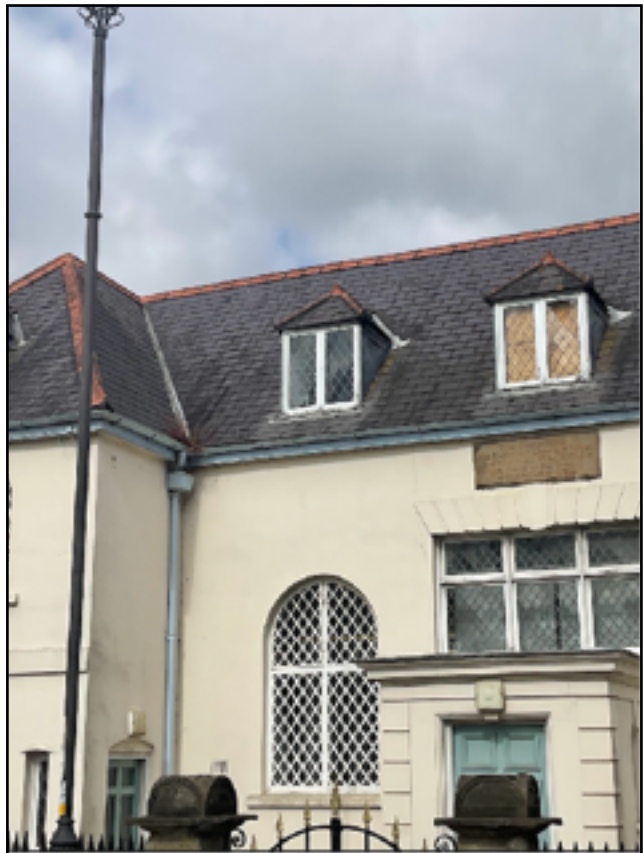
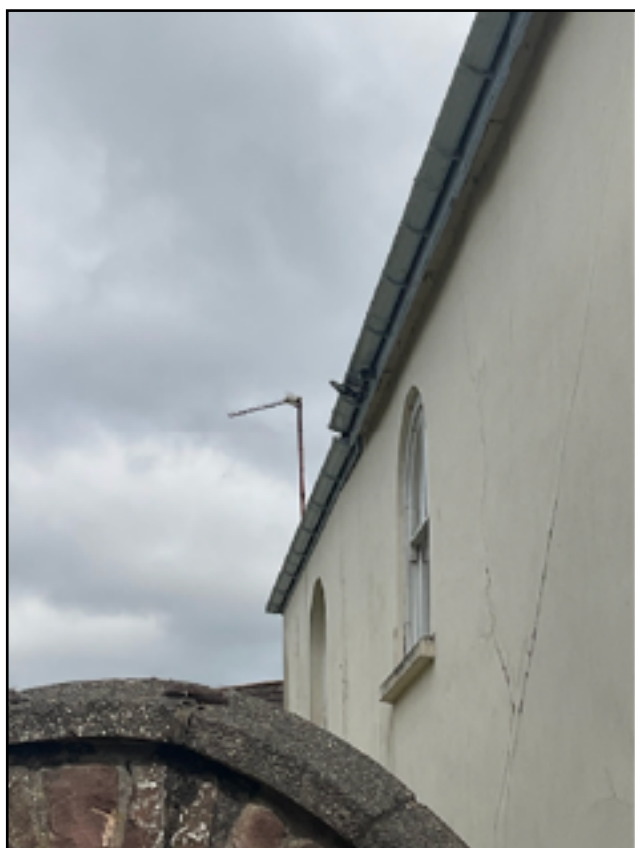
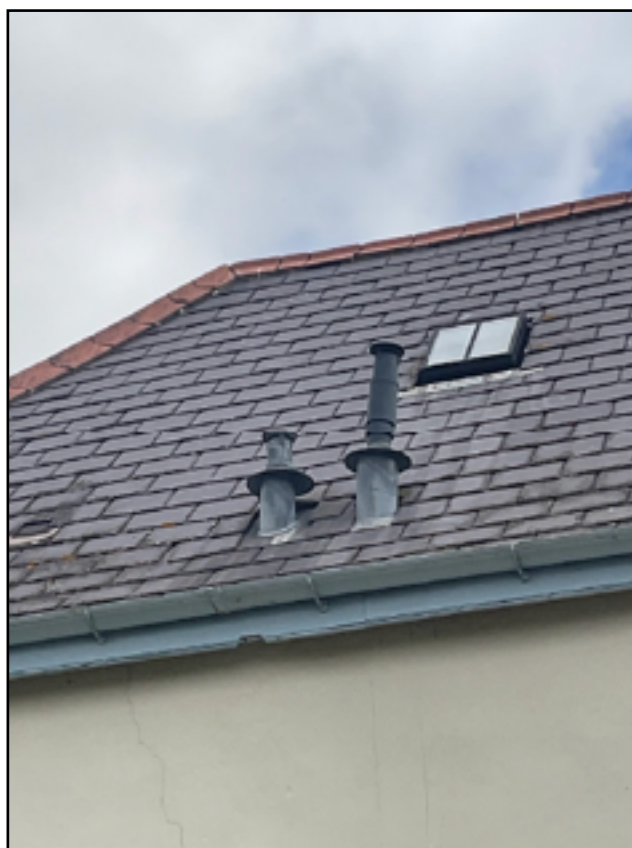
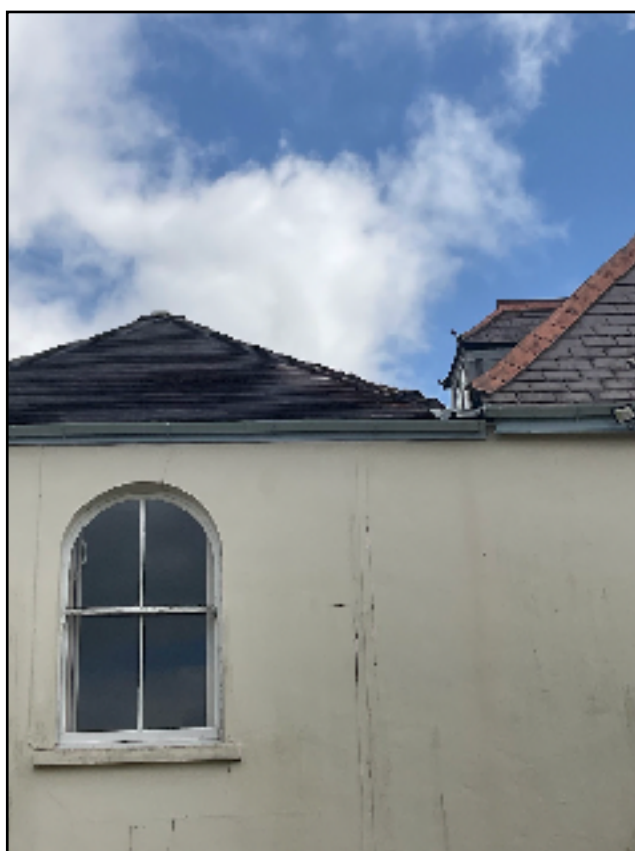
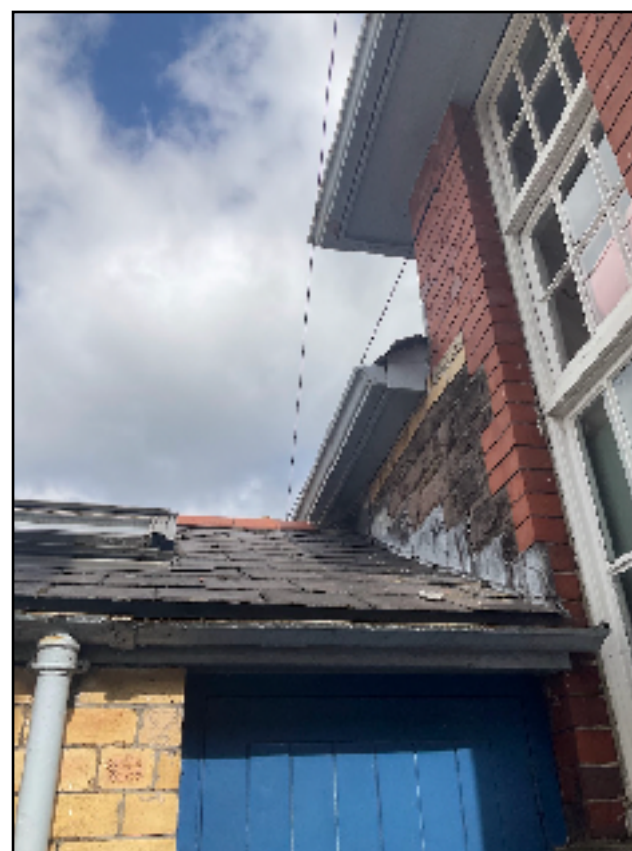
**6.6 Examples of apertures allowing access to cavities in the building:**

**6.3 Due to the age and condition of the building, there were a number of opportunities present for bats to access and use the building and those that were available were deemed as having moderate potential for roosting bats. There were areas raised lead around all of the dormer windows; areas of raised fasciae; apertures around the chimneys; areas of missing mortar along the ridge lines; a number of raised and slipped slates and apertures between the soffits and the walls.**

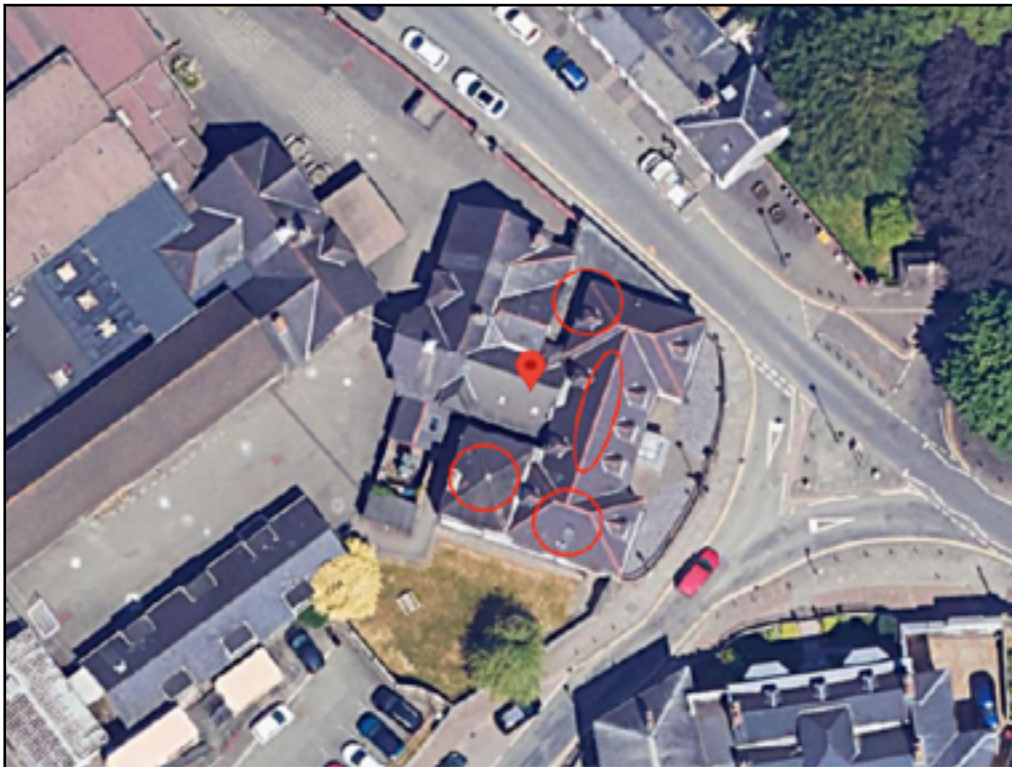
**7.2** There were four accessible roof voids within the building. The approximate locations of the roof voids have been identified in the below plan. None of the voids were boarded out and there was insulation covering the floor of each space. Each of the voids were lined and there were no areas of significant light ingress present within the voids.

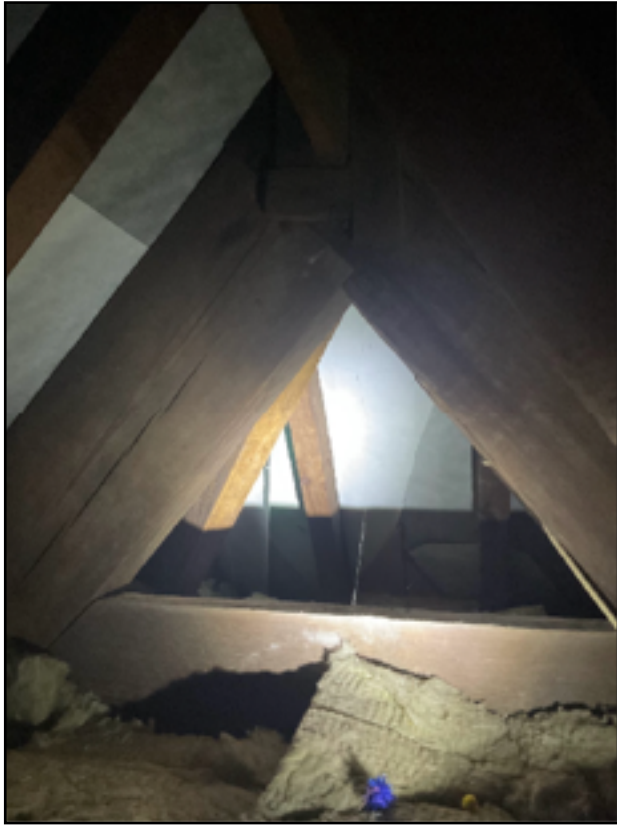
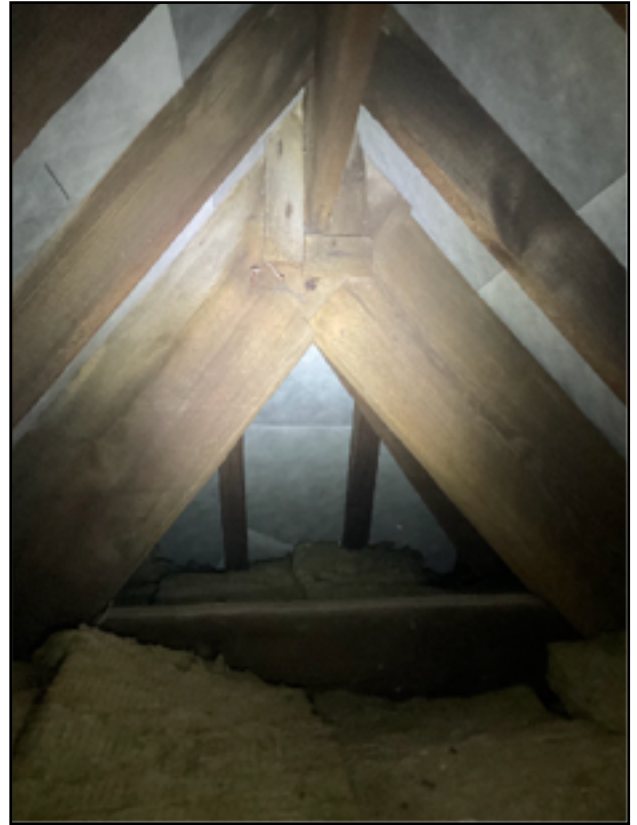
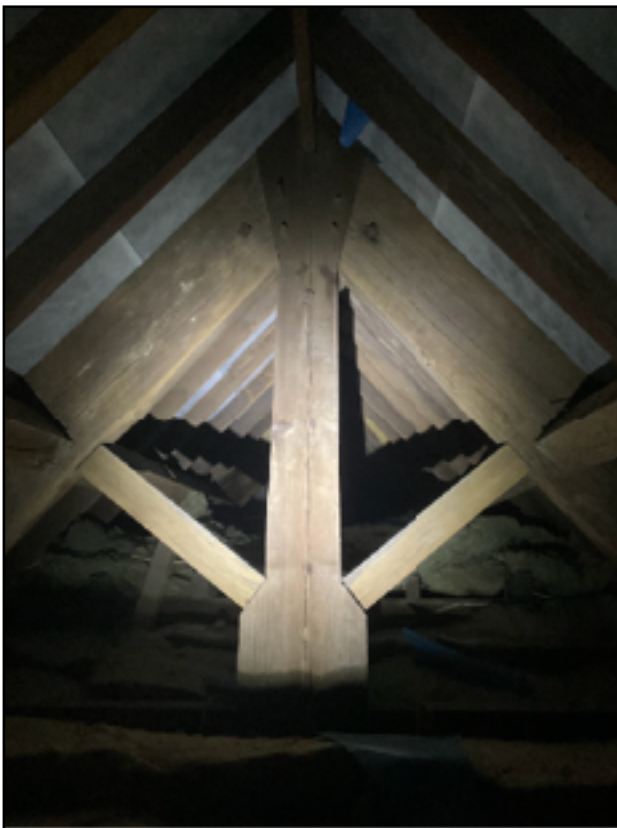
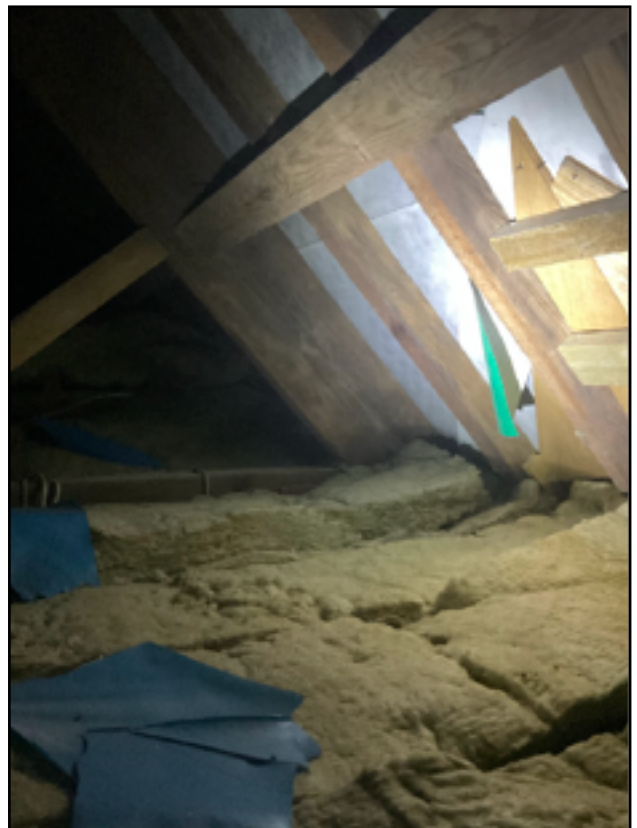
**7.3** No droppings or evidence of bats were discovered on any internal features.

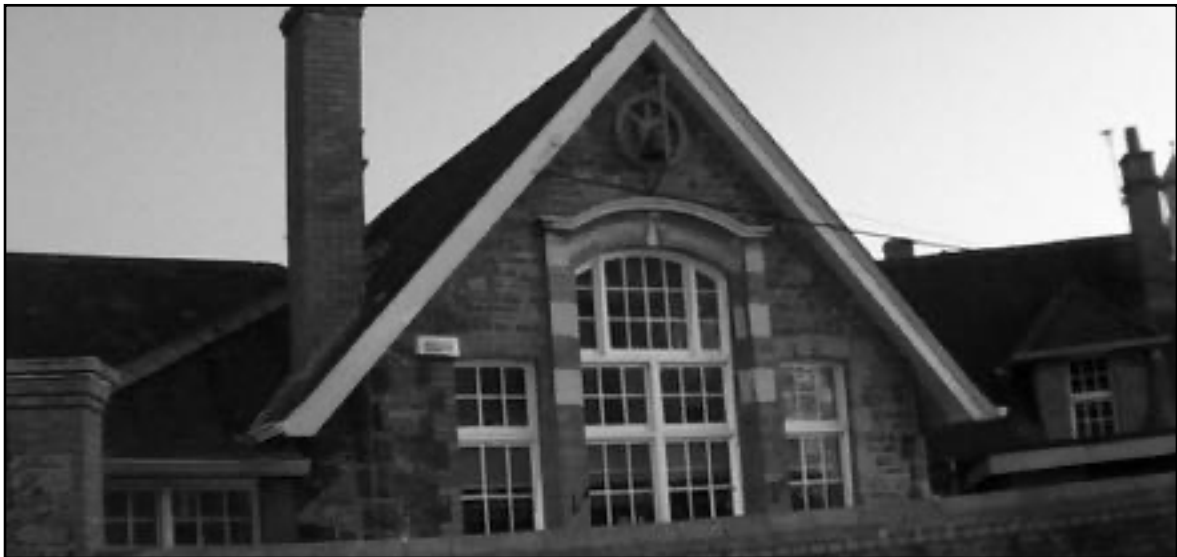
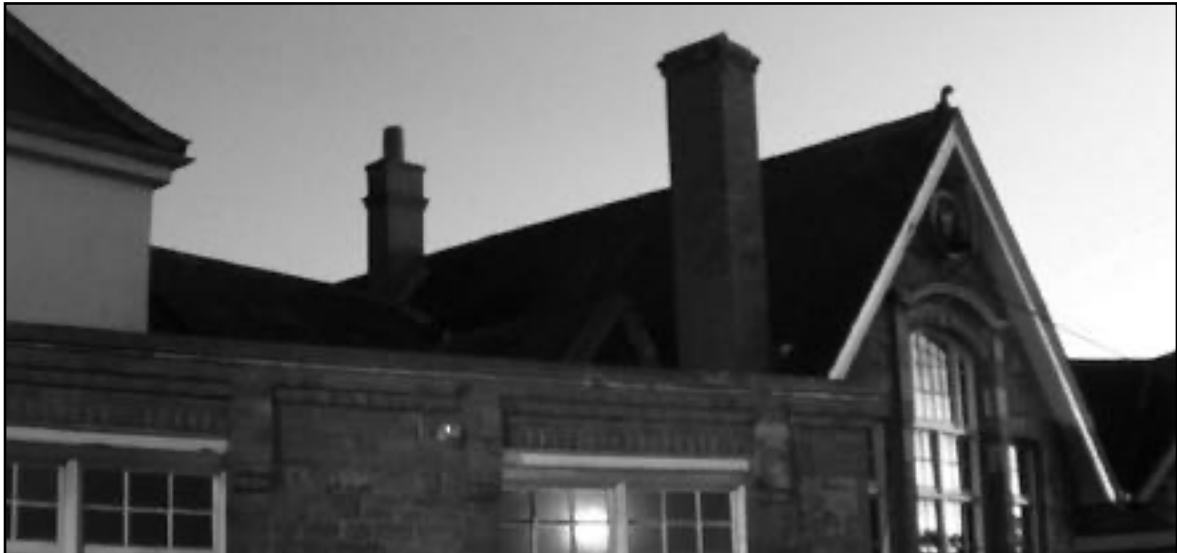
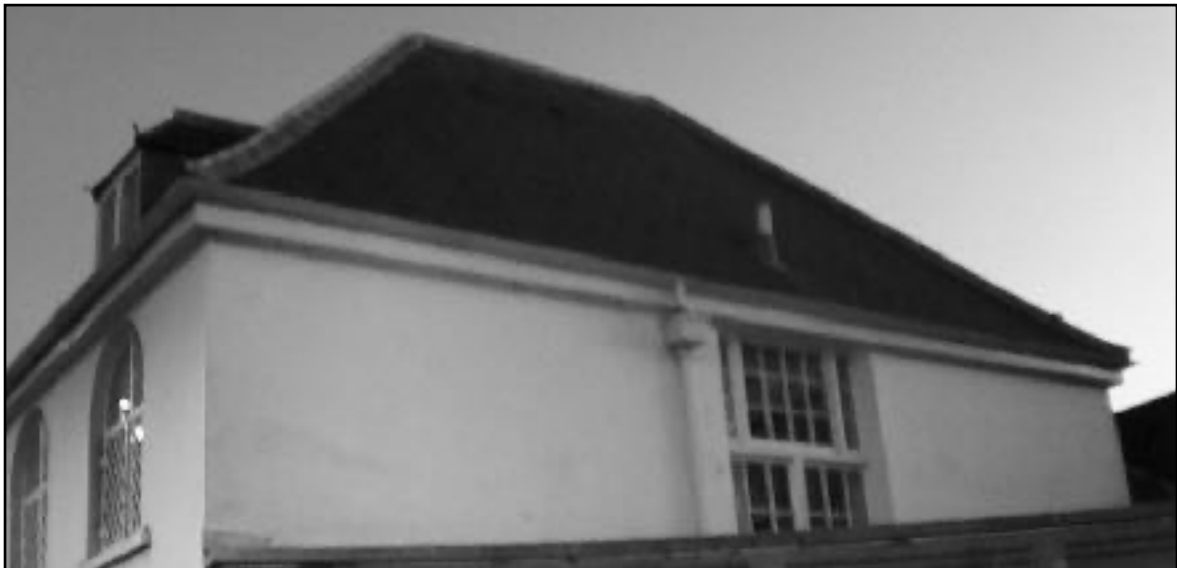
8.11 Examples of NVA Still Shots:

**8.10** During the second emergence survey, only a single Noctule bat call was recorded and the bat was observed commuting high over the site.

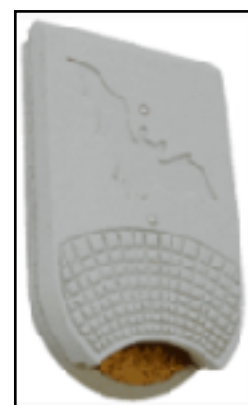
**10.2** It is proposed that new roosting for bats be created by fitting one Schwegler 1FQ surface mounted bat box on the southern side of an existing chimney. The bat box will be surface mounted on the chimney so that it will be out of visual sight of any children which will discourage disturbance and it will also be located in an area where, in the very unlikely event that the fixings fail, it will not fall to the ground.

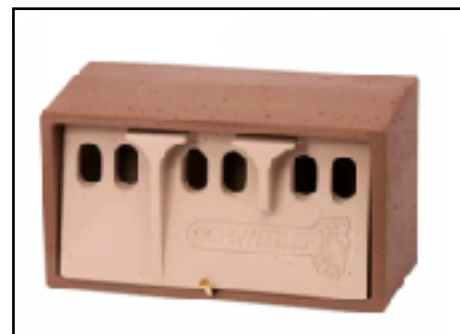
**10.4** One ISP Schwegler Sparrow Terrace will be surface mounts on the northern elevation of the existing building. **This will not be situated on a south facing elevation.**

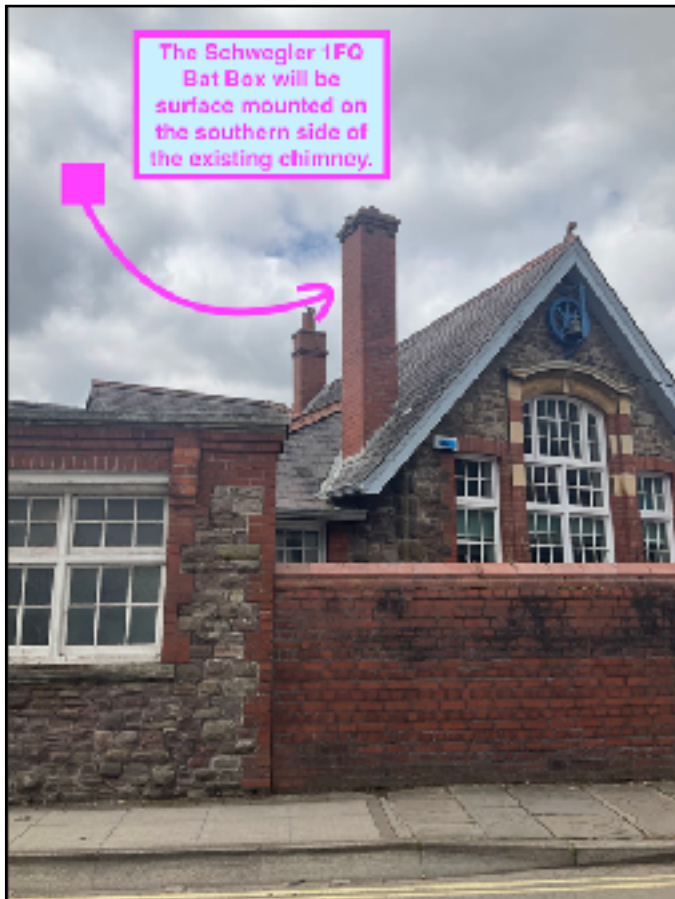
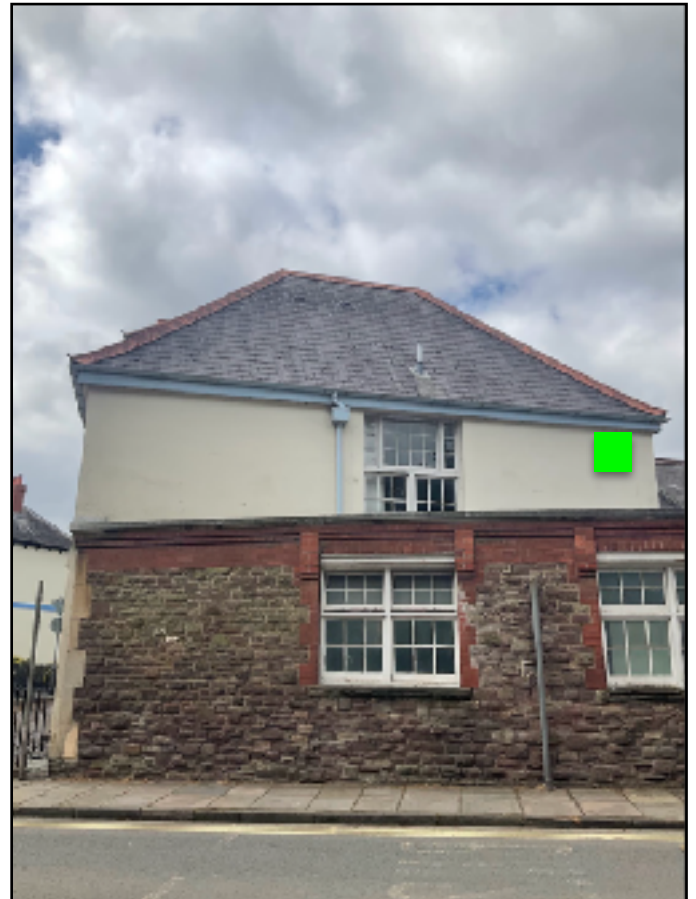
#### 10.8 Recommended Locations of Bat and Bird Enhancements:

1SP Schwegler Sparrow Terrac

Schwegler IFQ Surface Mounted Bat Box
