# PORT OFFICE – ABP NEWPORT PRELIMINARY ROOST ASSESSMENT (PRA) AND ACTIVITY SURVEY FOR BATS

| <b>TITLE:</b> | Preliminary Roost Assessment (PRA) and Activity Survey for Bats |

| <b>PROJECT REF:</b> | 238-03-19-25 |
| <b>REPORT No.:</b> | 238-03-19.R4 |

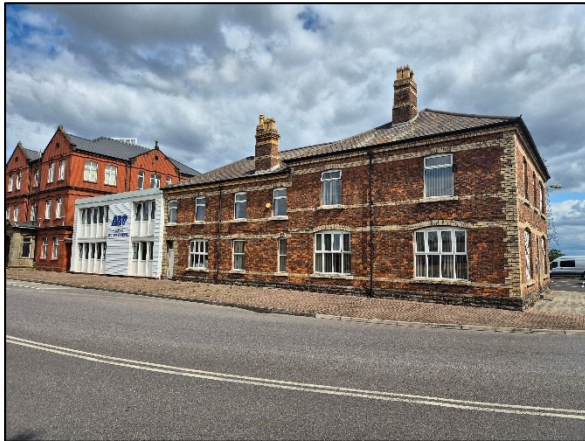
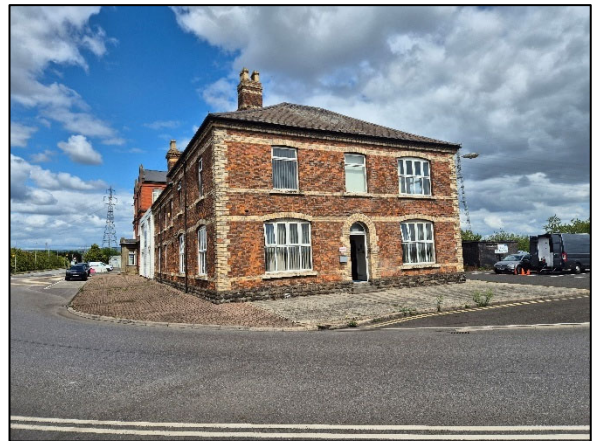
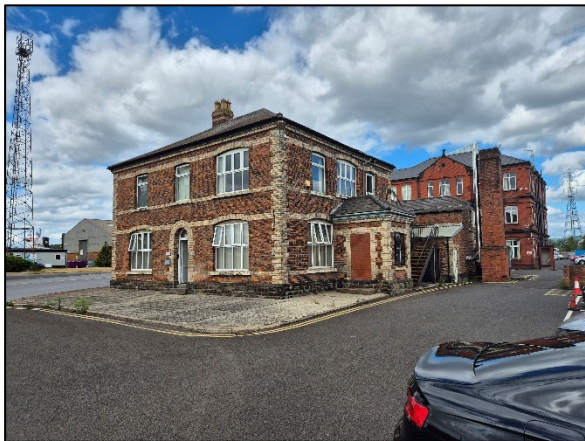
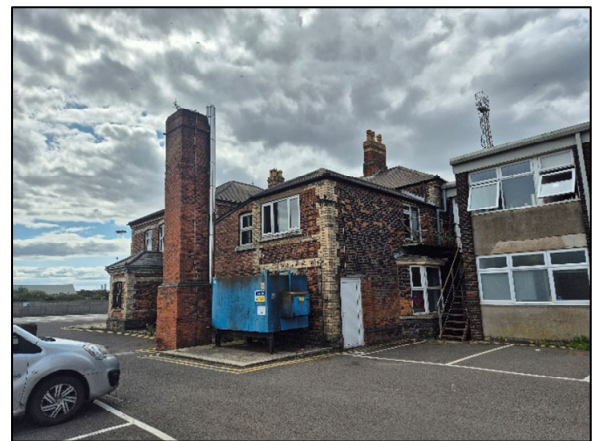
**Figure 3 – (W) Aspect of MSB Looking (NE)**

**Figure 4 – (S) Aspect of MSB, Looking (N)**

**Figure 5 – (SE) Corner of MSB, Looking (W)**

**Figure 6 – (NE) Corner of MSB, Looking (S)**

The main survey building consists of a 2-storey brick building of approximate 22m x 15.5m dimension, and is visible in Figures 3 – 6 above.

soffits. The masonry and associated mortar of the building was observed to be in generally excellent condition during the survey, with no significant areas of damage being recorded around the entirety of the main survey building which could be utilised by either crevice or void-dwelling bats.

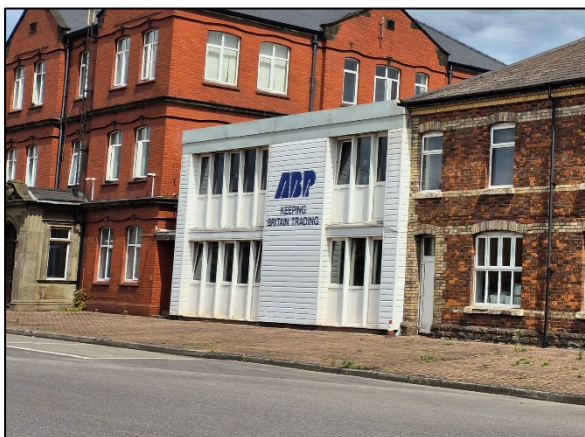
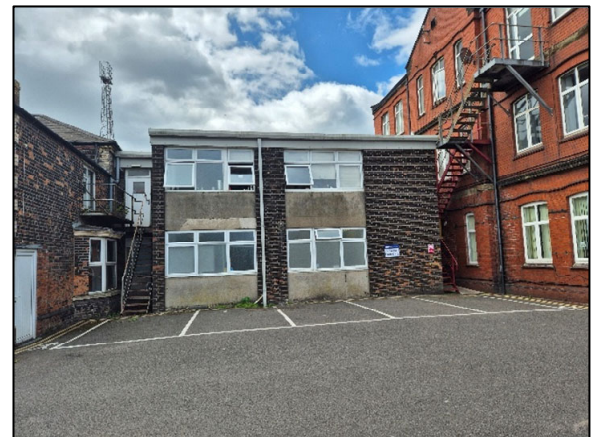
**Figure 7 – (W) Aspect of Flat Roofed Extension**

**Figure 8 – (E) Aspect of Flat Roofed Extension**

This section of the building also possesses steel fascias, and the condition of both the steel roof sheeting and fascias was observed to be excellent, with no lifting or other suitable features for bats being recorded. A small gap is present behind the steel fascias however, which was assessed to provide some limited roosting potential for crevice dwellers, although this gap is shallow and does not permit access/egress to the building interior via these locations.

The exterior of the flat roofed extension provides little in the way of roosting opportunity for bats, and was subsequently concluded to possess negligible potential to support roosting bats.

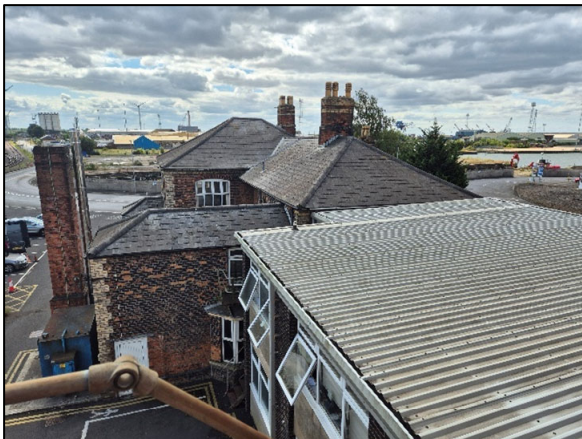
Both of these roofs have been constructed from what appears to be slate or concrete / asbestos composite tiles, and although in generally good condition, a small number of lifted and slipped tiles were recorded which were assessed to be of suitable size to potentially support crevice-dwellers and/or permit access/egress to the building interior(s) via these areas.

Furthermore, both roofs possess half-round ridge tiles which are of the same material type as the roof tiles of the building. The ridge tiles were observed to be in generally good condition, and no missing tiles were observed across both roofs of the main survey building during the walkover survey. Small sections of missing mortar were observed beneath some of the ridge tiles however, and these gaps were assessed to be of sufficient size to act as PRFs or potential access/egress points to the building interior for crevice dwellers within these locations.

**Figure 9 – Roof of MSB in Picture Background**

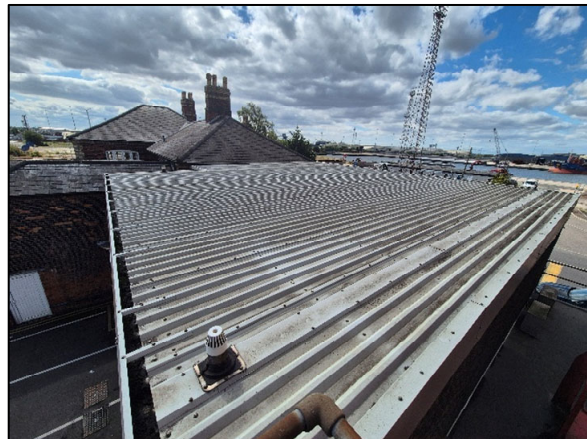
**Figure 10 – Roof of Flat Roofed Extension**

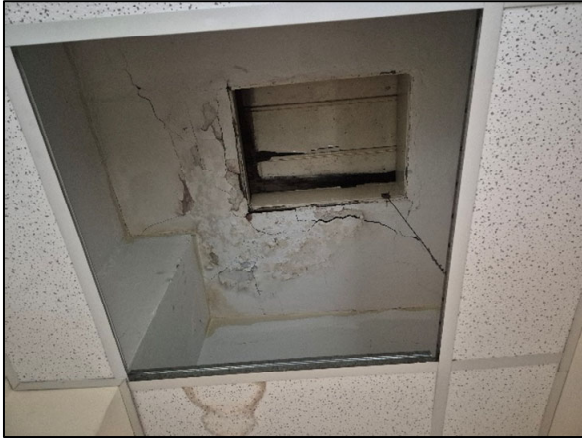
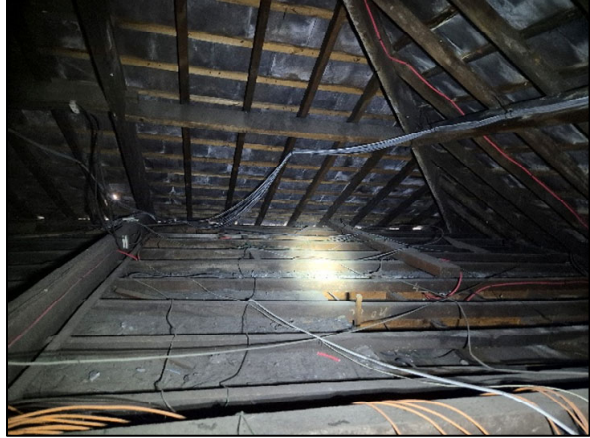
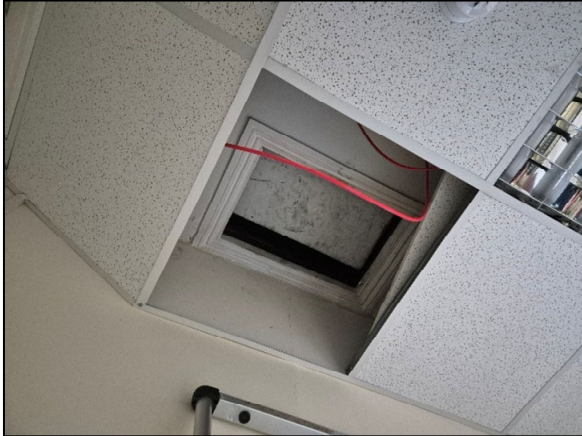
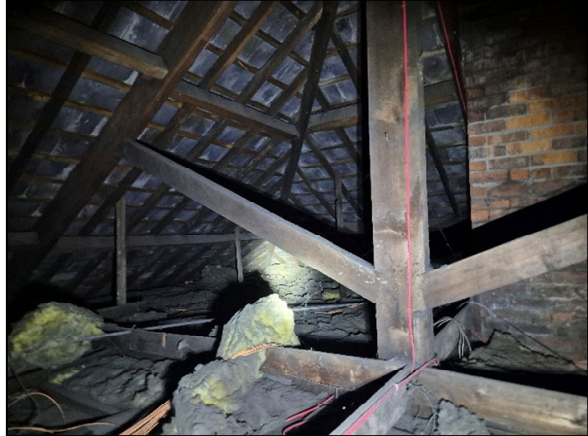
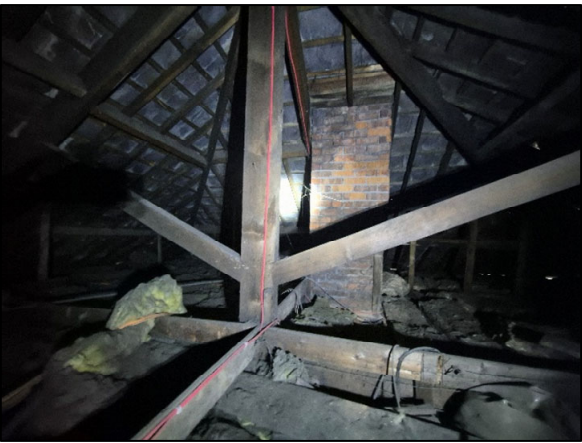
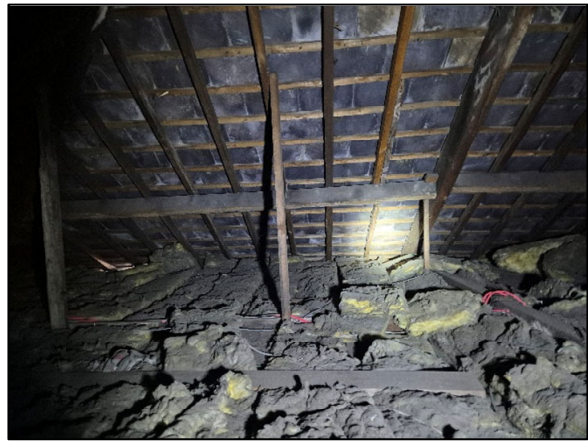
**Figure 11 – Access Point to (N) Section of Main Loft of Main Survey Building**

**Figure 12 – (N) Section of Main Loft of MSB, Looking (NE)**

**Figure 17 – Access Point to (S) Section of Main Loft of Main Survey Building**

**Figure 18 – (S) Section of Main Loft of MSB, Looking (SW)**

**Figure 19 – (S) Section of Main Loft of MSB, Looking (SW)**

**Figure 20 – (S) Section of Main Loft of MSB, Looking (SE)**

The interior space of the Main Loft of the Main Survey Building is accessible via two loft hatches within the ceiling at 1<sup>st</sup> Floor Level (above the suspended ceiling situated in each location), with each loft hatch permitting access to different areas of the loft (namely a northern and southern section). The loft is L-Shaped in design and consists of 1 single space, with each section of the loft being accessible via gaps present around a brick chimney in the northern section of the loft.

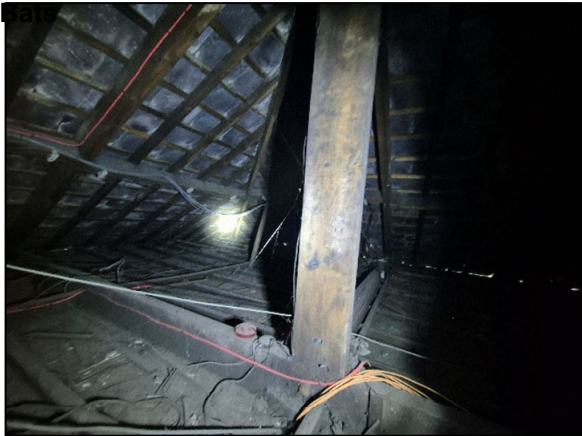
**Figure 13 – (N) Section of Main Loft of MSB, Looking (NW). Light Ingress visible To the Right, which May Permit Access/Egress for**

Further to the above, a number of potential access/egress points for bats was recorded to the main loft of the main survey building. Light ingress was visible in a number of locations, primarily along the northern wall of the northern section of the main loft, whilst additional light ingress was recorded within the southern section of the main loft, primarily along the eastern and southern walls. The gaps appear to be at the extent of the fascia boards / decorative brickwork within these locations, and no significant damage to any roof tiles was recorded.

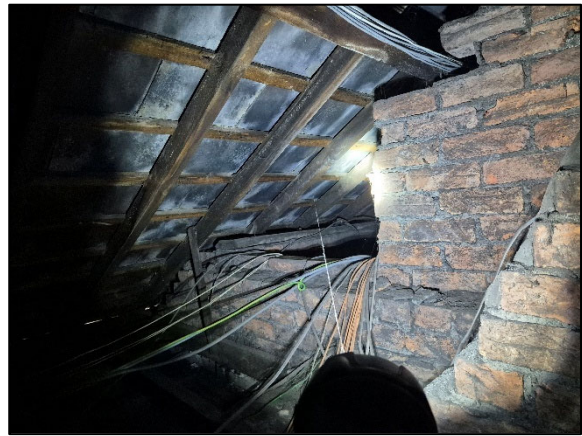
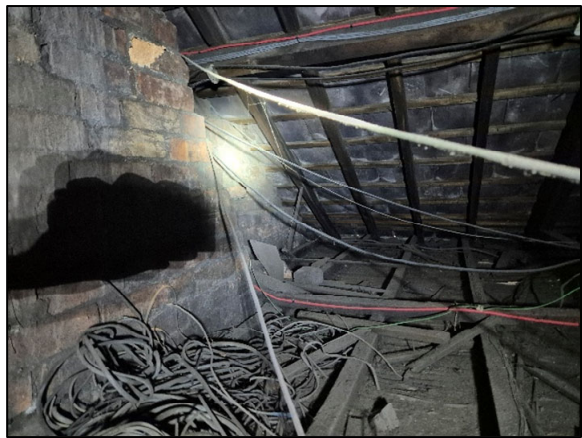
**Figure 14 – Gap Around (E) Side of Chimney Breast Enables Access to (S) Section of Main Survey Building Loft**

**Figure 15 – Gap Around (W) Side of Chimney Breast Enables Access to (S) Section of Main Survey Building Loft**

Two chimneys are present within the main loft of the building, with one each being situated within the northern and southern sections of the loft. The chimneys have been constructed from brick, and the brickwork and mortar was observed to be in good condition across both chimneys, with no significant areas of damage being recorded which may be utilised by crevice-dwelling bats. Gaps above the extent of the brickwork of the chimneys within the main loft of the survey building were however assessed to be of sufficient size in which crevice-dwellers may potentially roost.

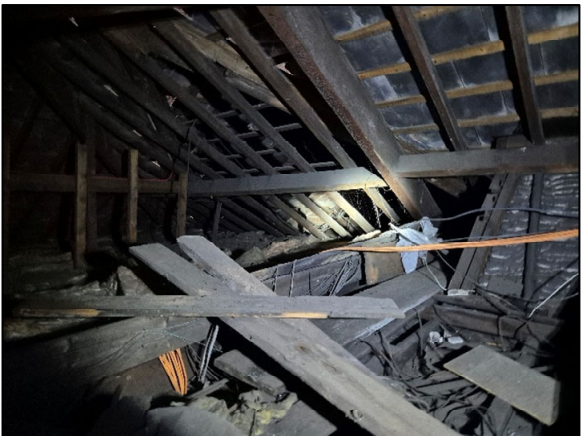
**Figure 21 – (S) Section of Main Loft of MSB, Looking (NW). The Loft is L-Shaped, and Connects to the (N) Section via this Location**

The southern section of the loft is supported by a large timber king post and associated trusses, whilst the roof is supported by a combination of timber rafters and purlins, onto which additional timber battens have been overlaid.

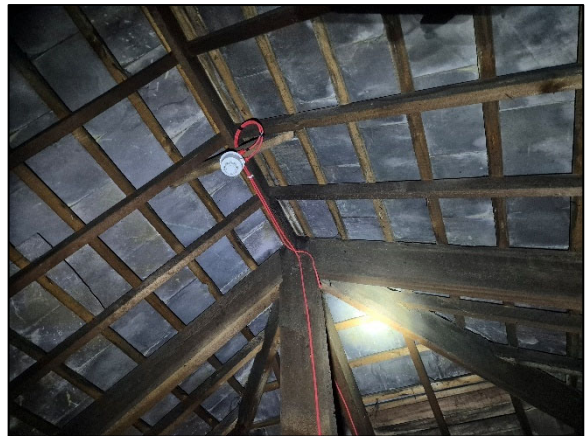
**Figure 22 – Underside Roof Detail of (S) Section of Main Loft. The Roof Tiles in this Location have been Set Directly onto Timber Battens, with No Felt Underlay Present**

With the above being said, the fact that no membrane is present between the roof tiles and interior loft means that any damage to the roof tiles of the building would subsequently permit the access/egress of bats directly into the loft interior via these damaged areas, and bats would not need to crawl in order to achieve access to interior spaces.

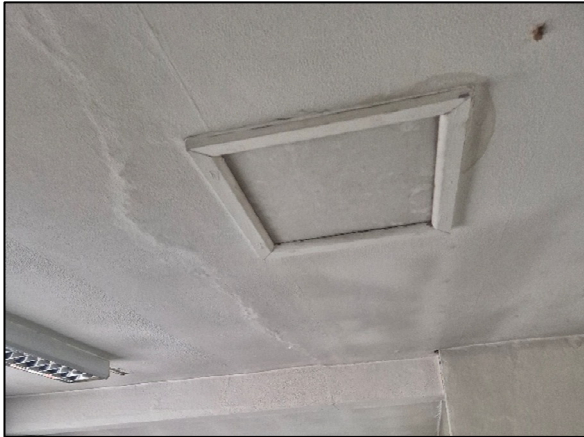
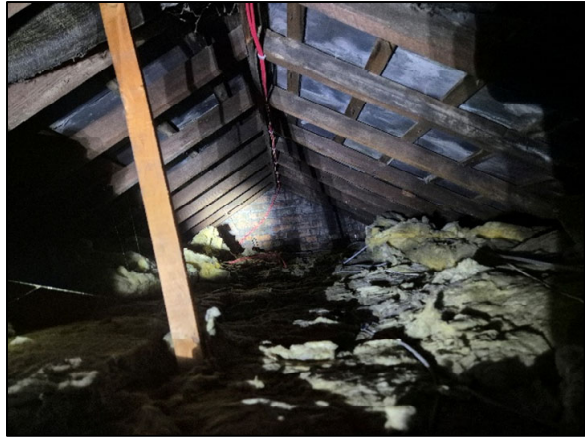
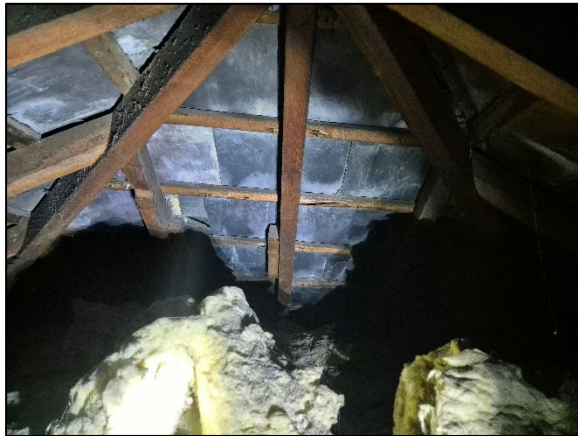
**Figure 23 – Access Point to Standalone Small Loft at (NE) of Building**

**Figure 24 – (NE) Standalone Loft Interior, Looking (SW)**

**Figure 25 – (NE) Standalone Loft Interior, Looking (NE)**

The interior of the north-eastern standalone loft is similar to that recorded in the main loft of the main survey building. The roof of the building has been constructed from timber features, onto which the slate tiles of the building have been set directly in most locations.

It should be noted however that no light ingress was recorded within the small standalone loft at the north-east of the building, and no potential access/egress points for bats to the loft interior were also recorded.

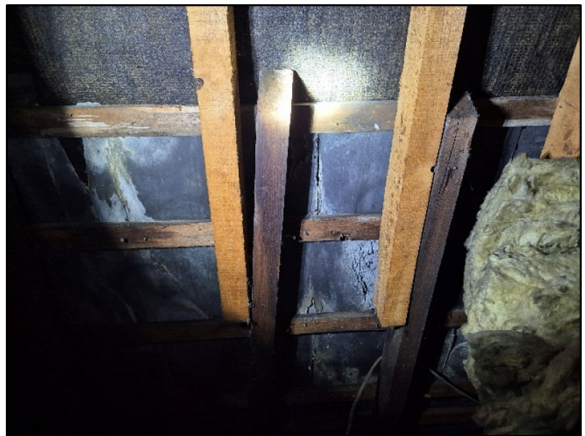
**Figure 26 – Detail of Underside of Roof. Although Most of the Roof Tiles are Overlaid Directly onto Battens, Some Roof Felt Underlay is Present in Some Areas**

Small areas of roofing felt were however recorded within this loft, and it is likely that a small gap is present between the roof tiles of the building and the interior underlay, which may be utilised by crevice-dwelling bats should they be able to gain access to this area (via damaged or slipped exterior roof tiles, for example).

- **Gaps between Roof Tiles and Felt Underlay within North-Eastern Standalone Loft** – Although the majority of the roof tiles of the building across all areas have been overlaid directly onto timber battens, a small amount of roofing felt is present beneath the tiles of the north-eastern standalone loft. A small gap is likely present between the roof tiles and the felt underlay in this location, which could potentially be utilised by crevice-dwelling bats if they are able to gain access to this area via any unrecorded areas of damage;
