**Bat Survey:** 114-116 Alexandra Road, Newport, NP20 2JG

**Instructed by:** Andrew Jones

**Reported by:** Ecological Services Ltd

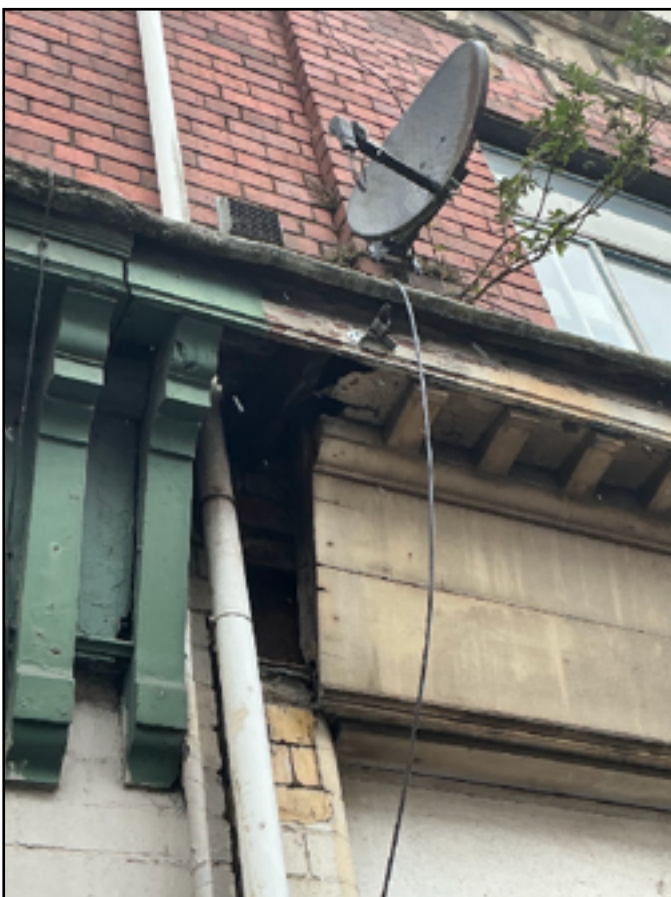
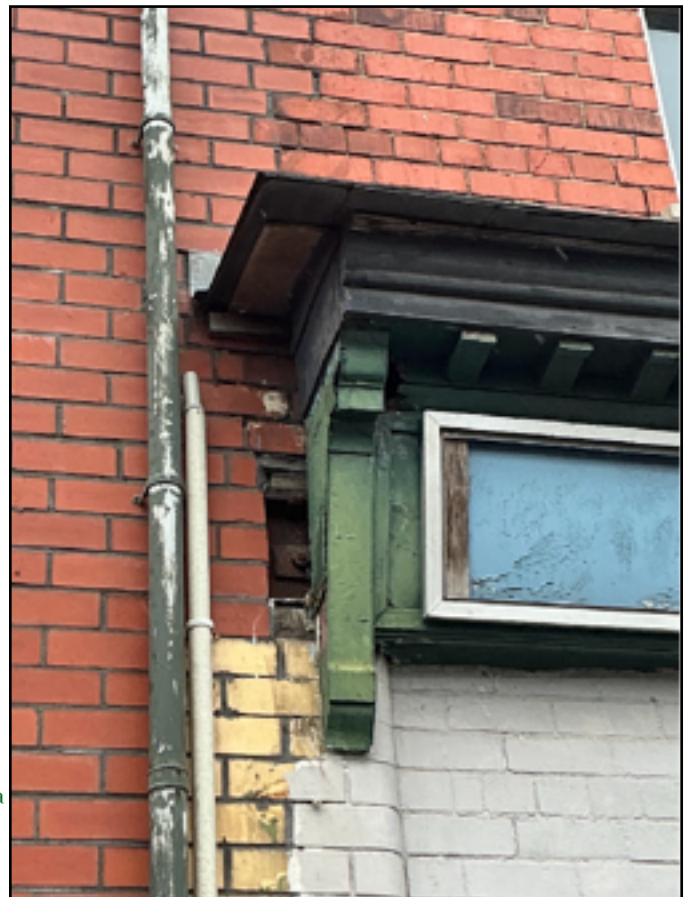
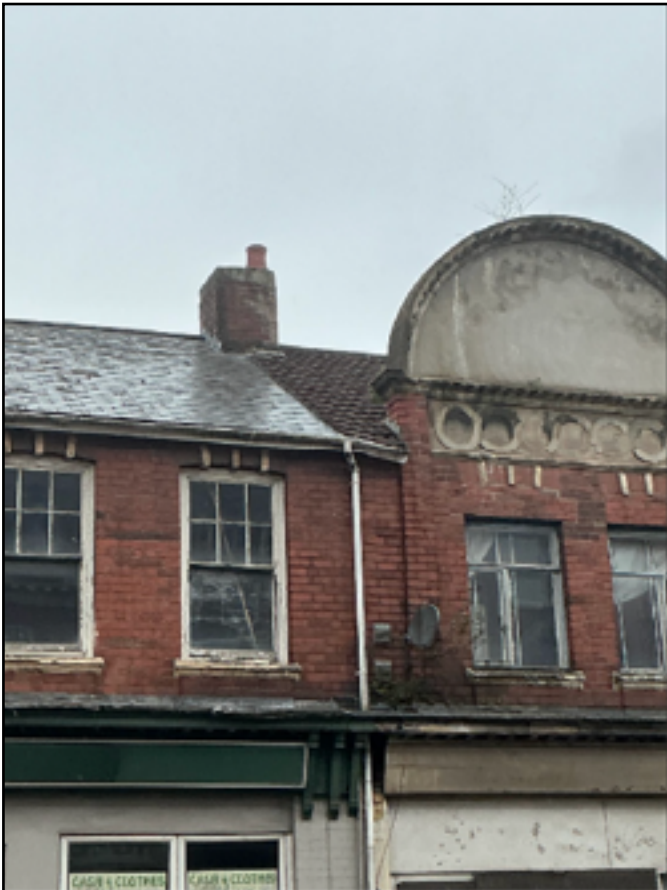
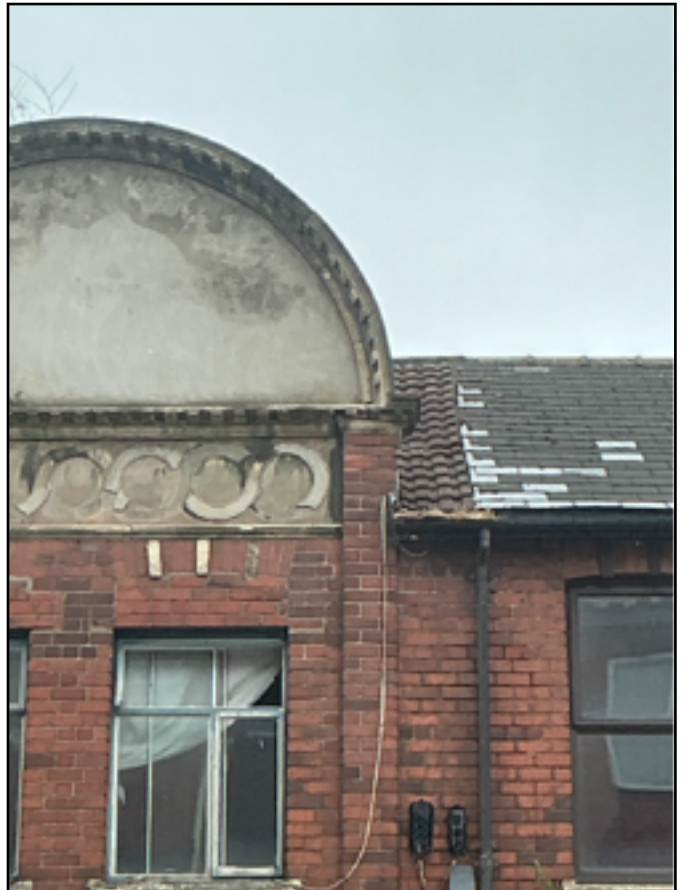
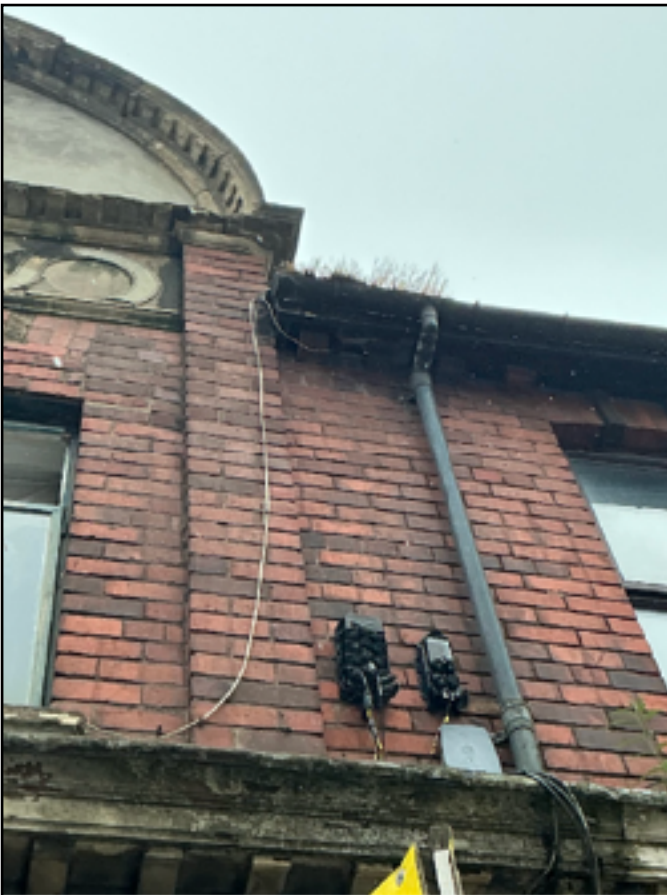
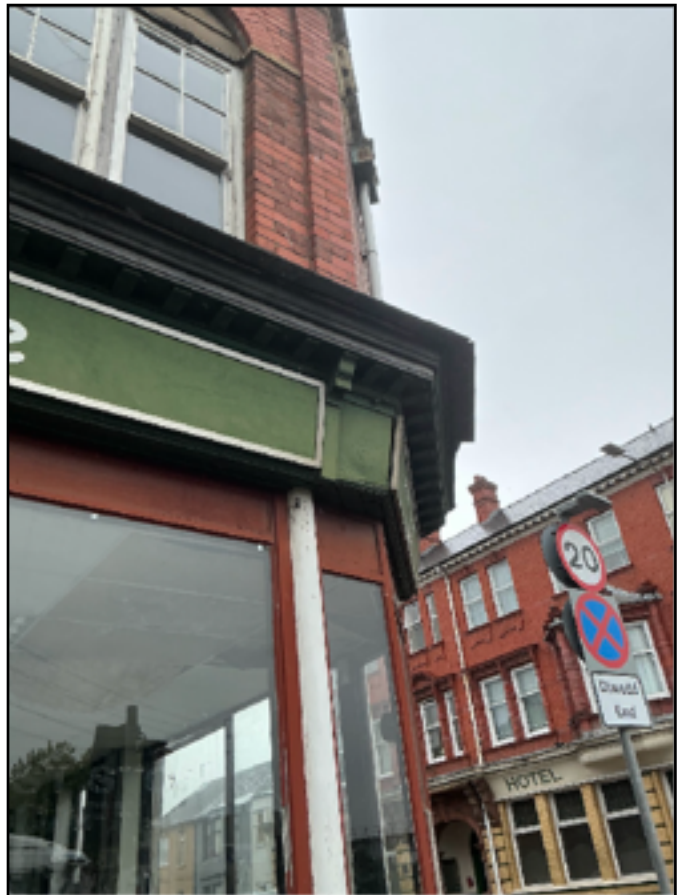
**6.3** Due to the age and condition of the building, there were a number of opportunities present for bats to access and use the building and due to the presence of the dormers to the front of the roof, not all areas of the roof could be visualised. Therefore, following the survey guidelines, the building was classed as having moderate potential for roosting bats. There were raised ridge tiles and areas of raised lead flashing; apertures in the stone mouldings; raised roofing slates and tiles; areas of missing mortar; a missing window pane and apertures in the signage to the front of the property.

**6.4** No droppings or evidence of bats were discovered on any external features.

**6.6** Examples of apertures allowing access to cavities in the building

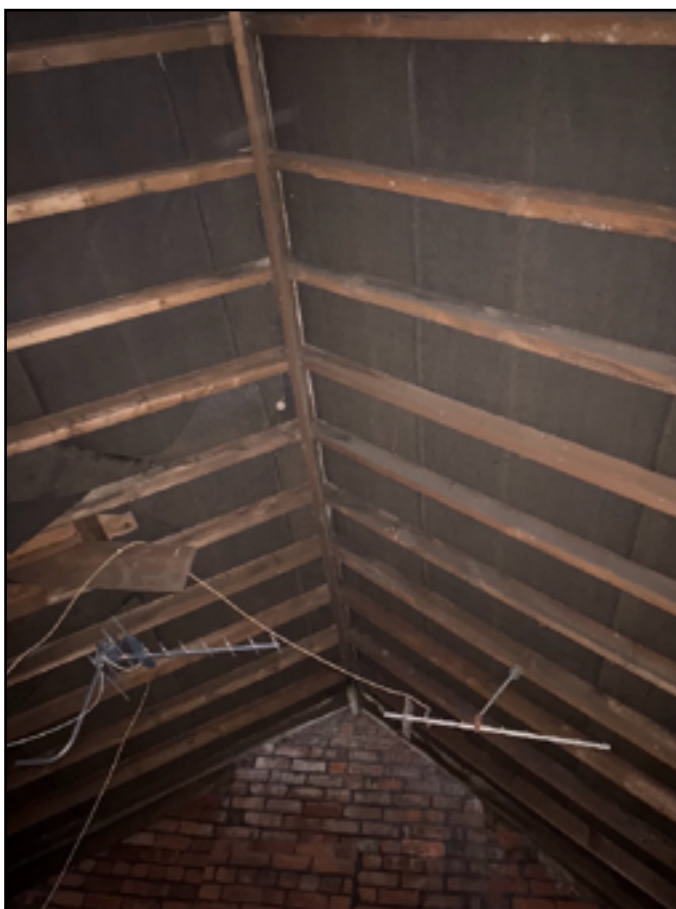
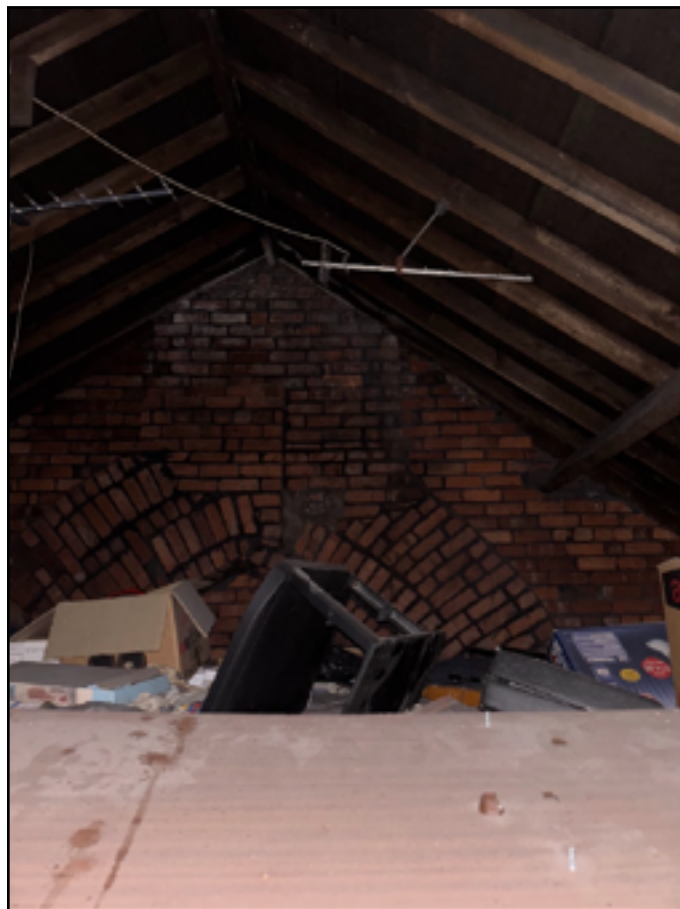
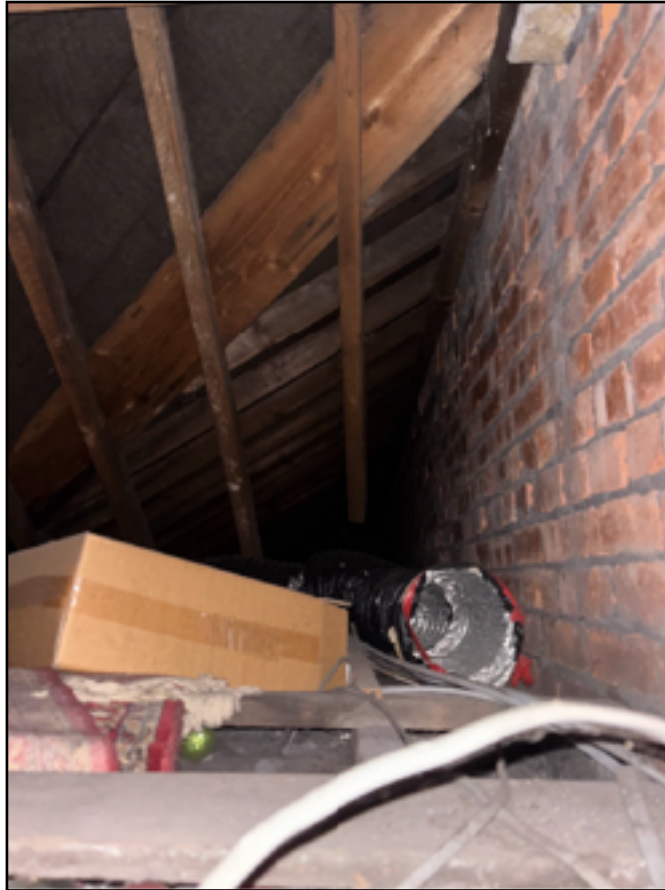
**7.2** There was an attic space within the building. The attic space was not fully accessible due to health and safety concerns; there was a significant amount of storage within the space. The space was lined; not boarded out and of a traditional cut design. There were small areas of light ingress at eaves level.

**7.3** No droppings or evidence of bats were discovered on any internal features.

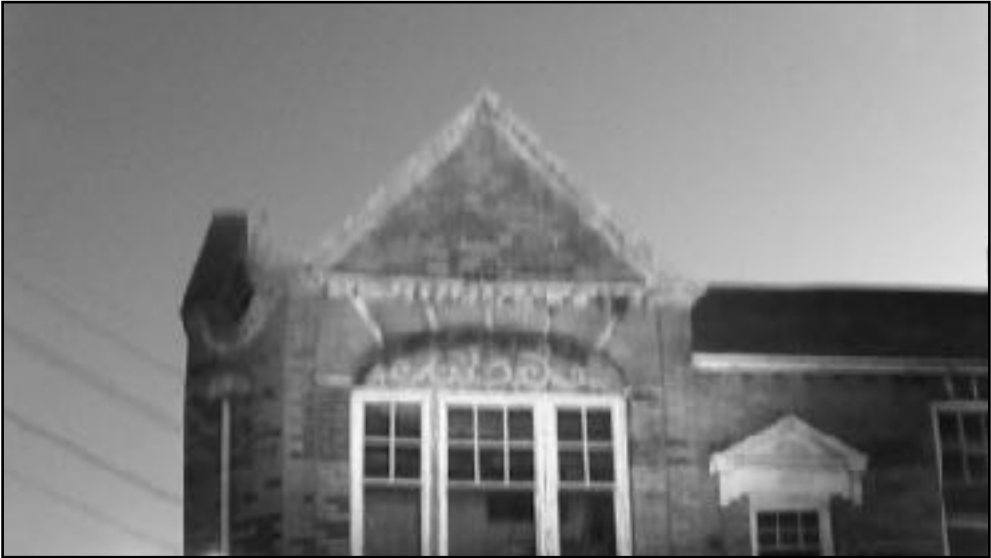
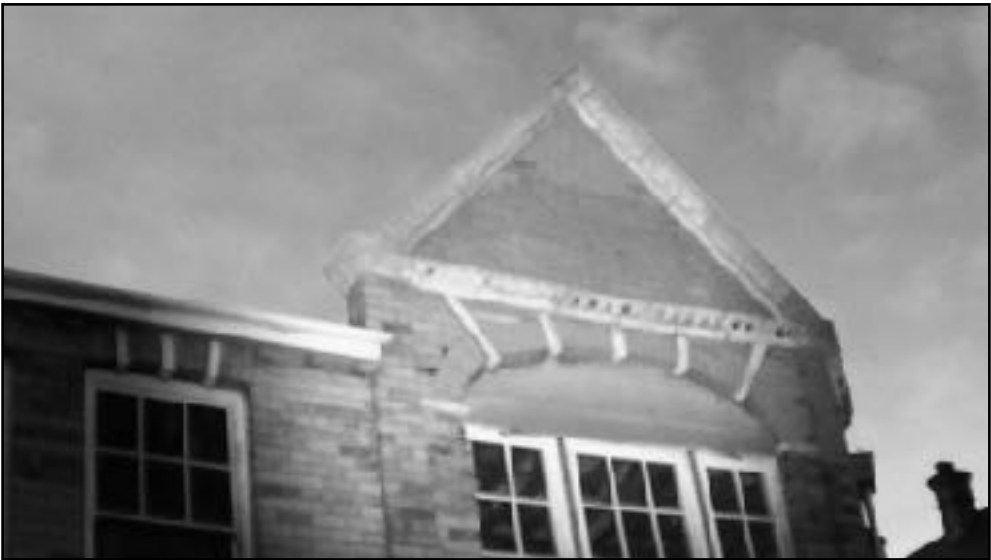
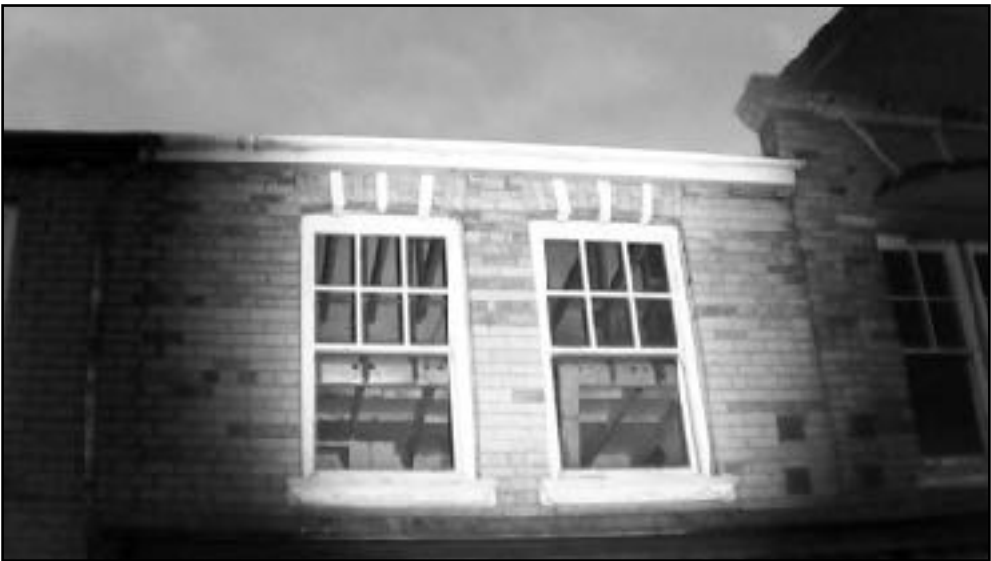
8.11 Examples of NVA Still Shots:

**8.9** During the first emergence survey, only Noctule bat calls were detected and the bats were not observed.

**8.10** During the second emergence survey, no bats were detected or observed.

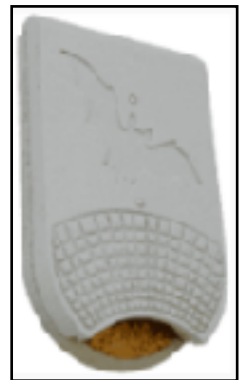
**10.2** It is proposed that new roosting for bats be created by fitting one Schwegler 1FQ surface mounted bat box on the south eastern elevation of the building.

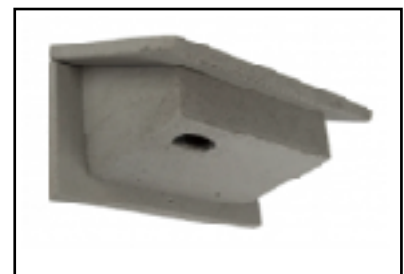
**10.4** One Vivara Pro WoodStone Swift Box will be surface mounted on the north eastern elevation of the building. **This will not be situated on a south facing elevation.**

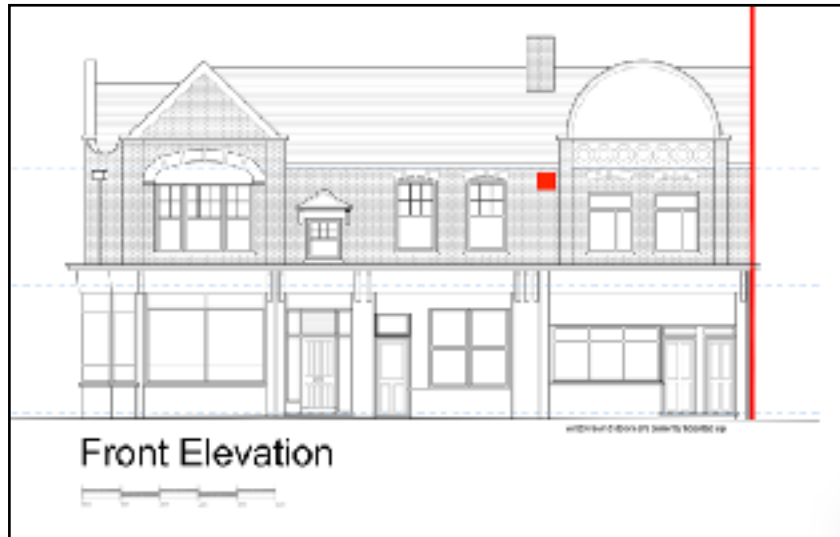
North Eastern Elevation

Location of Vivara Pro WoodStone Swift Box

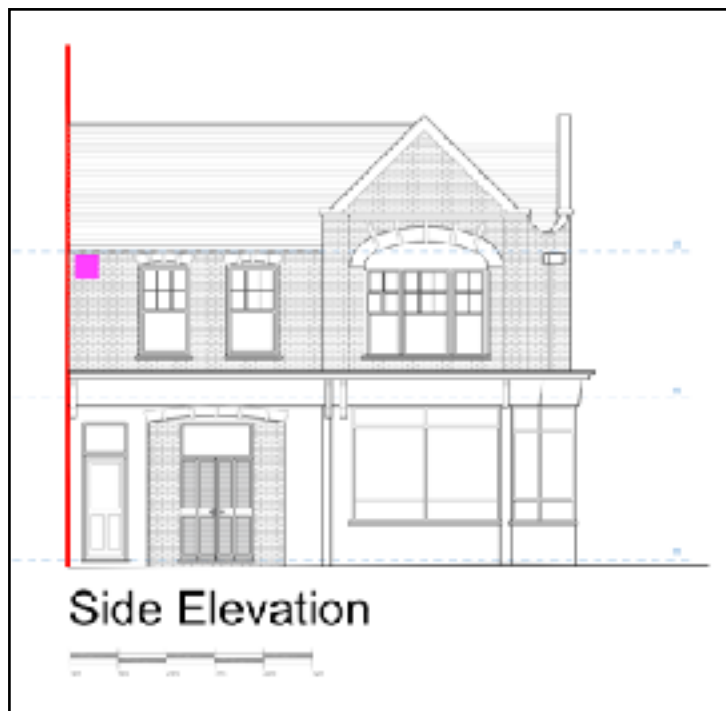
South Eastern Elevation

Location of Schwegler IFQ Bat Box
