Settlement Report
Proposed Residential Development
Herbert Road
Newport

Prepared for: Engie

August 2018

Report No. 12032/SR

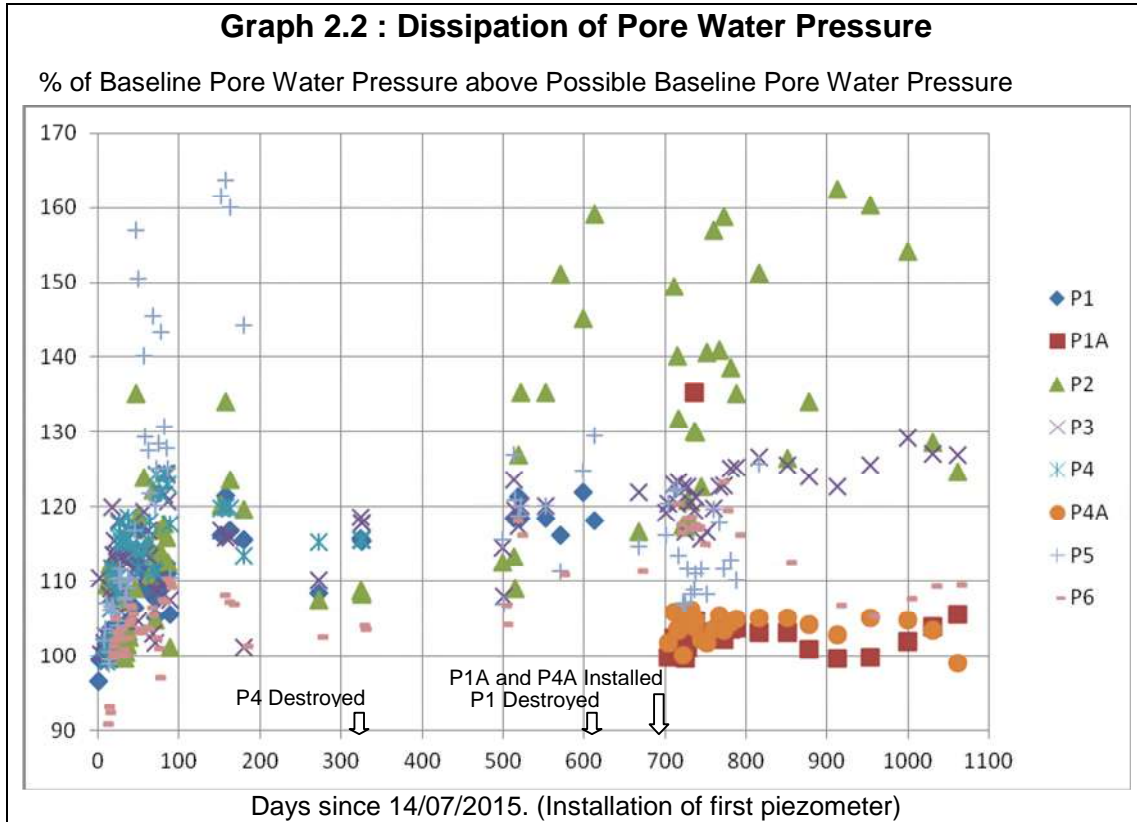
During settlement pore water pressure dissipates as water is squeezed out of consolidating material. The graph below shows the generation of peak pore water pressure generated by the placement of fill typically between 3 and 5 months after the commencement of the earthworks.

Pore water pressure has been observed to be dissipating, evidence of consolidation and settlement. However the monitoring of pore water pressure dissipation has been disrupted by filling events.

Pore water pressure dissipation of a single filling event should produce a single curve. However multiple filling events are likely to explain for the peaks and troughs of pore water dissipation suggesting that following the initial placement of the assessed stockpile further material has been placed on site.

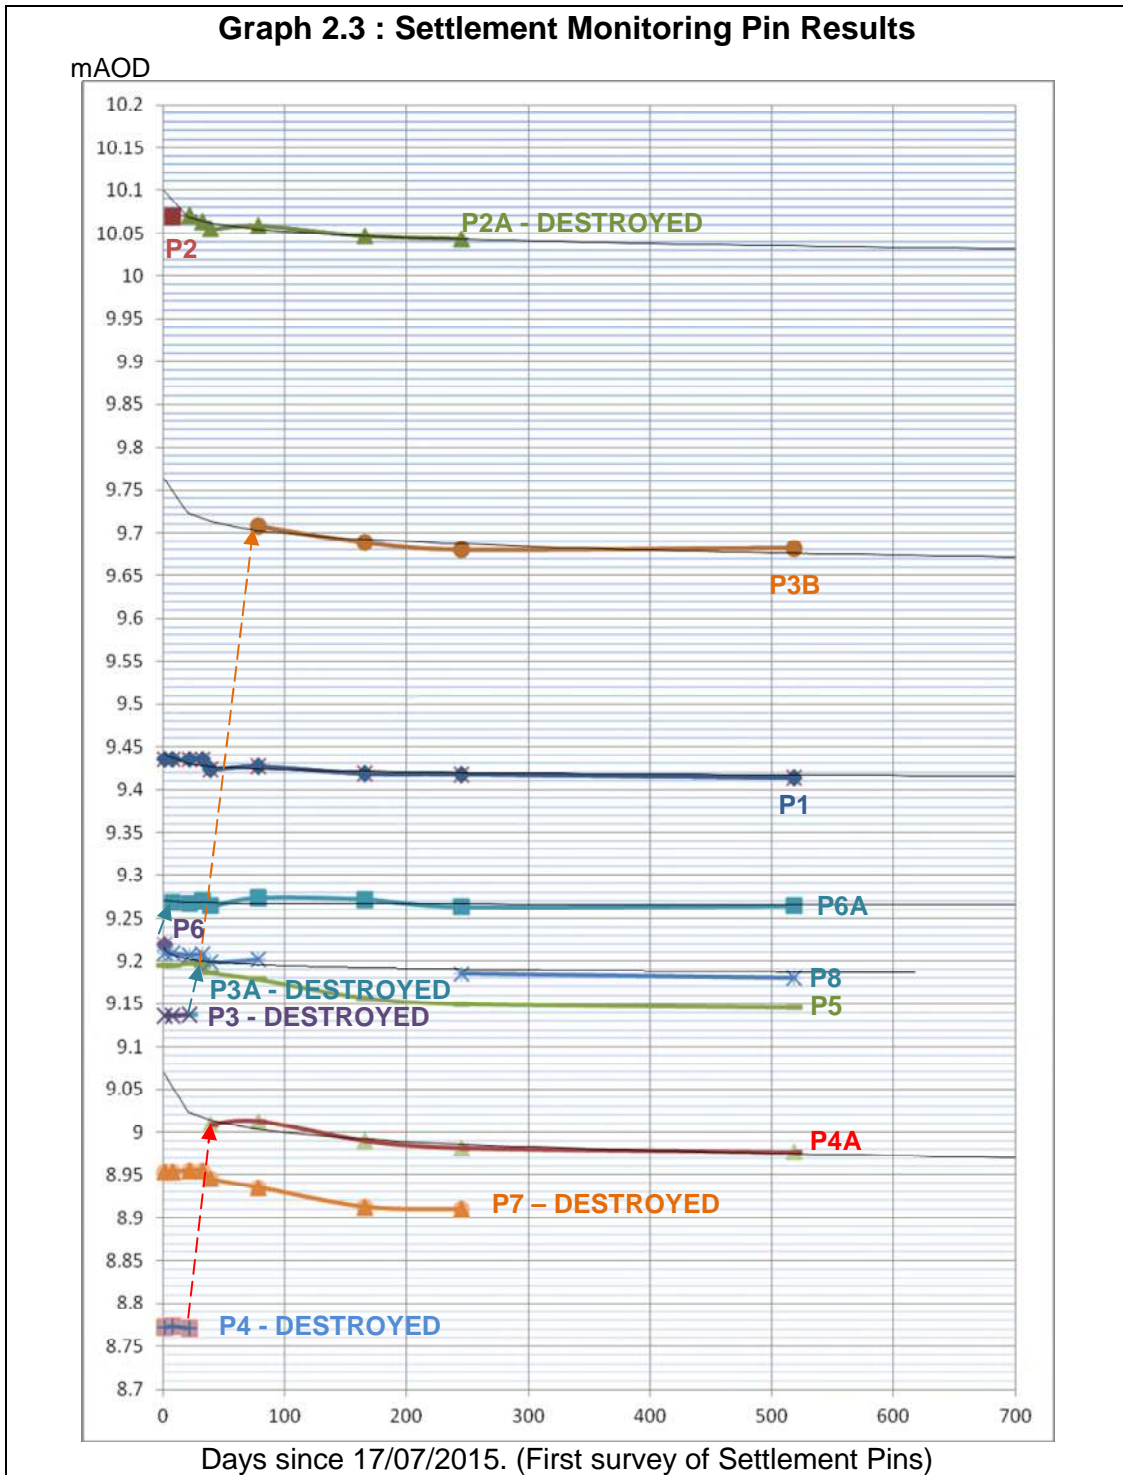
The graph below shows all of the surveyed original monitoring pins on an arithmetic time scale. When a monitoring pin was damaged or destroyed an effort was made to replace the pin. When a monitoring pin was damaged / destroyed it was given a sequential alphabetical designation.

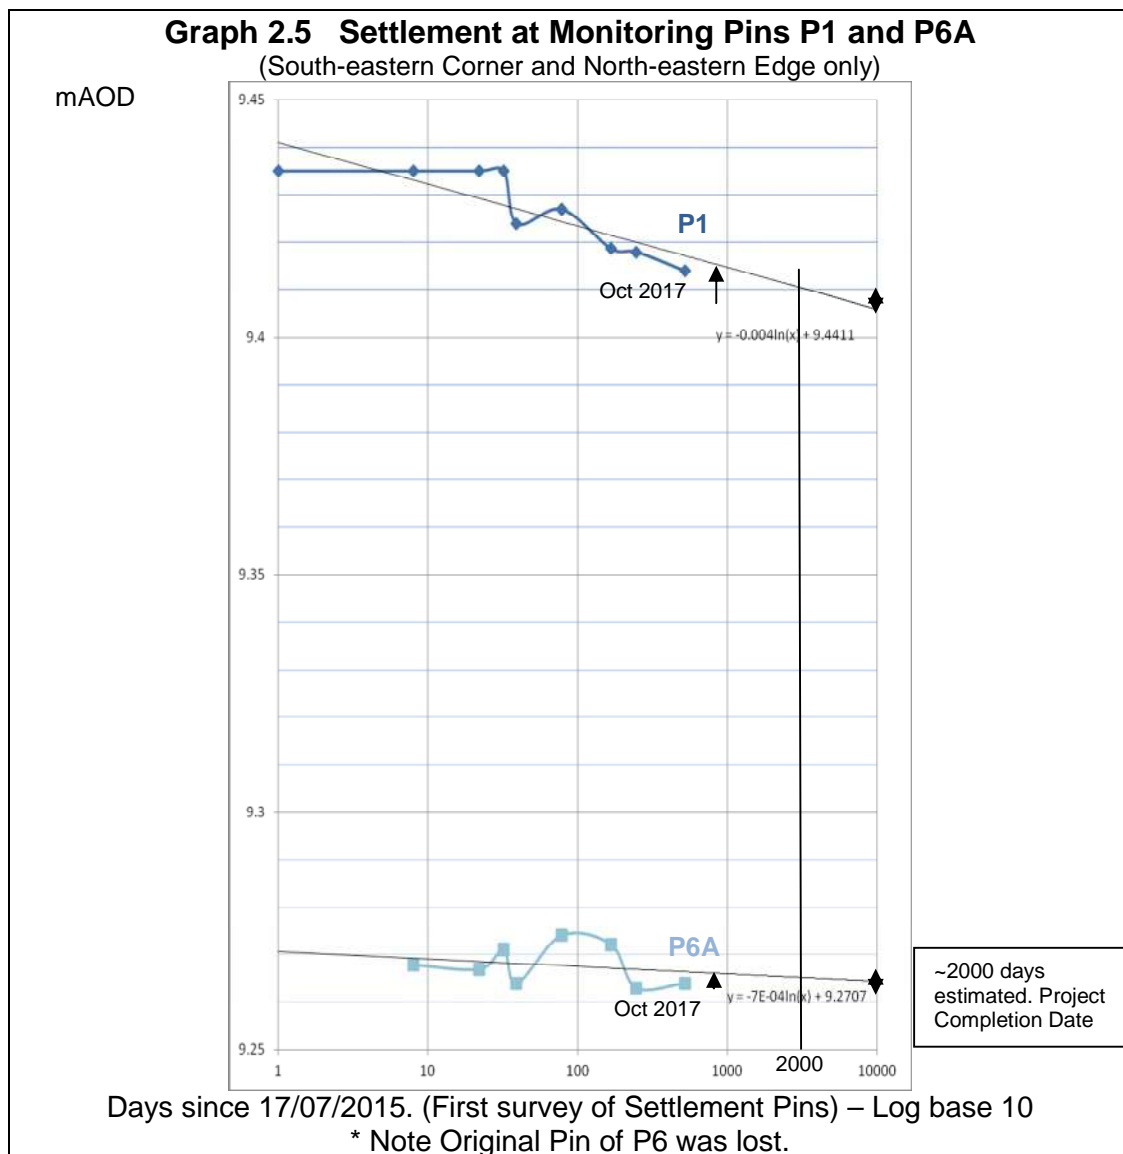
Data for Monitoring Pin 1 (located near the South-eastern Corner of the site) is complete and to date indicates settlement of ~21mm over 517 days. Conjecturing future settlement from the data obtained indicates that levels may settle to 9.405mAOD after 10^4 days (~30years or 2045). With the last survey indicating levels of 9.414m a further 0.010m (10mm) should be anticipated under the current surcharge by 2045 or ~5mm after project completion.

Monitoring Pin 6

Unfortunately baseline conditions for Monitoring Pin 6 (located within the North-eastern corner of the site) were lost as the pin was destroyed. Monitoring Pin 6A has however recorded ~5mm of settlement over 510 days. Whilst the initial readings may be lost it may be possible to conjecture future settlement from the data obtained.

Following the current trend of settlement the above graph indicates at that levels may have settled at 9.27mAOD after 10^4 days (~30years or 2045). With the survey indicating fluctuating levels of 9.263m no further settlement is anticipated under the current surcharge by 2045.
