## **VERIFICATION REPORT**

**1 – 4 TROSTREY STREET  
NEWPORT  
WALES  
NP19 7BB**

**Reference Number 3188/Rpt 3v1  
February 2025**

Prepared for  
ADRA Homes LLP

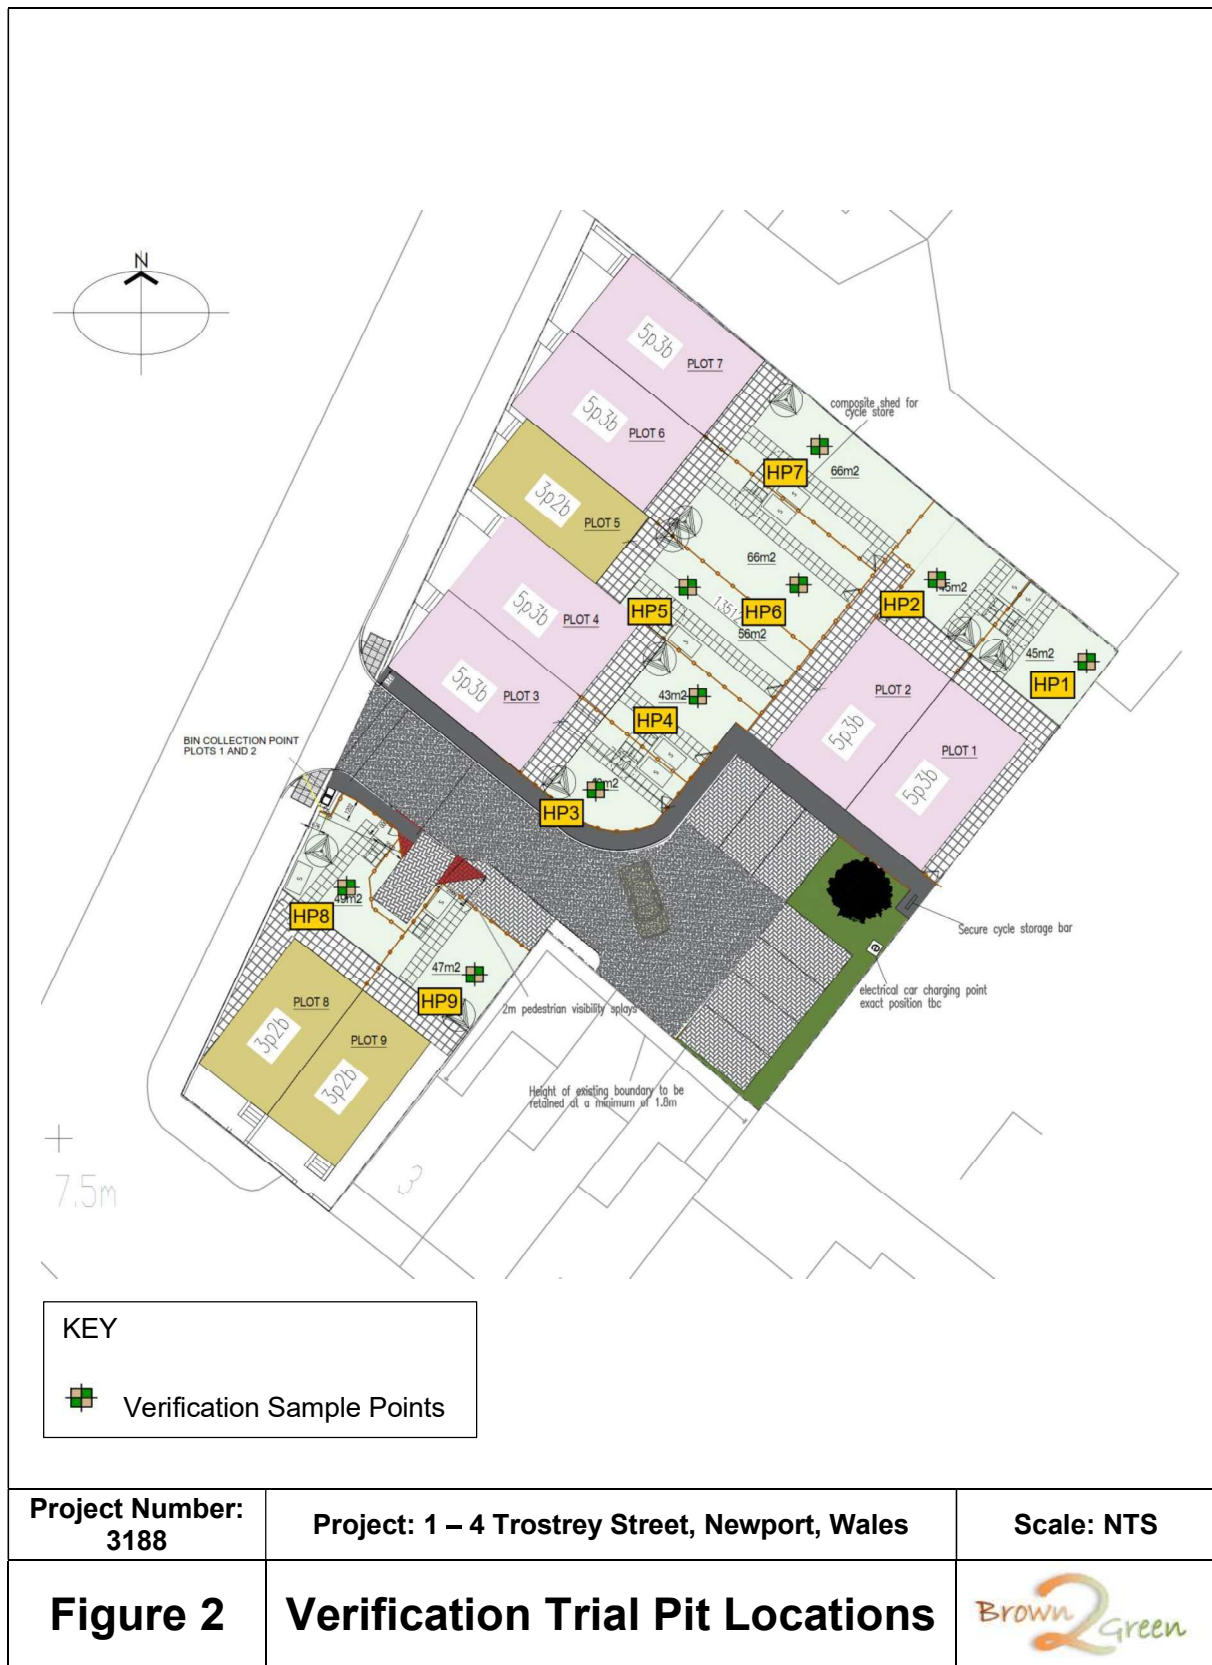
| Figure 2 | Verification Trial Pit Locations |

The verification was completed on 27<sup>th</sup> January 2025 and consisted of the excavation of hand dug trial pits to the base of the placed material. The locations of the trial pits are presented in Figure 2.

The inspection concluded that within the rear gardens, a minimum of 600mm of capping has been provided. It has been noted that the imported material comes from the same source. A geotextile membrane and no dig barrier were also noted at the base of the placed material.
