# GeoShield Verification Report 1

PROJECT REFERENCE: GEO104558 R01

PROJECT: Trostrey Street

SPECIFICATION: Verified in accordance CIRIA 735.

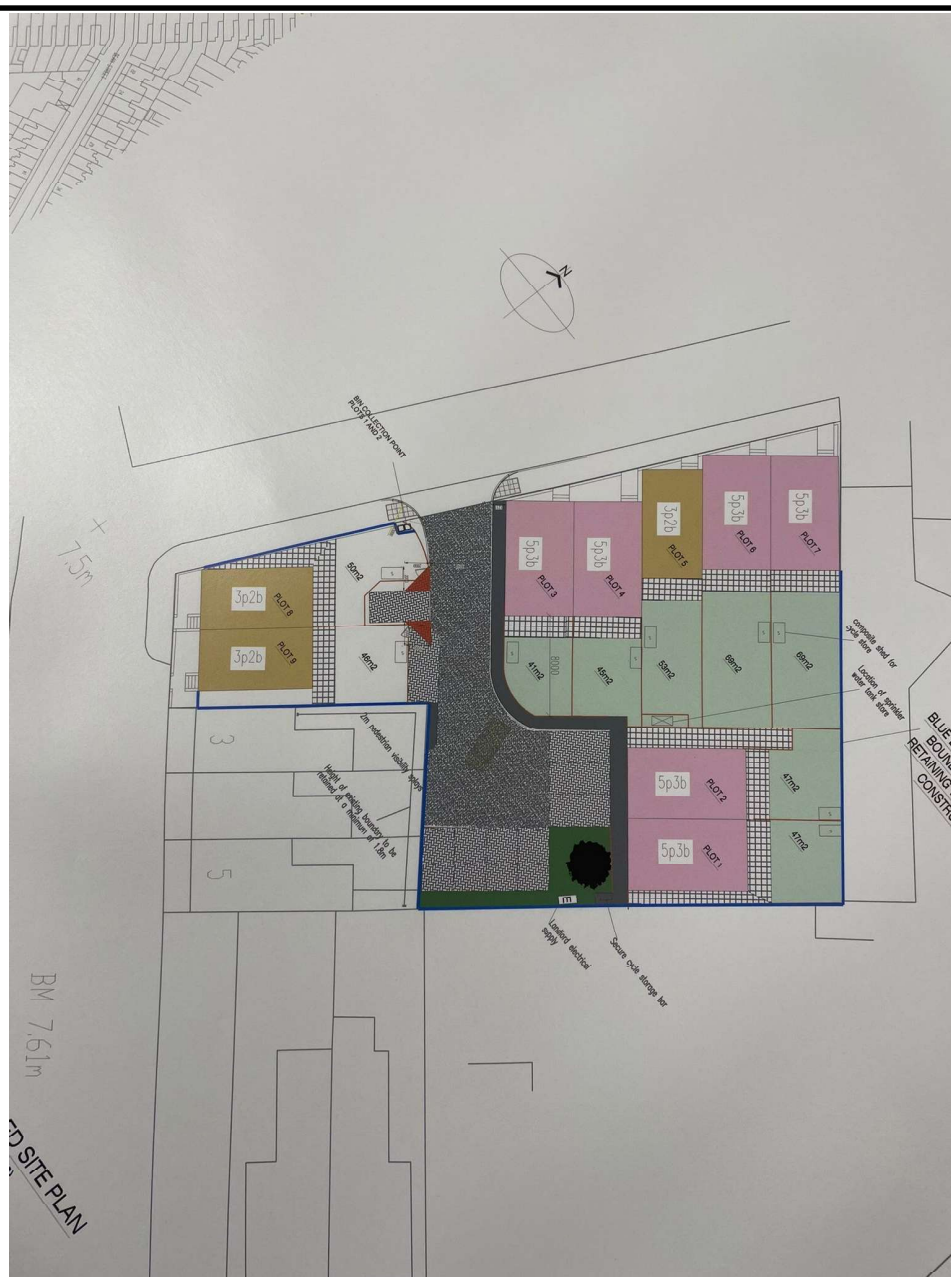
## Verification Layout

The photograph above shows a plan layout of the site, showing all nine plots inspected during the visit today.

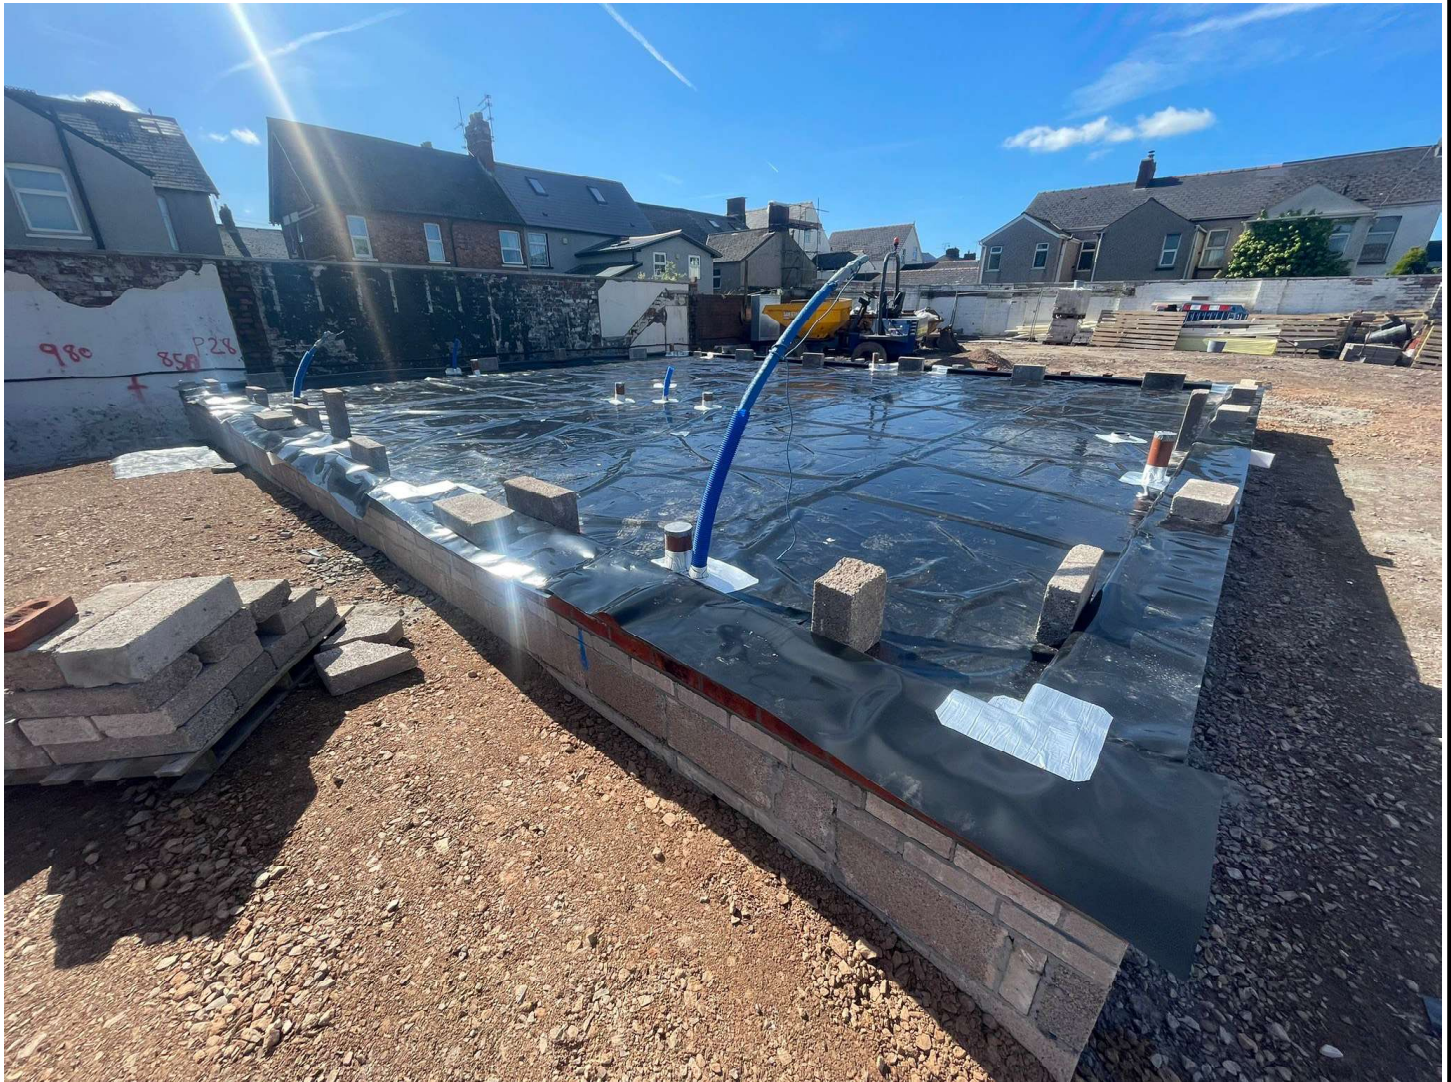
The photograph above displays an overview of Plots 1 & 2, where today's verification inspection took place on site.

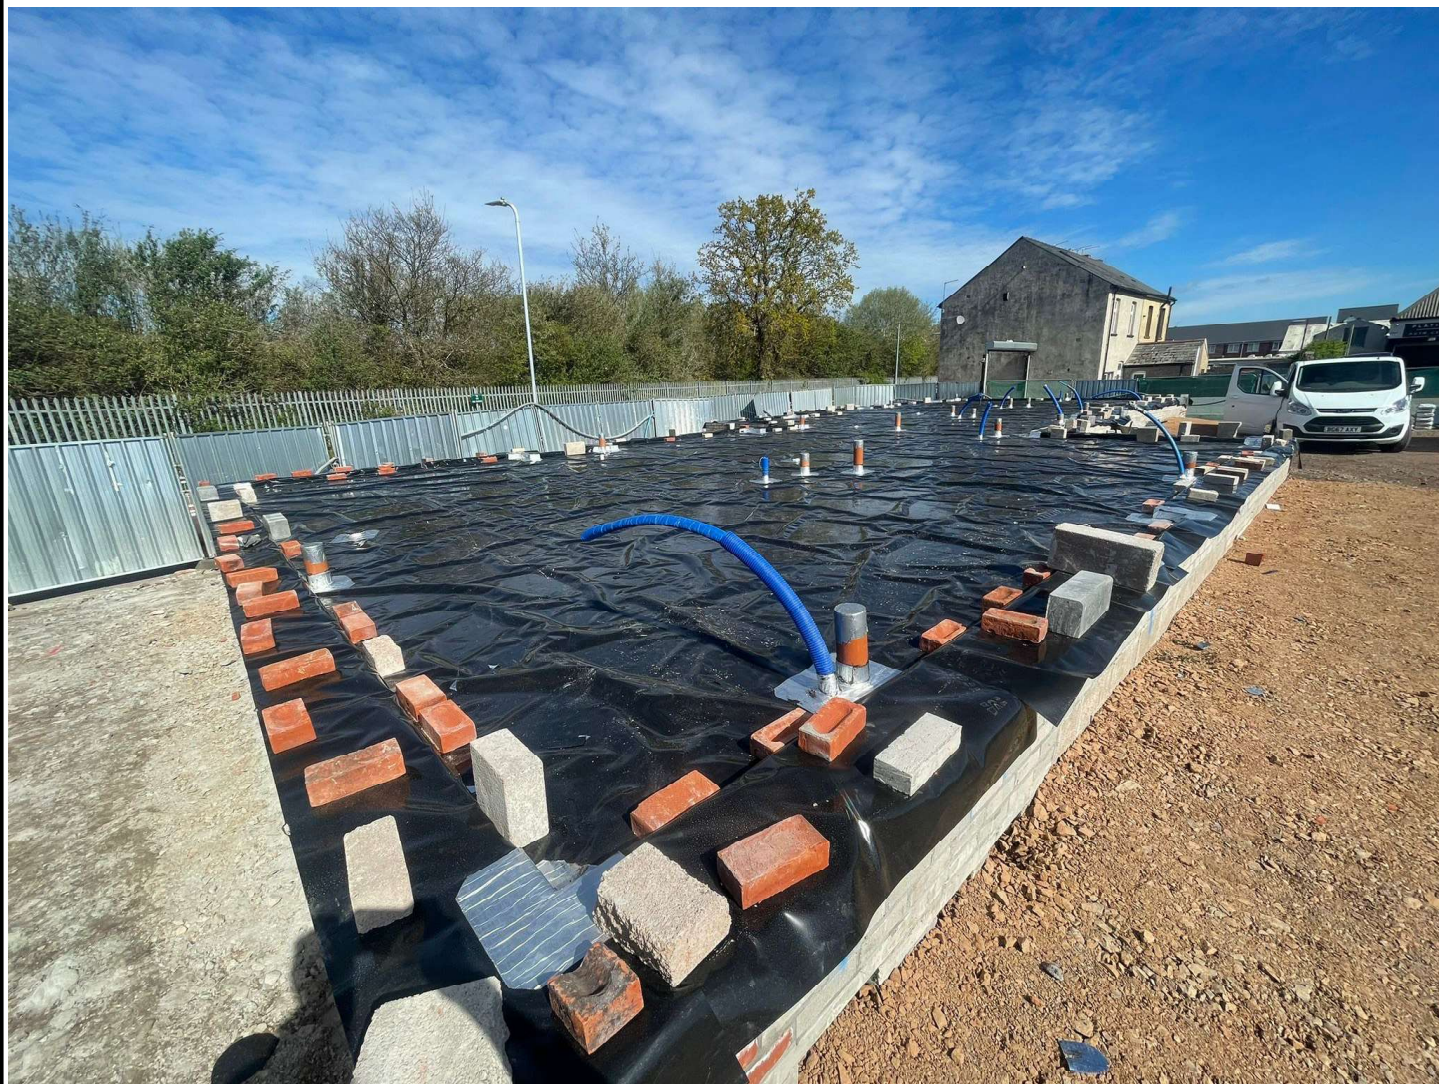
The photograph above displays an overview of Plots 3, 4, 5, 6 & 7, where today's verification inspection took place on site.

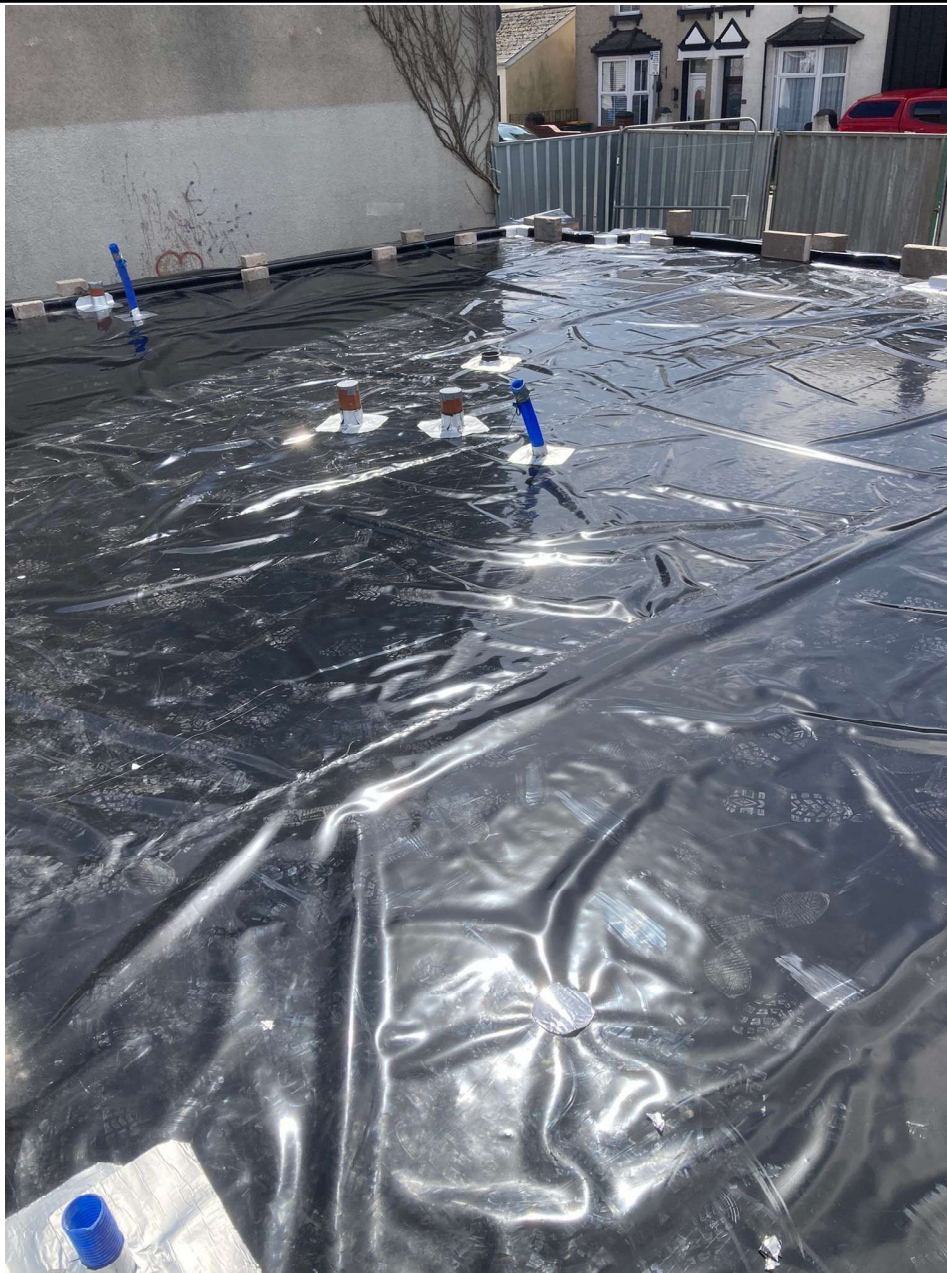
The photograph above displays an overview of Plots 8 & 9, where today's verification inspection took place on site.

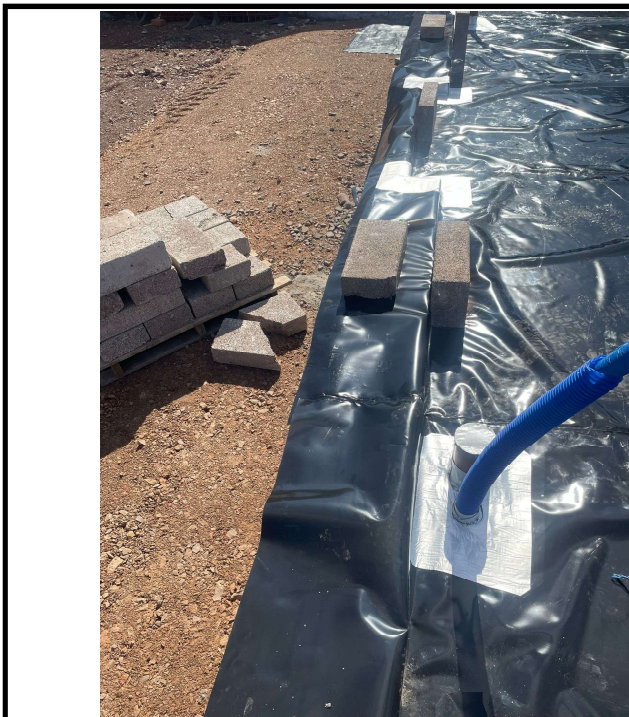
### Installation of RTEC 4 Gas Membrane

A complete line out of the RTEC 4 Gas Membrane has been installed across the footprint of Plots 1, 2, 3, 4, 5, 6, 7, 8 & 9. The RTEC 4 Gas Membrane has been installed over the entirety of the perimeter block work cavities of all the plots to ensure continuity throughout.

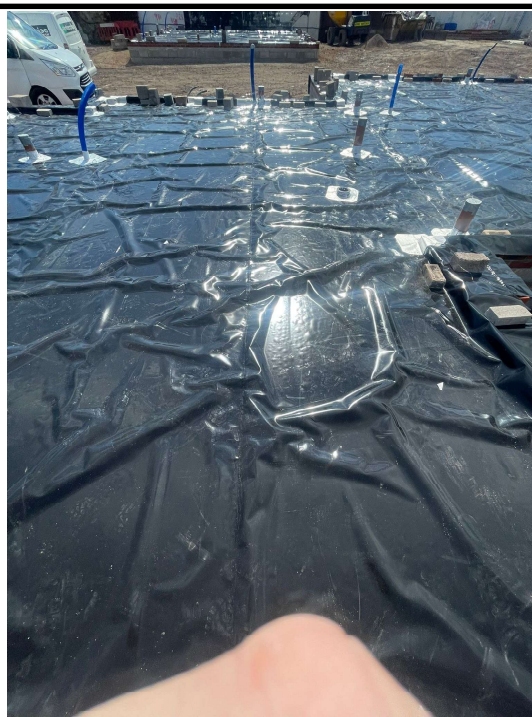
All lap joints between the adjacent sheets of RTEC 4 Gas Membrane have been overlapped a minimum of 100mm and heat welded using a hot air tool and a silicone roller with adequate pressure applied to ensure a continuous weld is achieved. Installed in accordance with manufacturer's specifications.
