Phase 2  
Ground Investigation

Client: Lidl Great Britain  
Ltd

Commercial Street,  
Risca

Report No: 1137.03.01

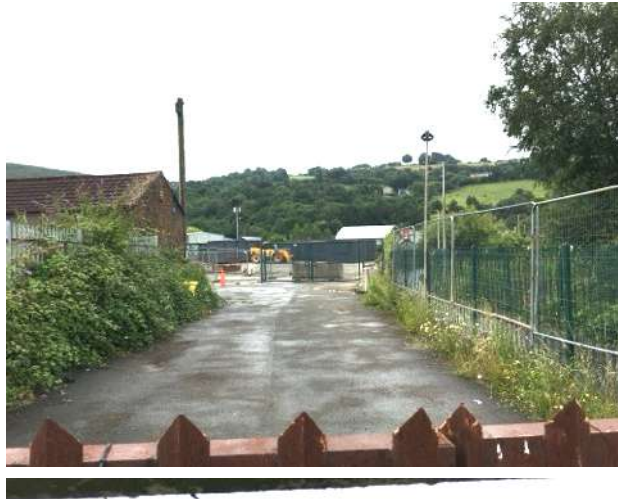
**Photo 1:** Taken from site entry on Commercial Street facing south, asphalt surfacing present. Signage on the gate, indicates that the site is used as storage yard by Thames Valley Builders.

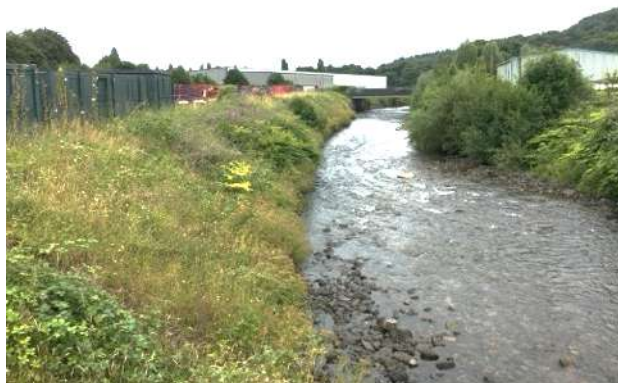
**Photo 2:** Taken from pedestrian footbridge over Ebbw River facing east. Fencing surrounding site parallel to river at top of sloping bank. Note: Water appeared to be very clear.

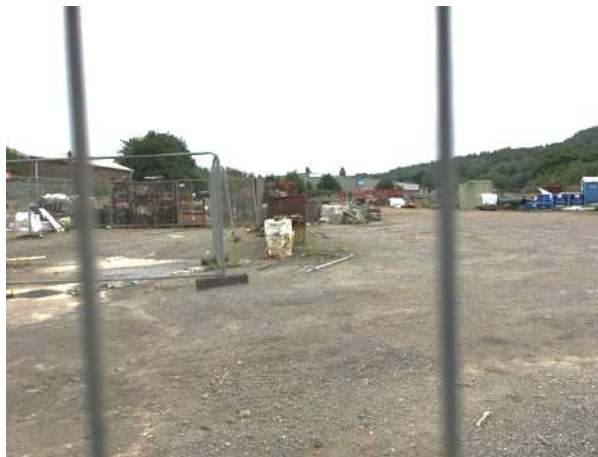
**Photo 4:** Taken through fence showing main area of site, spill kits evident, uneven made ground, with evidence of rubble from potential demolition in the background.

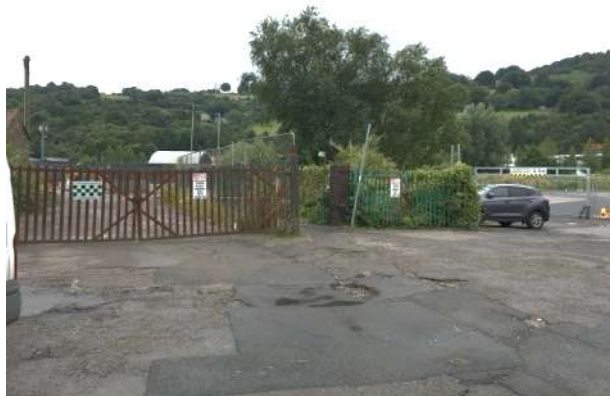
**Photo 5:** Access entry to site and public footpath leading to bridge over Ebbw River, with evidence of fresh surface laid on site to the west (right side of image)

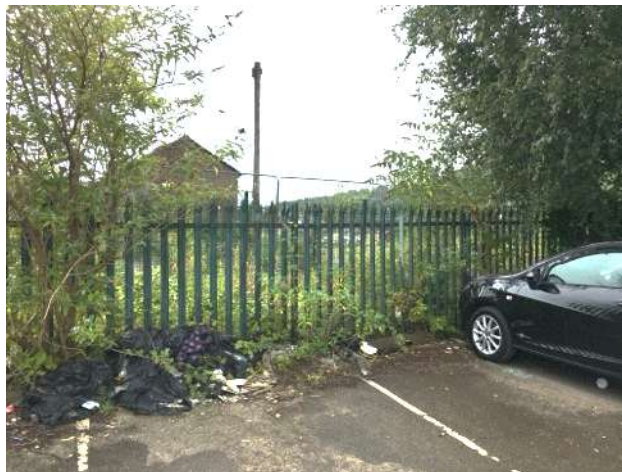
**Photo 6:** Evidence of fly tipping in parking area to west of access point.

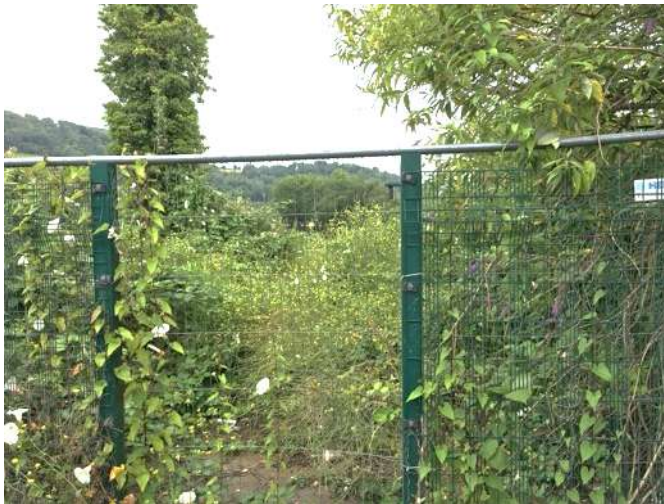
**Photo 7:** Evidence of overgrown vegetation in area on west side of public footpath

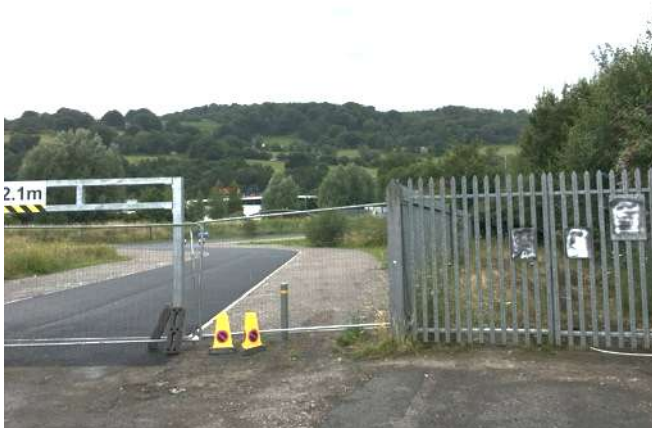
**Photo 9:** Plot of land to the west with freshly laid road surface.
