# **Robinwood Belmont Hill, Caerleon, NP18 1JX**

Bat Activity Survey Report

June 2026 | Issue 1VA

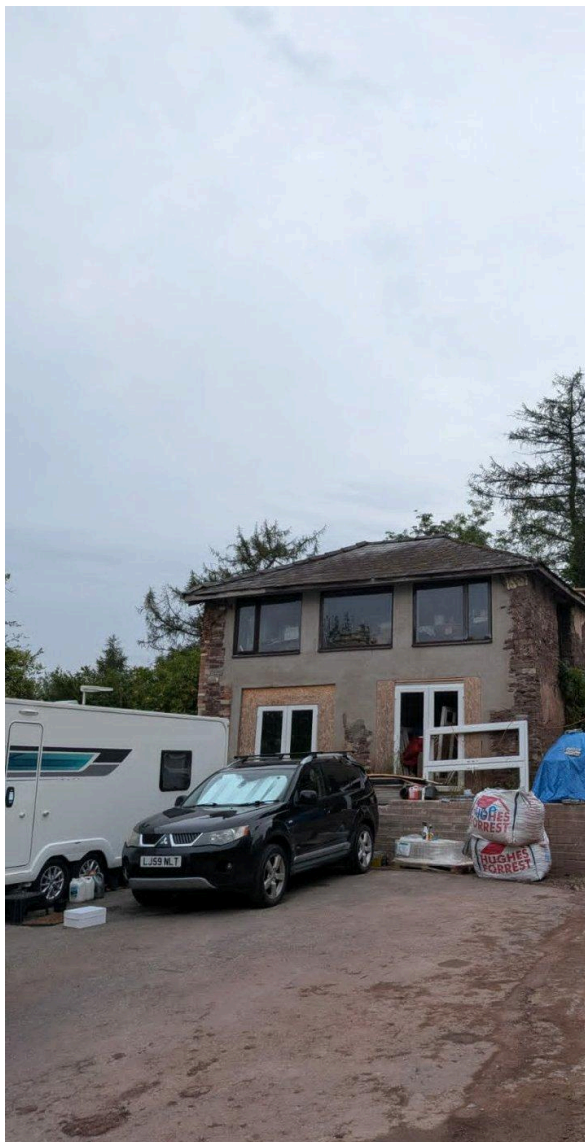
*Plate 1 – Front (south-western) elevation showing the rendered first floor over exposed random rubble sandstone, slate hipped roof*

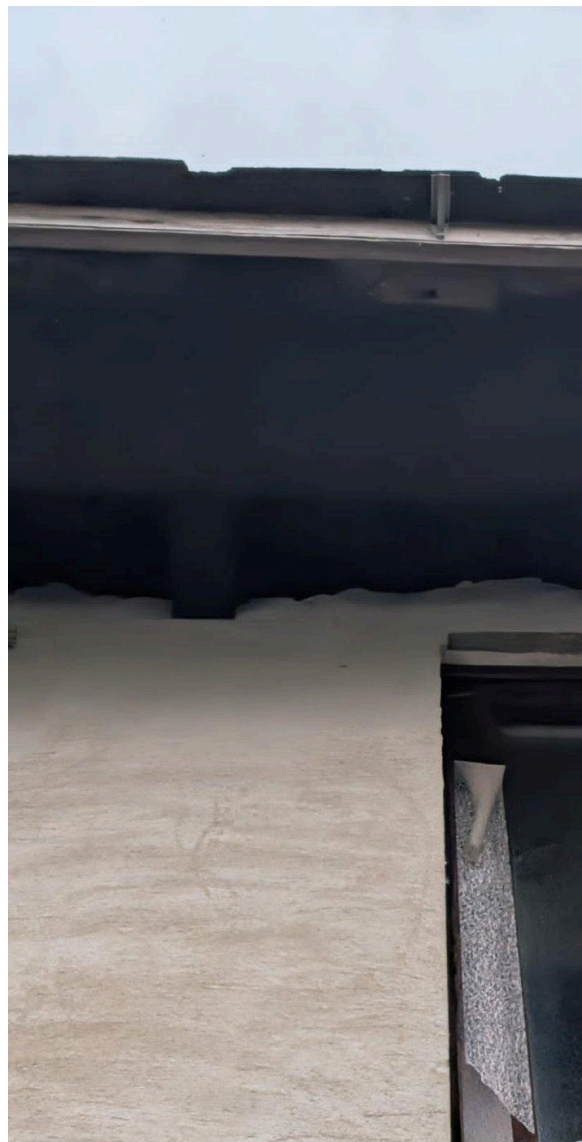
*Plate 2 – Eaves and soffit detail showing the painted timber soffit, lead flashing and a gap at the soffit/wall junction*

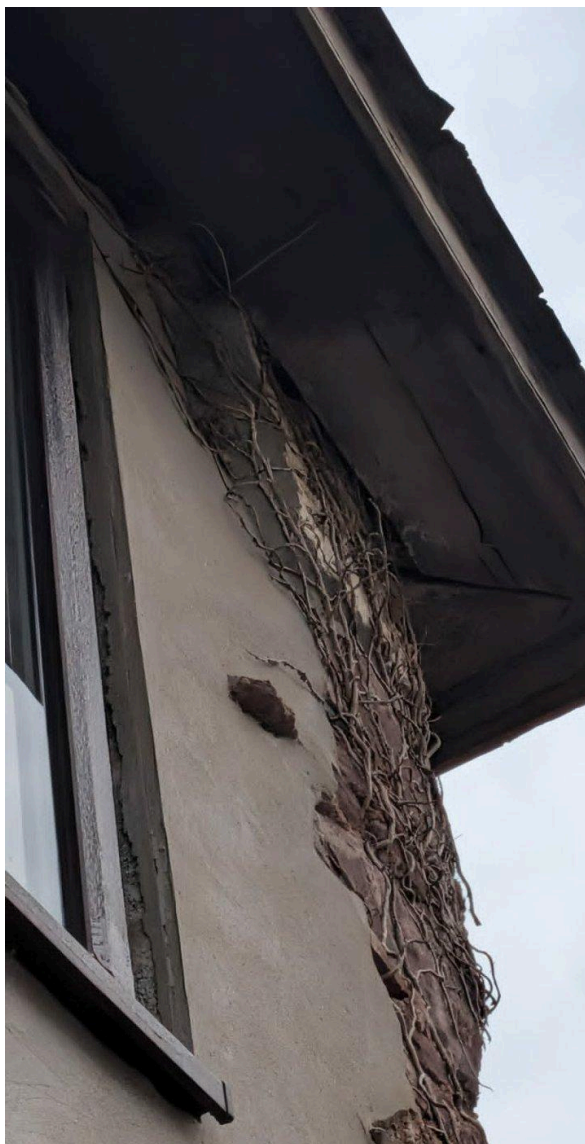
*Plate 3 – Eaves and verge detail showing exposed roof timbers, lead flashing and dead climbing vegetation against the rendered wall adjacent to a first-floor window*

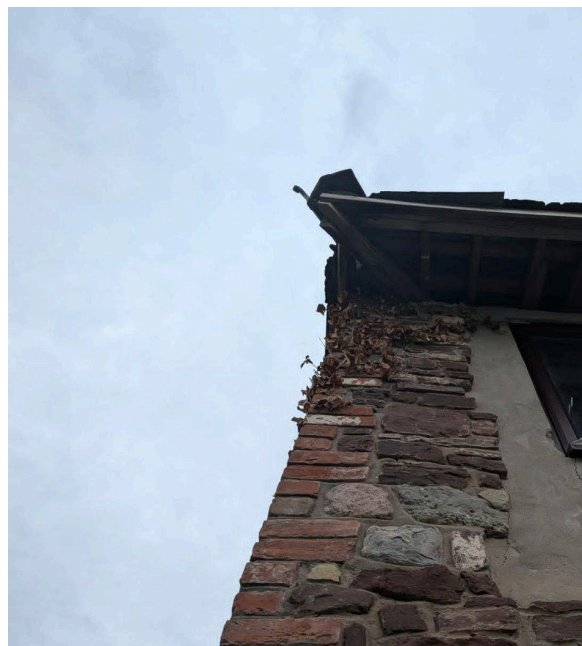
*Plate 4 – Gable apex showing exposed random rubble stonework and brick quoins, weathered rafter feet and dead vegetation beneath the eaves*

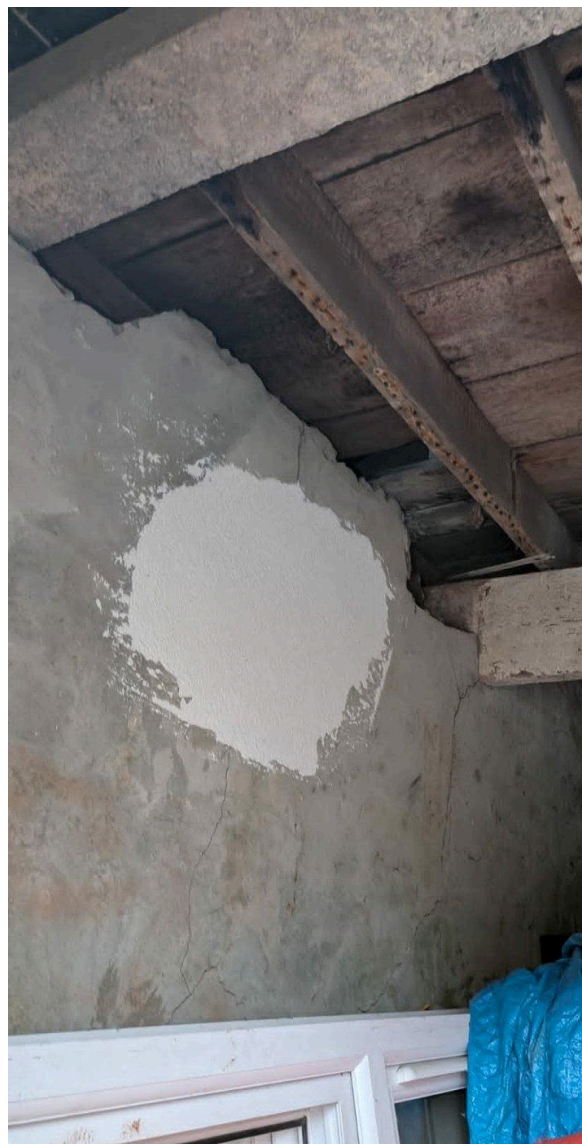
*Plate 6 – Ground floor interior showing exposed ceiling joists, cracked render and patched plasterwork to the stone walls*

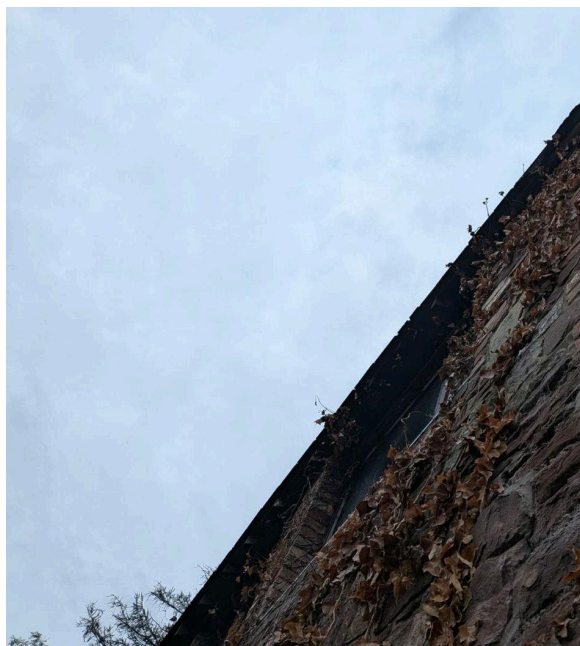
*Plate 8 – Gable corner detail showing coursed stone and brick quoins, exposed rafter feet and dead ivy growth beneath the eaves*

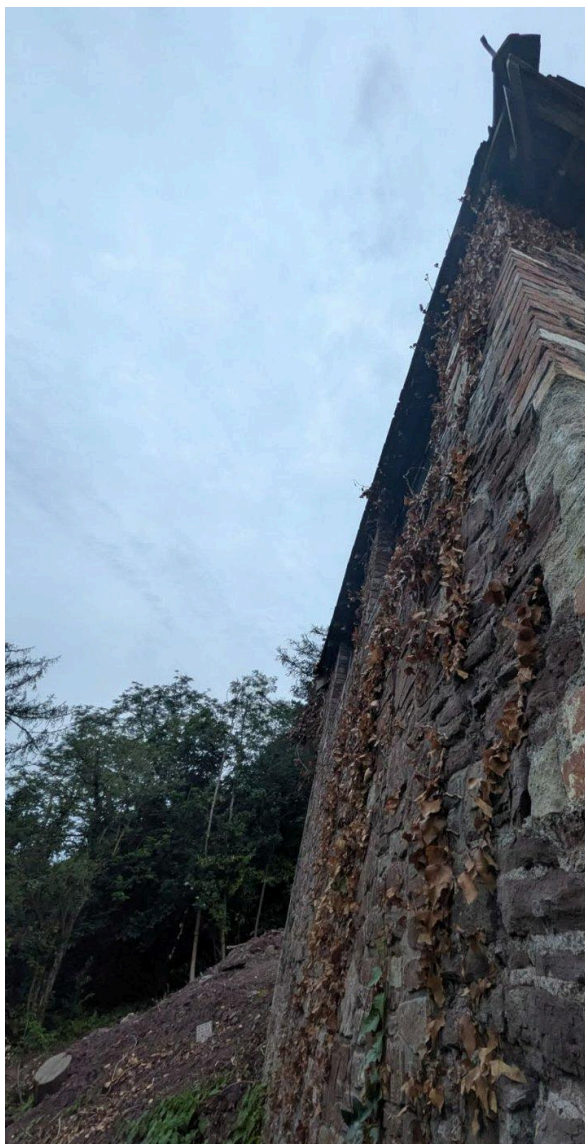
*Plate 9 – Rear gable showing exposed stonework, brick quoins, timber rafters at the verge and dead climbing vegetation*

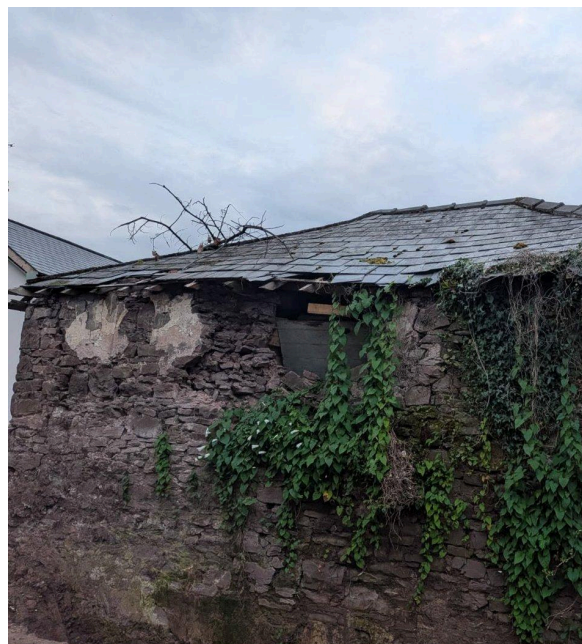
The survey carried out by BE Ecological Ltd revealed no droppings or evidence of bats on the exterior of the building. A number of potential access points were noted, including gaps beneath slipped and missing slates, openings at the eaves and verges where the roof timbers and sarking are exposed, and gaps within the weathered and partly missing render and pointing of the stone walls. Dense climbing vegetation (ivy) was present across parts of the elevations and beneath the eaves. The exposed stonework, slipped slates and gaps at the eaves provide a number of features of interest for roosting bats. The building was assessed as being of moderate potential for roosting bats.

*Plate 10 – Rear elevation showing the slate hipped roof with slipped and missing slates, ivy growth and gaps at the eaves/wall junction*

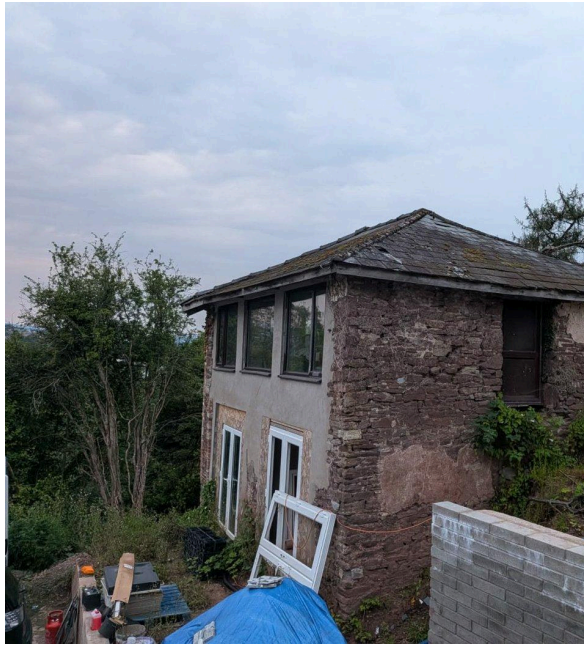
*Plate 11 – view of the rear and side elevations*
