# PORT OFFICE – ABP NEWPORT PRELIMINARY ROOST ASSESSMENT (PRA) AND ACTIVITY SURVEY FOR BATS

| <b>TITLE:</b> | Preliminary Roost Assessment (PRA) and Activity Survey for Bats |

| <b>PROJECT REF:</b> | 238-03-19-25 |
| <b>REPORT No.:</b> | 238-03-19.R4 |

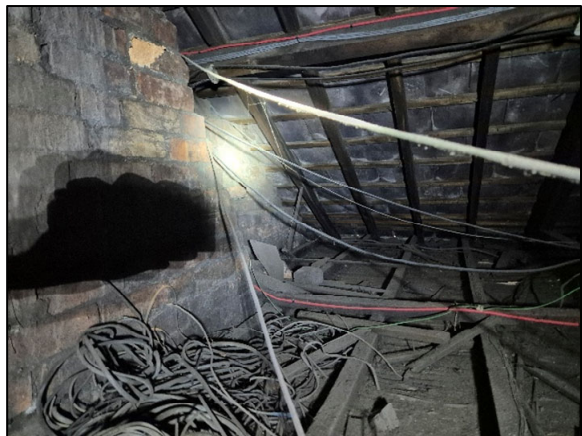
**Figure 15 – Gap Around (W) Side of Chimney Breast Enables Access to (S) Section of Main Survey Building Loft**

Two chimneys are present within the main loft of the building, with one each being situated within the northern and southern sections of the loft. The chimneys have been constructed from brick, and the brickwork and mortar was observed to be in good condition across both chimneys, with no significant areas of damage being recorded which may be utilised by crevice-dwelling bats. Gaps above the extent of the brickwork of the chimneys within the main loft of the survey building were however assessed to be of sufficient size in which crevice-dwellers may potentially roost.
