# LEWIS HOUSE – ABP NEWPORT PRELIMINARY ROOST ASSESSMENT (PRA) AND ACTIVITY SURVEYS FOR BATS

| <b>TITLE:</b> | Preliminary Roost Assessment (PRA) and Activity Surveys for Bats |

| <b>PROJECT REF:</b> | 238-03-19-25 |

## LEWIS HOUSE – ABP NEWPORT

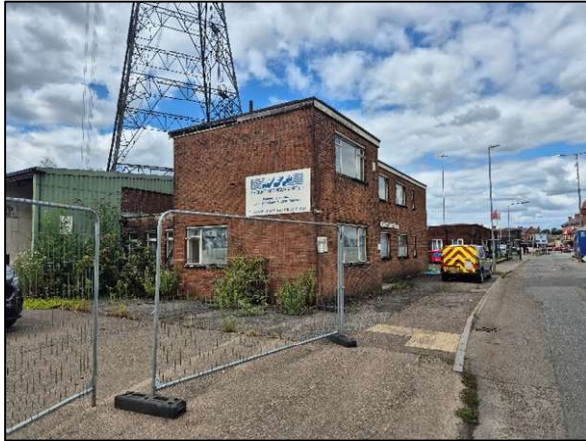
**Figure 3 – Two-Storey Brick Section of Bld.**

The external walls of the single-storey and two-storey sections of the offices / workshops are constructed of traditional facing brickwork in stretcher bond style. Although much of the mortar and brickwork was observed to be in generally good condition, some signs of weathering and localised erosion were recorded, particularly at lower levels where rising damp and vegetation growth appear to have taken hold.

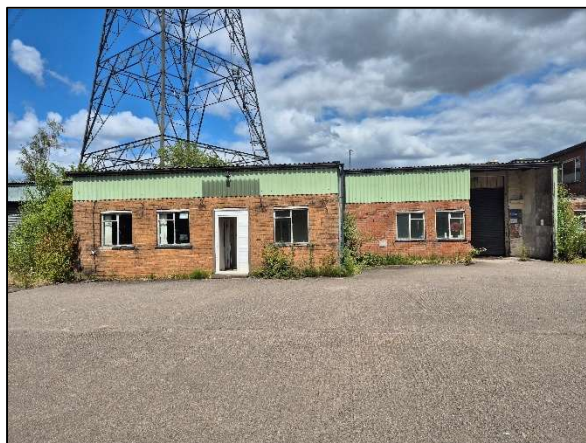
**Figure 5 – Single-Storey Brick Section of Bld. (S)** **Figure 6 – Steel Framed Warehouse (Left of Image)**

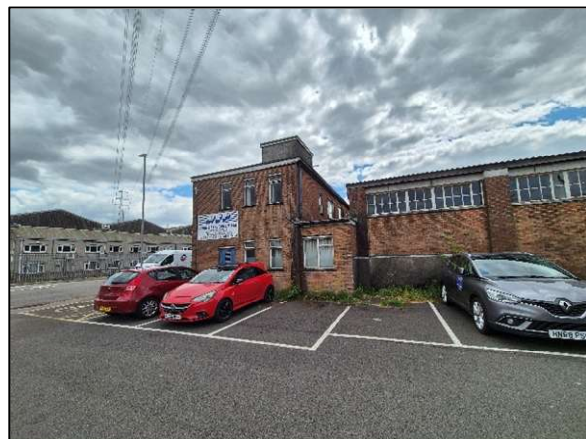
**Figure 8 – Two-Storey Brick Section of Bld. (S)**

Small cracks and breaks in the brickwork were also recorded along the south-eastern corner of the building, and these were assessed to be of sufficient size to be utilised by crevice-dwelling bats.

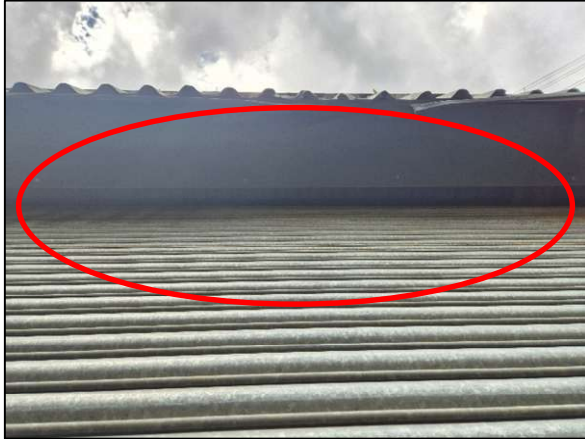
Large gaps are present around the tops of the roller shutter doors, which may permit access to both the steel framed warehouse and single-storey brick section of the building. Furthermore, damaged brickwork was recorded in the vicinity of the south-eastern roller shutter door, which may provide PRFs and or access/egress to the building interior in this location for crevice-dwelling bats.

**Figure 9 – Gap above Roller Shutter Door to Eastern Steel Warehouse May Permit Access/Egress for Bats**

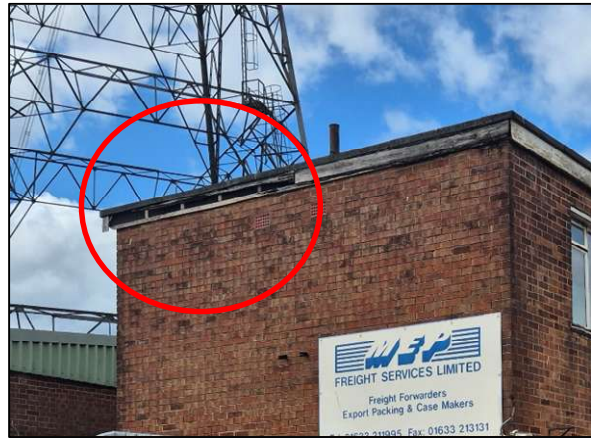
Significant damage was recorded to the timber fascia board on the southern side of the building however. Missing sections of the fascia board within this location were assessed to enable the potential access/egress for crevice dwelling bats to PRFs which may be situated beneath the flat roof of the building in this location.

**Figure 10 – Damaged / Missing Timber Fascia Board at (SE) of Building May Permit Access/Egress for Bats to Interior & Associated PRFs**

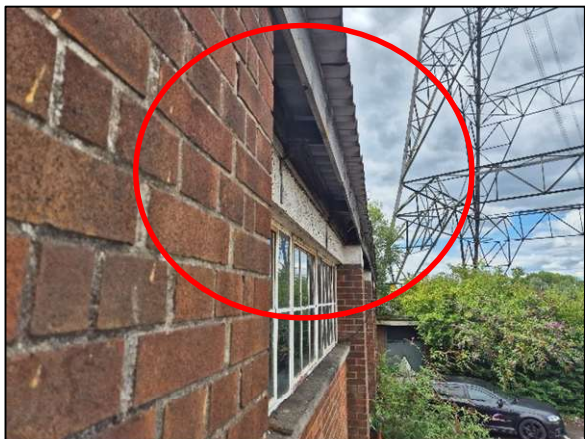
The brick sections of the building possess exposed timber fascia boards. The fascia boards on the northern side of the building were in a generally fair condition, although a gap was identified behind this fascia board which may permit access/egress to the loft void situated beneath the corrugated steel sheet roof, or may be utilised as a PRF by crevice-dwelling bats.

**Figure 11 – Gap Behind Timber Fascia Board on (N) Side of Building May Permit Access/Egress for Bats to Interior & Associated PRFs**

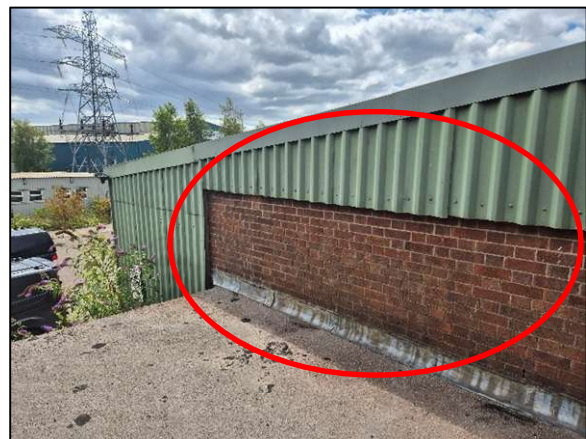
**Figure 12 – Gaps Behind Steel Cladding and Brick Wall May Offer Some Roosting Potential for Crevice-Dwelling Bats, and May Permit Access/Egress to Building Interior Via these Locations**

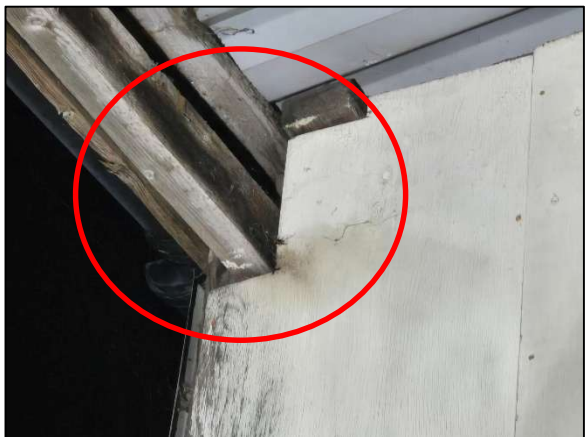
**Figure 13 – Gap and Potential Smudging Where Timber Framework Meets Wall in vicinity of Roller Shutter Door at (SE) of Survey Building**

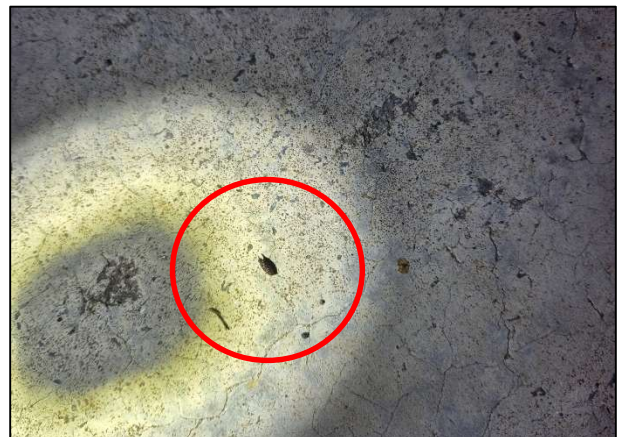
**Figure 14 – Bat Dropping Identified Beneath Potential Access/Egress Point as visible in Figure 14, Suggests this Feature is being Utilised by Bats**

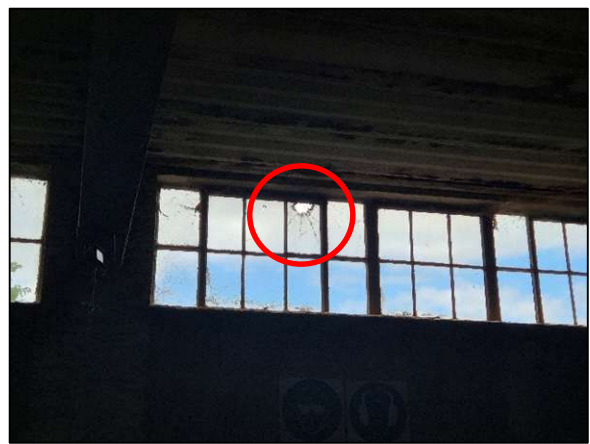
**Figure 16 – Damaged Window Pane along (N) Wall of Single-Storey Brick Structure May Permit Access**

- **Damage to Glass Windows along (N) Side and Open Windows around Building** – Small areas of damage to <5 window panes on the northern side of the single-storey brick building were recorded during the survey, which may permit access/egress for bats to the main Ground Floor interior room of this building. Furthermore, a small number of open windows were also recorded during the PRA, with these being situated on the two-storey brick building and on the southern side of the single-storey building, enabling the potential access/egress of bats to the respective building interiors in each location;

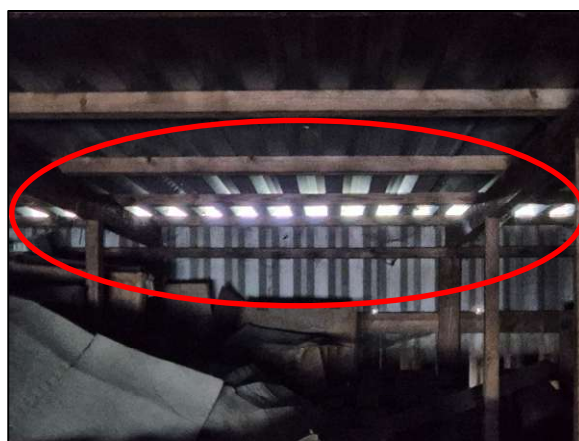
**Figure 20 – Light Ingress from Gaps Under Corrugated Roof Sheets May Permit Access/Egress for Bats**

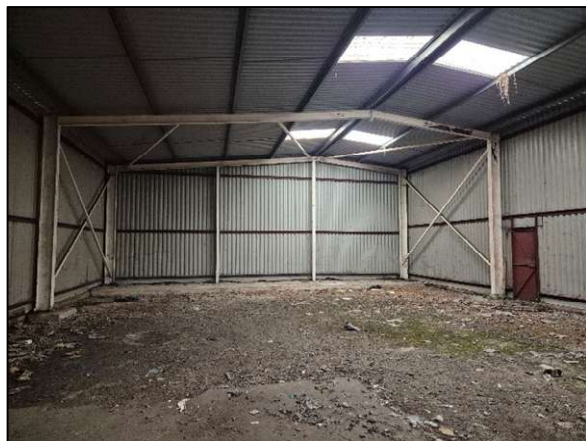
**Figure 21 – (W) Steel Clad Wall of Steel Framed Warehouse, Looking (W)**

The interior of the warehouse is open and spacious in nature, with no internal partitioning. Potential roosting features within the main warehouse itself are limited, although the building could be used opportunistically as a night roost should conditions allow.

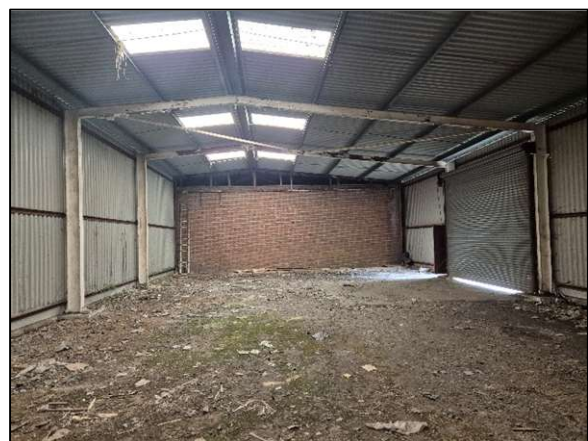
**Figure 22 – (E) Brick Wall of Steel Framed Warehouse, Looking (E)**

The brick wall at the eastern end of the building meanwhile offers some additional roosting potential, particularly between the edge of the brick wall and the corrugated steel cladding, whereby a small void of sufficient size to potentially be utilised by crevice-dwellers is present. The condition of the brickwork and masonry itself is in generally excellent condition however, with limited areas being observed in which crevice-dwelling bats may be able to roost.

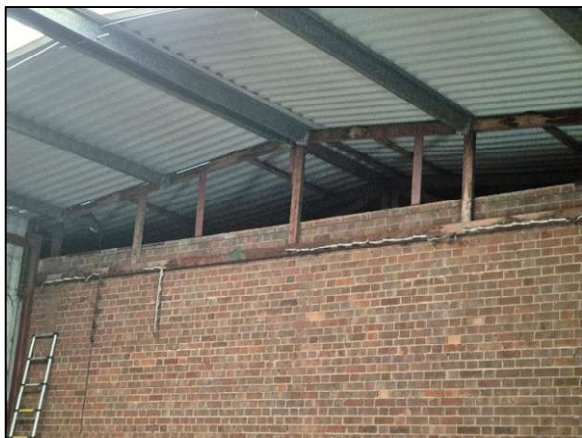
**Figure 23 – Gap above Extent of Brick Wall, Opens Out into Void above (N) Section of Single-Storey Brick Building**

Subsequently, the primary potential roosting features for bats within the steel framed warehouse are situated within the void above the extent of the brick wall at the west of the building.

The void offers some potential roosting features for bats, with these primarily being associated with gaps between intersecting timber features, which may be suitable for crevice-dwelling bats. It should be noted that the void space was not surveyed in its entirety due to safety concerns; however of the areas that were accessible, no evidence of roosting bats was found.

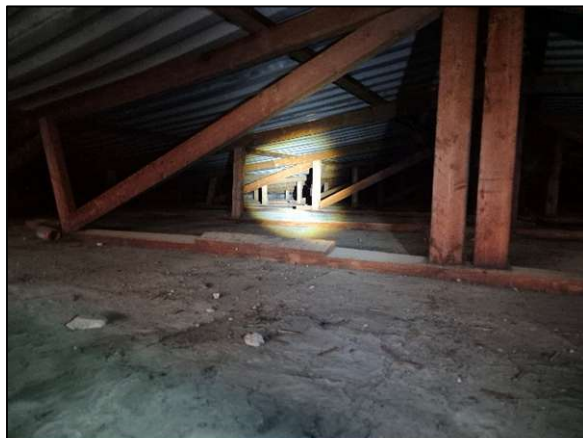
**Figure 25 – Void Interior above Single-Storey Brick Building, Looking (E)**

Small areas of light ingress were recorded in some areas, whereby lifted steel panels were identified (as visible in top right of Figure 25). Subsequently it is likely that the void is directly accessible for bats from the building exterior, whilst bats are able to potentially enter the void via the main warehouse interior, via the large gap above the extent of the brick wall.

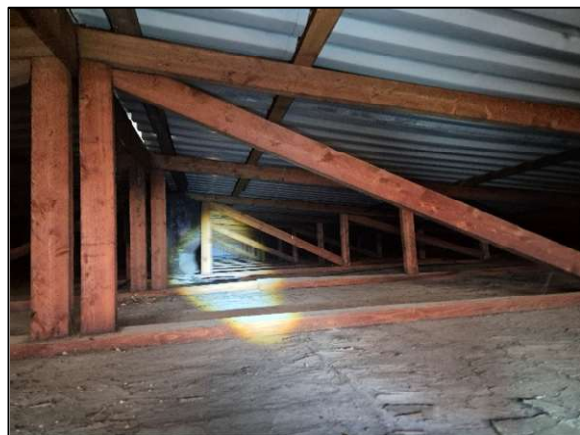
Timber framework is present within the void, onto which the steel roof sheets of the main warehouse have been set. The void continues along the whole length of the single-storey brick building, and terminates at the end of the building, beyond which the two-storey brick building is situated.
