Charles Williams Church In Wales  
Heritage Impact Assessment  
Junior School Window Replacements &  
Maintenance

Revision 1

12.09.2025

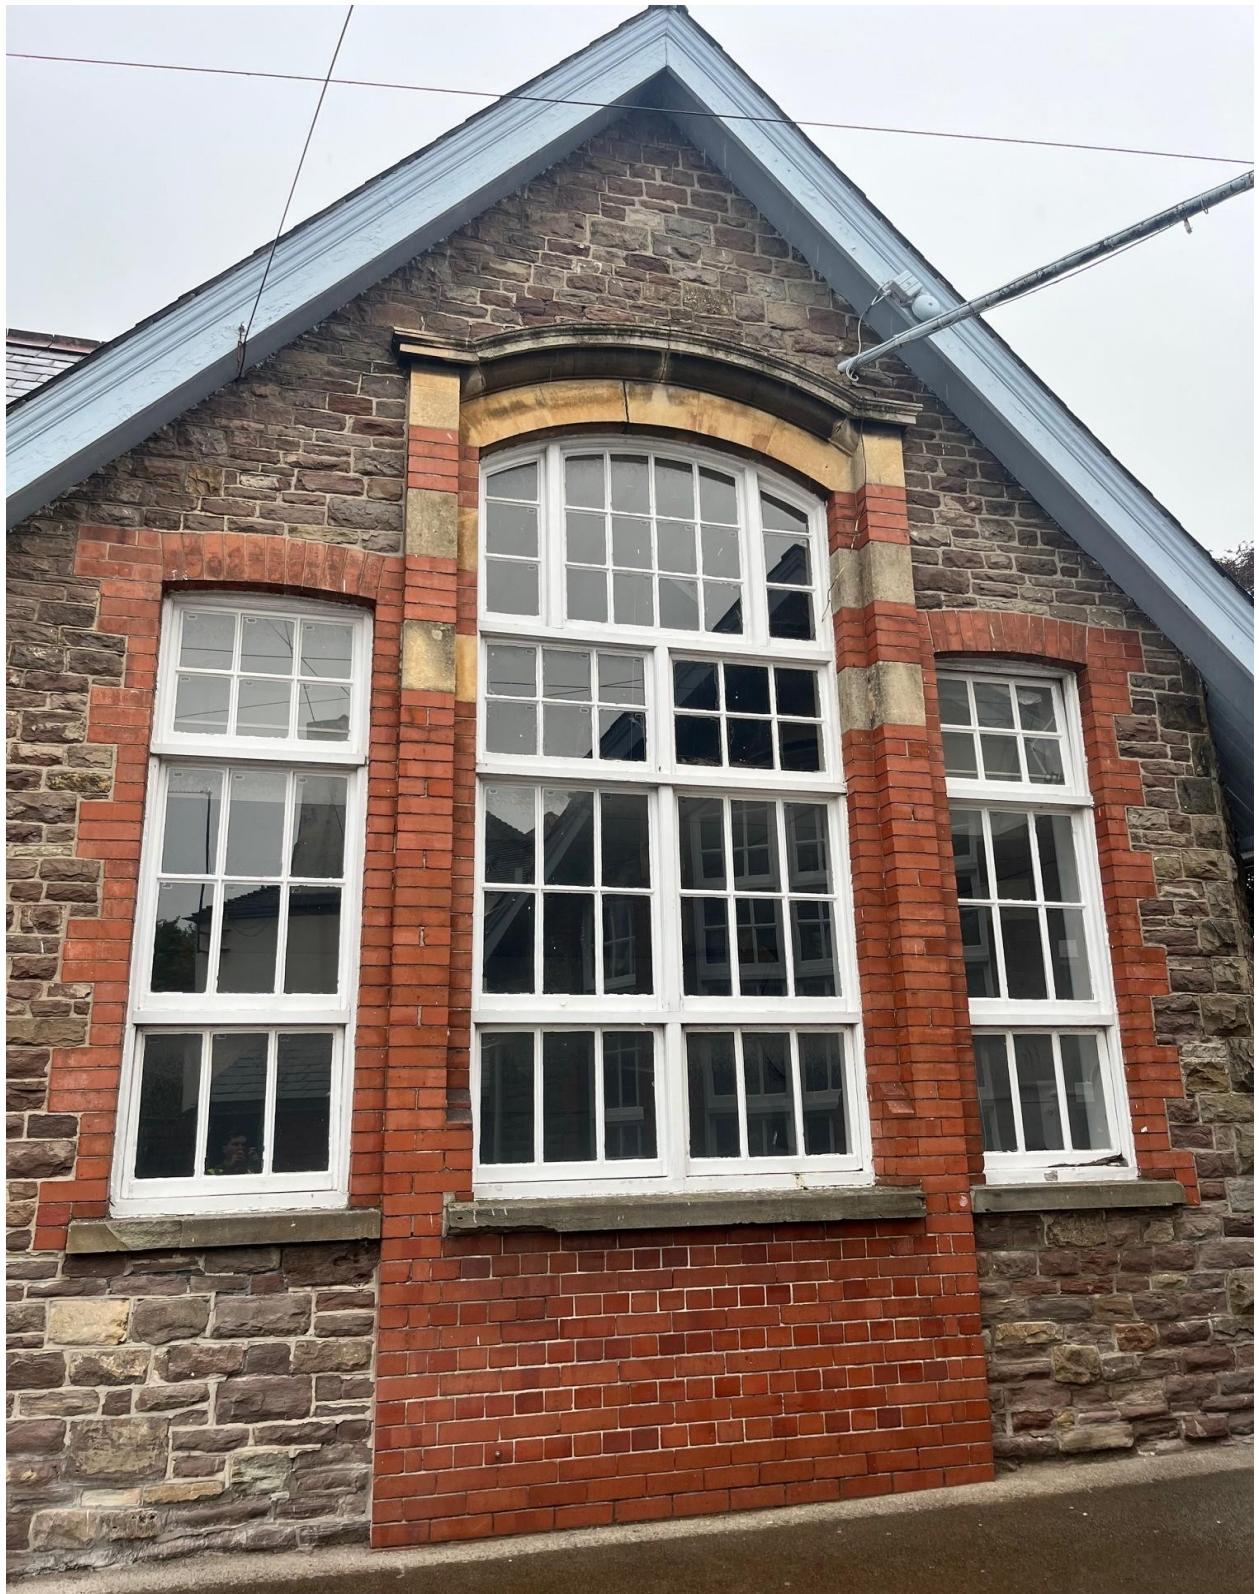
*Photo 1: One example of the Casement windows marked for replacement*

Many of the existing windows are in poor condition and inoperable, resulting in inadequate ventilation throughout classrooms. This compromises both teaching conditions and pupil wellbeing. Their replacement with fully operable timber units will significantly improve ventilation and comfort levels within the building, ensuring the school remains functional and fit for purpose.

| Proposal | Objective | Impact on Evidential Value | Impact on Historic Value | Impact on Aesthetic Value | Impact on Communal Value | Mitigation |
|---|---|---|---|---|---|---|
| <b>Replacement of timber casement windows with operable, slimline double-glazed units</b> | Replace deteriorated, inoperable windows with new sash units for ventilation, improved classroom conditions, and better thermal performance | <b>Low adverse</b> – minor fabric loss offset by faithful replication of detailing. | <b>Negligible</b> – design character retained. | <b>Medium beneficial</b> – improved condition, energy efficiency, and visual integrity | <b>High beneficial</b> – improved comfort, ventilation, and sustainability for ongoing school use. | New windows to replicate original joinery, glazing patterns and finish. Timber sustainably sourced, painted appropriately. |

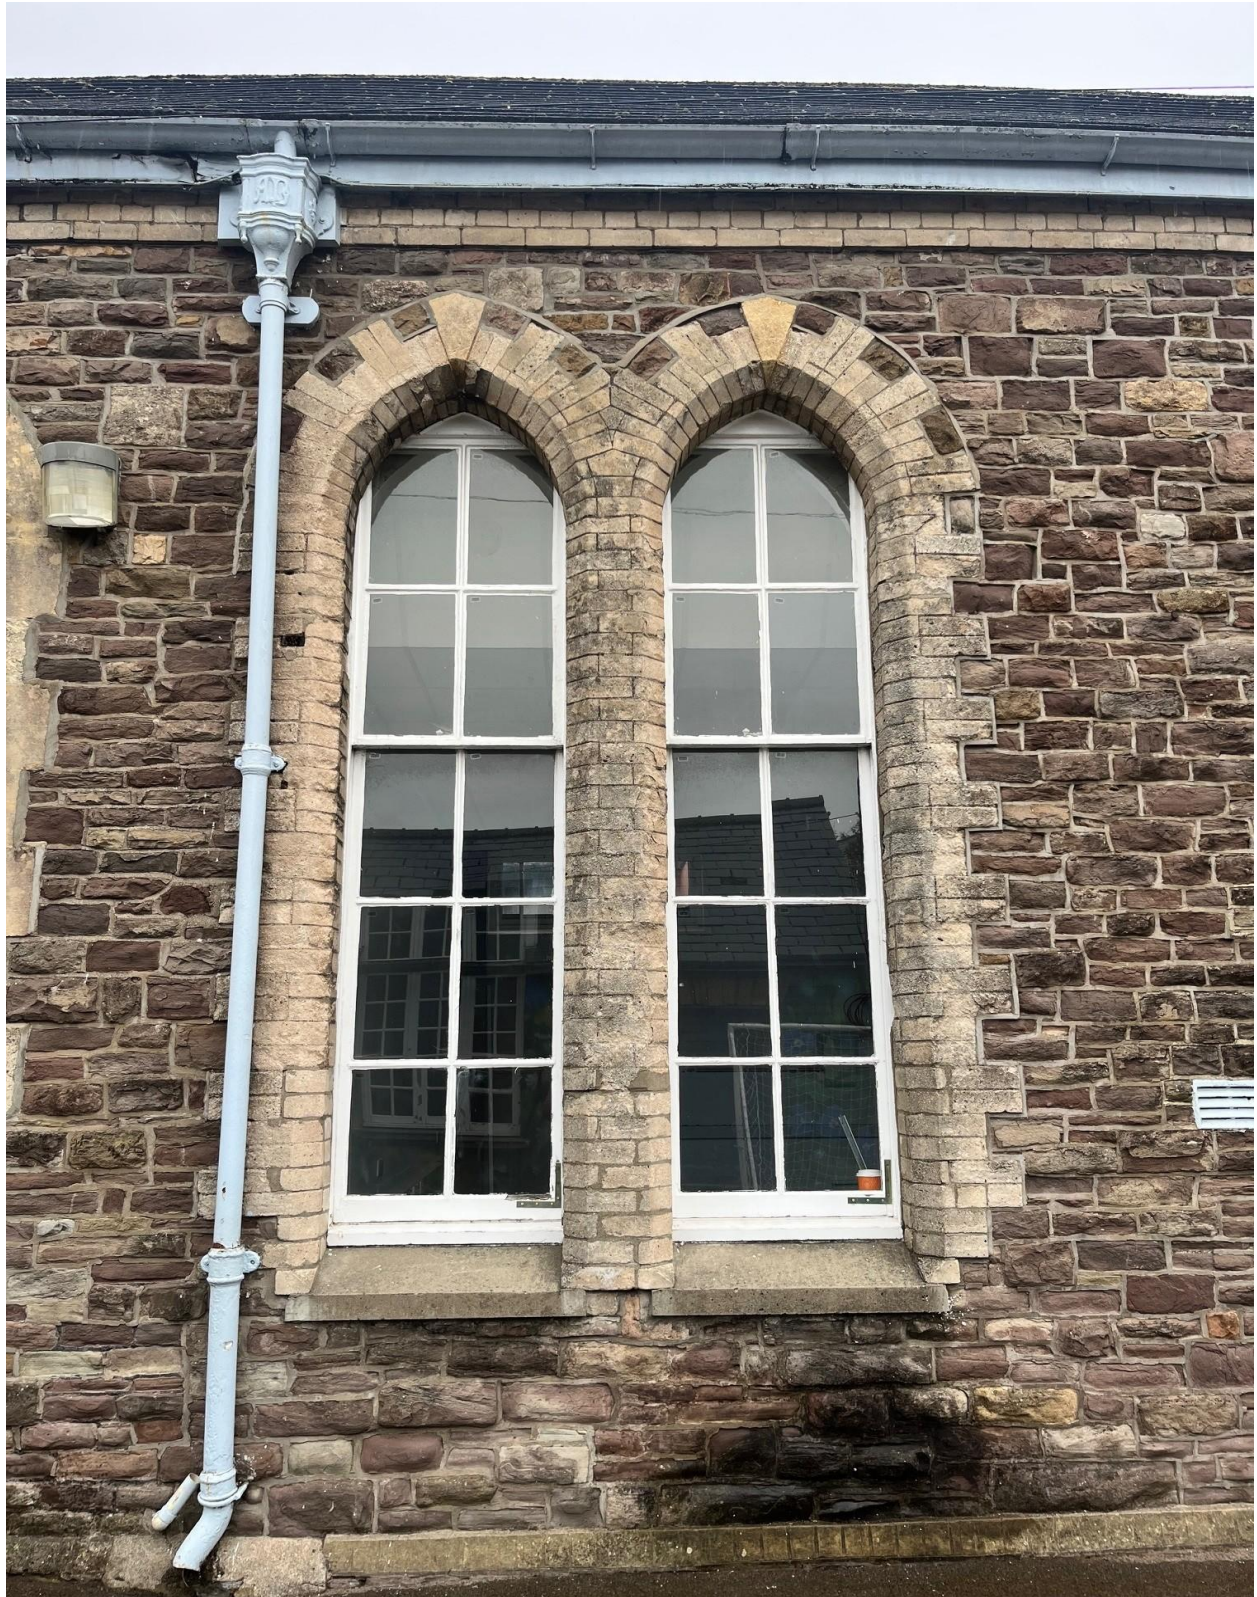
*Photo 2: One example of the box sash windows marked for replacement, also condition bargeboards & soffits.*

| Proposal | Objective | Impact on Evidential Value | Impact on Historic Value | Impact on Aesthetic Value | Impact on Communal Value | Mitigation |
|---|---|---|---|---|---|---|
| <b>Replacement of timber sash windows with operable, slimline double-glazed units</b> | Replace deteriorated, inoperable windows with new sash units for ventilation, improved classroom conditions, and better thermal performance | <b>Low adverse</b> – minor fabric loss offset by faithful replication of detailing. | <b>Negligible</b> – design character retained. | <b>Medium beneficial</b> – improved condition, energy efficiency, and visual integrity | <b>High beneficial</b> – improved comfort, ventilation, and sustainability for ongoing school use. | New sashes to replicate original joinery, glazing patterns and finish. Timber sustainably sourced, painted appropriately. |

| Proposal | Objective | Impact on Evidential Value | Impact on Historic Value | Impact on Aesthetic Value | Impact on Communal Value | Mitigation |
|---|---|---|---|---|---|---|
| <b>Repair/replace ment of soffits and bargeboards</b> | Address decayed timber soffits and bargeboards to ensure weather protection and visual integrity. | <b>Low adverse</b> – some original material lost, but replaced in kind. | <b>Negligible</b> – minimal change to historic understanding. | <b>Low to medium beneficial</b> – reinstated elements improve appearance and integrity. | <b>Low beneficial</b> – better maintained appearance enhances perception. | Like-for-like timber replacements using traditional joinery techniques. Painted finish to match historic precedent. |

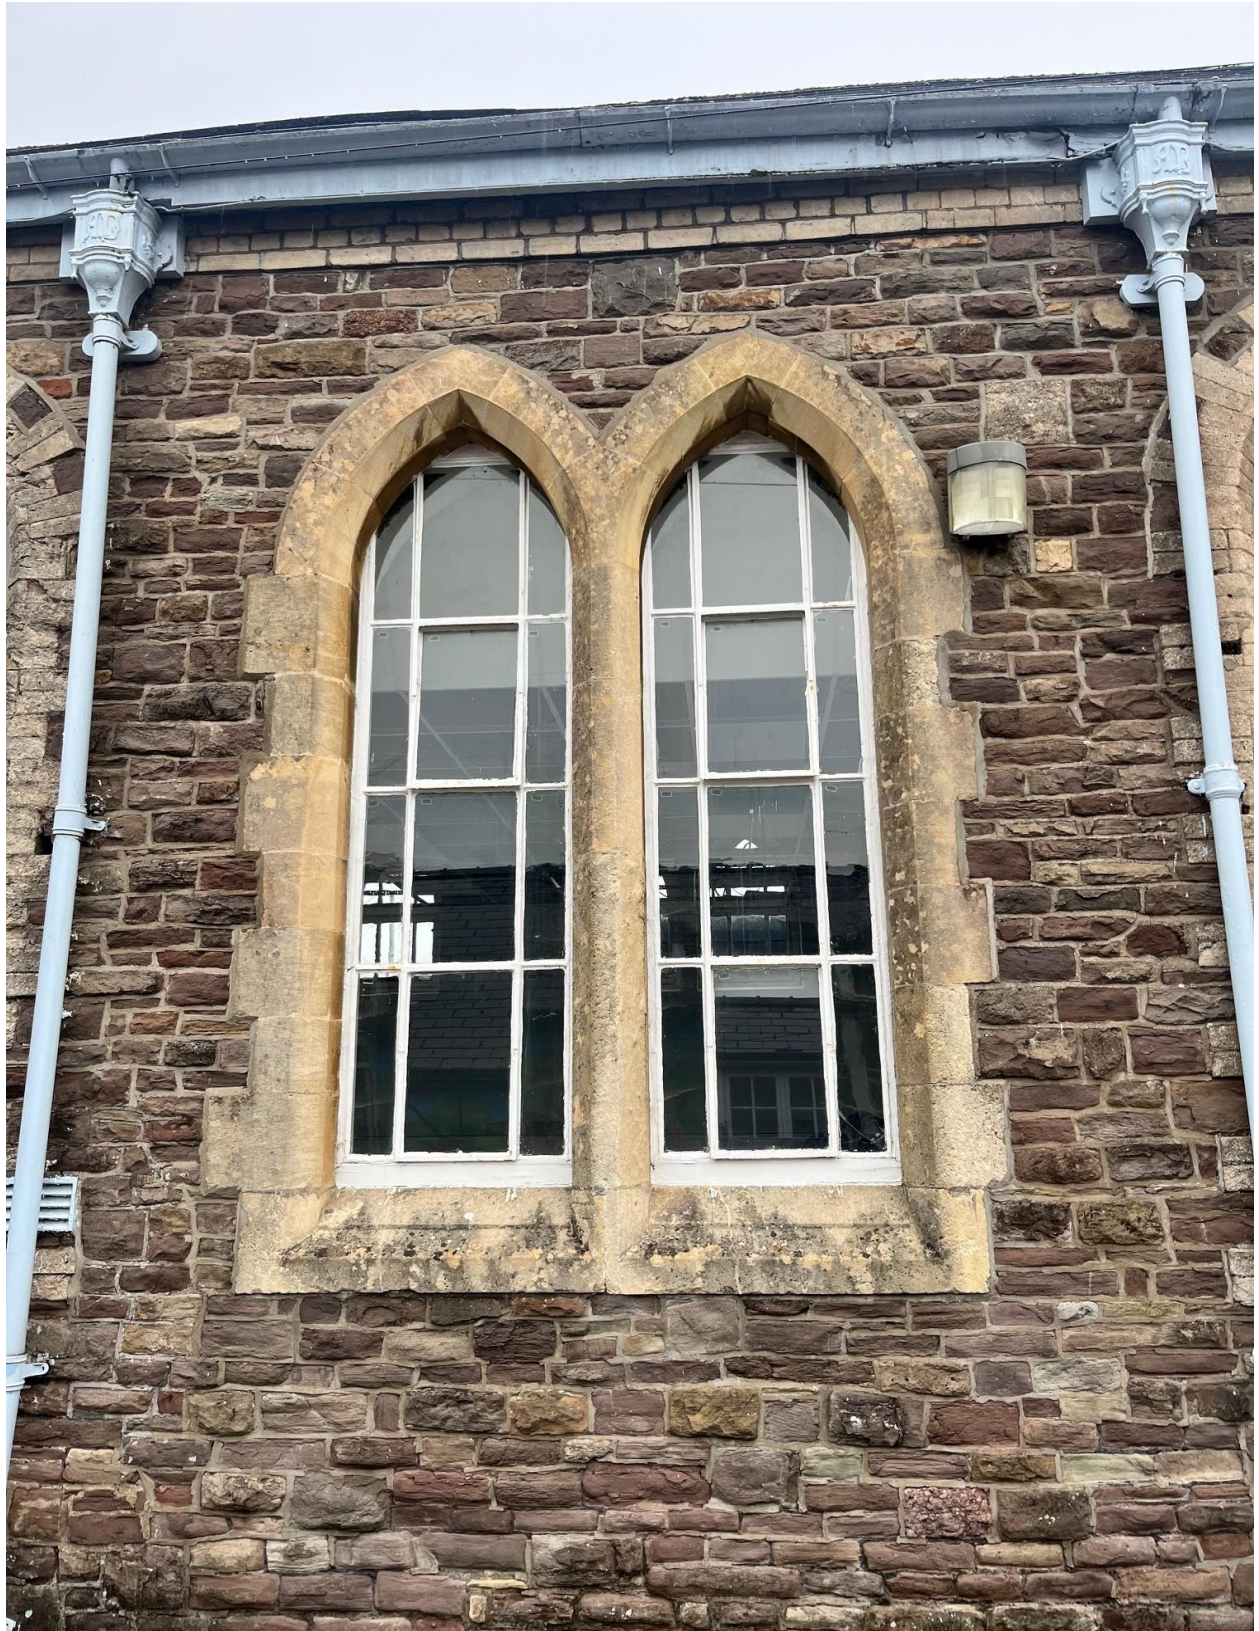
Photo 3: Example of a different Bathstone surround on the same building.

The brick window surrounds (quoins) have suffered extensive spalling and are actively allowing water ingress into the masonry fabric, accelerating deterioration of adjacent elements. Reinstatement in Bathstone provides a durable and authentic solution that is consistent with other surviving surrounds on the building, believed to have been original. The use of Bathstone is further justified given the difficulty in sourcing suitable imperial-sized brick in a matching colour.

| Proposal | Objective | Impact on Evidential Value | Impact on Historic Value | Impact on Aesthetic Value | Impact on Communal Value | Mitigation |
|---|---|---|---|---|---|---|
| <b>Removal of damaged brick quoins and reinstatement in Bath stone</b> | Address deterioration where existing brick quoins are spalled, preventing water ingress and protecting adjacent sash windows. | <b>Low adverse to low beneficial</b> – some fabric loss, but reinstatement with historically appropriate Bath stone restores authenticity. | <b>Medium beneficial</b> – strengthens the building's relationship with the Grade II* Caerleon Endowed House. | <b>High beneficial</b> – Bath stone reinstatement enhances façade integrity and visual legibility. | <b>Low beneficial</b> – improved condition and appreciation by users. | Works to be carried out by skilled masons using Bath stone detailed to match surviving profiles. Protection of adjacent fabric ensured. |

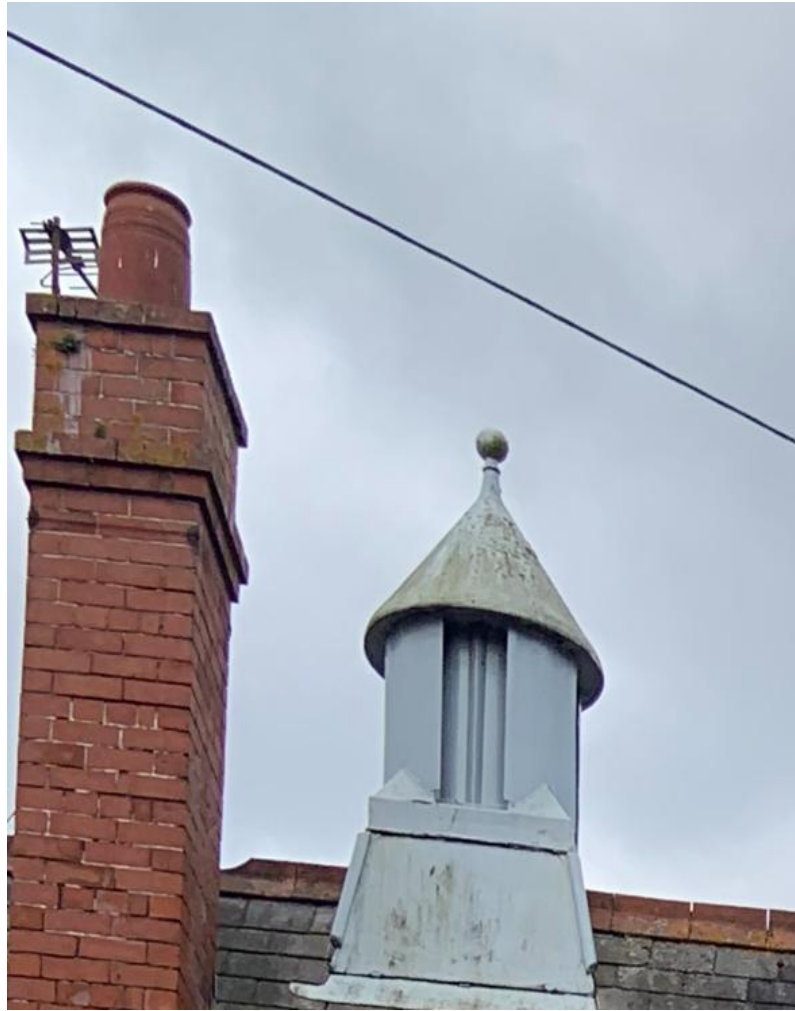
*Photo 4: One of two windcatchers marked for maintenance*

| Proposal | Objective | Impact on Evidential Value | Impact on Historic Value | Impact on Aesthetic Value | Impact on Communal Value | Mitigation |
|---|---|---|---|---|---|---|
| <b>Repair/replace ment of windcatchers</b> | Improve ventilation systems by repairing or replacing existing windcatchers. | <b>Low adverse</b> – minor material loss. | <b>Negligible</b> – functional feature, limited historic sensitivity. | <b>Low beneficial</b> – repairs improve uniformity and reduce visual intrusion of deterioration. | <b>Medium beneficial</b> – improved ventilation supports ongoing communal function. | <b>Repairs/replacements</b> will match original design and profiles to maintain historic character. |
