Ref: LBC/19/00686 – TSD06  
Date: 20/08/2025

## **MATERIAL SAMPLES CONDITION: CONDITION 2 APPLICATION – SHIREHALL REF: LBC/2019/00686**

Please find below photographs taken of the samples of materials proposed for the REPLACEMENT of cleaved / cracked STONES of the grins hill / witton fell (buff sandstone colour) on selected areas to South (front) facade at the above applicant site:

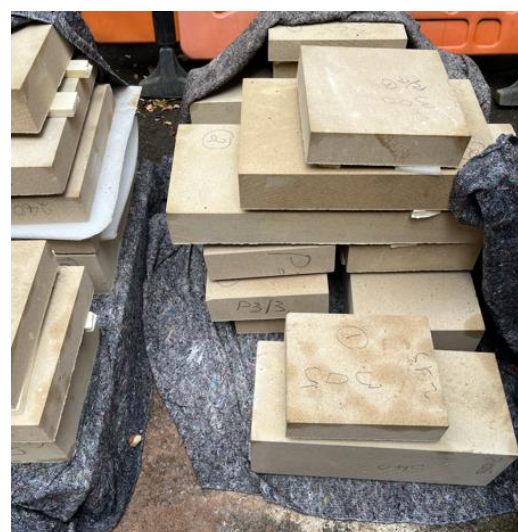
Plate 4: New stone arrived ready for carving

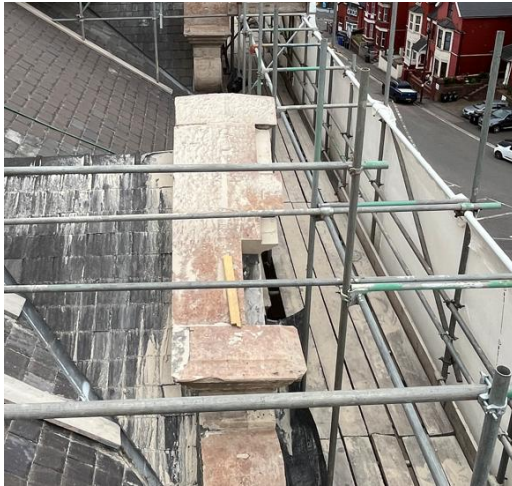
Plate 5: Cutting out defective stone (pediment 3)  
Templating completed for new stone order.

Cleaved, split and delaminated Buff sandstones faces (South elevation) of Shirehall replaced using new Witton Fell Quarry Buff sandstone slips (min 50mm thick), pinned with stainless steel rods to existing good stone, bedded on lime mortar with buff lime pointing over to exactly match existing stones in type, colour, dimensions and fit.

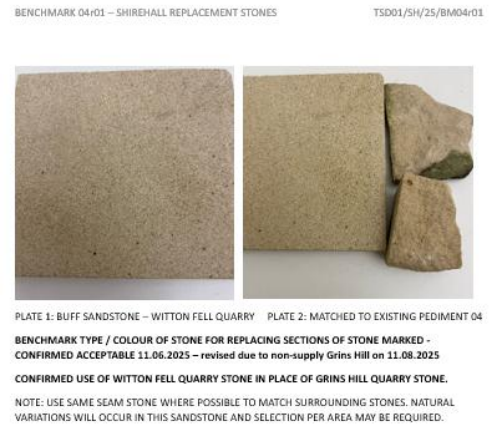
Plate 6: Benchmarking document for  
replacement stone approval.
