Ref: LBC/19/00686 – TSD09

## **MATERIAL SAMPLES CONDITION: CONDITION 2 APPLICATION – SHIREHALL REF: LBC/2019/00686**

Please find below photographs taken of the samples of materials proposed for the REPLACEMENT of cleaved / cracked / holed BRICKS (yellow imperial stock), on selected areas to North (rear) and East (left side) facade at the above applicant site:

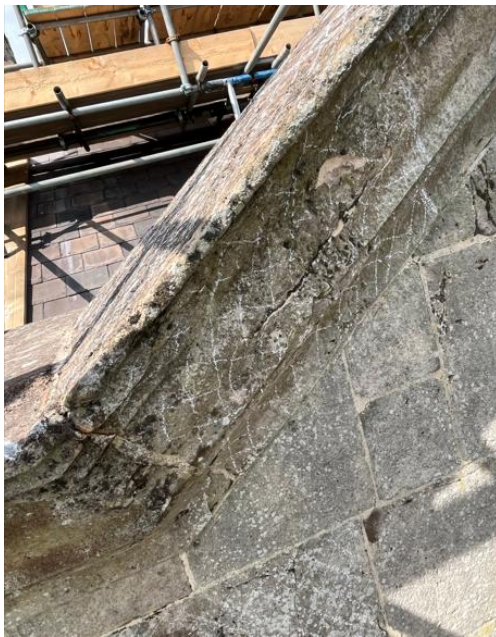
Plate 1: Existing stone face delaminations  
Marked with chalk and templated for replacement

Cleaved, split / holed or defective YELLOW STOCK BRICKS (North and East elevations) of Shirehall are to be replaced using new Witton Fell Quarry Buff sandstone slips (min 50mm thick), pinned with stainless steel rods to existing good stone, bedded on lime mortar with Blaenavon dark lime pointing over to exactly match existing BRICKS in type, colour, dimensions and fit.

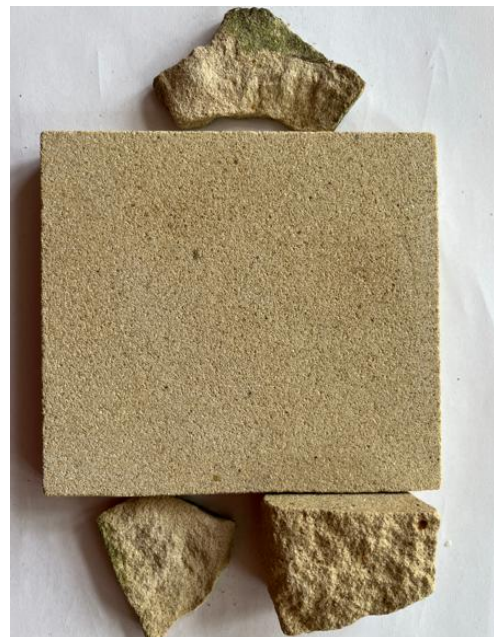
Plate 2: Witton Fell quarry, Buff sandstone  
matched to pieces of existing fallen stone at  
Shirehall.

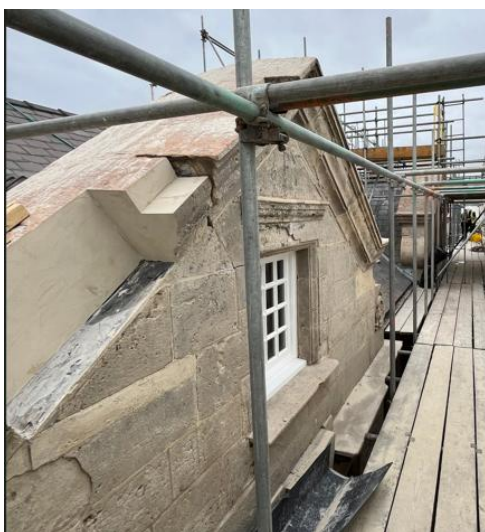
Plate 3: Cutting out defective stones

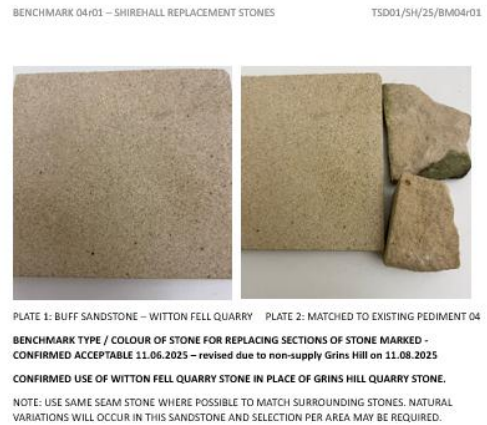
Plate 6: Benchmarking document for  
replacement stone approval.
