Ref: LBC/19/00686 – TSD12  
Date: 05/09/2025

## **MATERIAL SAMPLES CONDITION: CONDITION 2 APPLICATION – SHIREHALL REF: LBC/2019/00686**

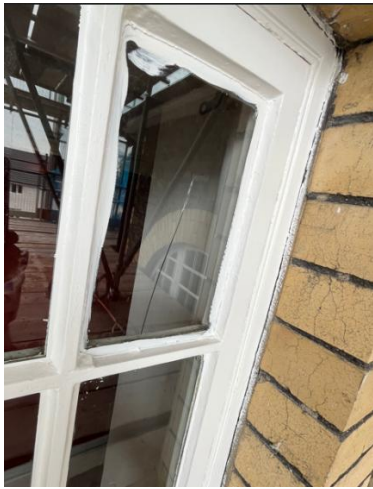
Plate 1: Broken / cracked existing windows

Cracked or broken GLASS WINDOWS (all elevations) of Shirehall are to be replaced using matched glass - to exactly match existing BROKEN PANE in specification, dimensions and fit. All sound original glazing remains.

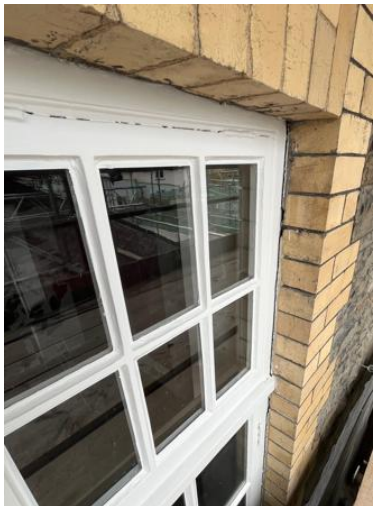
Plate 3: Replacement glazing pane

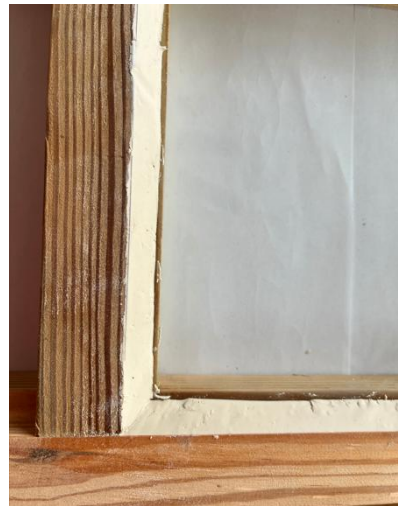
Plate 4: On site fitted and new putties to hold
