St Paul's Church Newport

Structural Appraisal of Existing Roof Structure Updated May 2015

Project Number: 6882

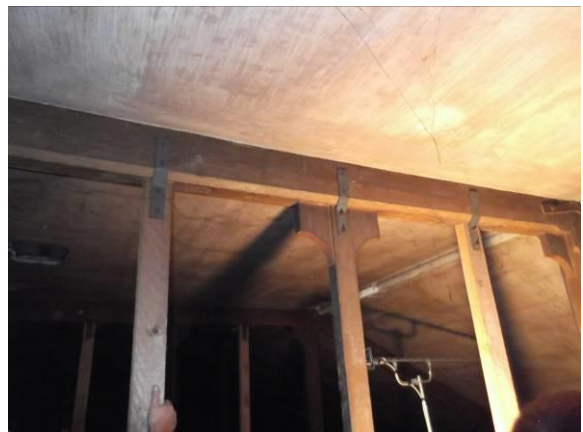
3.23. In the centre of the truss are what appear to be non-structural vertical members tennoned into the horizontal truss members, these have been strapped into the head beam and are connected at the base via wrought iron angle brackets.

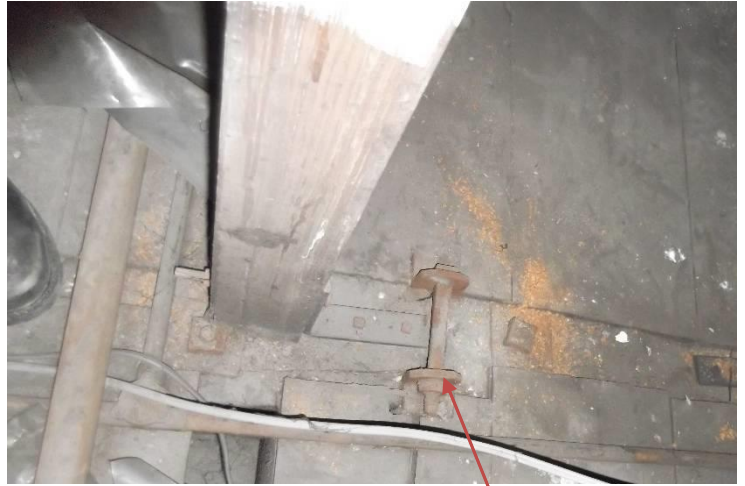
3.24. For five of the trusses the bottom chord of the truss is formed from two timber members. These are connected together near the middle of the span by a bolted cast iron plated connector. The timbers form a vertical half lap each with a lap length of est. 700mm. An iron plate is recessed into the base of the timbers. 4 bolts connect the plate to the timbers: two bolts per member, one through the main body and a second through the half lap near the tip. Iron straps wrap around the members at the tip of the half lap, these straps are through bolted above the top of the timber member.

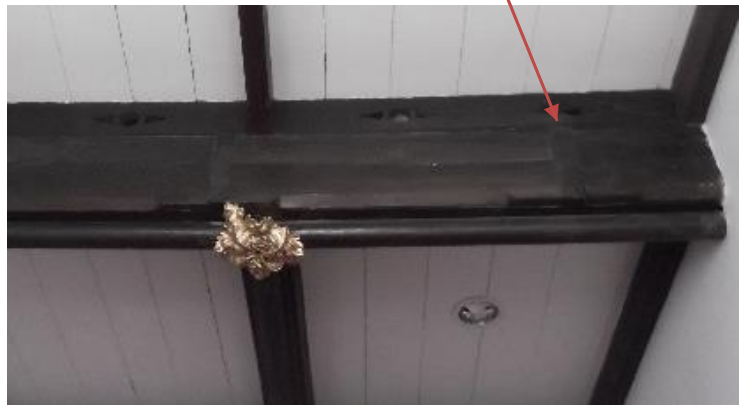
3.25. It is not clear if the plate and the straps are cast as one element or if they are independent elements. Each of the five trusses have differing setting out of the connection and bolt-strap arrangements leading the opinion that the straps and plate are not connected together.

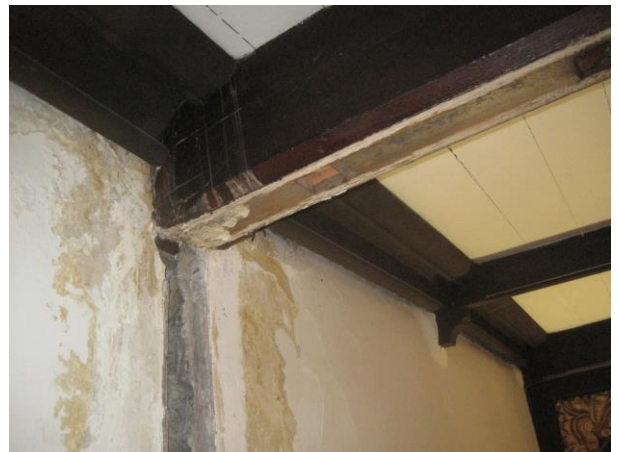
When inspected following the collapse of the bracket, no immediate distress was found to the truss bearing end, as reported at the time.

The photo shows the bearing end of the bottom chord of the truss in 2013.

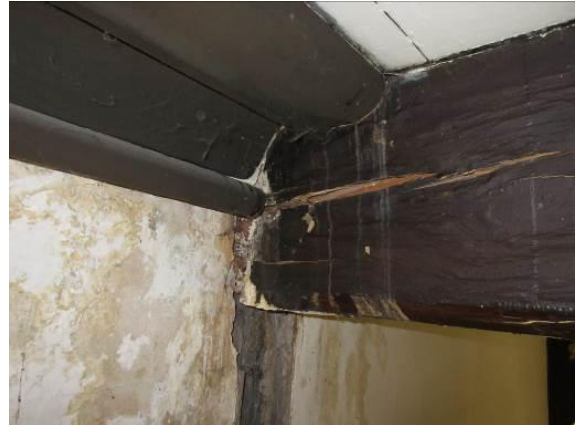
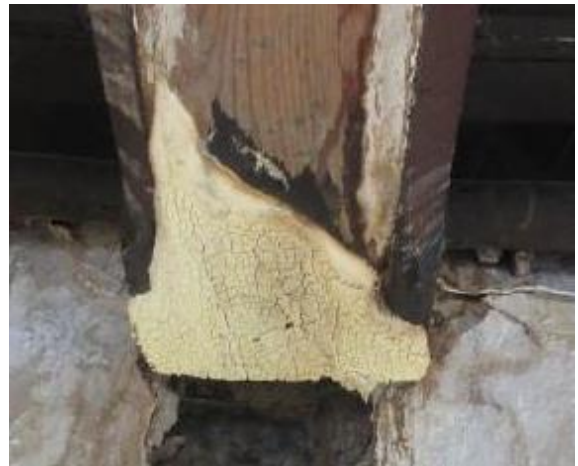
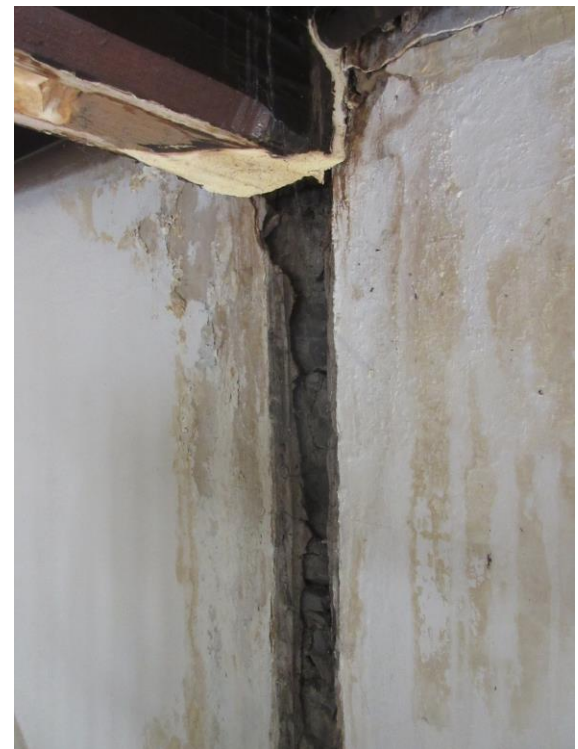
There is evidence of a significant fungal attack of the timber, visible on the underside. This will have contributed to the deterioration of the timber, and is almost certainly caused by continuing water ingress from the parapet gutter above the truss bearing.

The weather at the time of inspection and for the preceding couple of weeks had been dry, but there is significant damp staining on the wall at the truss location.

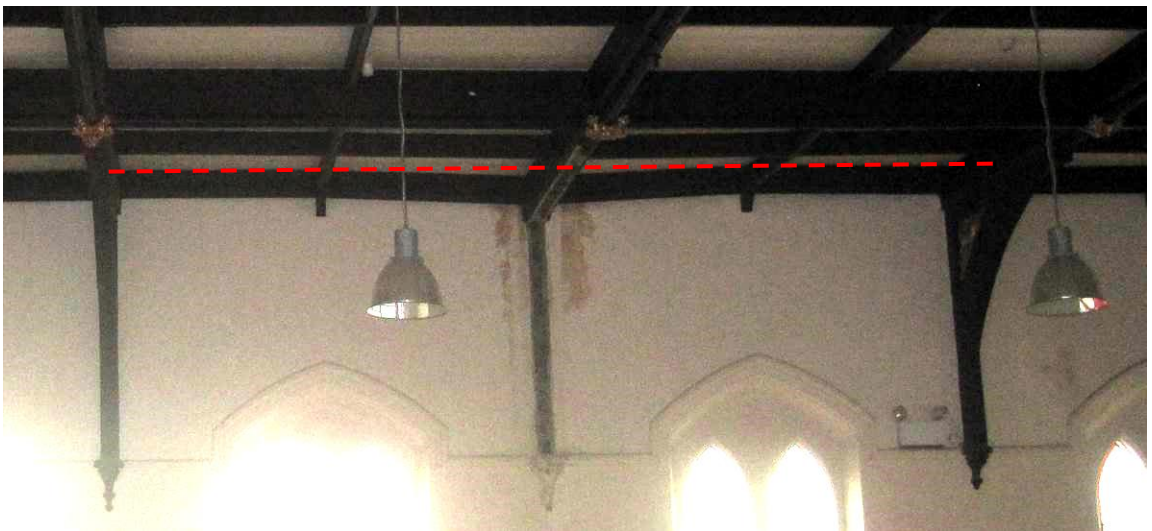
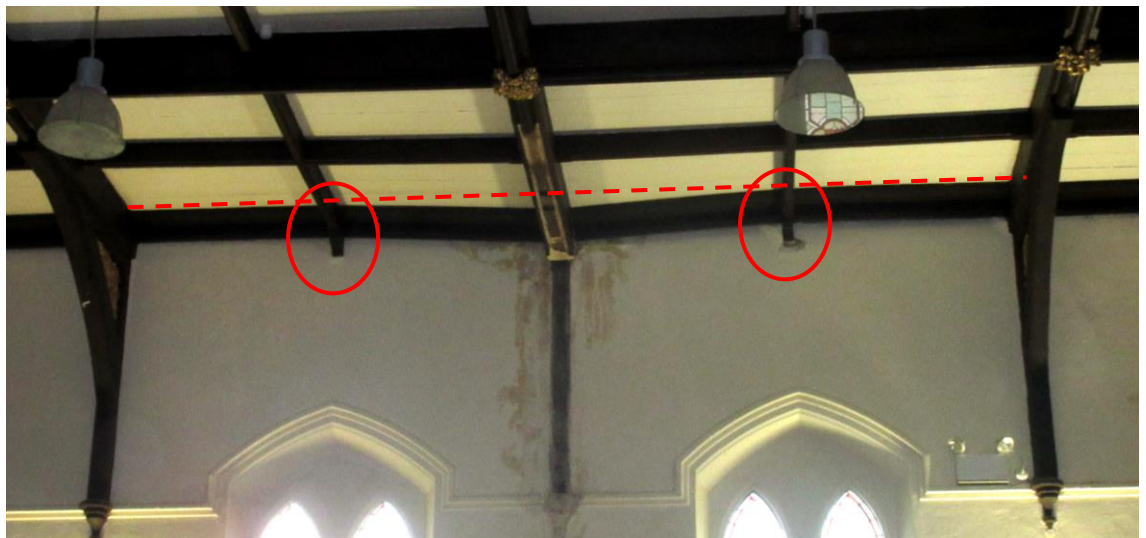
The images below (upper:2013, lower 2015) show the overall deflection of the bearing end of truss 4 relative to the adjacent trusses, and also the extent of the damp staining. It is clear that the defects are progressive, and the effects are spreading laterally across the ceiling, to the secondary timbers midway between the truss ends, which are being pulled away from the wall also.

This suggests that the continuing deterioration of the truss bearing is leading to load being shed into adjacent timbers which are not intended to carry it.

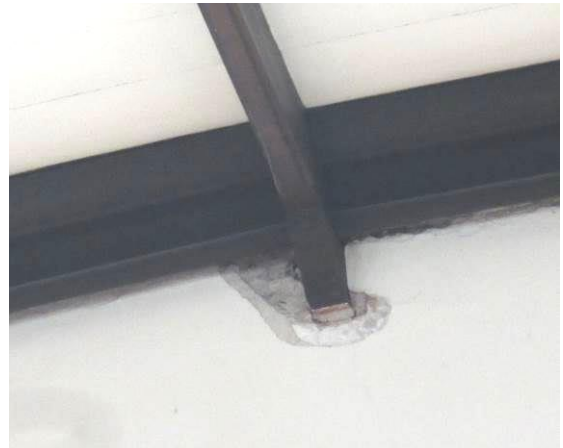
It was noted that plaster had fallen from the south wall at the bearing of a secondary ceiling timber midway between Truss 4 and Truss 3.

This suggests that the roof structure is pulling away from the wall here, which may be associated with the continuing deterioration of the end of Truss 4

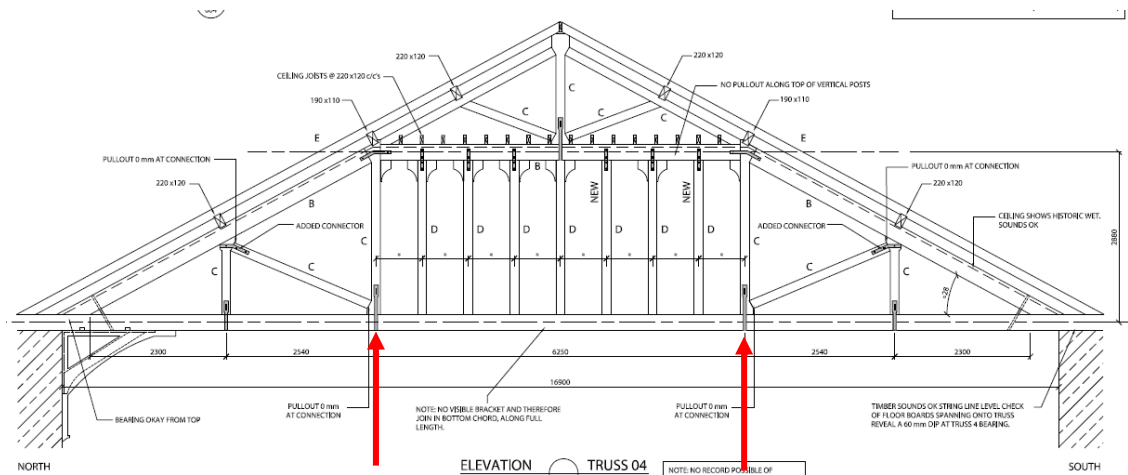
The condition of the bearing end of Truss 4 remains unknown, but it seems clear that it is likely to be actively deteriorating. The further plaster fall in the 2 weeks since the last inspection emphasises this.

The overall integrity of Truss 4 is therefore at risk. The currently proposed propping to the south bearing end will not address this, as it is intended to provide local support only. This is still required, but it is proposed that the truss be further propped at two other key support points:

It is proposed that this propping take the form of towers of scaffolding (traditional steel scaffolding, not a demountable aluminium access tower) erected under the truss, similar to that proposed for the south bearing end (see sketch 6882/SK05 attached). The towers are to be clad in solid boarding (plywood or similar) to a height of 1.8m to prevent unauthorized access to the scaffolding. The towers are to provide support to the bottom chord of the truss, but no attempt is to be made to jack it up.

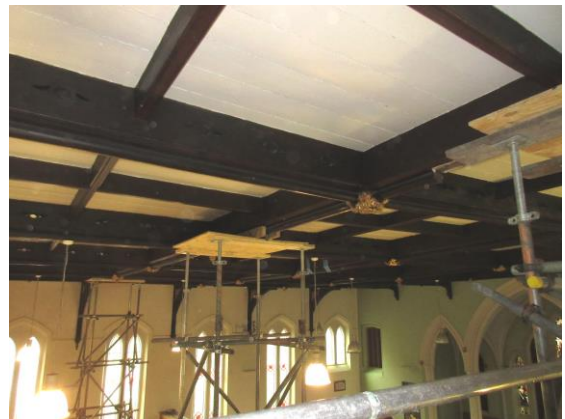
The three scaffold props are now in place, two beneath the queen post locations (see report SVR04), and one at the south bearing end.

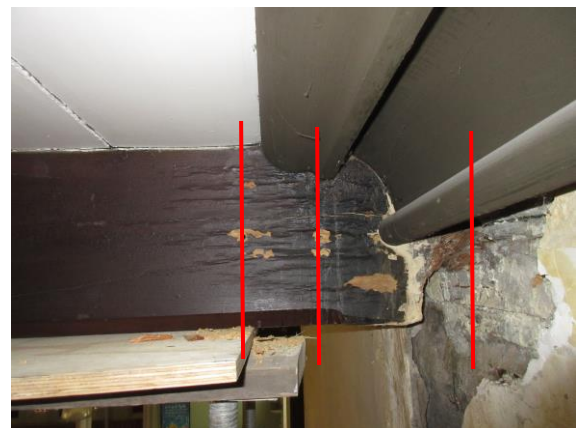
However, when the tie beam was drilled to assess its integrity away from the face of the wall, it was found to be reasonably sound 200mm from the wall, and apparently undamaged 340mm from the face of the wall.

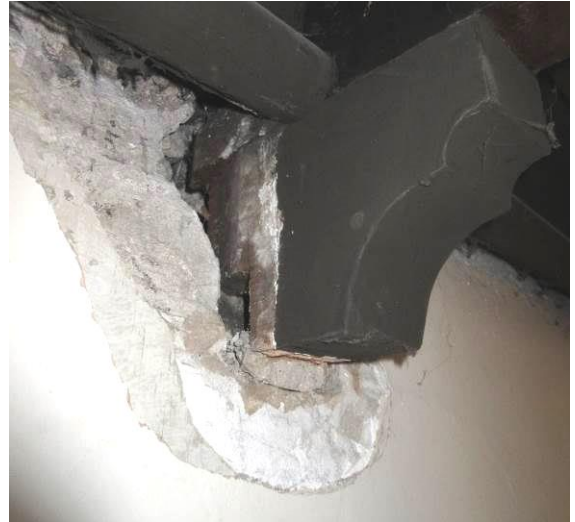
The ceiling beam between trusses 3 and 4 is pulling significantly out of the wall, and has minimal bearing remaining. The gap behind the timber moulding parallel to the wall is approximately 40mm.

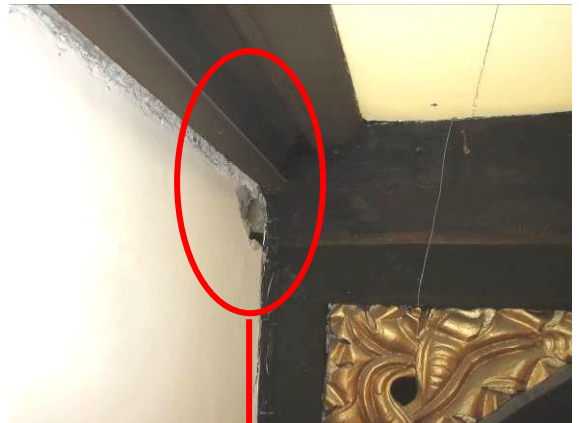
For comparison, the bearing end of Truss 3 was inspected, to establish the original relationship of the truss bearing end and the wall.

A small notch in the bottom chord is visible where it bears on the wall.

The timber is in reasonable condition.

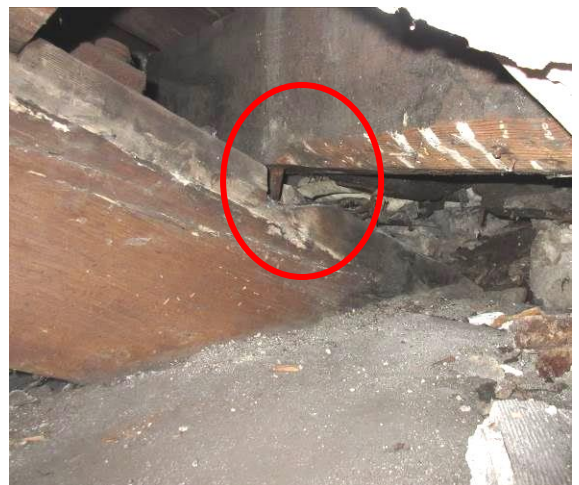
There is a purlin towards the bottom of the roof slope, which has separated from its bearing on the top chord of the truss. The purlin is continuous over the truss, probably spliced at trusses 3 and 5 on either side.

A vertical gap of about 45mm has opened up at the bearing onto truss 4, presumably demonstrating that the purlin is now spanning twice as far as originally intended, and providing unintentional support to the truss end, which is now to some extent hanging from it.

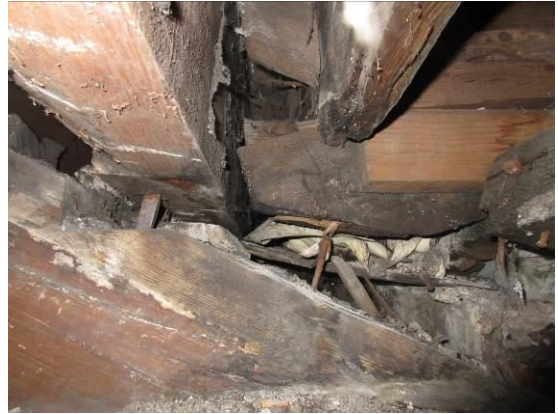
Beyond the purlin, further into the eaves, the underside of what appears to be the parapet gutter construction is partly visible. The timbers here are of various ages and in variable condition, suggesting a number of phases of maintenance/repair.

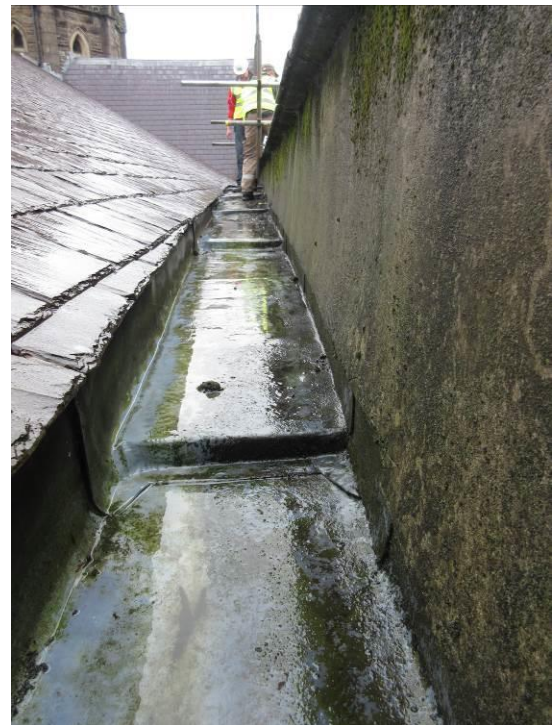
There is evidence of a proprietary 'painted' repair to a split in the lead of the gutter immediately above the bearing end of truss 4. It is not known when this repair was undertaken, and for how long the split was present prior to it being repaired.

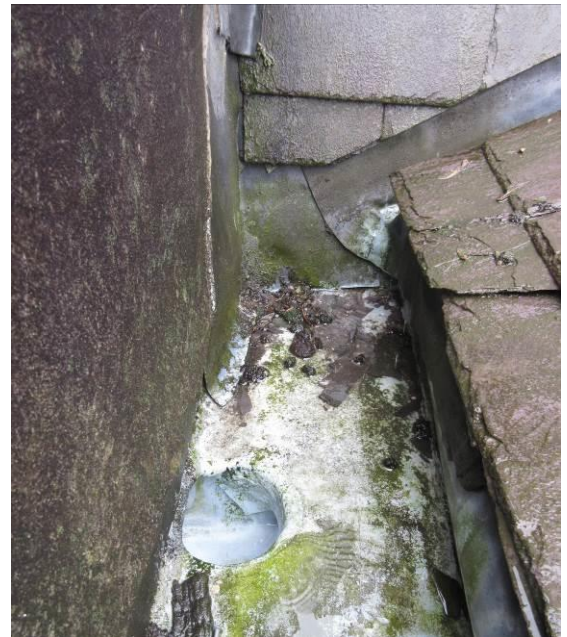
At the outlet at the west end (adjacent to the bearing end of Truss 1) the gutter is holding water and the lead detailing at the junction with the valley gutter appears untidy.

It is not clear if this may be contributing to the poor condition of the truss end below (in the first floor office).

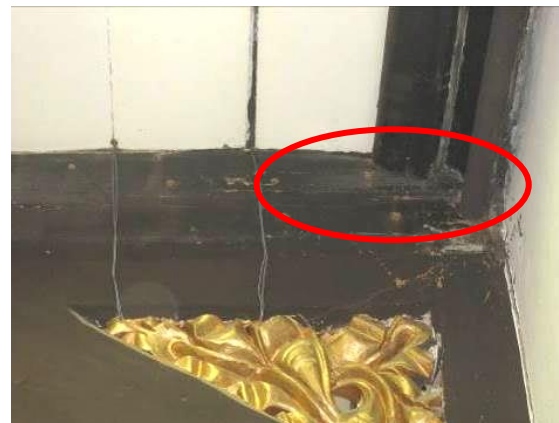
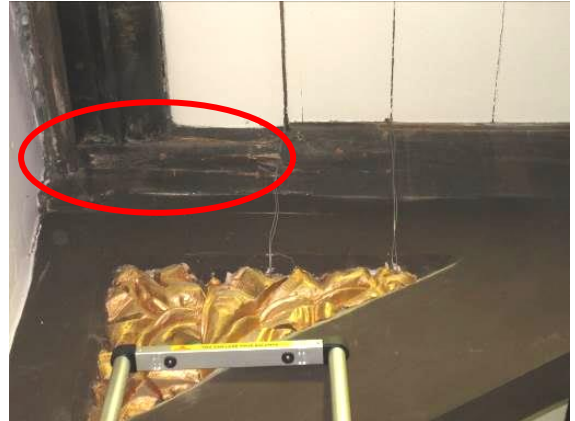
Inspection of Truss 1 south bearing end

The end bearing of Truss 1 (exposed in the first floor office) was inspected, and drilled to test the integrity of the timber.

Decay has occurred to the upper part of the bottom chord close to the bearing. This is in evidence on both sides of the timber.

Similar to Truss 4, the timber is in very poor condition close to the bearing but improves quite rapidly away from the wall.

As part of this design process, the current condition of the south bearing end of Truss 1 should also be considered further, to determine within what timeframe repairs are required here.

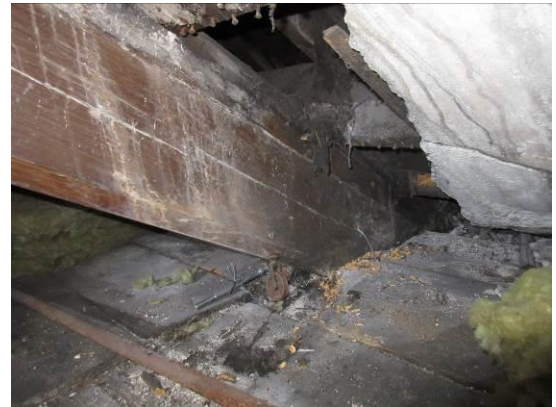
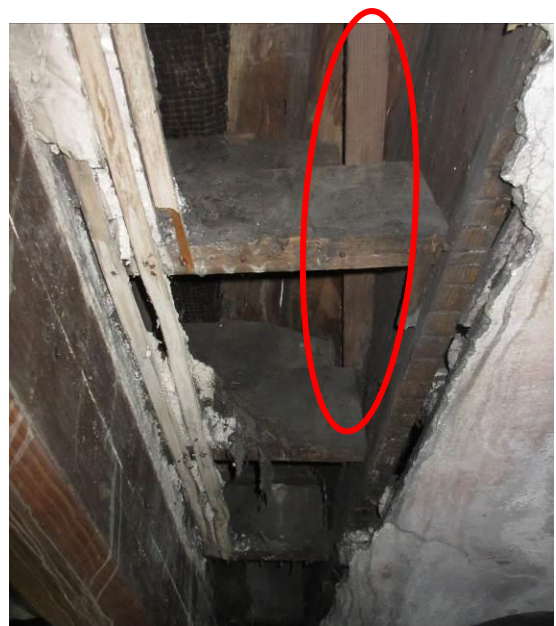
The image shows the valley 'blade' (circled) and the principal rafter of Truss 1 to the left.

There is clear evidence of historic water ingress beneath the valley, in terms of damp staining to plaster, etc.

It was not possible to inspect the bearing end of the Truss at the wall head.

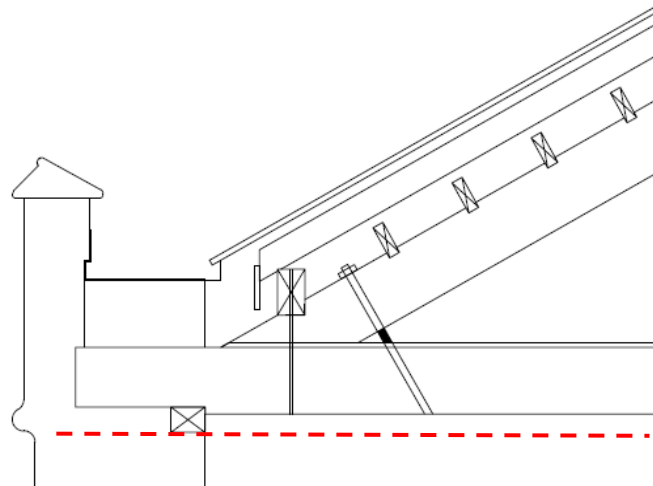
'As built'

The truss has dropped significantly at its bearing, as shown in the photographs above and the two sketch sections below, compiled from our site records. The upper shows the truss geometry 'as built', the lower Truss 4 as now found on site.

The red dashed lines provide a horizontal datum; the yellow highlighted area is the zone of severe, verging on total, timber decay.

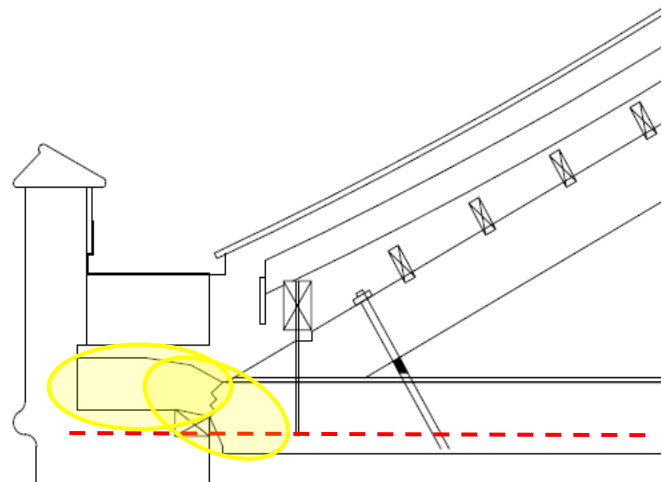
Current condition

The investigations confirm the very poor condition of the south bearing end of Truss 4, and the structural failure of the bottom chord or tie beam, where it bears on the external wall.

The repair is likely to comprise renewal of the bearing end of the truss in steel plate, flitched into the timber (ie located on its centerline) to reduce the visual impact on the truss tie beam where it is visible in the main worship space. The likely extent of the steel plate is shown indicatively on the sketch below. It will be held in place by steel through bolts, and the deteriorated timber will be renewed to match the existing. A concrete padstone will be cast in the wall for the new steelwork to bear on.

Stripping of the slate roof finishes local to the truss end, removal of a section of the parapet gutter and its framing, renewal of anticipated decayed common rafter ends, renewal of decayed wall plate, renewal of gutter framing and leadwork, making good of finishes internally.
