ARBORICULTURAL REPORT

Health and Condition Survey

**140 Caerleon Road
Newport
NP19 7GS**

Date: July 2024

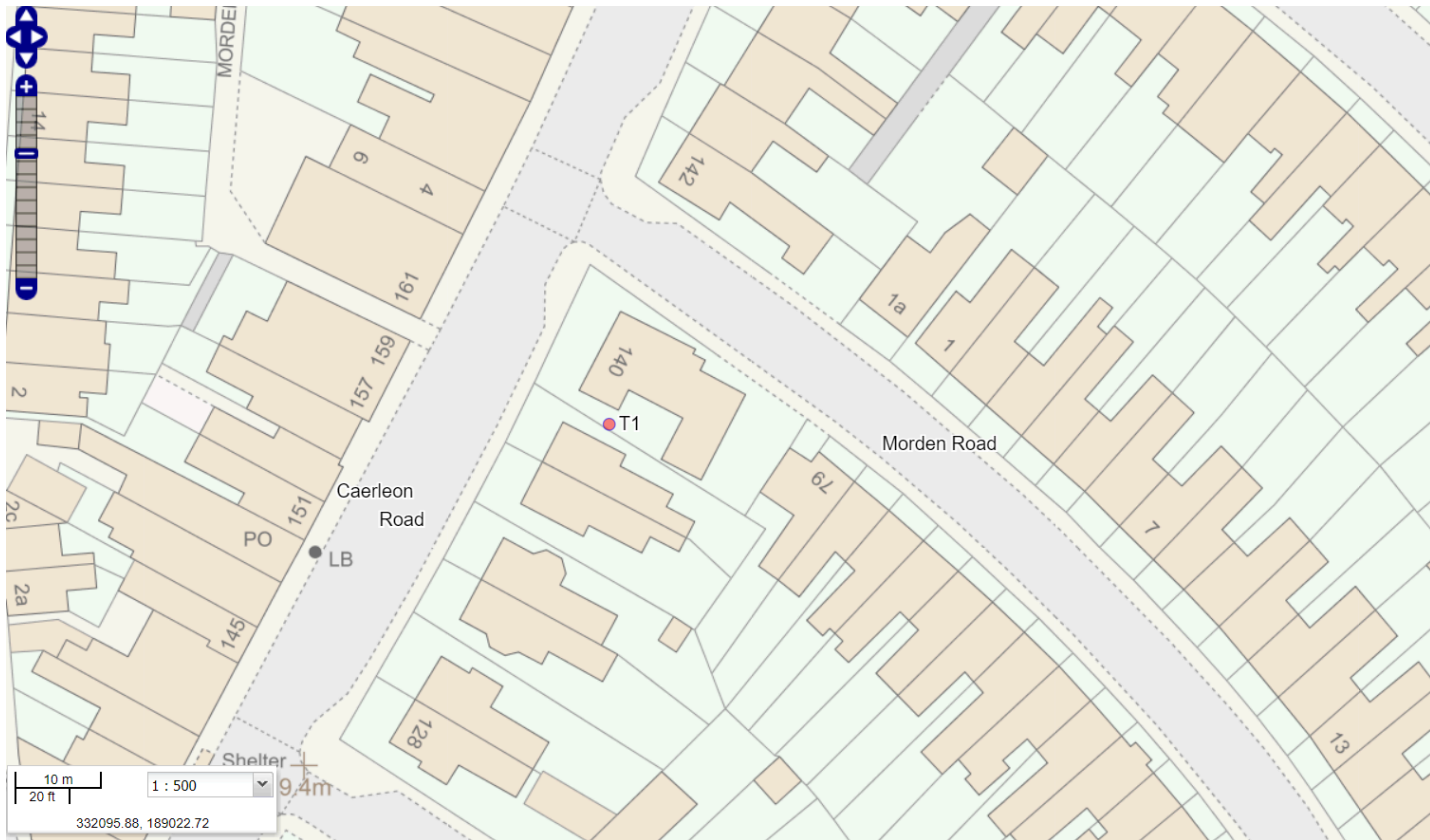
TREE AND SITE LOCATION PLAN

This property is currently disused and can be accessed from the Caerleon or Morden roads. The single tree that is on the site is shown in IMAGE 1. The tree is located on the southern side of the main building and at its nearest point the main stem is 1.88 metres from the building.

1. To prevent further structural damage this tree should be removed to within 50cms of the existing ground level.
2. All recommended tree work should be completed within the recommended time period in Table 1 and in accordance with BS3998:2010 Tree Work - Recommendations and current good practice.
3. Prior to any tree pruning or removal the structure of the tree should be checked for roosting, nesting or hibernating species such as bats and birds. (Refer to the biodiversity section below).
